Construction Impact & Management Statement for soon to be Lodged Development Application

MARCH 2019

84 Hilma Street

COLLAROY PLATEAU, NSW

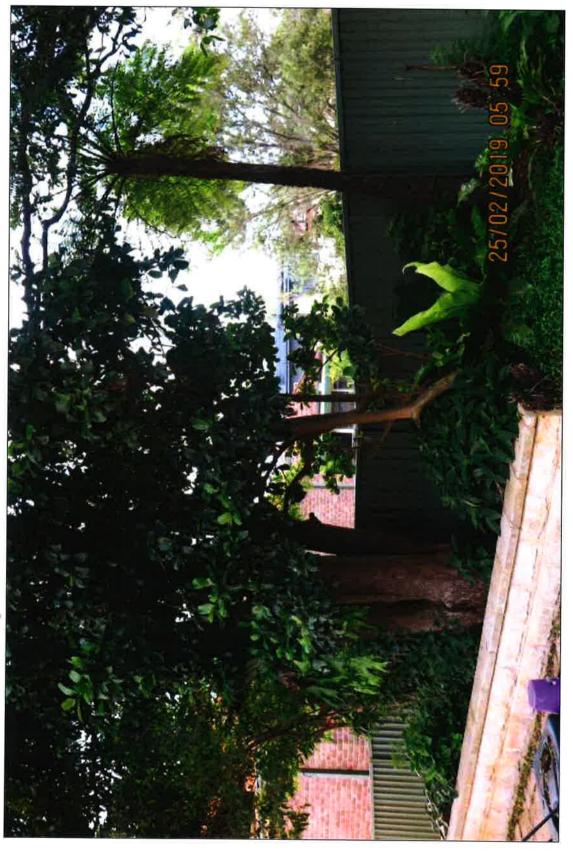
Figure 2: Illustrates location & condition of the discussed tree plus above photograph of rear yard character.

ľ											
	Identification	Height (m)	Height Crown (m)	ОВН (ш)	TPZ (m)	SRZ (m)	Age	Health/ Vigour	Retention/ Significance Values	Form/Habit	Comments
	Syzygium australe Bush Cheny Lilly Pilly	00.6>	<10.50	<0.40 <0.40 <10.50 Multiple trunks*	6.96	2.69	Long term established	Good Se Good	High/ High	Typical	Replace: Tree is considered as incompatible with the DA proposal on two grounds, (i) the percentage of pruning required for reasonable new built form &) tree canopy separation plus (ii) ground level disturbance to its supporting root system.

- Protected Tree #1 is to be Replaced with at least one (1) new canopy tree.
 Below is a list of considered to be suitable new tree species for the subject site.

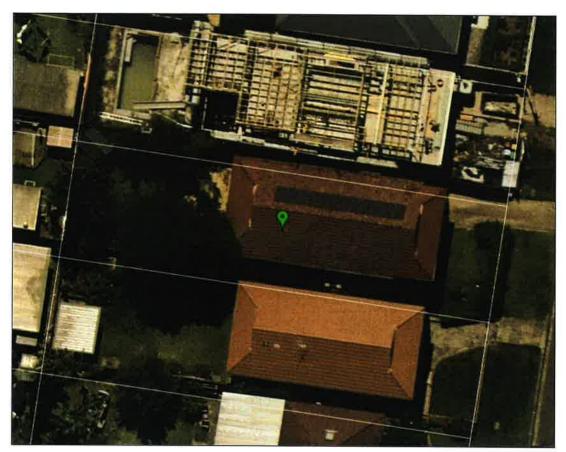
The discussed tree is confirmed to be located within the subject site with a significant percentage of its canopy within both the subject site & the adjoining rear yard of 82 Hilma Street. See below 4 March 2019 'aerial photograph', courtesy of the NearMap® (webtool).

Figure 3: Above, illustrates the subject site & adjoining properties (as confirmed on Monday, 4 March 2019).

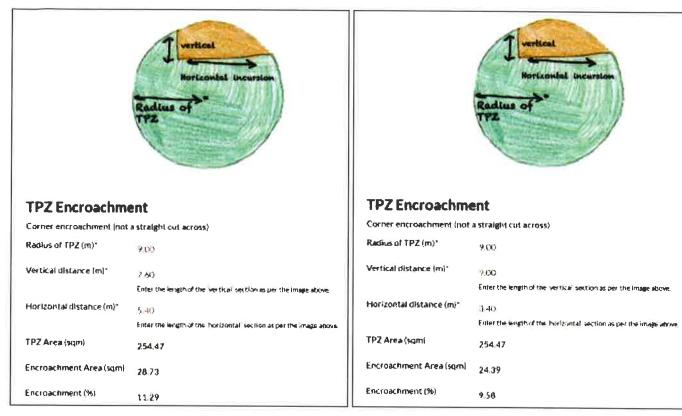
The proposed works create by definitions within the Australian Standard (AS4970-2009 Protection of trees on development sites, (see Chapters 3, 4 & 5) a 'Major Encroachment' of Tree Protection Zone (from herein TPZ) total surface area. The breach is calculated to be an approximate 20.00% encroachment, i.e. 53.12m^2 of a total TPZ surface area of 254.70m^2 . See below calculation tool results for the residence & the swimming pool/swimming pool surrounds which have been combined to get the above stated outcome.

Figure 4: The above calculations (left side for residence footprint at ground level, right side for swimming pool/swimming pool surrounds at ground level) are CONSERVATIVE. Simply, there may be a very slight (i.e. less than 1.5% variation) if calculated using more accurate software.

With a Structural Root Zone (from herein SRZ) radial distance of 3.14m a 'significant breach' is proposed (but not able to be supported) as per the plans provided. Combining the TPZ total surface area 'Major Encroachment', the (on paper totally unacceptable) SRZ radial distance breach & 'Canopy Pruning' essential to establish the proposed residence roofline footprint & reasonable 'tree canopy/new built form separation' (in this situ defined as 2.00m) this tree relative to its Useful Life Expectancy (from herein ULE) cannot be assessed as able to be viably retained. Simply, the proposed works are totally incompatible with the discussed tree with respect to its ULE if disturbed as has been proposed.

On this basis the proposed works require the discussed tree to be replaced with at least one (1) new similar at maturity 'canopy density footprint' tree species. The same outcome could be achieved using more than one (1) new but smaller at maturity new tree species. A list of potentially new suitable to the subject site 'canopy providing trees is provided as part of the Site Specific "Tree Plan of Management". (See page 17 for easily separated/printable form body of this document Site Specific "Tree Plan of Management".)
