GEOTECHNICAL RISK MANAGEMENT POLICY FOR PITTWATER

REPORT TO ROYAL HASKONING DHV

Figure 3: Section A Showing Potential Landslide Hazards

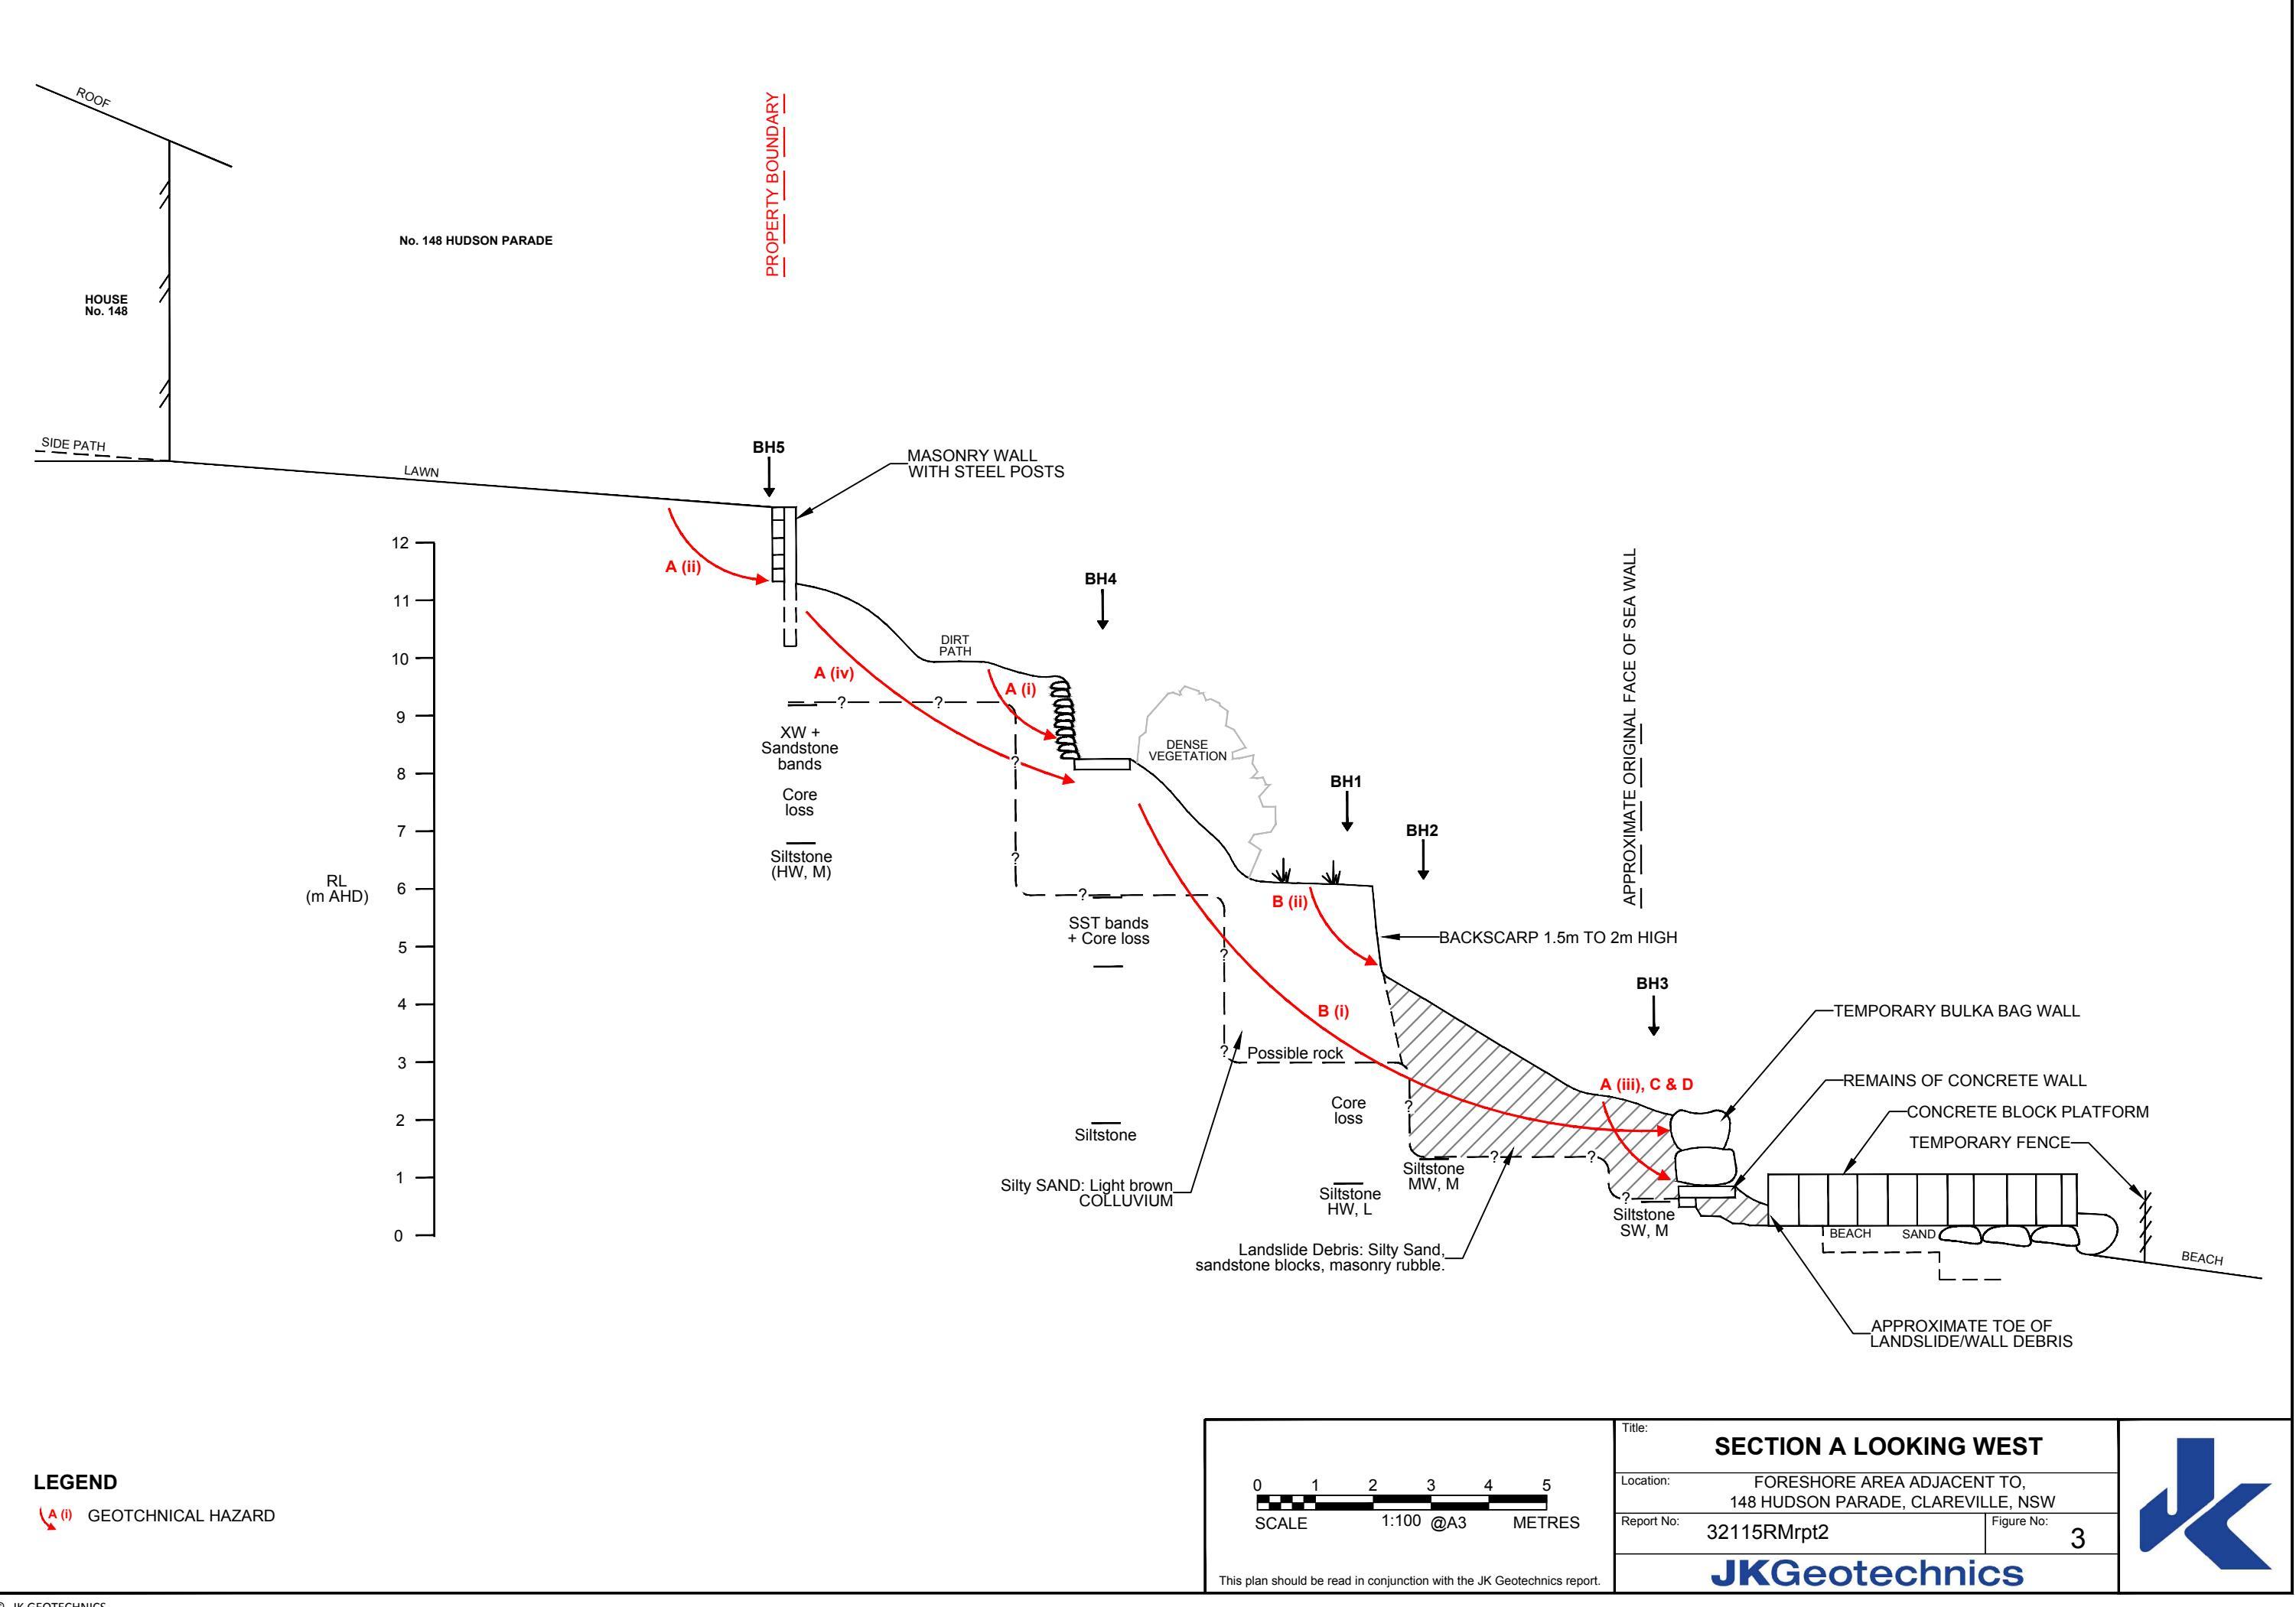
We recommend that the summary of observations which follows be read in conjunction with the attached Figures 2 and 3.

At the time of our most recent inspection (5 February 2021), the site featured a landslide about 15m wide which, at the foreshore, extended westwards from the timber boatshed (the eastern end) to a neighbouring roughly mortared sandstone block retaining wall (1.5m height) founded on the bedrock platform, to the west. The width of the landslide was similar to the northern frontage of the upslope property (No. 148 Hudson Parade) and the length of the failed seawall.

The landslip extended upslope (to the south) about 6m to 7m from the rear of the temporary bulka bag retaining wall supporting the toe area of the landslide. The bulka bag wall comprised stacked gravel filled bags with plastic matting landward of the crest to provide temporary erosion protection from any wave overtopping. The bulka bag wall had been placed on the remains of the overturned concrete seawall (about 0.3m thick) which had failed in February 2020 and covered a portion of the stepped siltstone bedrock wave cut platform. The stepped bedrock wave cut platform extended east and west beyond the site boundaries.

The portion of foreshore slope landward of the backscarp featured a narrow dilapidated concrete stepped walkway that extended south-westwards upslope from the boat shed. A stacked and roughly mortared sandstone retaining wall (maximum 2m height) formed the upslope side of the stepped walkway and in places the wall face was eroding and/or blocks were missing.

A neighbouring gabion retaining wall (about 1m height) founded on the bedrock platform, extended eastwards from the eastern end of the site. The gabion wall face was bulging. Behind the crest of the gabion wall the neighbouring steep overgrown foreshore area sloped down to the foreshore at a maximum of about 35°. The slope surface was uneven and several trees were leaning over from vertical back to the south.

The neighbouring roughly mortared sandstone seawall to the west was uneven and the eastern end adjacent to the toe of the foreshore slope area within the site, was in a dilapidated condition.
