Arboricultural Impact Assessment Report

Prepared for: Northern Beaches Essential Services Accommodation

Site: 16 Wyatt Avenue Belrose NSW 2085

Date: June 2021

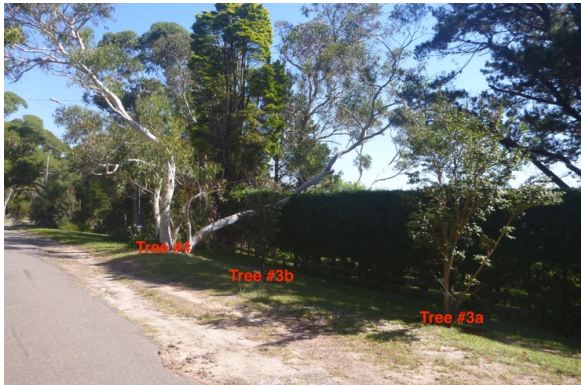
Figure 4 – Trees 3a, 3b, 4

3b	<i>Lagerstroemia indica</i> (Crepe Myrtle)	A1	2	1.5	footprint	Tree is located within the footprint of the new entrance pathway. Tree is a small species that can be easily replaced with an advanced specimen	Remove and replace
4	<i>Eucalyptus haemastoma</i> (Scribbly Gum)	A2	7.92	3.63	27.3% Major	The construction of the bin room, front pathway and new kerb and gutting will result in a 27.3% incursion into the TPZ of the tree which is considered major under section 3.3.3 of AS4970-2009. Excavations required for the bin room (6.08%) and front pathway (7.87%) are to be done by hand under the supervision of the project	Retain

The construction of the bin room and front path must be done on or above existing grade. The slabs should consist of a bed Sandy loam with 1.5-2cm stone chips or gravel with no fines to act as a skeleton and be used as a subbase .This will help limit damage to the fine feeder roots. Then once the base is down and compacted, permeable paving/ asphalt /concrete can be placed on top.

The two *Lagerstroemia indica* (Crepe Myrtle) scheduled for replacement on the Council owned nature strip are to be replaced using the same species planted from a container of no less than 100L in size.

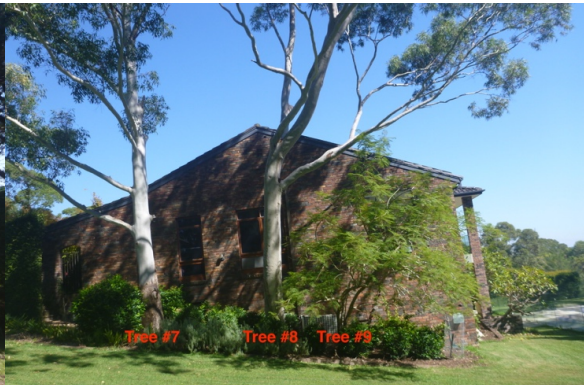
Figure 5 – Trees 7, 8, 9 close to existing dwelling

Tree ID	Species	Retention value	TPZ radius (m)	SRZ radius (m)	TPZ encroachment	Discussion / Conclusion	Recommendation
7	<i>Eucalyptus saligna</i> (Sydney Blue Gum)	Z2	7.92	3.08	41.29% Major	Construction of the new driveway and building results in a 41.29% incursion into the TPZ and SRZ of the tree which is considered major under section 3.3.3 of AS4970-2009. Tree is eligible for removal as it is located 2.9m from the existing dwelling as the property is located within the 10/50 bushfire clearing entitlement.	Remove and replace
8	<i>Corymbia citriodora</i> (Lemon Scented Gum)	Z2	6.84	2.85	40.34% Major	Construction of the new driveway and building results in a 40.34% incursion into the TPZ and SRZ of the tree which is considered major under section 3.3.3 of AS4970-2009. Tree is eligible for removal as it is located 2.9m from the existing dwelling as the property is located within the 10/50 bushfire clearing entitlement.	Remove and replace

9	<i>Jacaranda mimosifolia</i> (Blue Jacaranda)	Z2	2	1.77	26.17% Major	Tree identified as an exempt species under the Northern Beaches Council Tree Regulatory Controls. The tree is also located 2.7m from an existing dwelling and is eligible for removal under the 10/50 bushfire clearing entitlement.	Remove and replace
10	<i>Casuarina cunninghamiana</i> (River She Oak)	A1	6.84	2.74	8.71% Minor	Demolition of the existing ancillary farm shed will equate to an 8.71% incursion into the TPZ of this tree which is considered minor under section 3.3.2 of AS4970-2009. The tree is located on an embankment, with works occurring well below the natural ground level of the tree. No works are predicted to impact the root system or canopy of this tree. Due to topography, tree protection is not required.	Retain
11	<i>Casuarina glauca</i> (Swamp She Oak)	A2	3.6	2.34	0%	Construction works occurring outside of protection zone below grade of tree, due to topography and location, tree protection is not required.	Retain

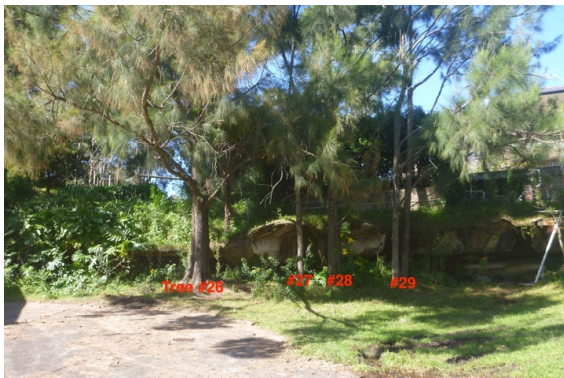
Figure 10 - Trees 26, 27, 28, 29

26	<i>Casuarina cunninghamiana</i> (River She Oak)	A2	7.32	3.04	37.71% Major	Construction of the new driveway will result in a 37.71% encroachment into the TPZ and SRZ of this tree which is considered major under AS4970-2009. The location of the tree at the base of the rock shelf may indicate that the tree has formed an asymmetrical root plate, towards the area of incursion. This would result in a greater impact to the root system of the tree, affecting its uptake of water and nutrients through loss of root mass. This tree is not retainable under the current proposal and will require replacement. Tree is eligible for removal under the 10/50 entitlement as it is located 7.6m from an existing farm building greater than 50m ² in area.	Remove and Replace

Tree ID	Species	Retention value	TPZ radius (m)	SRZ radius (m)	TPZ encroachment	Discussion / Conclusion	Recommendation
27	<i>Casuarina glauca</i> (Swamp She Oak)	A2	2.16	1.85	Footprint driveway	The tree is located within the footprint of the proposed driveway, this tree would be required to be removed and replaced under the current proposal.	Remove and Replace
28	<i>Casuarina glauca</i> (Swamp She Oak)	A2	4.44	2.51	Footprint	The tree is located within the footprint of the proposed driveway, this tree would be required to be removed and replaced under the current proposal.	Remove and Replace
29	<i>Casuarina glauca</i> (Swamp She Oak)	A2	3.84	2.41	Footprint	The tree is located within the footprint of the proposed driveway, this tree would be required to be removed and replaced under the current proposal.	Remove and Replace
30	<i>Casuarina cunninghamiana</i> (River She Oak)	A2	6	2.67	0%	No works are projected within the TPZ of this tree. Additional TPZ fencing required to protect root system from heavy machinery compaction and activities listed in section 6.7 of this report.	Retain

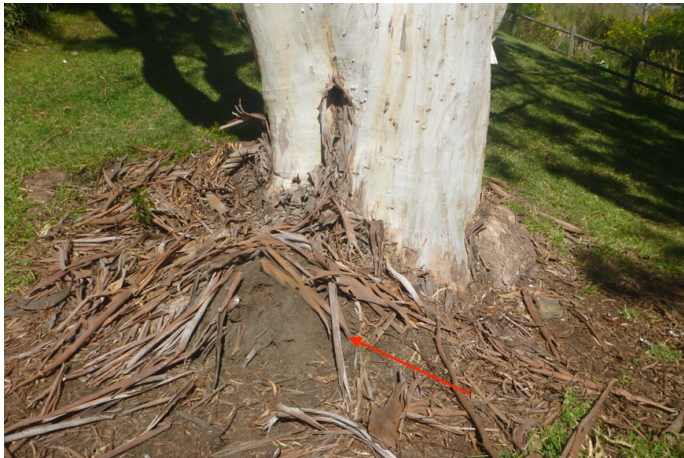
Figure 14 - Tree 37, red arrow shows subterranean termite nest

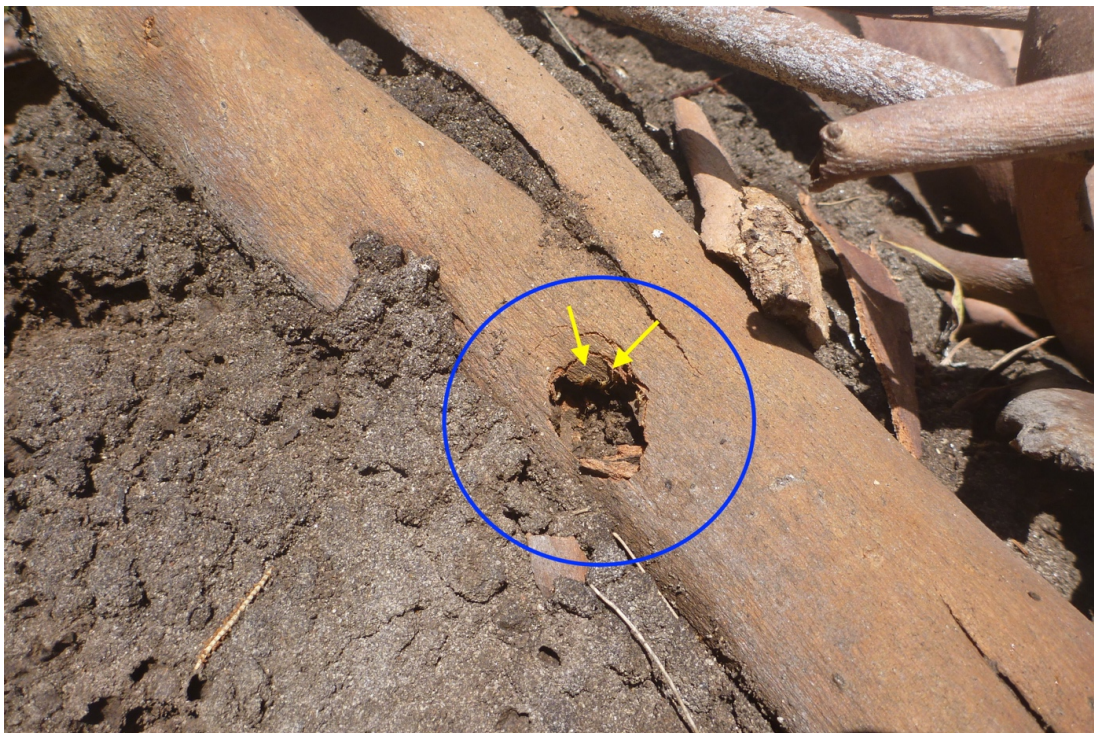
Figure 15 - Blue circle shows hole from probe to determine if nest is active, yellow arrow shows active termites
