RESIDENTIAL DEVELOPMENT 38 UNDERCLIFF ROAD, FRESHWATER NSW

Reference: P3371_01 rev2

19 December 2024

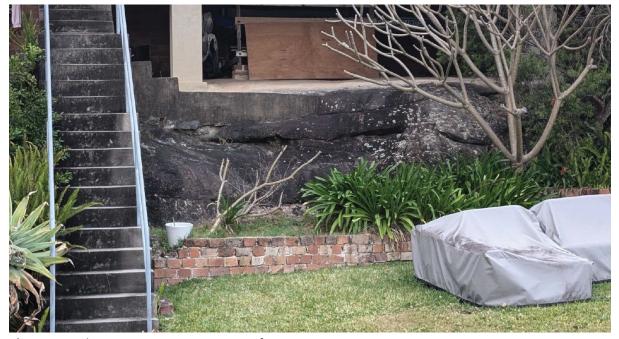
Sandstone outcrops at a cliff line approximately 1.5 m high near the centre of the site. The cliff line trends roughly east-west and comprises moderately weathered, medium strength Hawkesbury Sandstone.

Photo 1: Sandstone outcropping at centre of site.

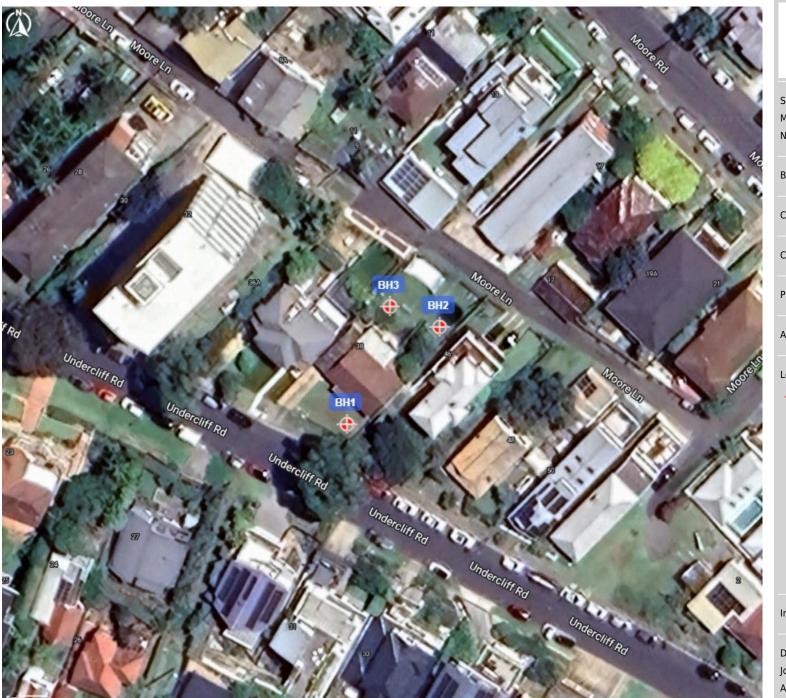
Borehole Location Plan

Borehole locations are shown on Figure 1 and borehole logs are presented in Appendix A.
