arboricultural impact assessment 62 hillside road, newport

22nd June 2016

prepared by Melanie Howden - Ass. Dip. Hort. (Haw. Ag. C.), SoA. Arb. MAIH, MIACA

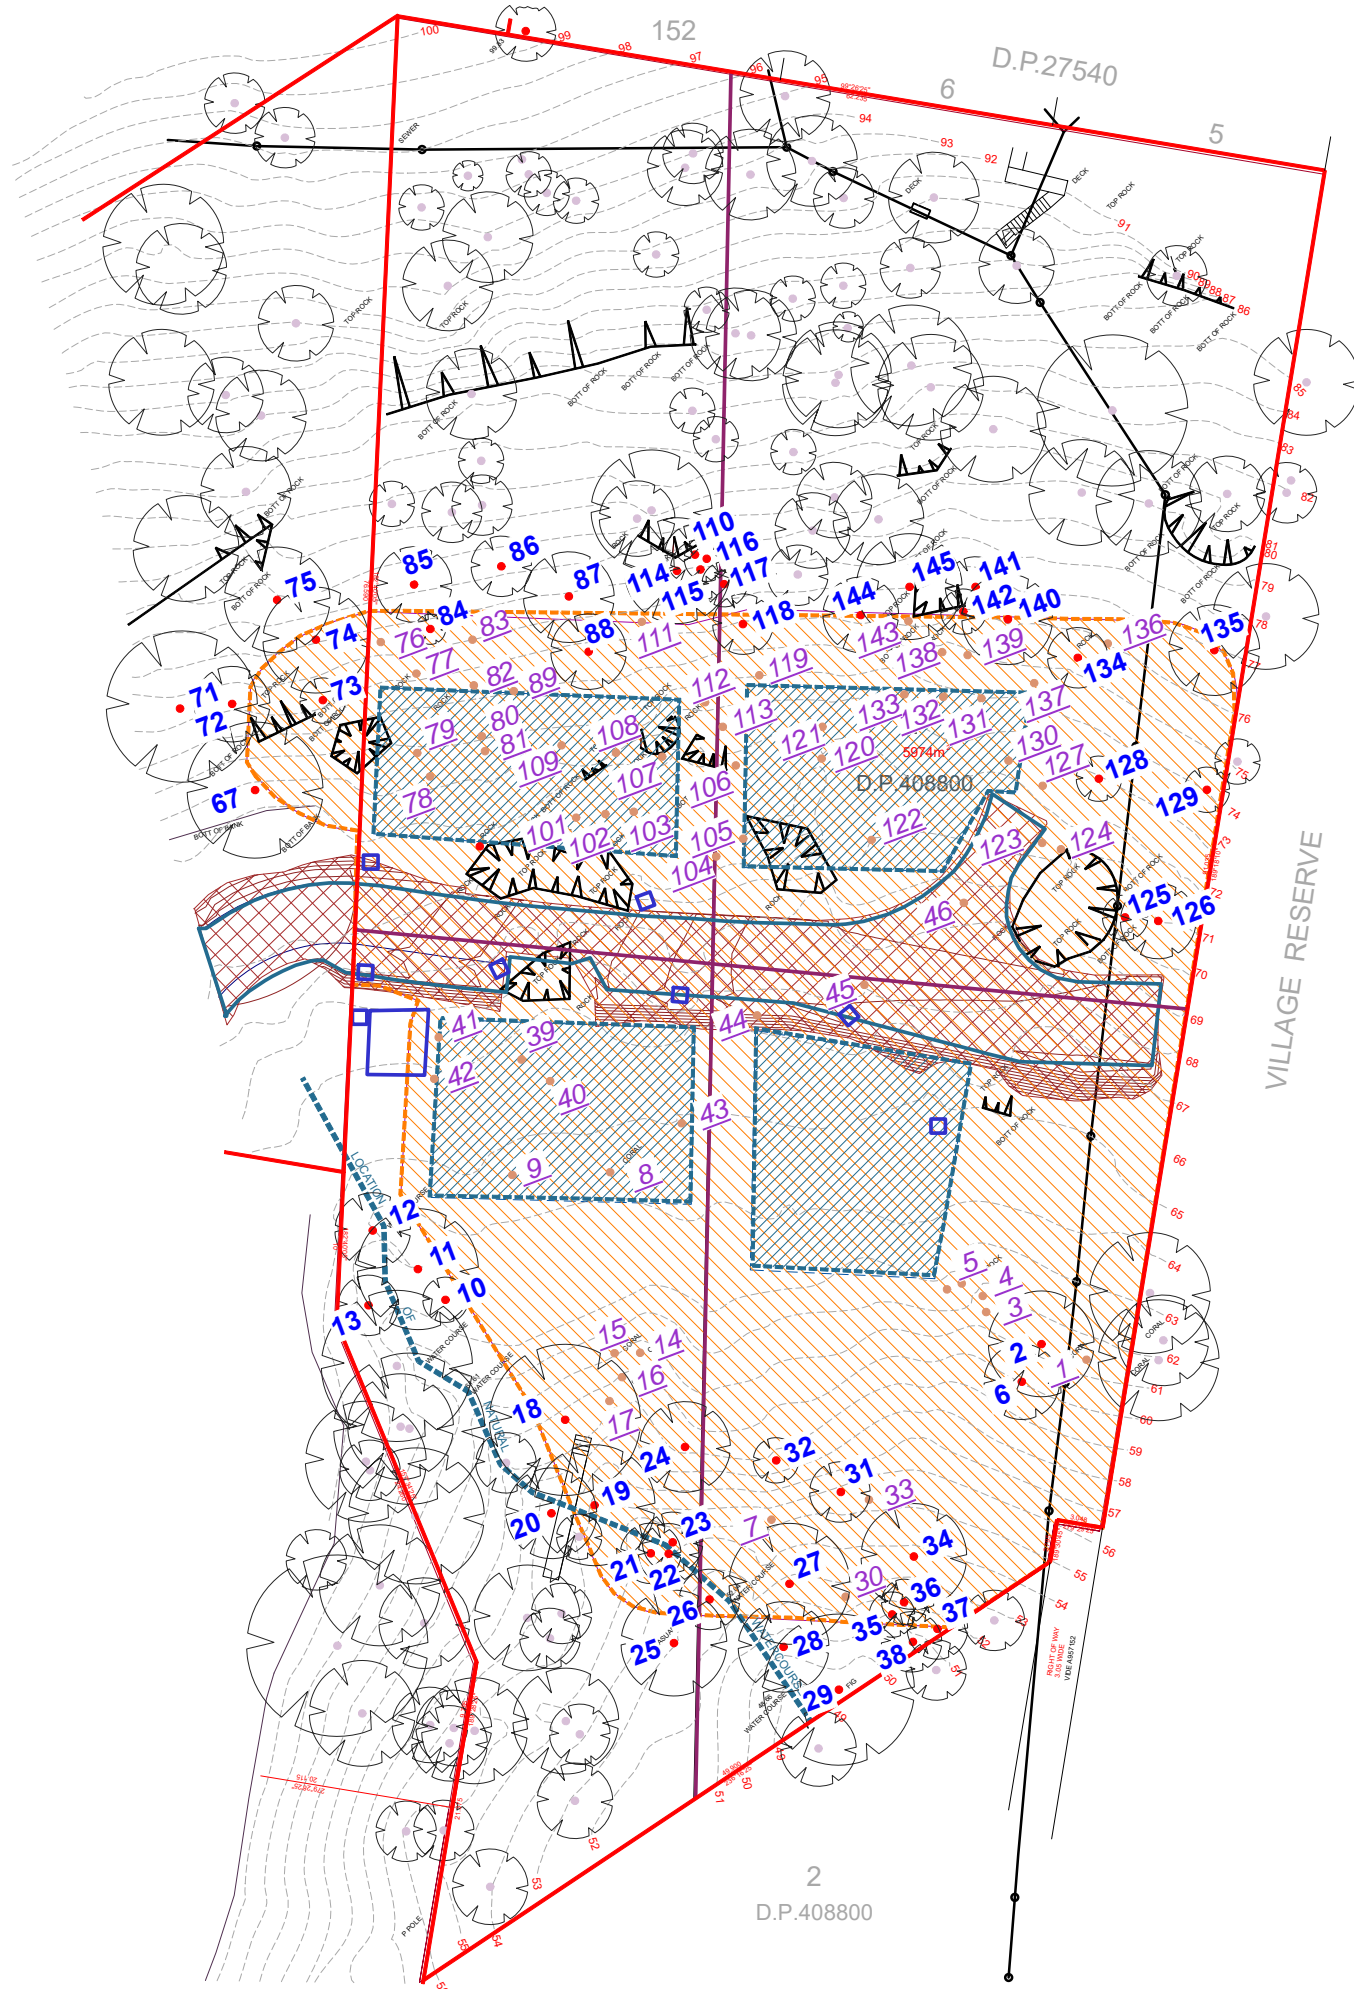
- trees to be retained
- trees to be removed
- trees to be retained - beyond proposed works areas & APZ

Prior to earthworks or construction activities, the removal of the identified trees should be undertaken with particular attention given to ensure that no damage occurs to the canopy foliage and branch structure of the trees to be retained.

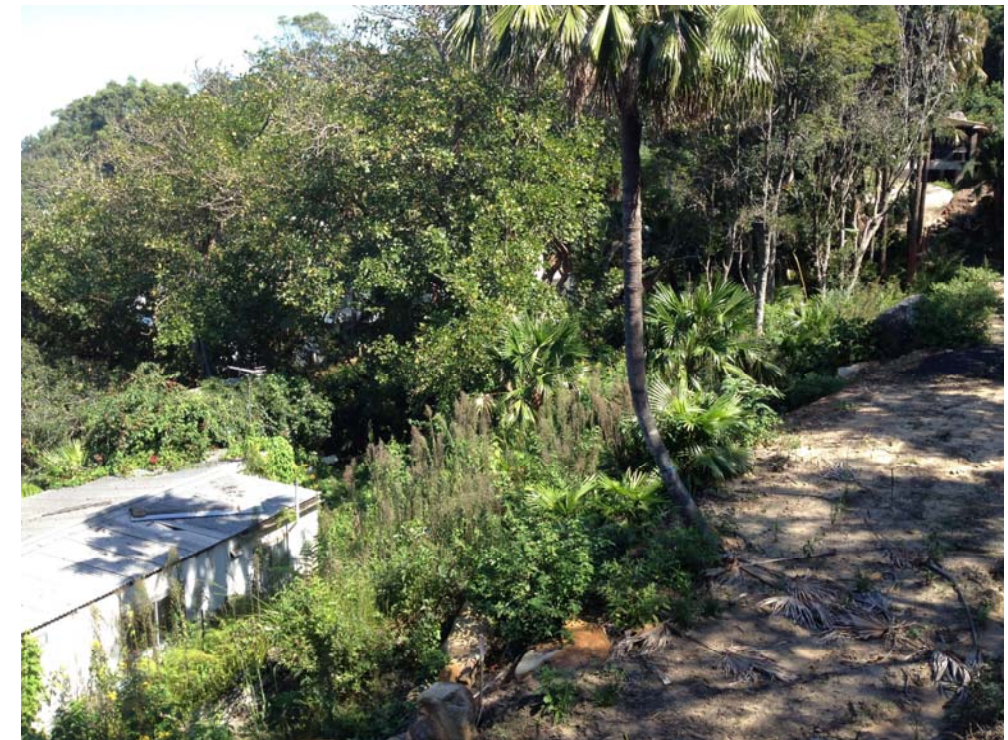
Figure 16.1 The existing earthen track looking south west with the palm, Tree No. 45 in the foreground.

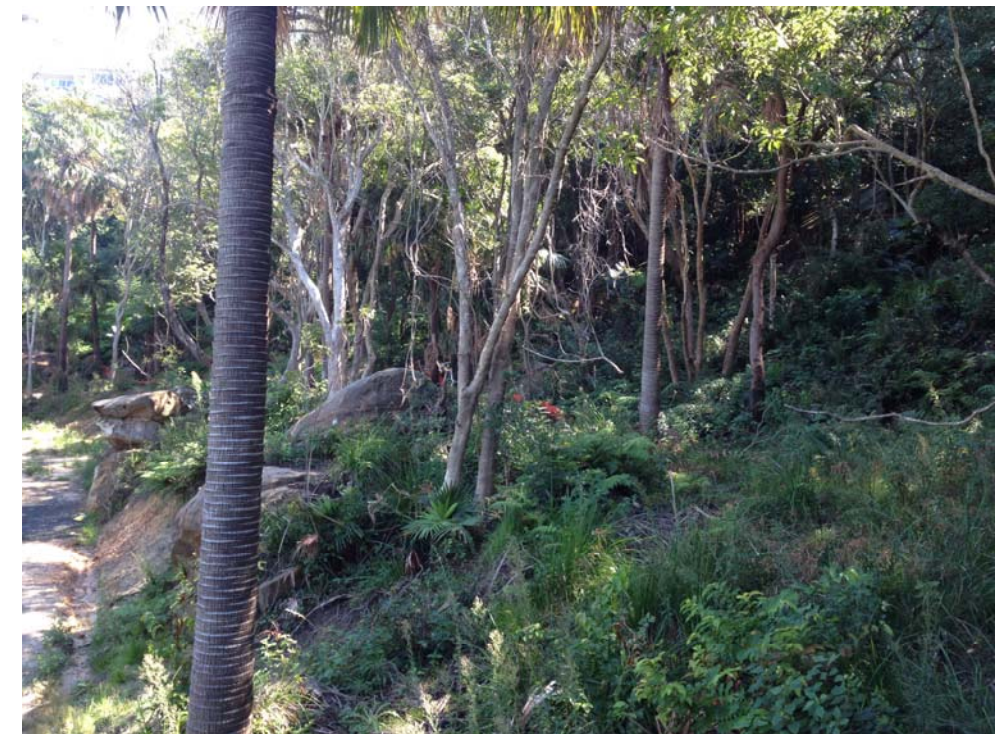
46	<i>Livistona australis</i>	Cabbage Palm	13	5	380	450	Mature single trunk tree with an elevated rounded form; an upright trunk/s and balanced canopy and branch development. No evidence of significant branch pruning.	Moderate L/scape Sig.	The tree appears stable and its branch attachment appears sound. The tree is considered to be in good health and displays good vigour.	Very Good	5%	None evident	1	On site	2.10	13.86
67	<i>Livistona australis</i>	Cabbage Palm	12	4	300	390	Mature single trunk tree with an elevated rounded form; an upright trunk/s and balanced canopy and branch development. No evidence of significant branch pruning.	Moderate L/scape Sig.	The tree appears stable and its branch attachment appears sound. The tree is considered to be in good health and displays good vigour.	Excellent	5%	The base of the palm is being undercut by the adjacent watercourse.	1	On adjacent Allotment	1.90	11.35

Figure 16.2 The vegetation upslope of the earthen track looking west with palm, Tree No. 46 in the foreground.
