Tree Assessment

Proposed incline lift, boat shed & landscaping

**6 Wirringulla Avenue
Elvina Bay**

Report Prepared by Julia Stanton
Syncarpia Vegetation Management
24 Windsor Street Tarbuck Bay 2428
juliastanton@ozemail.com.au
Mob:0417398050
October 2020

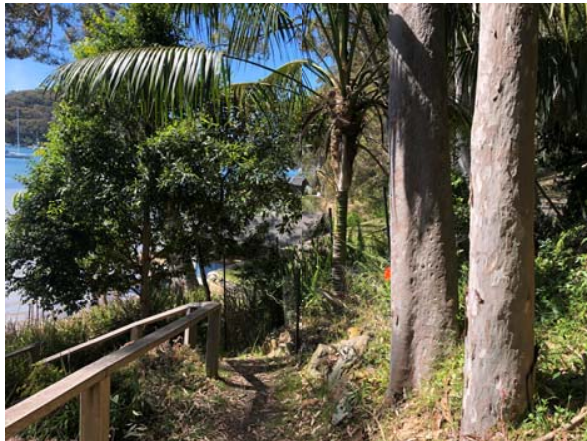
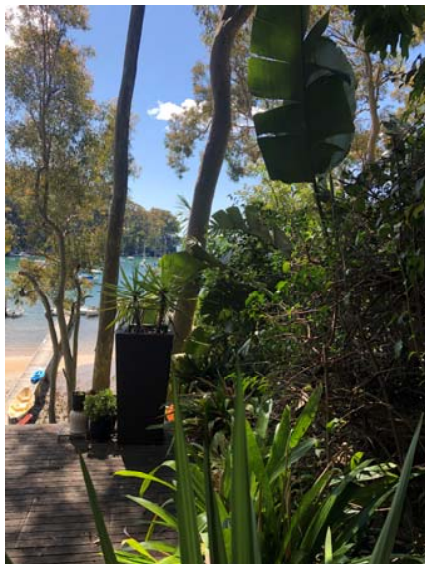
Minor excavation to accommodate incline lift footings @ 2m from this tree.

Minor excavation to accommodate incline lift footings @ 2.75m & 2m

Photo 1 existing vegetation incline lift foot print & Trees 3 & 4

Photo 2 Existing vegetation on incline lift foot print & Trees 3 & 4

Tree to be protected & retained, tree protection fencing & trunk protection to be established prior to commencement of site works, all excavation within 5m to be undertaken by hand, final location of footings to be flexible to accommodate any significant structural roots that may be encountered.

Tree to be protected & retained, tree protection fencing to be established prior to commencement of site works, all excavation within 5m to be undertaken by hand, final location of footings to be flexible to accommodate any significant structural roots that may be encountered.

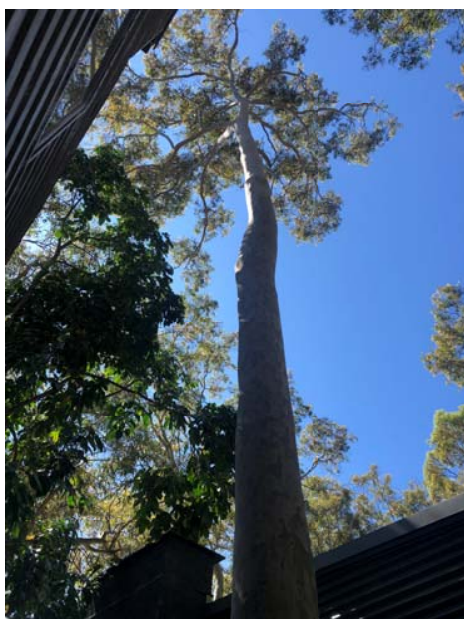
Tree 5 is a mature specimen of *Corymbia maculata* (Spotted Gum) in fair - good health condition.

Minor excavation to accommodate incline lift footing @ 2m

Photo 3 Tree 5 on neighbouring property

Tree to be protected & retained, tree protection fencing & trunk protection to be established prior to commencement of site works, all excavation within 5m to be undertaken by hand, final location of footing to be flexible to accommodate any significant structural roots that may be encountered.

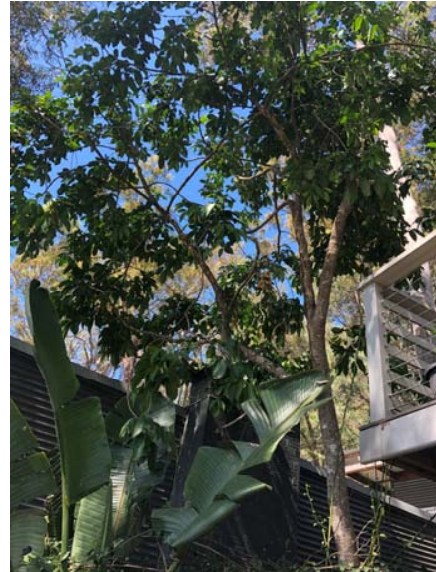
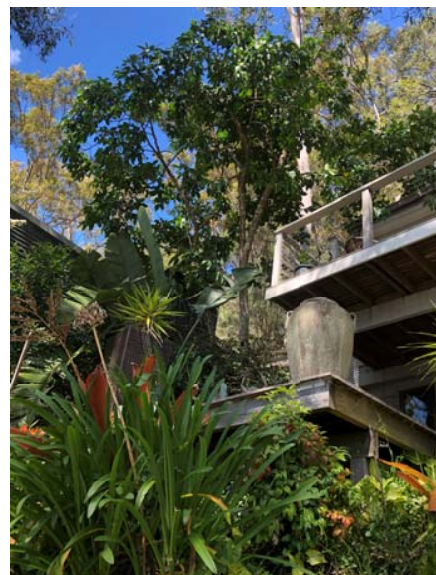
Tree 6 is a semi-mature specimen of the planted native rainforest shrub / small tree *Melicope elleryana* (Pink Euodia) good health & condition. This tree is direct conflict with the incline lift cart & is proposed for removal.

Photo 4 Tree 6 to be removed

Photo 5 Tree 6

6	<i>Melicope Elleryana</i>	Pink Euodia	Sm	10	6m	200	200	Good	Good	Planted native small tree located on property boundary	To be removed In conflict with inclinor cart	5a	4	Low

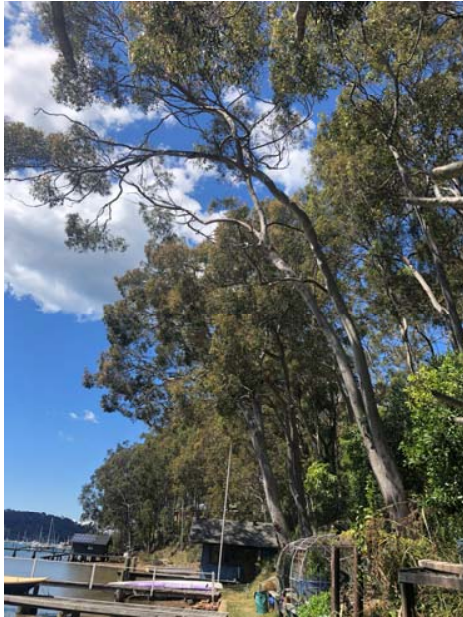
Tree 2 is a mature specimen of *Corymbia maculata* (Spotted Gum) in fair - good health & condition.

Calculated SRZ 3m. Minor encroachment into calculated SRZ with a small area of excavation to accommodate rear of boat shed located at 2.75m.

Excavation for boatshed within 15% of calculated TPZ.

Photo 1 Trees 2 & 1

Tree to be protected & retained, tree protection fencing to be established prior to commencement of site works, all excavation within 5m to be undertaken by hand.

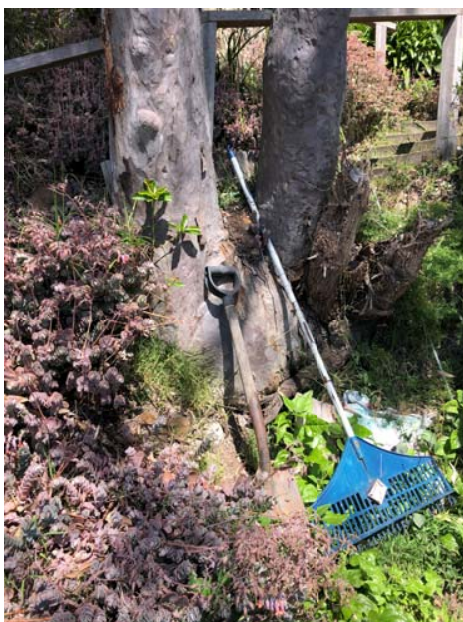
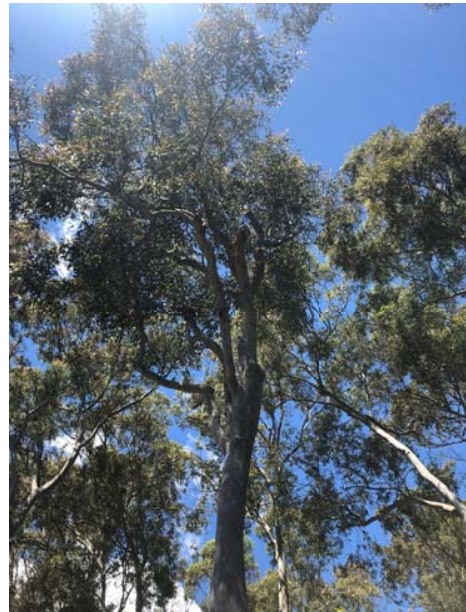
Tree 1 is a semi mature specimen of *Corymbia maculata* (Spotted Gum) in fair health & condition and of fair form. This tree is located adjacent to existing access track & existing modified garden area with evidence of previous modification / disturbance to natural soil levels in calculated SRZ & TPZ. This tree is located 2.75m from excavation associated with proposed incline lift and adjacent to timber retaining walls to stabilize the bank for access stairs, lawn & garden.

Photo 2 Tree 1

Photo 3 Tree 1

To compensate for tree loss & to enhance the ecological values of the site 3 healthy structurally sound specimens of *Corymbia maculata* (Spotted Gum) are to be planted in a suitable location in the foreshore vegetation area.

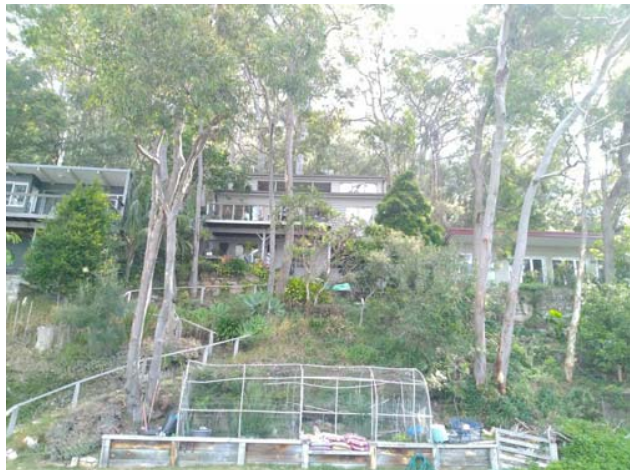
Photo 4 view of site from Pittwater Trees 1 & 2 in foreground
