Structural Report- Retaining Wall

58B Suffolk Avenue, Collaroy

Job No: 93159

2nd February 2018

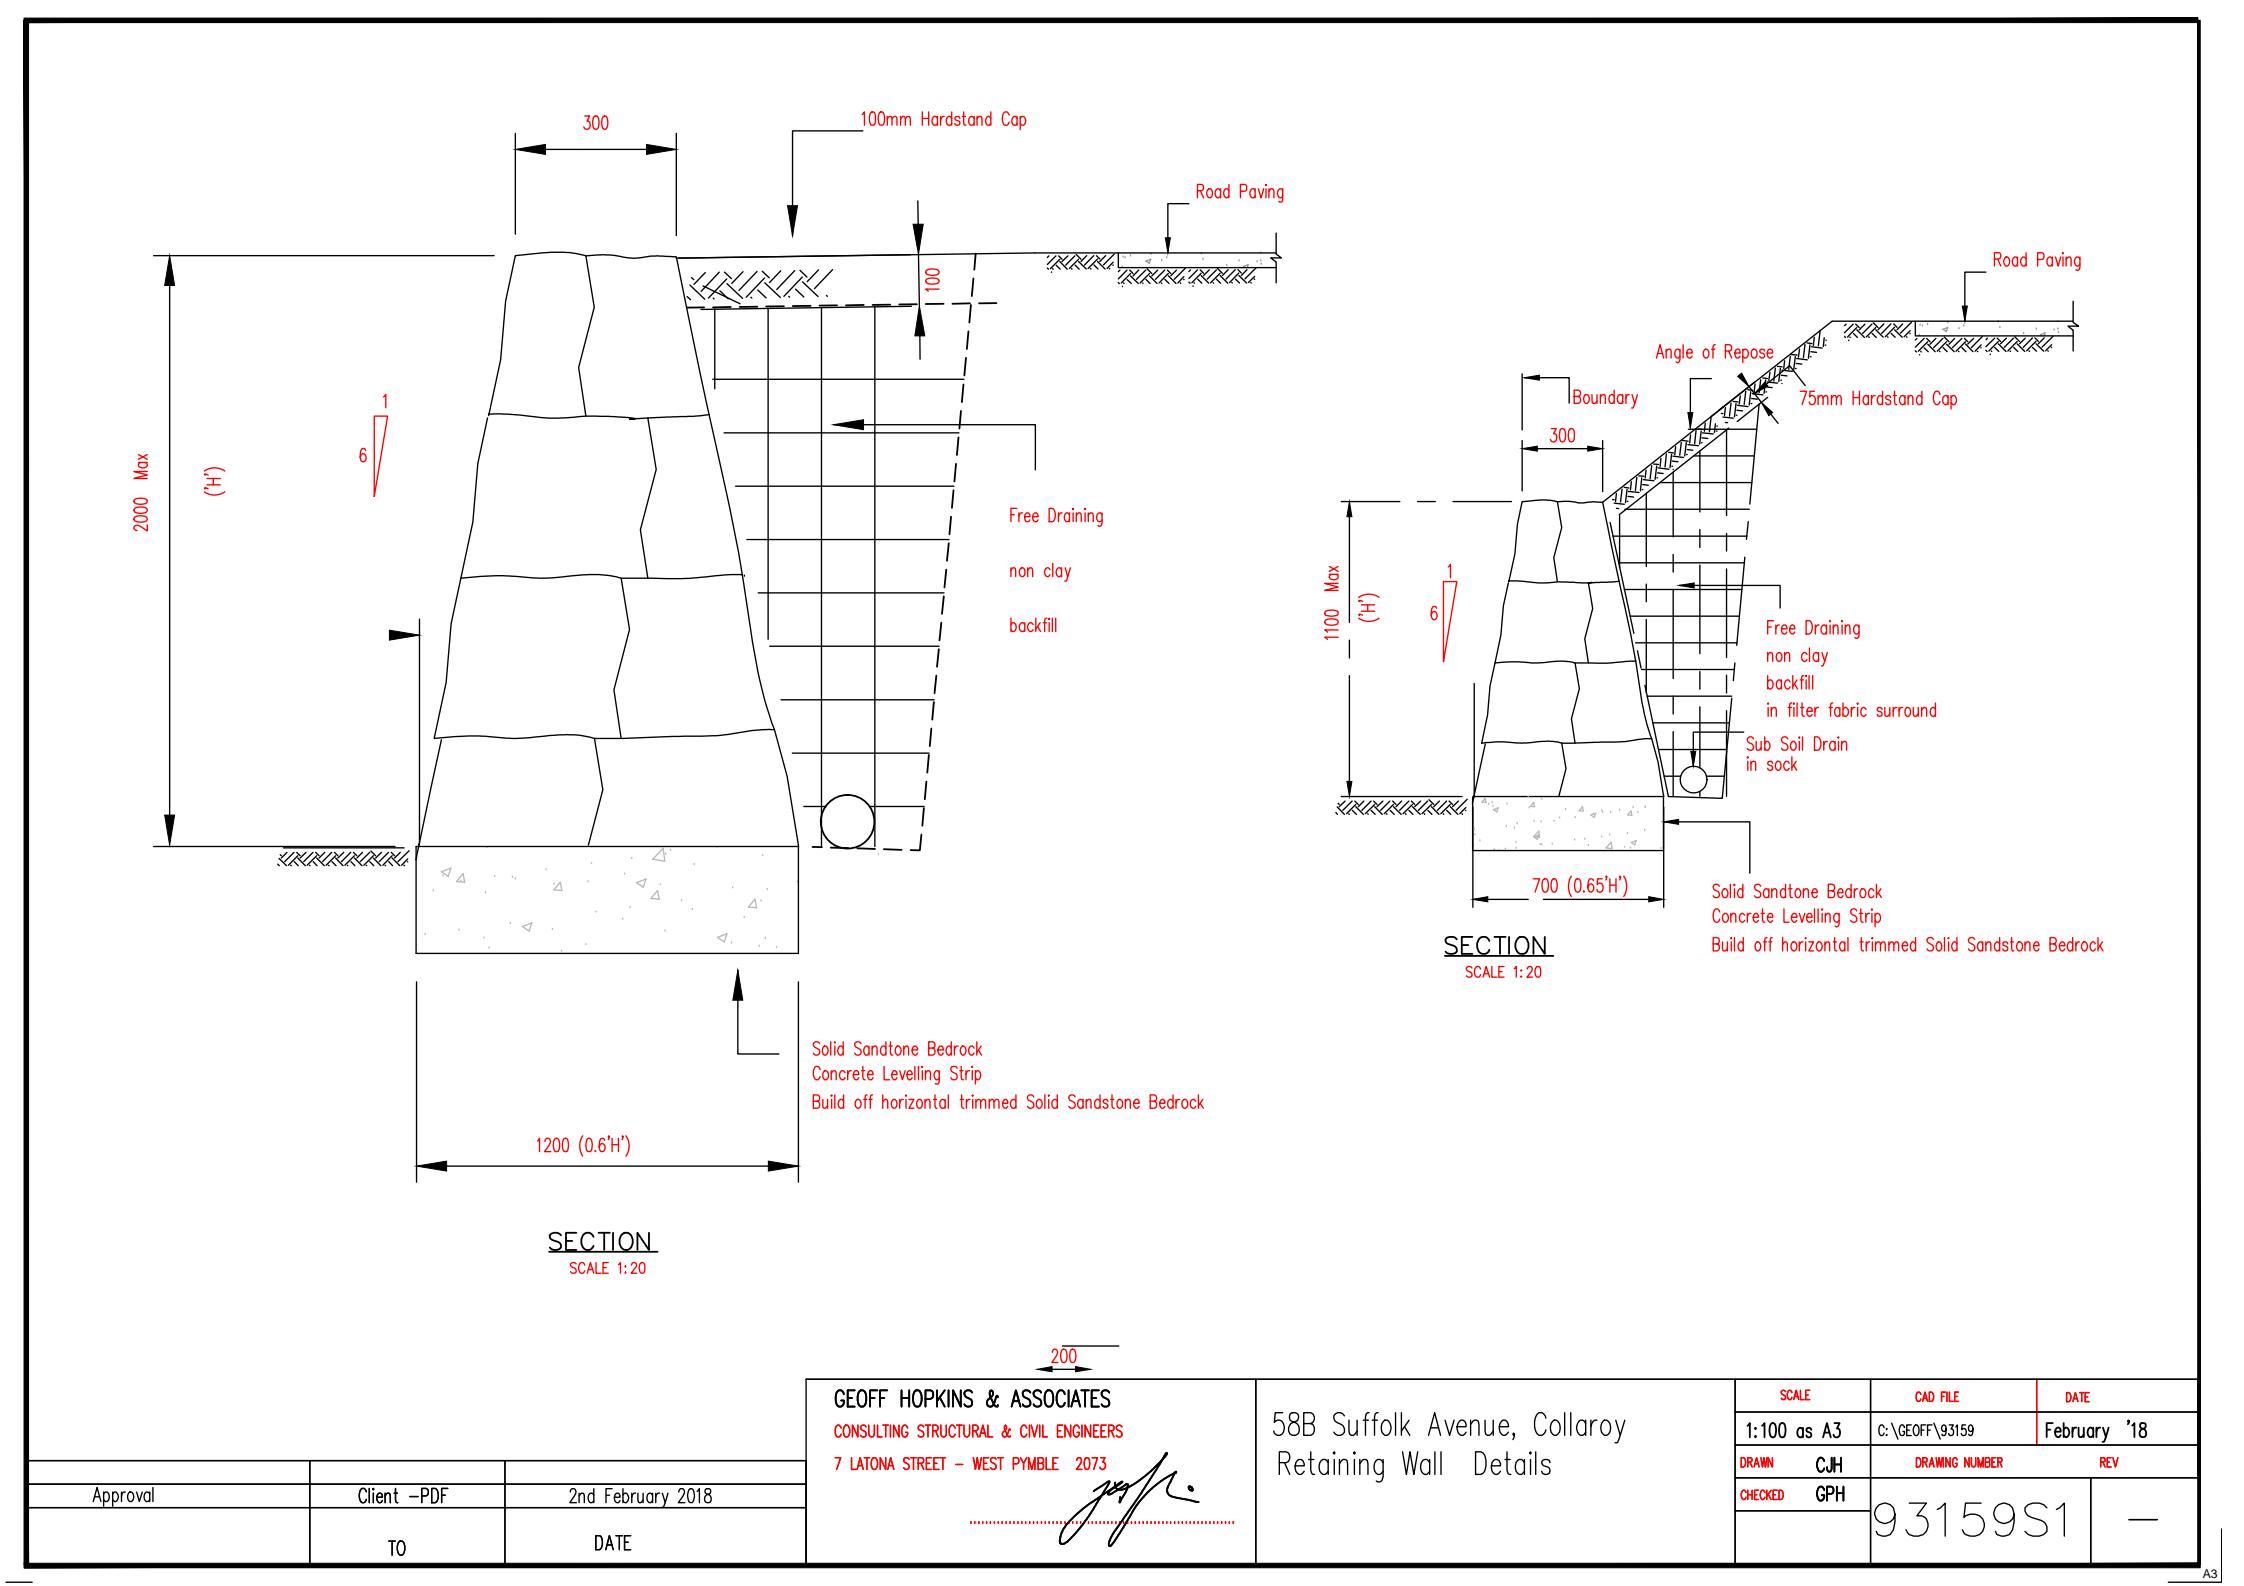
The wall is constructed as a 'Dry Wall', with sandstone blocks. The sandstone consists of blocks varying in size and are not interlocked. The wall measures approximately 2 metres high. Section of the wall have displaced and are in danger of collapse, as a result of 1 or more of the following:

- a. Lack of width of the base
- b. Lack of bearing on rock at the base
- c. The blocks are not interlocked and are not acting as 1 unit.d. Clay backfill behind the wall
- e. Surcharge from vehicles accessing the private driveway above
- f. The growth and swelling of trre roots growing within the soil backfill.

Partition area below the retaining wall as a 'No Go' area Remove bushes above the existing wall and poison tree roots. 150UC galvanized steel posts, embedded with concrete1500mm into 300mm cored holes at 1200 spacing offset 500mm from face of existing wall. Holes cored into solid sandstone bedrock certified by geotechnical consult due to their proximity to edge of the rock shelf. Backfill behing log wall with free draining non clay backfill. Install 150x100 treated pine sleepers slotted horizontally between posts.

Limit surcharge loading on road and behind the wall
