Arboriculture Construction Impact & Management Statement

August 2022

Site:	Lot 8 in DP 14630 103 Bynya Road PALM BEACH, NSW
Client:	Mark Eggers & Leanne Peterson
	c/- Rachel Hudson Architect
	Attention: Rachel Hudson
X	Email: rachel@rachelhudson.com.au
Author:	Kyle A Hill
14 6 3	Registered (Arb Aus #1884) Practising & Consulting Arbor
	Post Graduate Certificate in Arboriculture, Uni of Melb
	Diploma of Horticulture-Arboriculture TAFE, Grow SA
	Certificate of Horticulture, TAFE
	Certificate Advanced Tree Care TAFE
	Founder -Growing My Way Tree Services (1977)
	Member of International Society of Arboriculture
	Member of Arboriculture Australia

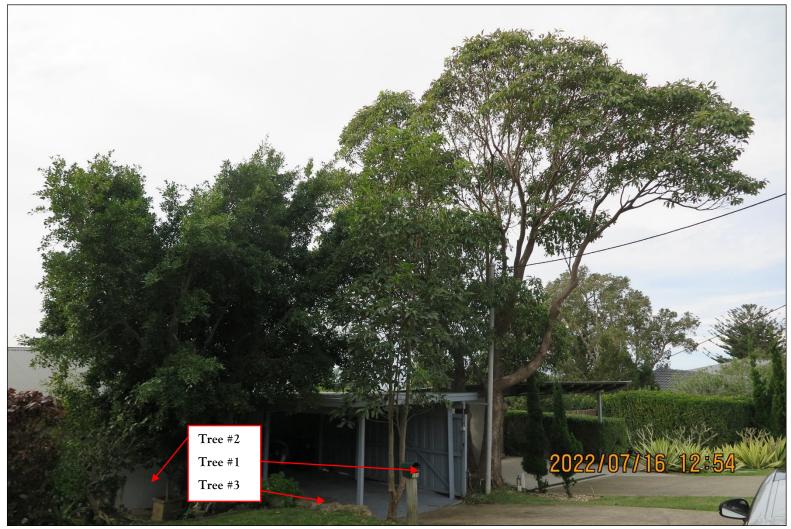
Figure 4: Left confirms the location of Tree #1, right confirms the location of Tree #2.

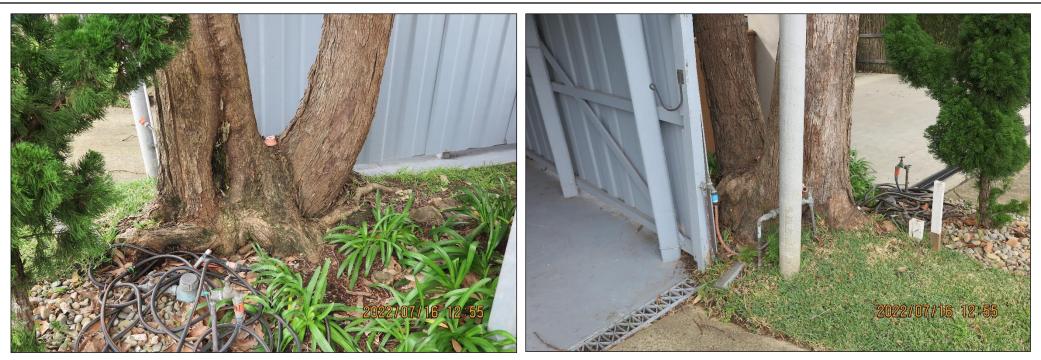
Figure 5: Confirms the location & character of Tree #1.

<u>Tree #1</u>: This tree is confirmed to be a NBC protected species. The tree is assessed as able to be retained with implementation of an intensive *Site Specific "Plan of Tree Management"*. On the basis ground level disturbance (to areas not already developed) within its calculated TPZ radial distance of 6.60m. are not proposed little to nil disturbance with respect to the new built form is proposed to occur.

➤ No builder's material of any description can be stored within the Tree Protection Zone radial distance (minimum 6.60m) on existing ground levels. Post completion of the project, the retained Project Arborist must document with supporting photographic evidence compliance with the AS4970-2009 provisions as well as any DA determination 'Conditions of Consent' specifications.

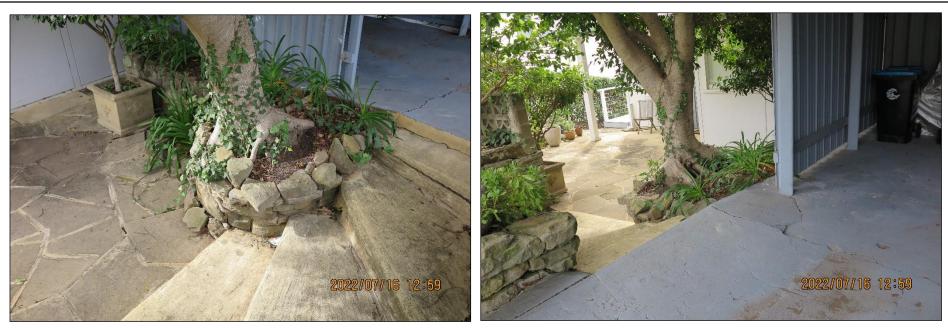
Figure 6: Above confirms the location of Tree #2. Below confirms the location of Tree #3.

<u>Tree #2</u>: This tree is confirmed to NOT be a NBC protected species. On this basis, we support it to be removed & replaced. Tree removal must only be undertaken by persons familiar with & able to abide by the *WorkSafe* (*WorkCover*) *Amenity Tree Industry 'Code of practice'*, 1998.

Tree #3: This tree is confirmed to be a NBC protected species. It is assessed as NOT able to be viably retained by implementation of standard AS4970-2009 *guideline provisions*. On this basis, we support it to be removed & replaced. Tree removal must only be undertaken by persons familiar with & able to abide by the *WorkSafe* (*WorkCover*) *Amenity Tree Industry* 'Code of practice', 1998.

- New tree specimens are to be sourced from growers/suppliers whose stock meets the production benchmarks of the Australian Standard (AS2303.2015 Tree stock for landscape use).
- ➤ New tree specimens are to be professionally planted & maintained for a minimum period of six (6) months once installed.
