J2370. 29th August, 2019. Page 1.

GEOTECHNICAL INVESTIGATION:

New Pool at 4 Yachtsmans Paradise, Newport

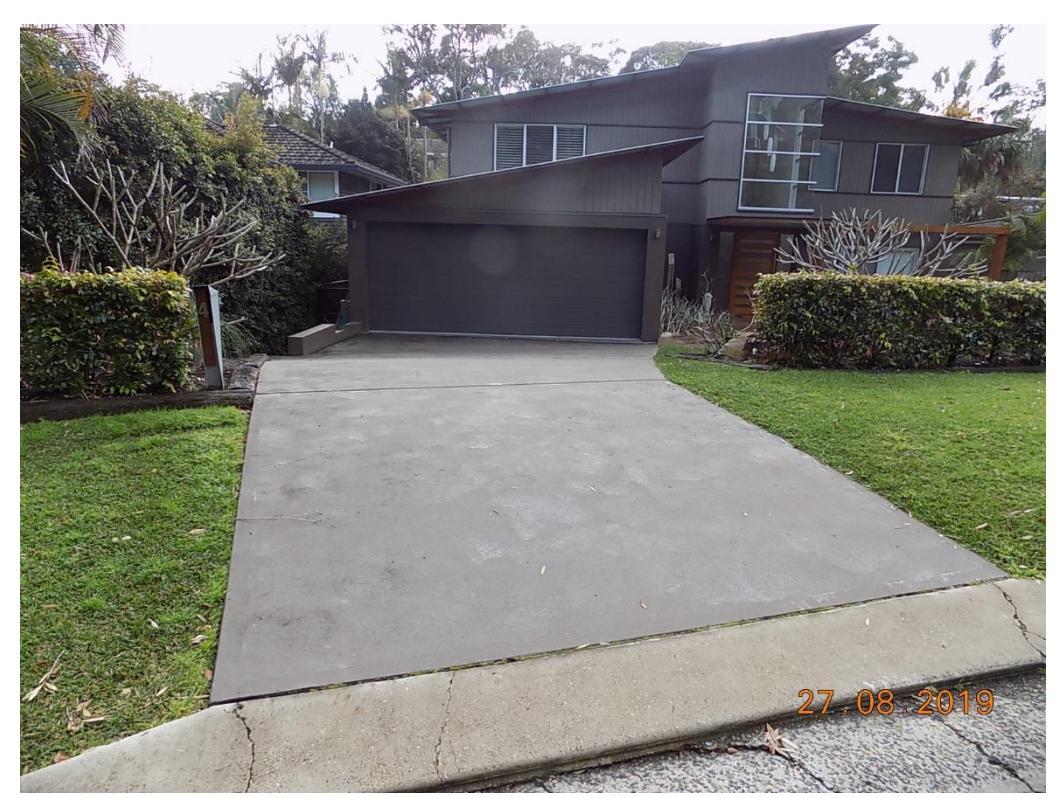
Photo 1

2.3 At the road frontage, a concrete driveway runs to a garage on the ground floor of the house (Photo 1). Between the road frontage and the house is a gently sloping lawn (Photo 2). The part two-storey rendered masonry house is supported on masonry walls (Photo 3). No significant signs of cracking or movement were observed in the external supporting walls. A near-level lawn surrounded by garden beds extends off the N side of the house to the N common boundary (Photo 4).

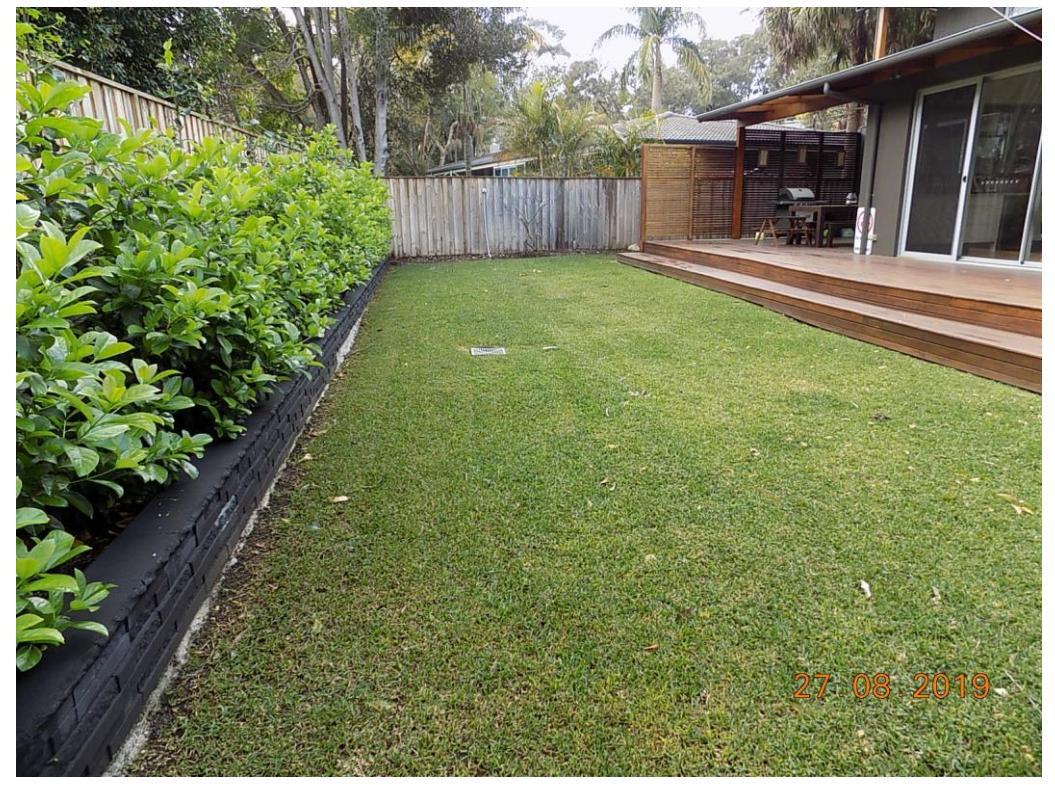
Photo 4

No geotechnical hazards were observed above, below, or beside the property. The excavation for the proposed pool is a potential hazard until retaining walls are in place (**Hazard One**). The proposed excavations undercutting the footings of nearby structures is a potential hazard (**Hazard Two**).

The proposed pool excavation will reach a maximum depth of ~1.8m, will be located ~1.0m from the timber deck on the downhill side of the house (Photo 4), ~2.0m from the E common boundary and ~2.3m from the N common boundary. Thus, the timber deck, E, and N common boundaries will lie within the zone of influence of the excavation. In this instance, the zone of influence is the area above a theoretical 30° line from the base of the excavation towards the surrounding structures and boundaries. Additionally, the excavation is expected to encounter wet clayey sands from an average depth of ~1.6m. Seepage at this level will likely undercut the excavation and cause batter collapse. As such, it is crucial that the following excavation advice is carried out to ensure the stability of the excavation is not impacted.

Where the timber deck falls within the zone of influence of the excavation, exploration pits in this location will need to be put down by the builder to determine the foundation depth and material. The pits are to be inspected by the geotechnical consultant.

If the foundations for the deck extend below the zone of influence of the proposed excavation, the excavation may commence. If they do not extend below the zone of influence of the proposed excavation, they will need to be underpinned prior to the excavation commencing. Alternatively, the deck can be supported from beyond the zone of influence of the pool excavation until the pool structure is in place.

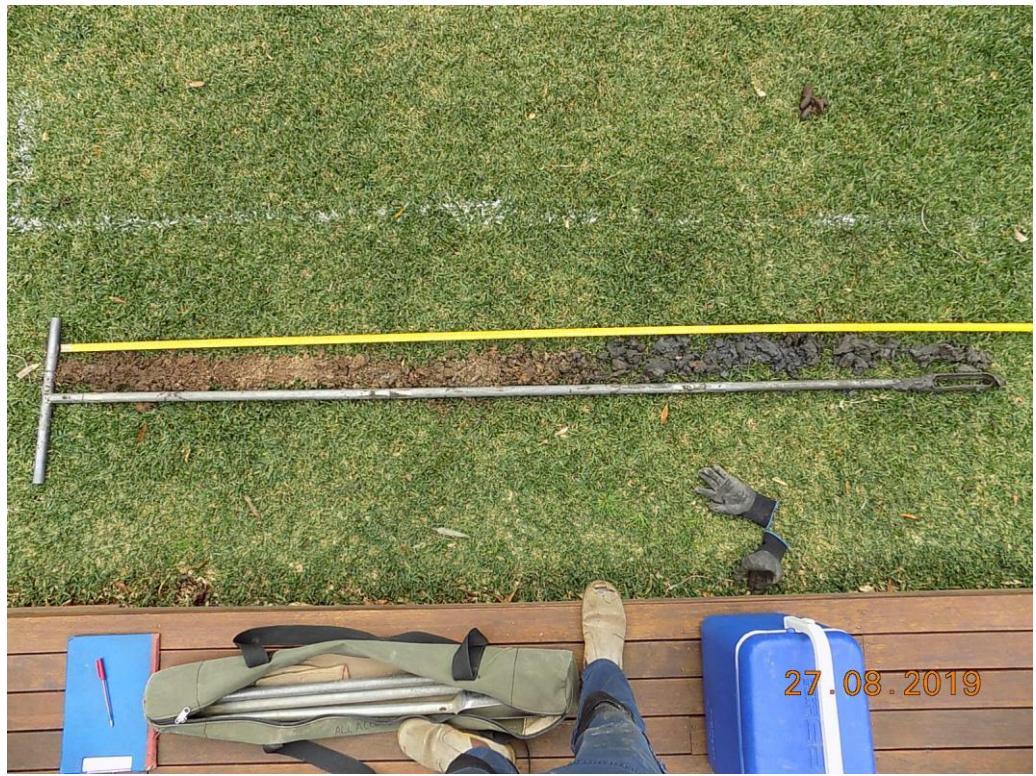
AUGER HOLE 1 (~RL4.9) – AH1 (Photo 5)

Depth (m)	Material Encountered
0.0 to 1.6	FILL , disturbed sandy soil, light brown and brown, very loose to loose, dry, fine to coarse grained with fine trace organic matter, shells, trace clay, and glass.
1.6 to 2.8	CLAYEY SAND , grey, medium dense to very dense, wet (very wet from 2.3m), fine grained with fine trace organic matter.

End of hole @ 2.8m in very dense clayey sand. Watertable encountered at ~2.3m.

Photo 5: AH1 – Downhole is from left to right.

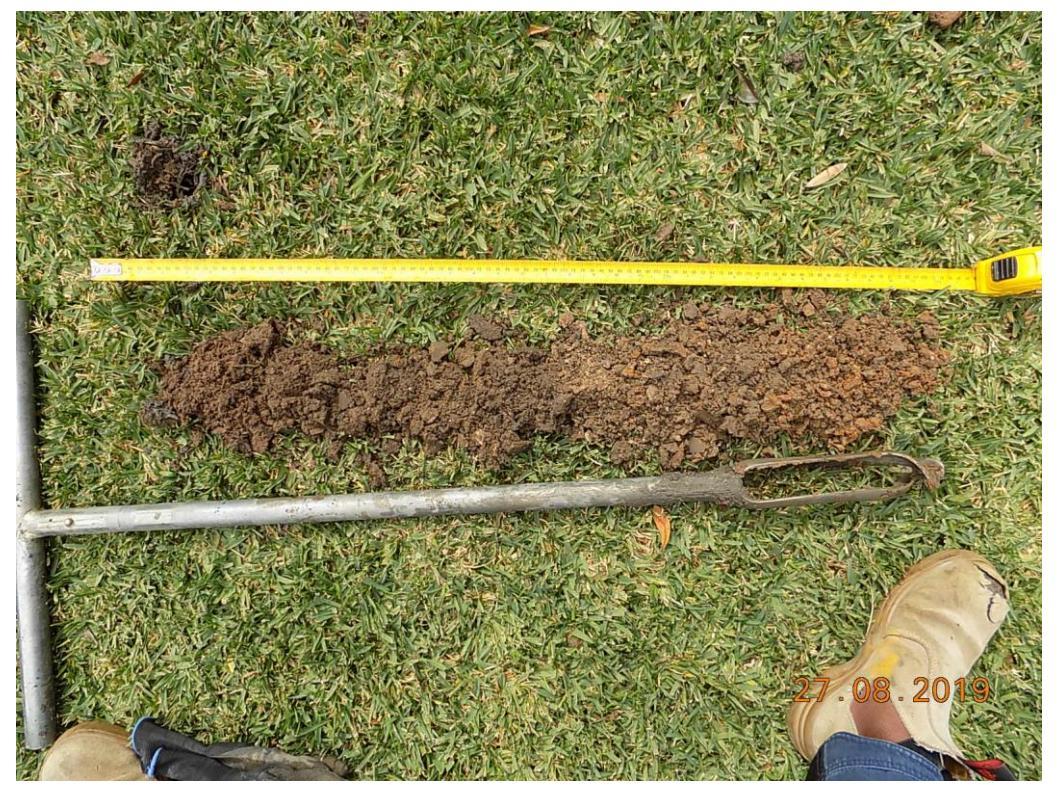
AUGER HOLE 2 (~RL4.9) – AH2 (Photo 6)

Depth (m)	Material Encountered
0.0 to 0.9	FILL , disturbed sandy soil, light brown and brown, very loose to loose, dry, fine to coarse grained with fine trace organic matter, shells, and trace clay.

Refusal @ 0.9m on unknown obstruction in the fill. No watertable encountered.

Photo 6: AH2 – Downhole is from left to right.

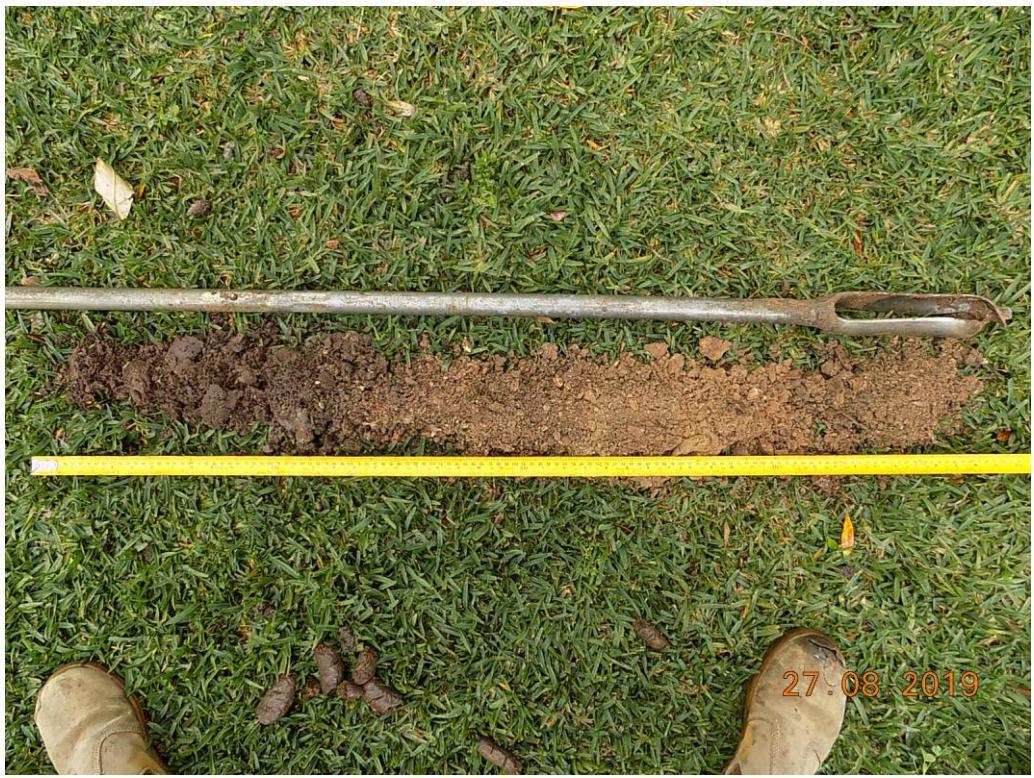
AUGER HOLE 3 (~RL4.9) – AH3 (Photo 7)

0.0 to 1.2 **FILL**, disturbed sandy soil, light brown and brown, very loose to loose, dry, fine to coarse grained with fine trace organic matter, shells, and trace clay.

Refusal @ 0.9m on unknown obstruction in the fill. No watertable encountered.

Photo 7: AH3 – Downhole is from left to right.

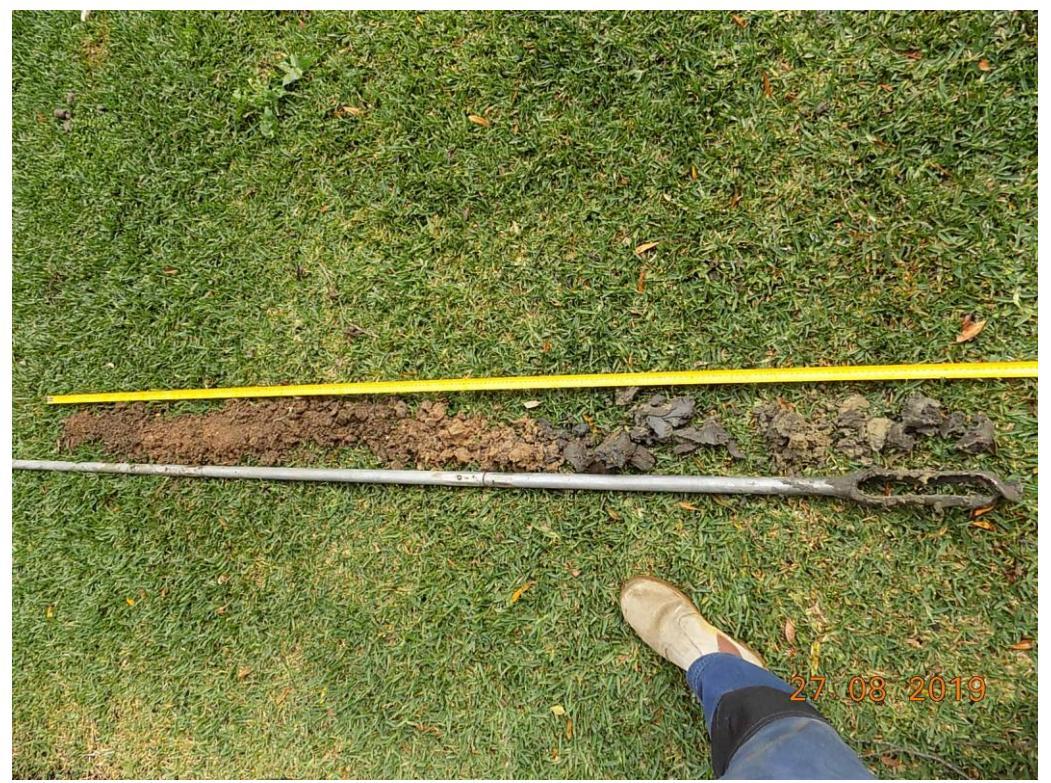
AUGER HOLE 4 (~RL5.0) – AH4 (Photo 8)

Depth (m)	Material Encountered
0.0 to 1.7	FILL , disturbed sandy soil, light brown and brown, very loose to loose, dry, fine to coarse grained with fine trace organic matter, shells, and trace clay.
1.7 to 2.4	CLAYEY SAND , grey, medium dense to very dense, wet (very wet from 2.1m), fine grained with fine trace organic matter.

End of hole @ 2.4m in very dense clayey sand. Watertable encountered at ~2.1m.

Photo 8: AH4 – Downhole is from left to right.

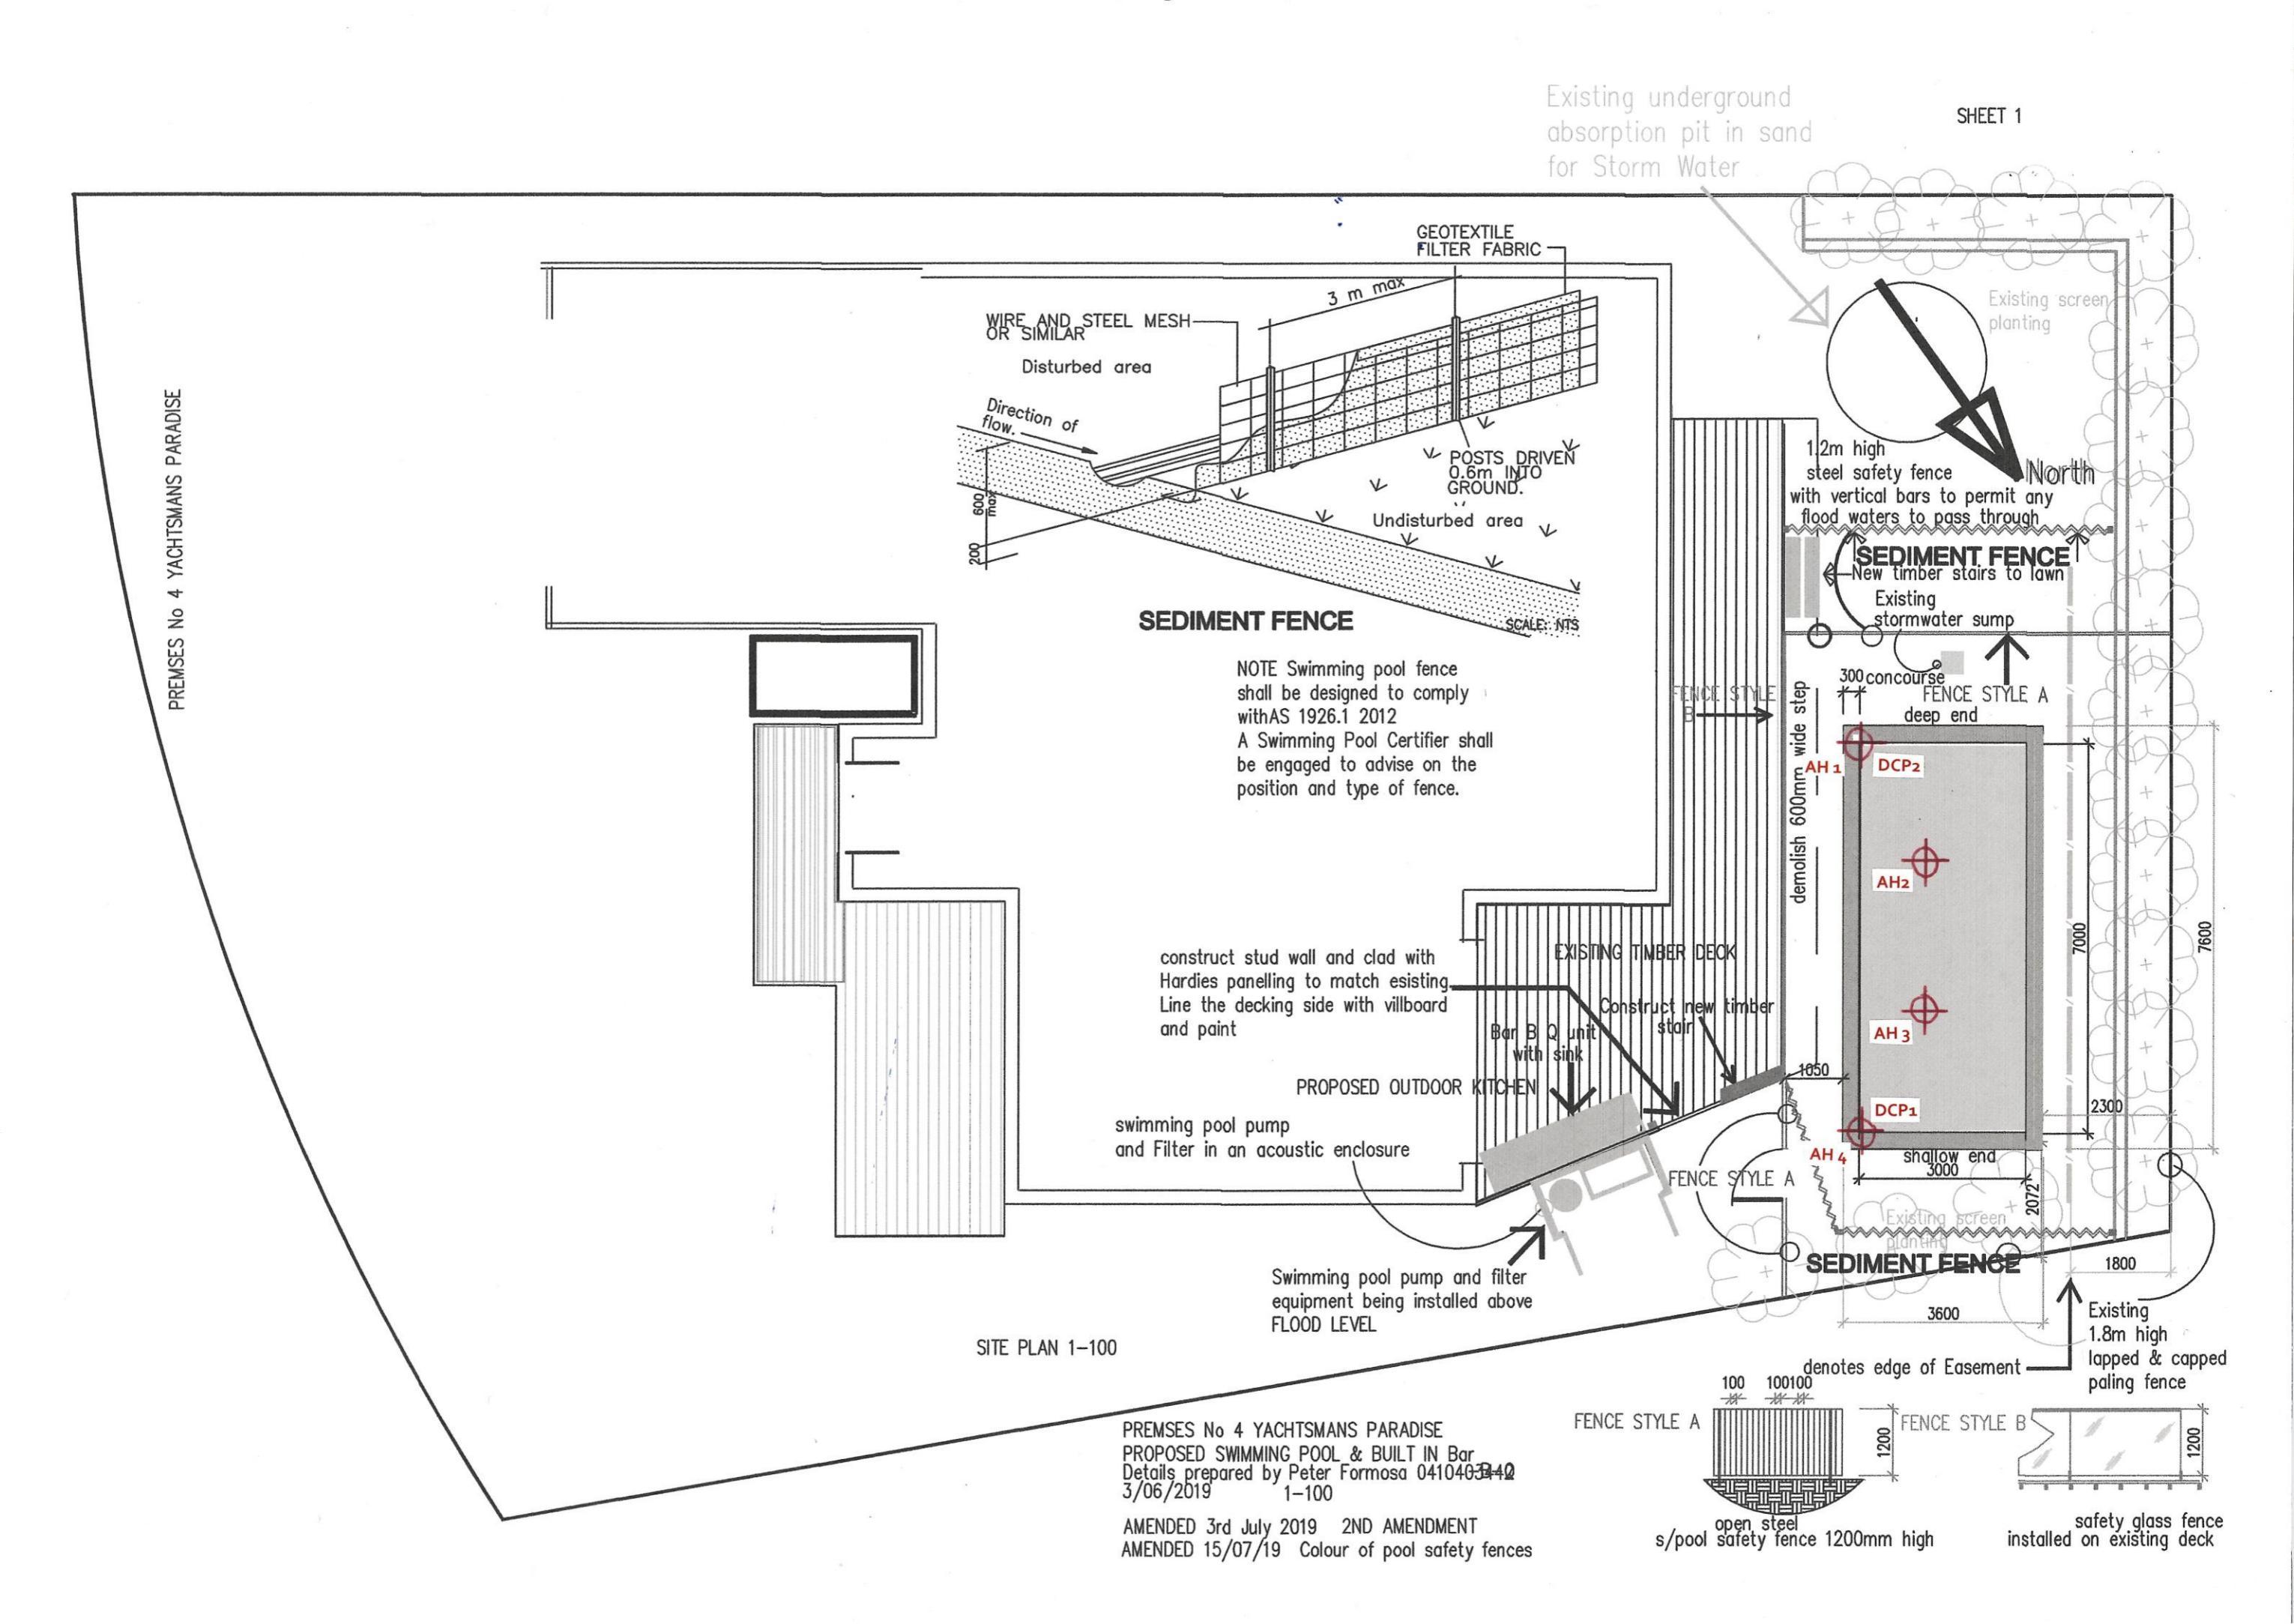
SITE PLAN – showing test locations

Four auger holes were put down to identify the subsurface materials. Two Dynamic Cone Penetrometer (DCP) tests were put down to determine the relative density of the subsurface profile. The locations of the tests are shown on the site plan. It should be noted that a level of caution should be applied when interpreting DCP test results. The test will not pass through hard buried objects so in some instances it can be difficult to determine whether refusal has occurred on an obstruction in the profile or on the natural rock surface. This is expected to have occurred in AH2, AH3, and DCP1:

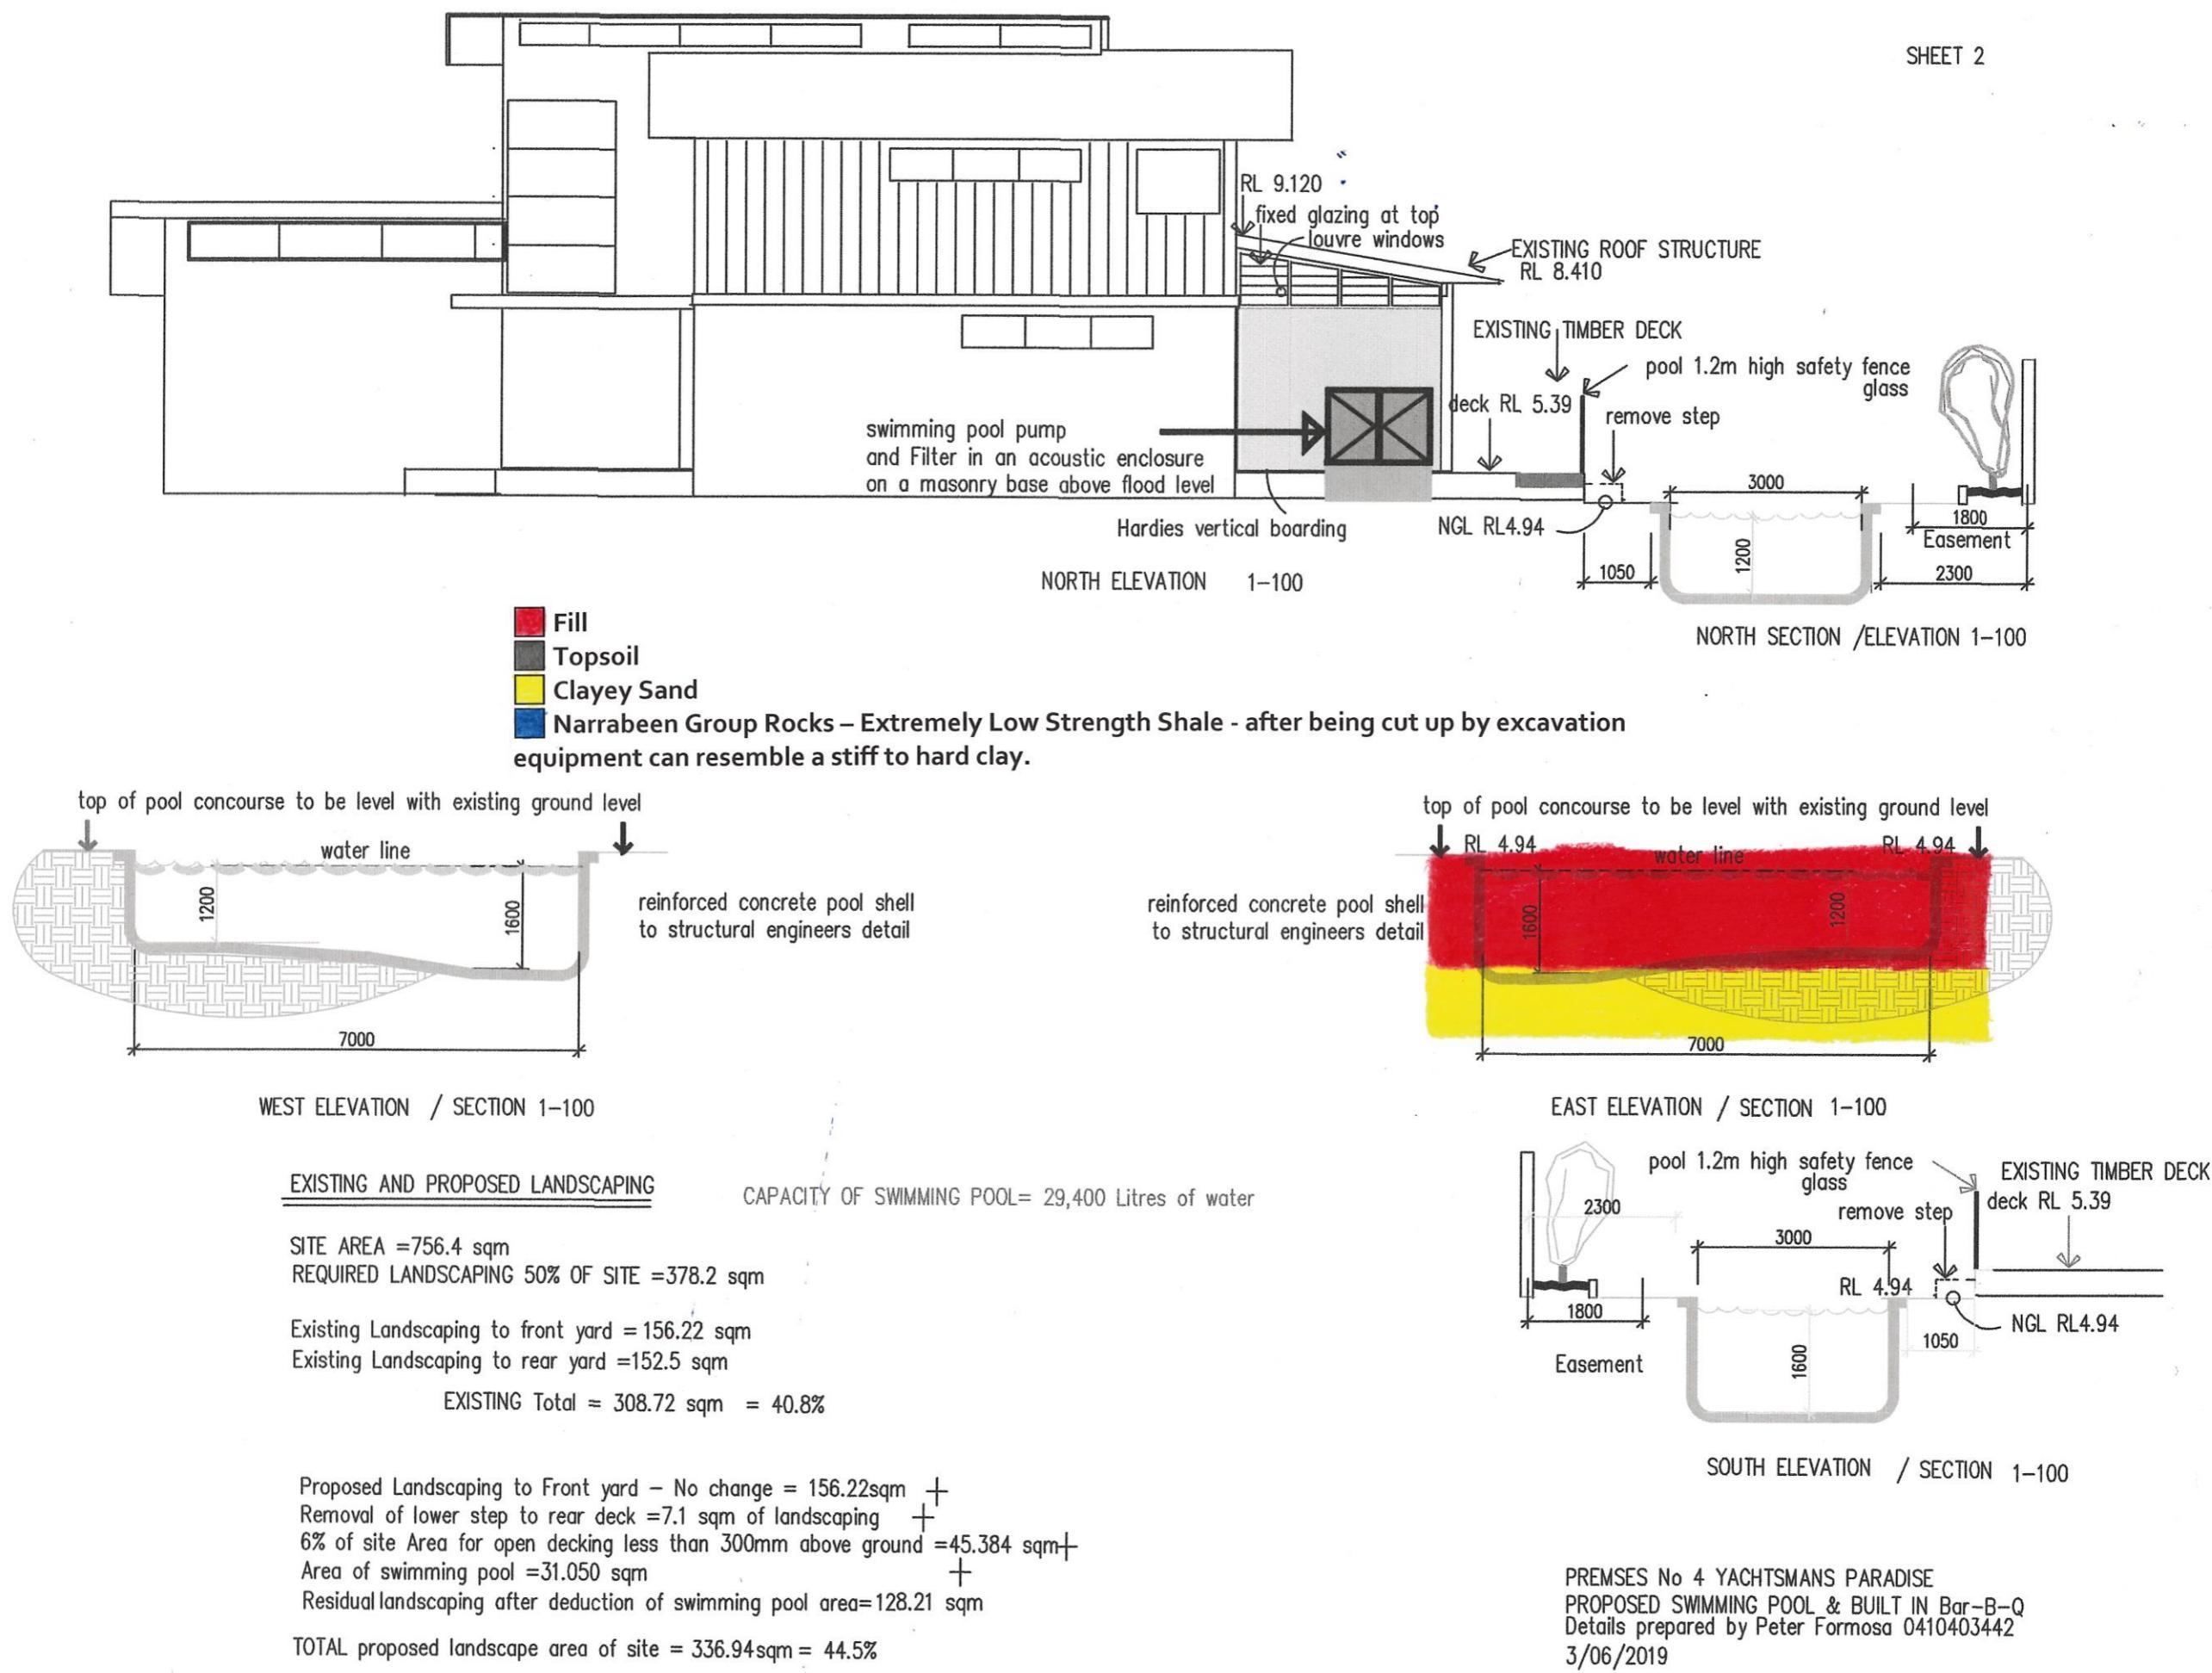
TYPE SECTION – Diagrammatical Interpretation of expected Ground Materials

The site encompasses the low-lying gulley between two slopes. It is underlain by manmade fill across the downhill side of the property over clayey sands that were encountered to the extent of the testing. The property has been levelled with manmade filling over what was likely a low-lying swamp or creek to a maximum depth of ~1.7m. The fill overlies clayey sands that extended to the extent of the depths tested at 2.8m. Rock was not encountered during the tests. The clayey sands were wet from ~1.6 and became very wet in the auger holes from a depth of ~2.1m. This indicates the watertable is present at this depth (~RL2.9). See the Type Section attached for a diagrammatical representation of the expected ground materials.
