REPORT

316 Hudson Parade, Clareville Upgraded Boatshed Works Coastal and Marine Damages Assessment

Client: Mr Tony Walls Reference: PA1959MARP1901310938 Status: P02.01/Final

Date: 31 January 2019

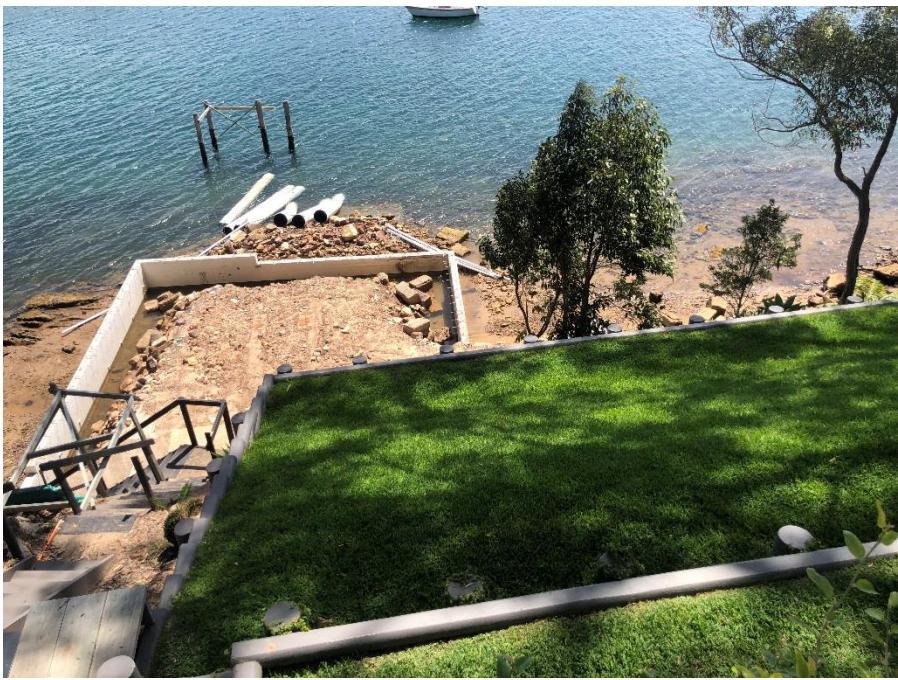
Photo 1 Dincel foundation wall enclosing demolished former boatshed. Toe of former ramp just visible below the waterline beyond the pile of demolished materials

The demolished rubble seawall which supported and protected the former boatshed was mostly contained within the perimeter (three sides) of the foundation wall, but also extended further seaward (**Photo 1**). All demolition materials were located over the former ramp and bedrock reef. No demolition materials appeared to be located beyond the perimeter of the reef and submerged remnant of the former boat ramp.

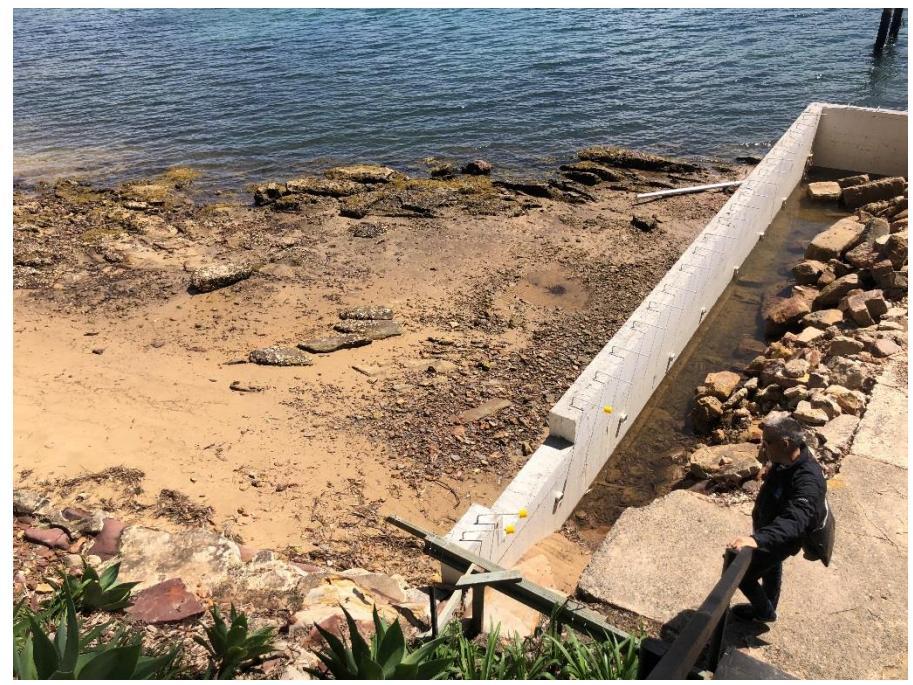
Photo 2 Southern Dincel foundation wall showing edge of rock shelf and sand overlay spread naturally from adjacent pocket beach

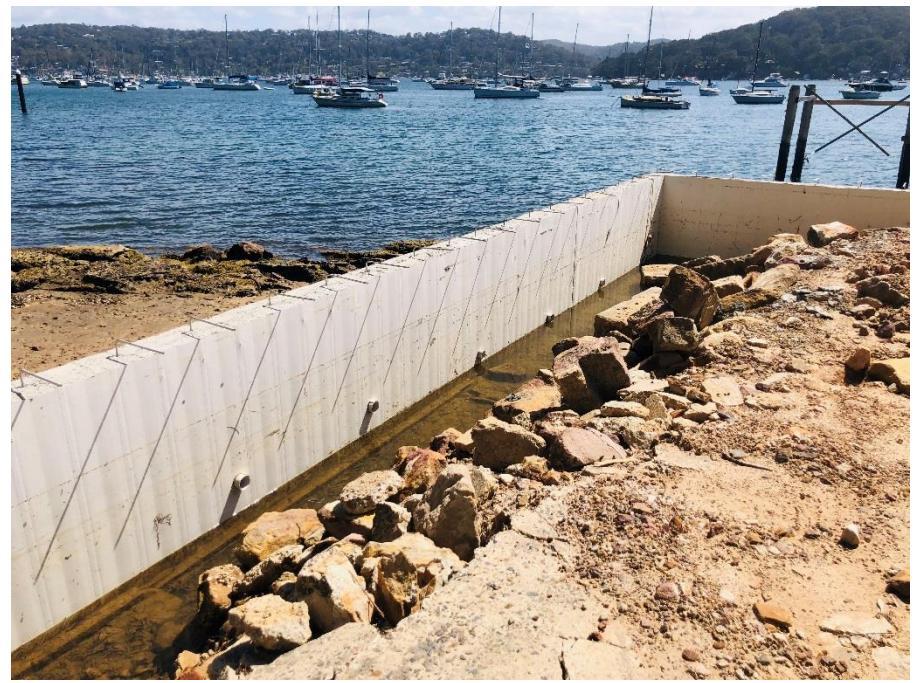
Photo 3 Southern Dincel foundation wall with outer poles of former jetty behind

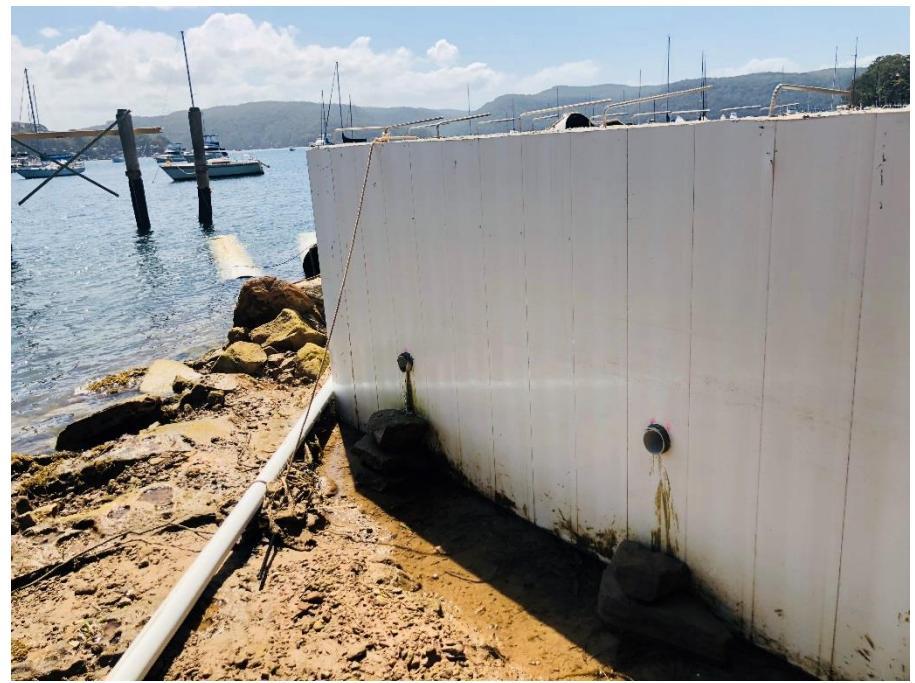
Photo 4 SW corner of Dincel foundation wall

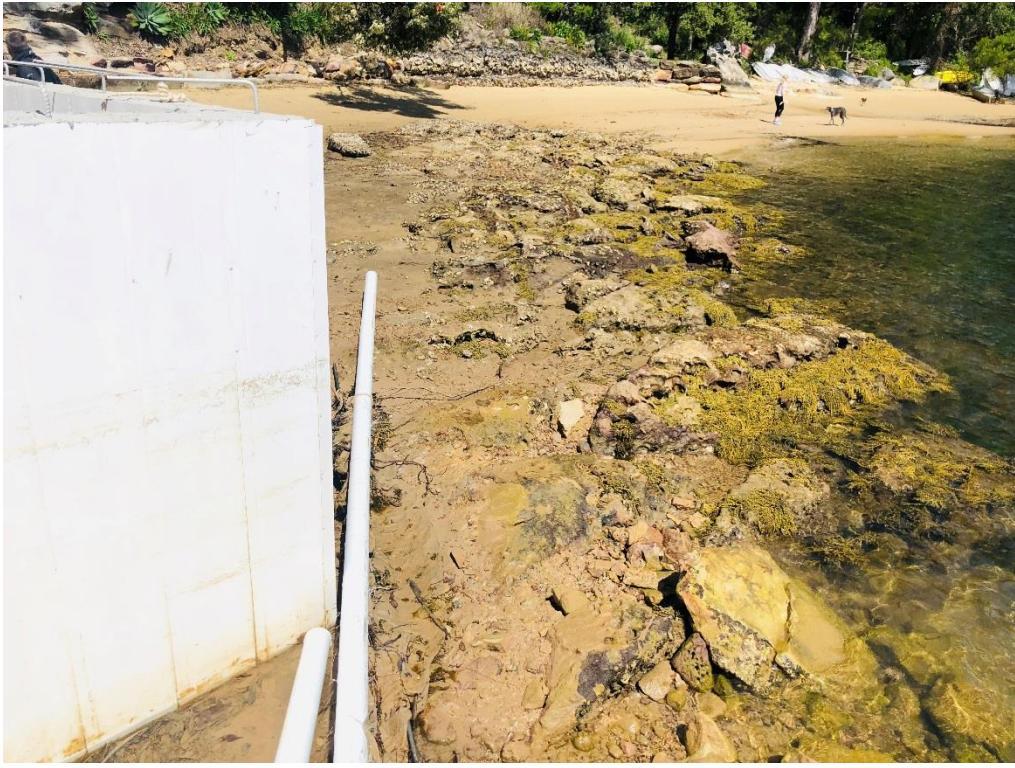
Photo 5 SW corner of Dincel foundation wall looking south showing fringing rock reef with pocket beach beyond

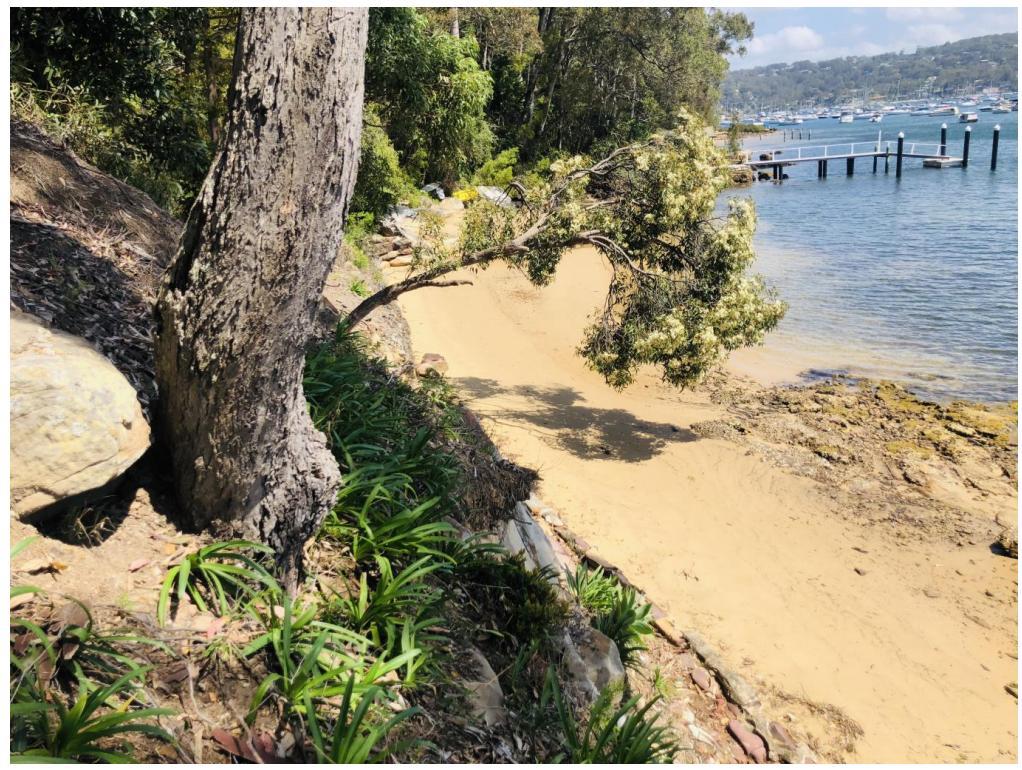
Photo 6 Pocket beach immediately south of boatshed site

A permanent drying pocket beach occurs immediately south of the boatshed. The beach width is variable, with its widest midpoint ranging from about 5 to 15m at mean tide established from 10 years of Nearmap air photos between October 2009 and November 2018.

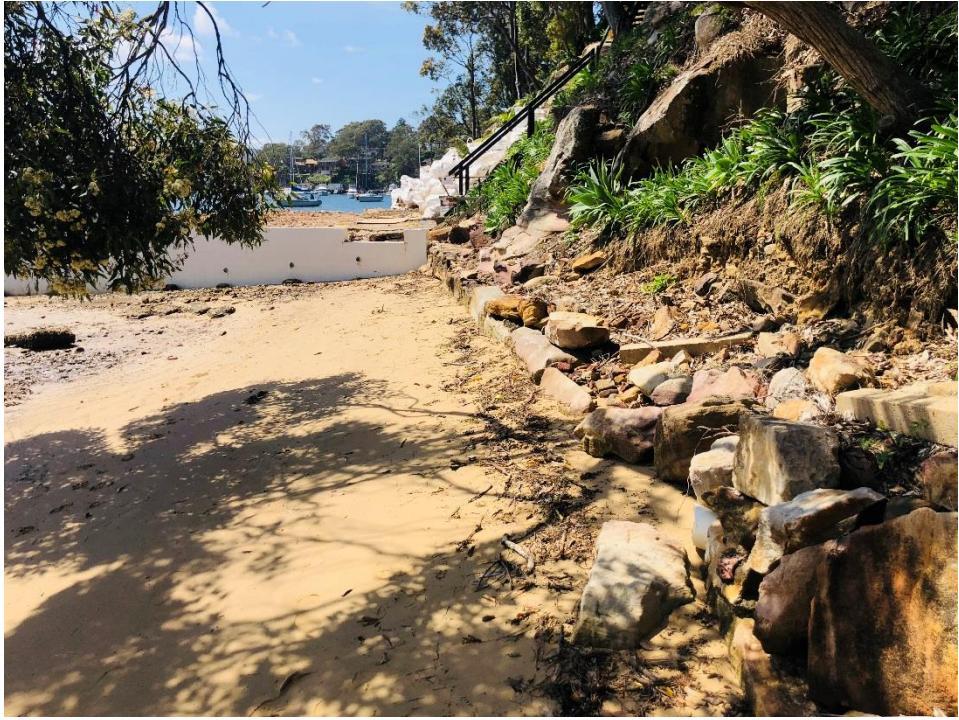
Photo 7 Pocket beach backed against dilapidated former seawall with southern Dincel foundation wall in background

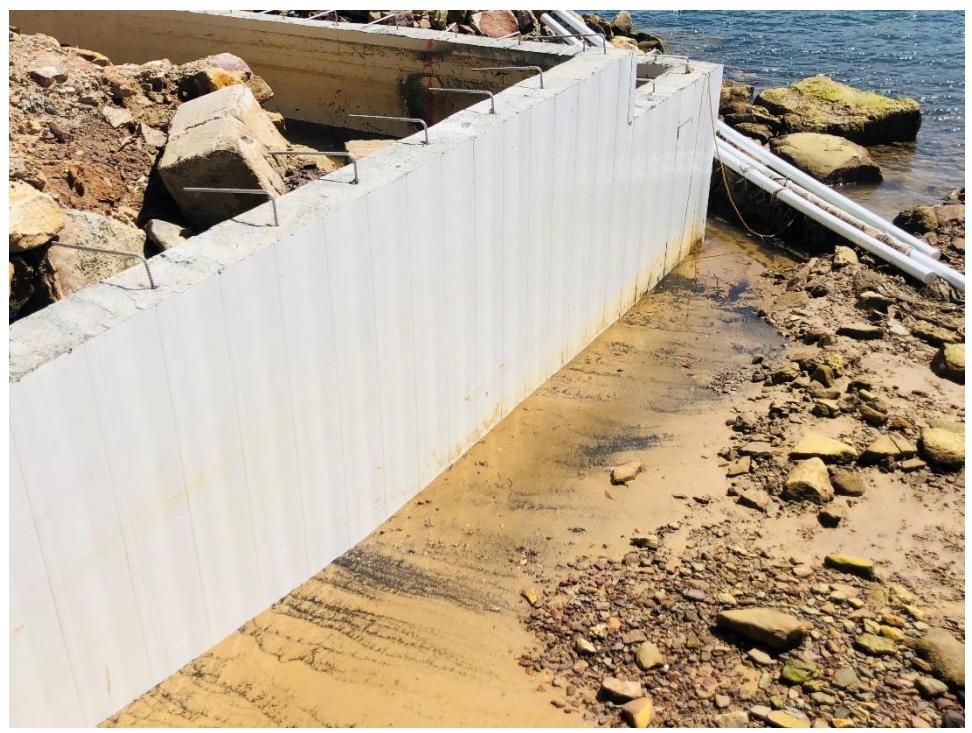
Photo 8 Northern Dincel foundation wall

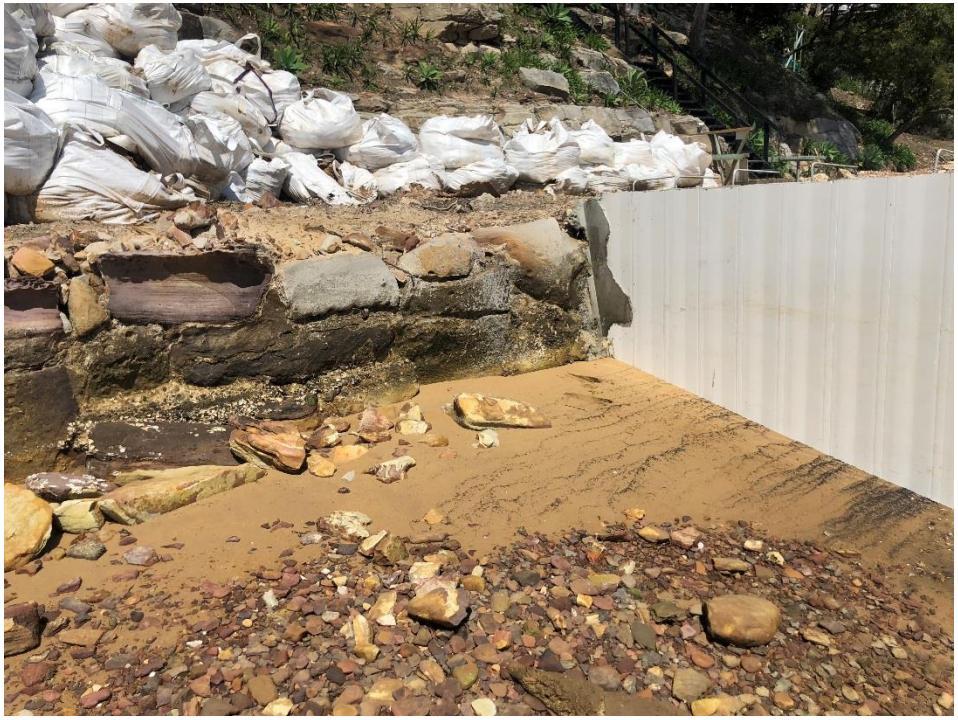
Photo 9 Minor sand fillet washed into corner against dilapidated rock seawall and northern flank of Dincel foundation wall

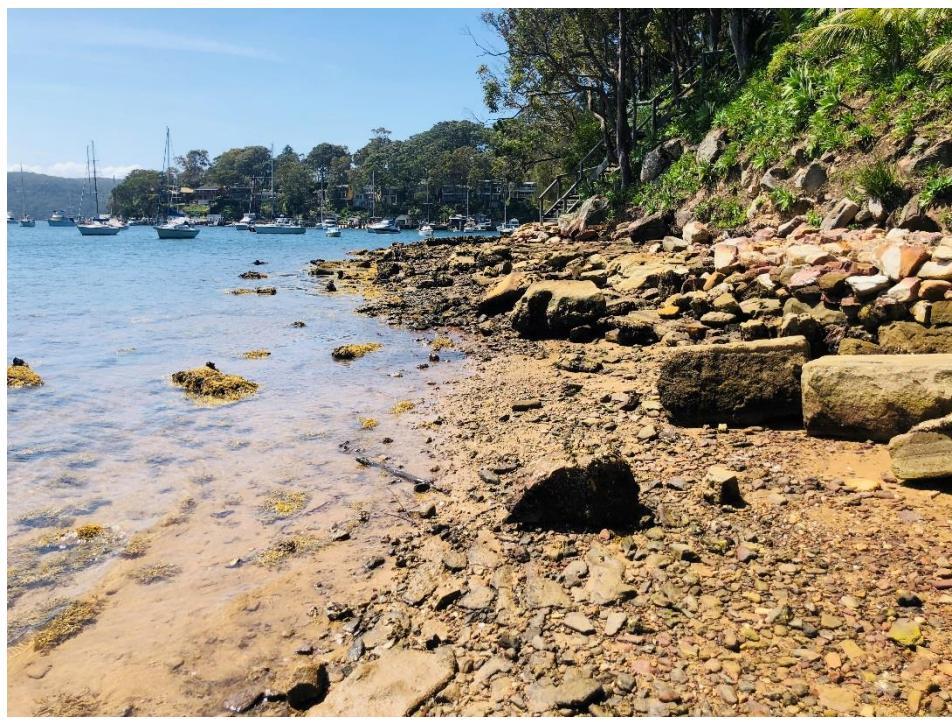
Photo 10 Rocky foreshore immediately north of boatshed site

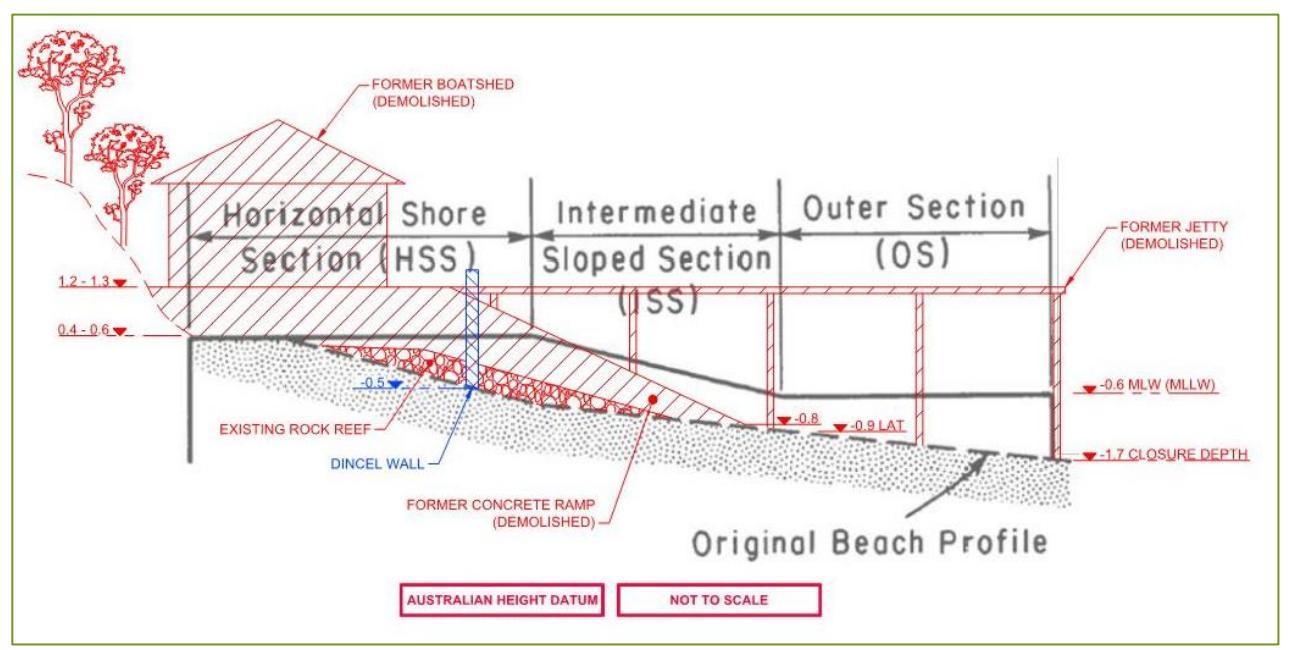
Figure 6 Theoretical sectional design of a groyne overlaid with marine structures at 316 Hudson Parade, Clareville (CERC, 1984)

The Dincel foundation walls extend seaward out to a bed level of approximately -0.5m AHD close to the junction between the HSS and ISS. The former marine structures and current Dincel foundation walls have been mapped onto the theoretical sectional design for a groyne as shown in **Figure 6**.

In a cross shore sense the pocket beach at the site is denoted by the dashed black line extending from 0.4-0.6m AHD at the back of the beach, out to below low water. The beach is, for all intents and purposes, contained within the HSS and ISS sections. The bedrock reef protrudes above the profile of the pocket beach, and is also confined to the HSS and ISS sections.

It follows from the geometry of the cross-shore section that the bedrock reef and former boatshed present as a partial groyne. **Figure 6** shows that a theoretical groyne section, if it were to fully contain updrift sand from moving downdrift, would need to occupy the OS out to a "closure level" calculated as -1.7m AHD (**Section 5.4**). While the former timber jetty did extend out this far, it was a suspended structure hence permeable to sand movement so would have provided no groyne retention function.

Importantly for the reason 5 matter, the Dincel walls are effectively located inside the HSS. While they may have a slightly higher elevation than the former boatshed floor level of 1.2-1.3m AHD, their influence as a groyne on littoral draft (or longshore sediment transport) would exhibit no material difference to that compared to the former boatshed and ramp structures.
