Tree Assessment

Boat Shed & Jetty

**121 Florence Terrace
Scotland Island**

Report Prepared by Julia Stanton
Syncarpia Vegetation Management
24 Windsor Street Tarbuck Bay 2428
juliastanton@ozemail.com.au
Mob: 0417398050
January 2020

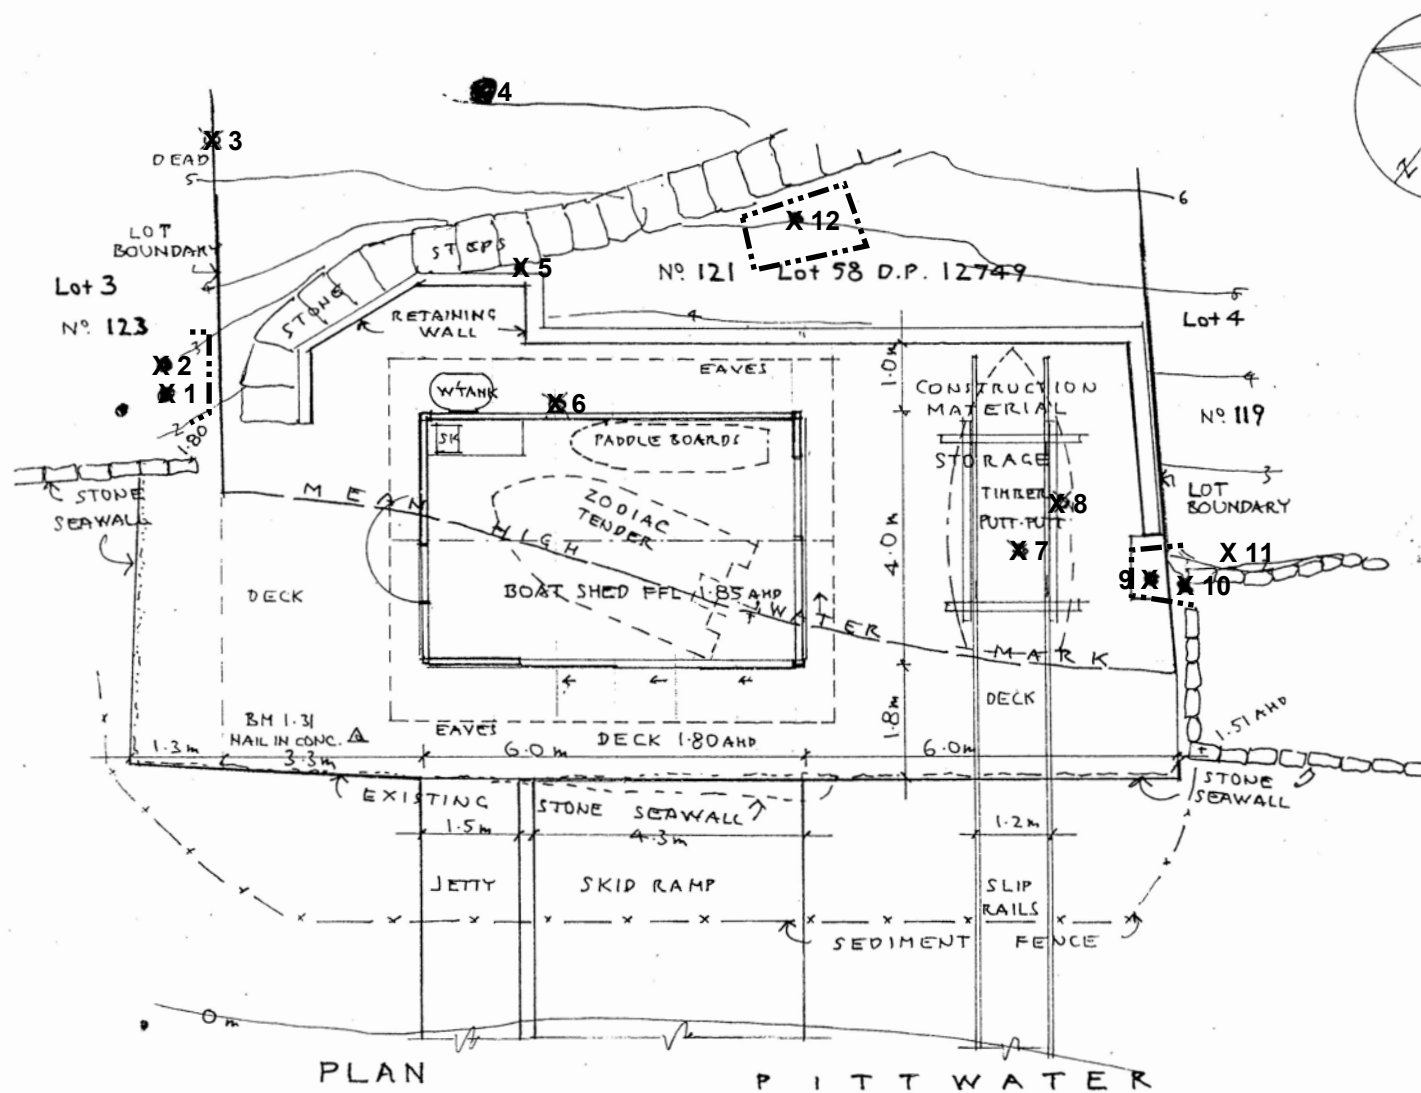
Site Plan / Tree Survey
January 2020

- Tree & soil protective zones are to be established and fencing is to be in place prior to commencement of site works (Specifically for Trees 1, 2, 9, 10, 11 & 12). Fencing is to be maintained for the duration of construction works. Refer to Figure 1 for recommended tree protective / exclusion fencing.

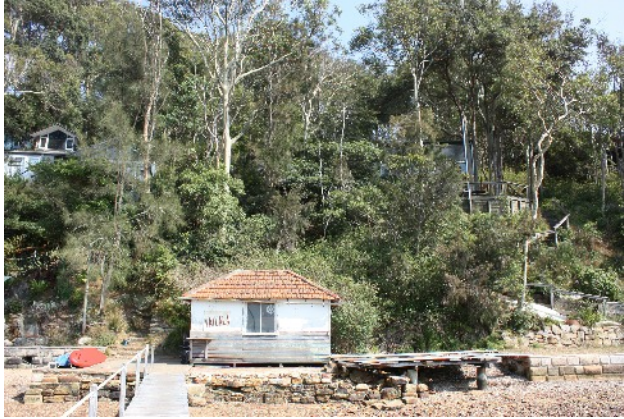
Photo 1 Existing boat shed, slip way, jetty & decking

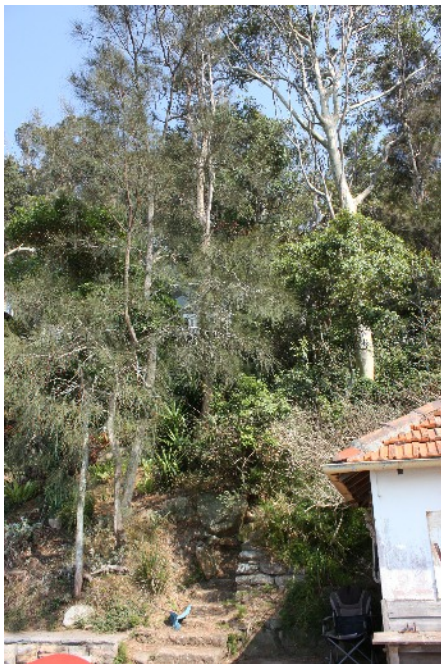
Tree 3 a semi-mature specimen of *Eucalyptus punctate* (Grey Gum) is a dead tree & does not require removal to accommodate the proposed development, however should be considered for removal on the basis of hazard management.

Photo 2 Trees 1 , 2, 3 & 4, stairs & Stone retaining wall

3	<i>Eucalyptus punctata</i>	Grey Gum	Sm				Dead	Dead	Remnant indigenous tree located on existing boundary.	Does not require removal to accommodate proposed development	4a	0	Medium

- Crown maintenance pruning (removal of dead, diseased & defective branches) is recommended for all trees to be retained (specifically Tree 4).
- All pruning works is to be undertaken by an experienced and qualified arborist in accordance with AS4373- 2007 Pruning of Amenity Trees.

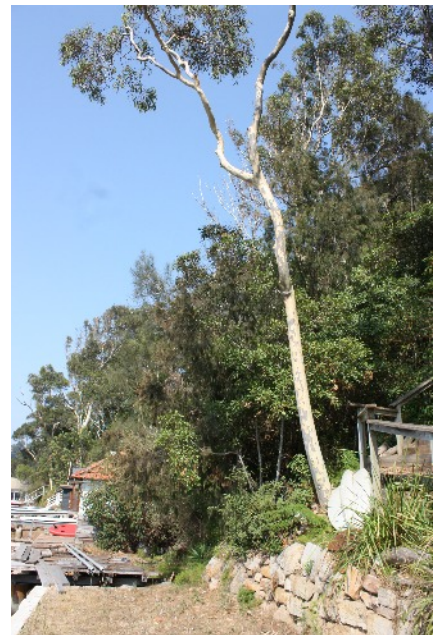
Tree 7 is a semi-mature specimen of *Rapanea variabilis* (Muttonwood) in fair to good health & condition.

Tree 8 is an immature specimen of *Allocasuarina torulosa* (Forest Oak) in fair health & condition.

Photo 3 Trees 7, 8, 9, 10 & 11
