# GEOTECHNICAL INVESTIGATION REPORT PROPOSED POOL HOUSE, SWIMMING POOL AND TERRACE 90 CABBAGE TREE ROAD, BAYVIEW, NEW SOUTH WALES MR ALEX JENKINS

MMGEO2021AJ\_AA REVISION A
AUGUST 2021

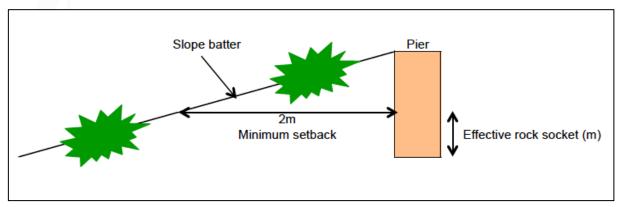
Diagramme 13.1: Required Minimum Setback for Calculation of Effective Rock Socket

To prevent slope instability and reduced bearing capacity from occurring, your attention is drawn to the need of applying the setback criteria shown in Diagramme 13.1 for calculation of effective rock socket length. Otherwise there would be a need to downgrade the bearing pressure values given in Table 13.1 by a factor of 0.5.
