ARBORICULTURAL IMPACT ASSESSMENT – 12 MOLONG STREET, NORTH CURL CURL

ARBORICULTURAL IMPACT ASSESSMENT:

**12 Molong Street
North Curl Curl, NSW**

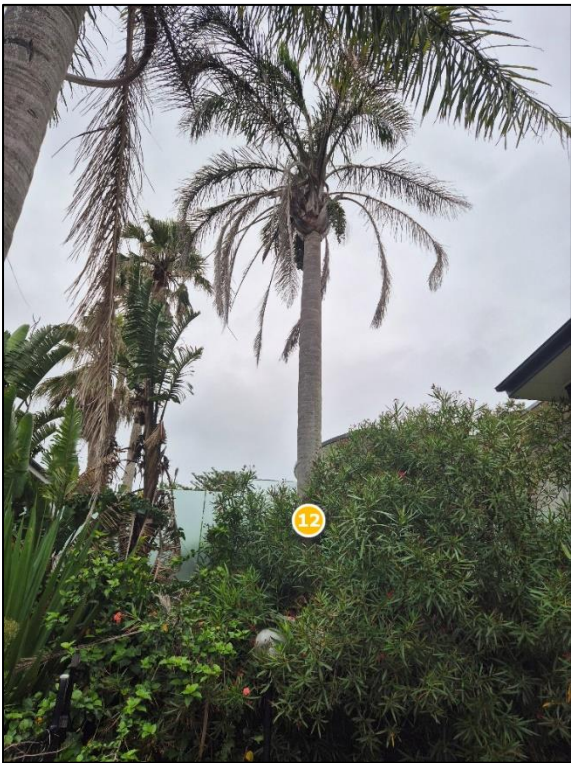
Figure 7 – Tree 12: *Syagrus romanzoffiana* – Low retention value.

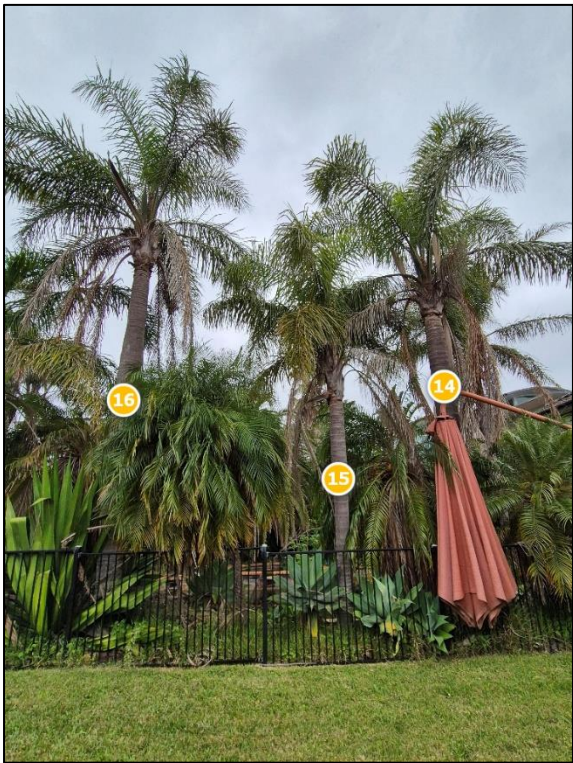
Figure 8 – Trees 14, 15 and 16: All *Syagrus romanzoffiana* – Low retention value.

14	<i>Syagrus romanzoffiana</i>	Cocos Palm	35	37	3.00	n/a	28	6	4	Good	Good	Mature	Dead fronds.	15-40 years	Low	Low	Proposed cabana, lawn and pool results in a major encroachment . Species is exempt.	Tree requires removal to facilitate the proposed development.
15	<i>Syagrus romanzoffiana</i>	Cocos Palm	24	27	2.50	n/a	20	5	3	Good	Good	Semi-mature	Dead fronds.	15-40 years	Low	Low	Proposed cabana, lawn and pool results in a major encroachment . Species is exempt.	Tree requires removal to facilitate the proposed development.
16	<i>Syagrus romanzoffiana</i>	Cocos Palm	40	43	3.00	n/a	28	7	4	Good	Good	Mature	Dead fronds.	15-40 years	Low	Low	Proposed cabana, lawn and pool results in a major encroachment . Species is exempt.	Tree requires removal to facilitate the proposed development.
17	<i>Syagrus romanzoffiana</i>	Cocos Palm	23	25	3.00	n/a	28	5	4	Good	Good	Semi-mature	Dead fronds.	15-40 years	Low	Low	Proposed cabana, lawn and pool results in a major encroachment . Species is exempt.	Tree requires removal to facilitate the proposed development.

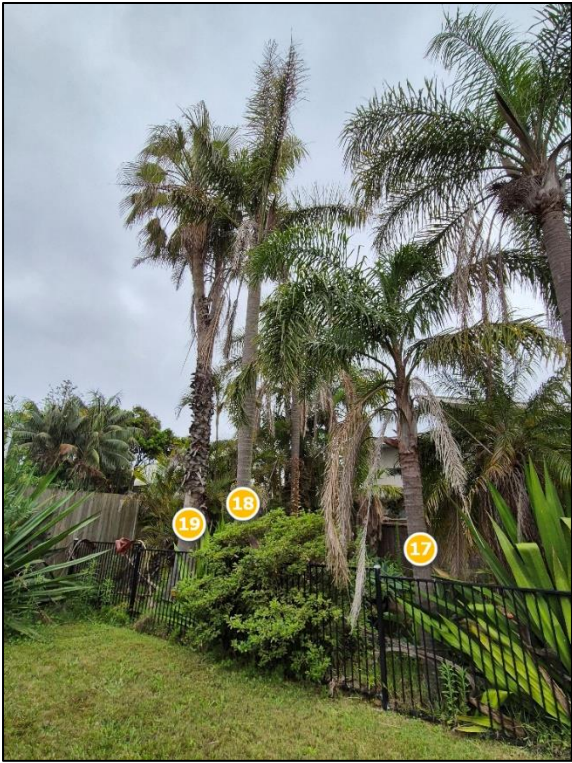
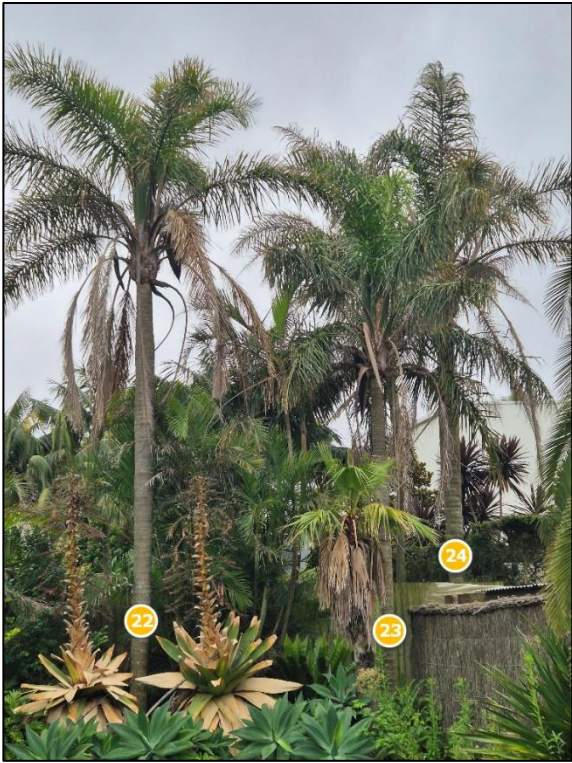
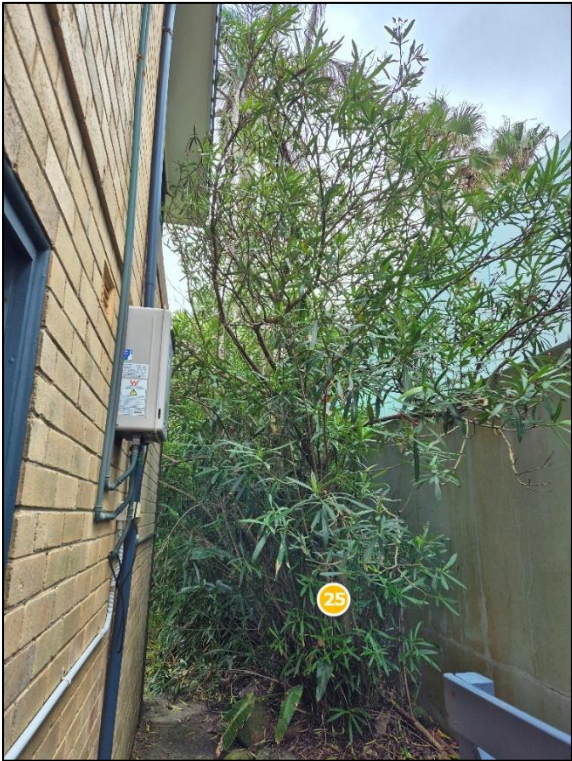
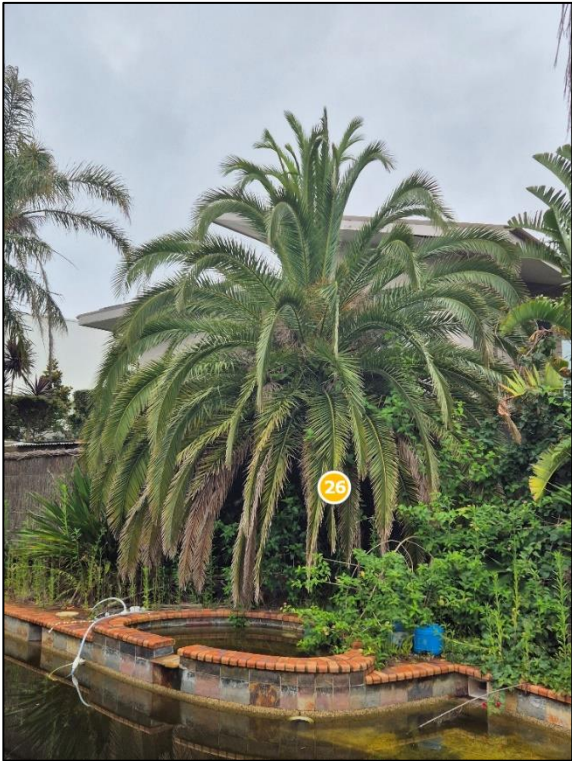
Figure 9 (top left) – Trees 17, 18 and 19 - Low retention value.
Figure 10 (top right) – Trees 22, 23 and 24 - Low retention value.
Figure 11 (bottom left) – Tree 25: *Nerium oleander* - Low retention value.
Figure 12 (bottom right) – Tree 26: *Phoenix canariensis* - Low retention value.

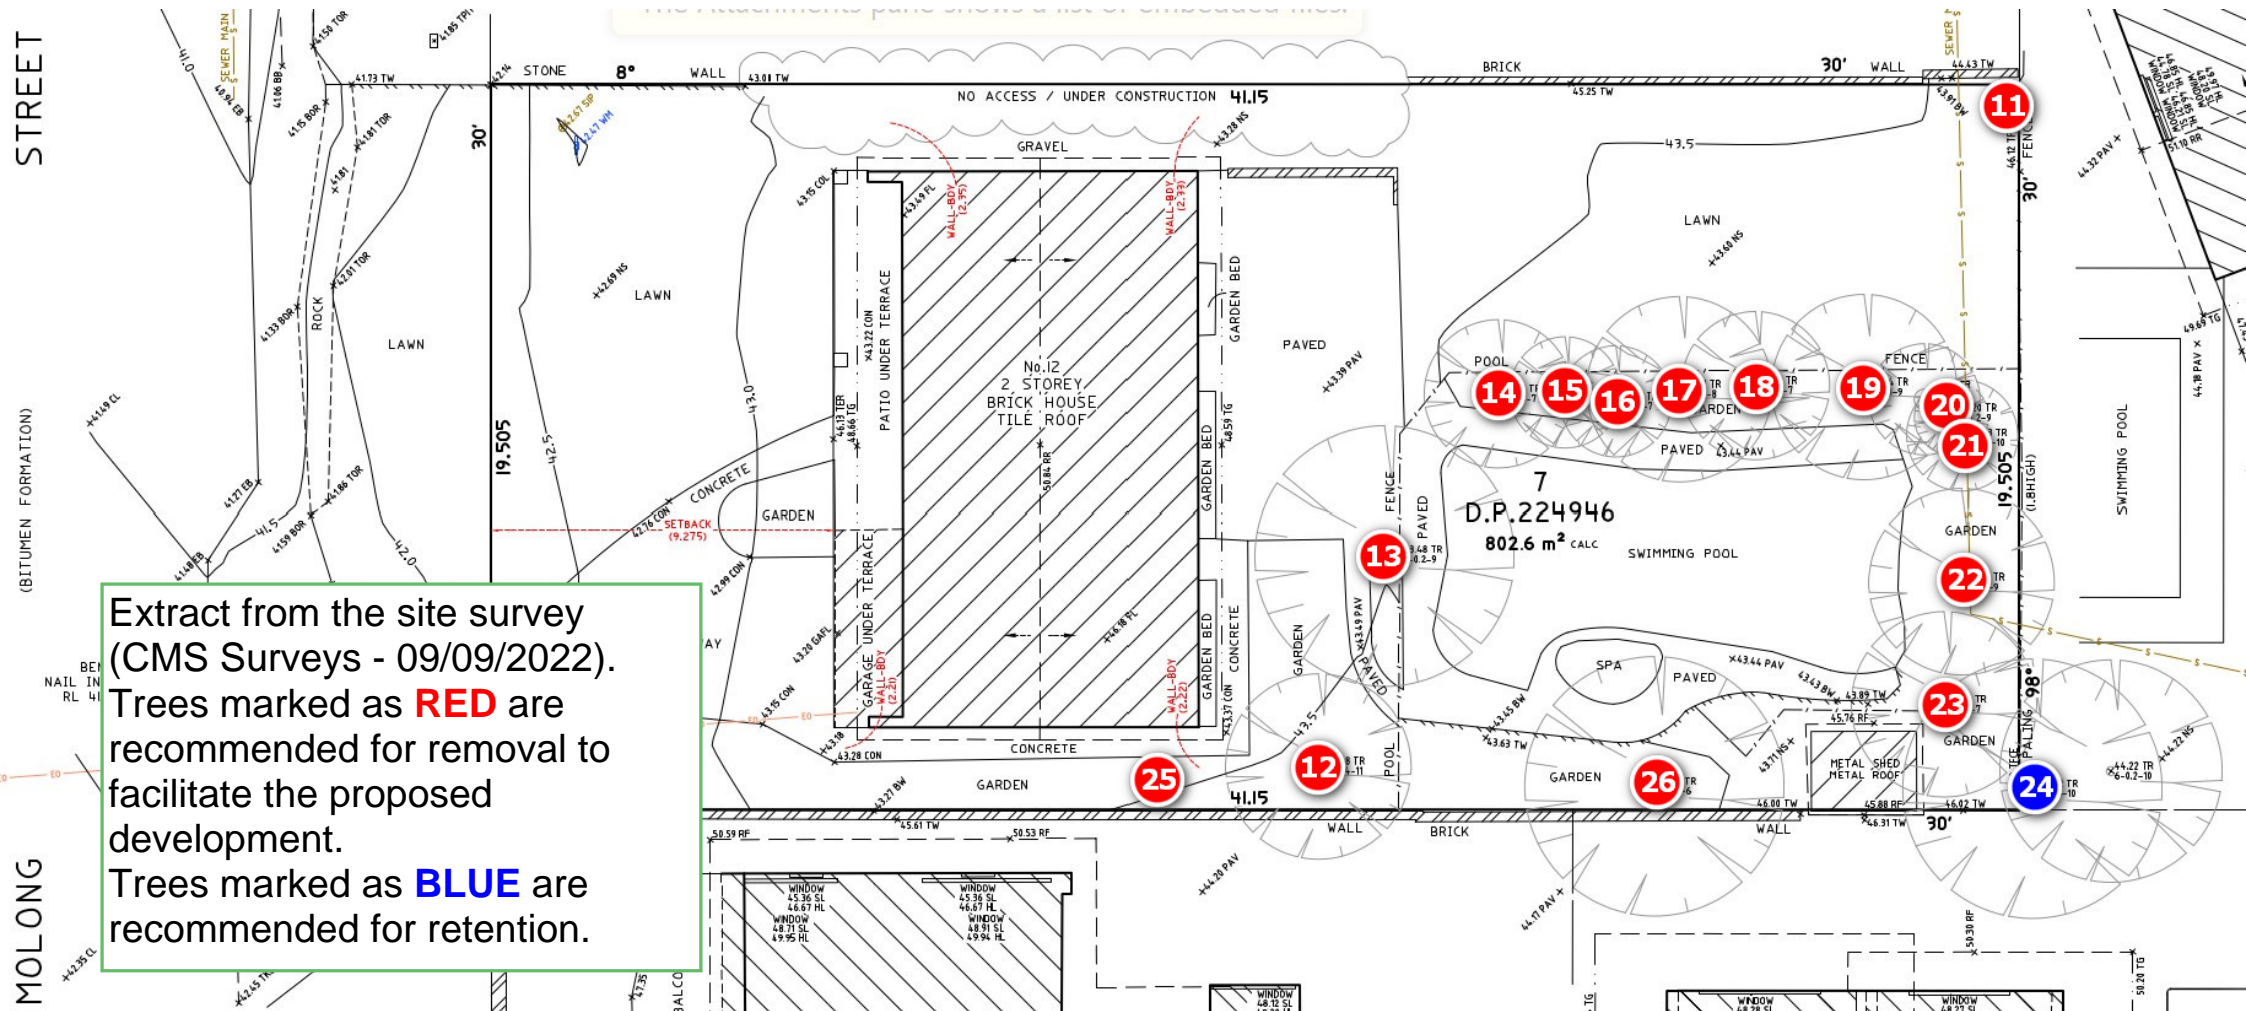
APPENDIX 2 - TREE REMOVAL PLAN

Fifteen (15) trees are recommended for removal to facilitate the proposed development. These trees are numbered 11-23, 25 and 26. These trees are shown in red on the Tree Removal Plan (appendix 2). All 15 of these trees were assigned as Low retention value. These trees are located wholly within the footprint of the proposed development.

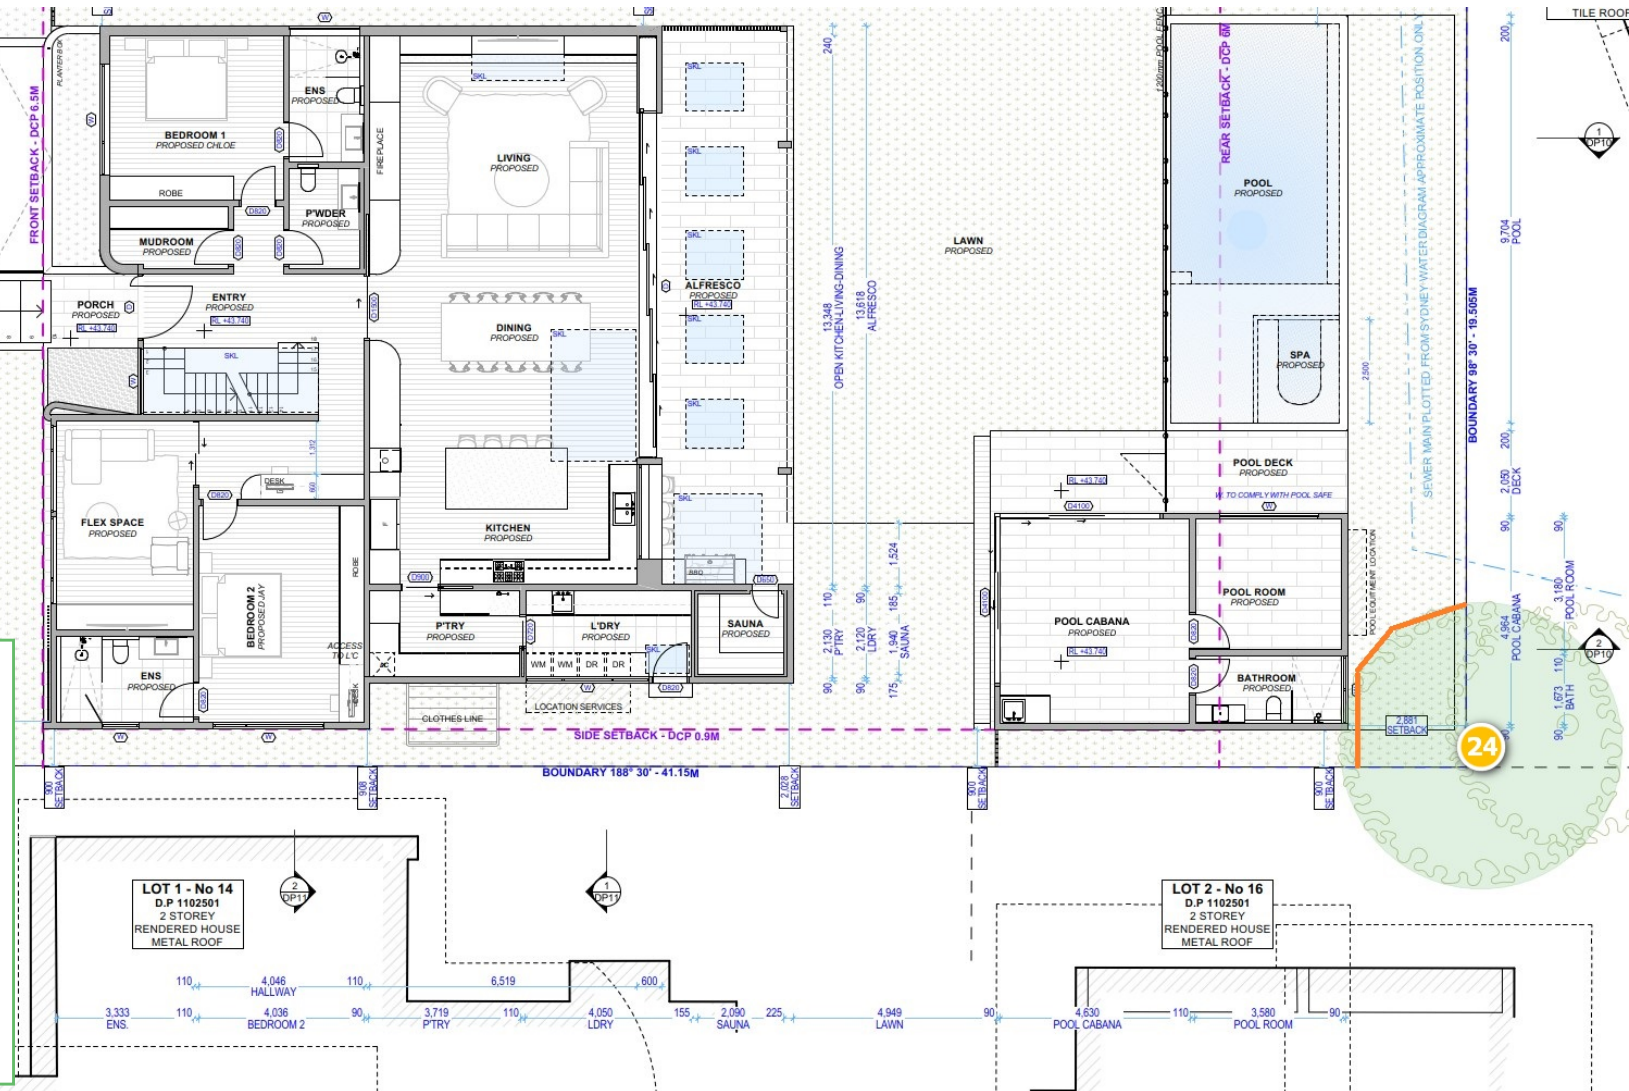
APPENDIX 3 - TREE PROTECTION PLAN

The northeast corner of the proposed pool cabana structure incurs very slightly upon the TPZ of tree 24. The encroachment is minor and deemed negligible. To ensure that no excavation occurs beyond the footprint for the northeast corner of the pool cabana, tree protection fencing is required to protect the TPZ of this neighbouring tree.

Plan extracted from the proposed ground floor plan (Action Plans - 02/12/2024)
 The 3.5m TPZ for tree 24 has been marked up to scale.
Orange mark up delineates the positioning of the tree protection fencing.
 Install tree protection fencing in a semi-elliptical fashion, ensuring it is 3.5m from the trunk of tree 24.

The tree protection fencing is to be installed at a minimum of 3.5m from the base of tree 24. The orange markup in appendix 3 delineates the *approximate* location and orientation of the fencing. The fencing is to be installed immediately after the existing pool and surrounding area has been demolished, and prior to any excavation for the footings for the pool cabana structure.
