J3451A. 6th July, 2021 Page 1.

INFILTRATION TESTING:

For Proposed Infiltration Trench at 23 Hay Street, Collaroy

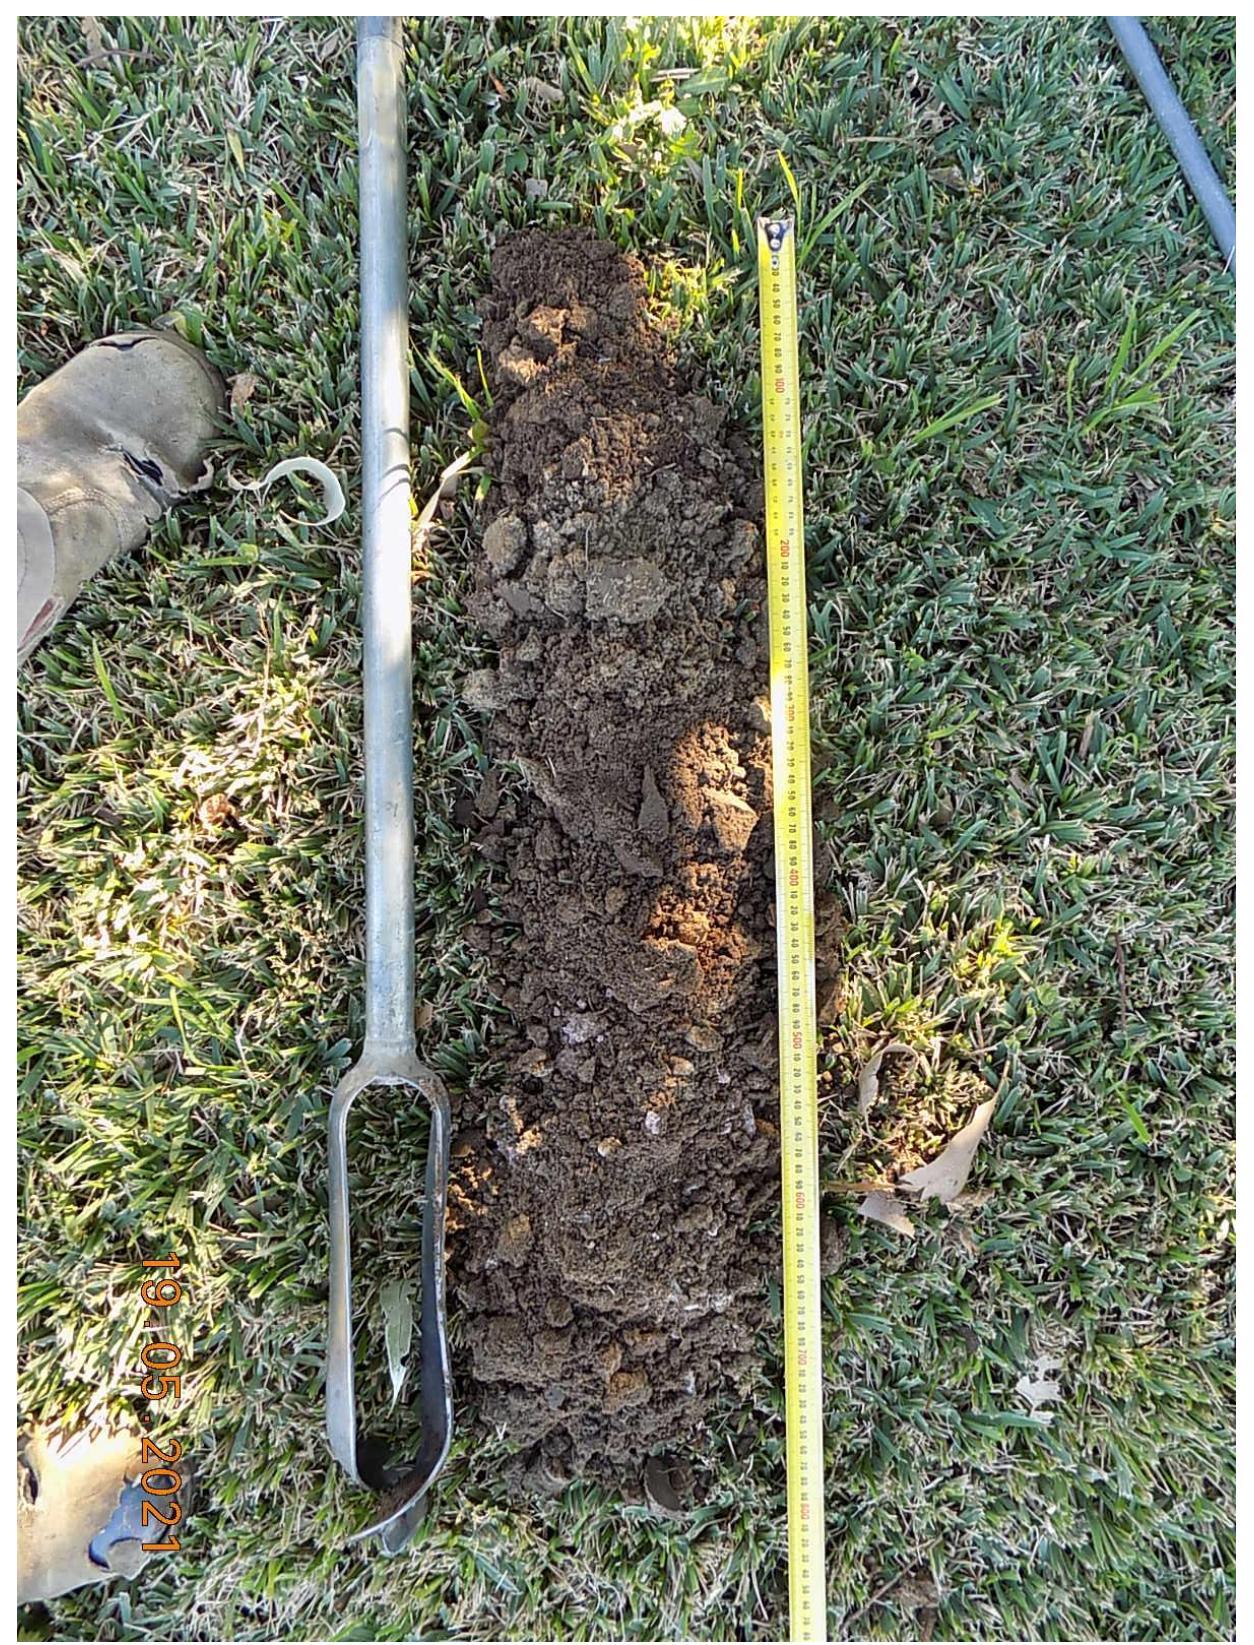
Photo 1: AH1 – Downhole is from top to bottom

AUGER HOLE 1 (~RL27.4) – AH1 (Photo 1)

0.0 to 0.8 **FILL**, disturbed clayey soil, dark brown, medium dense to dense, dry, fine to coarse grained with fine trace organic matter and rock fragments.

End of test @ 0.8m in fill. No water table encountered.
