Arboricultural Impact Assessment (AIA) report

Prepared for
Ekaterina & Emanuel Panagopoulos
regarding 2a Edgecliffe Esplanade,
Seaforth, NSW.

3.12.24
VERSION 1

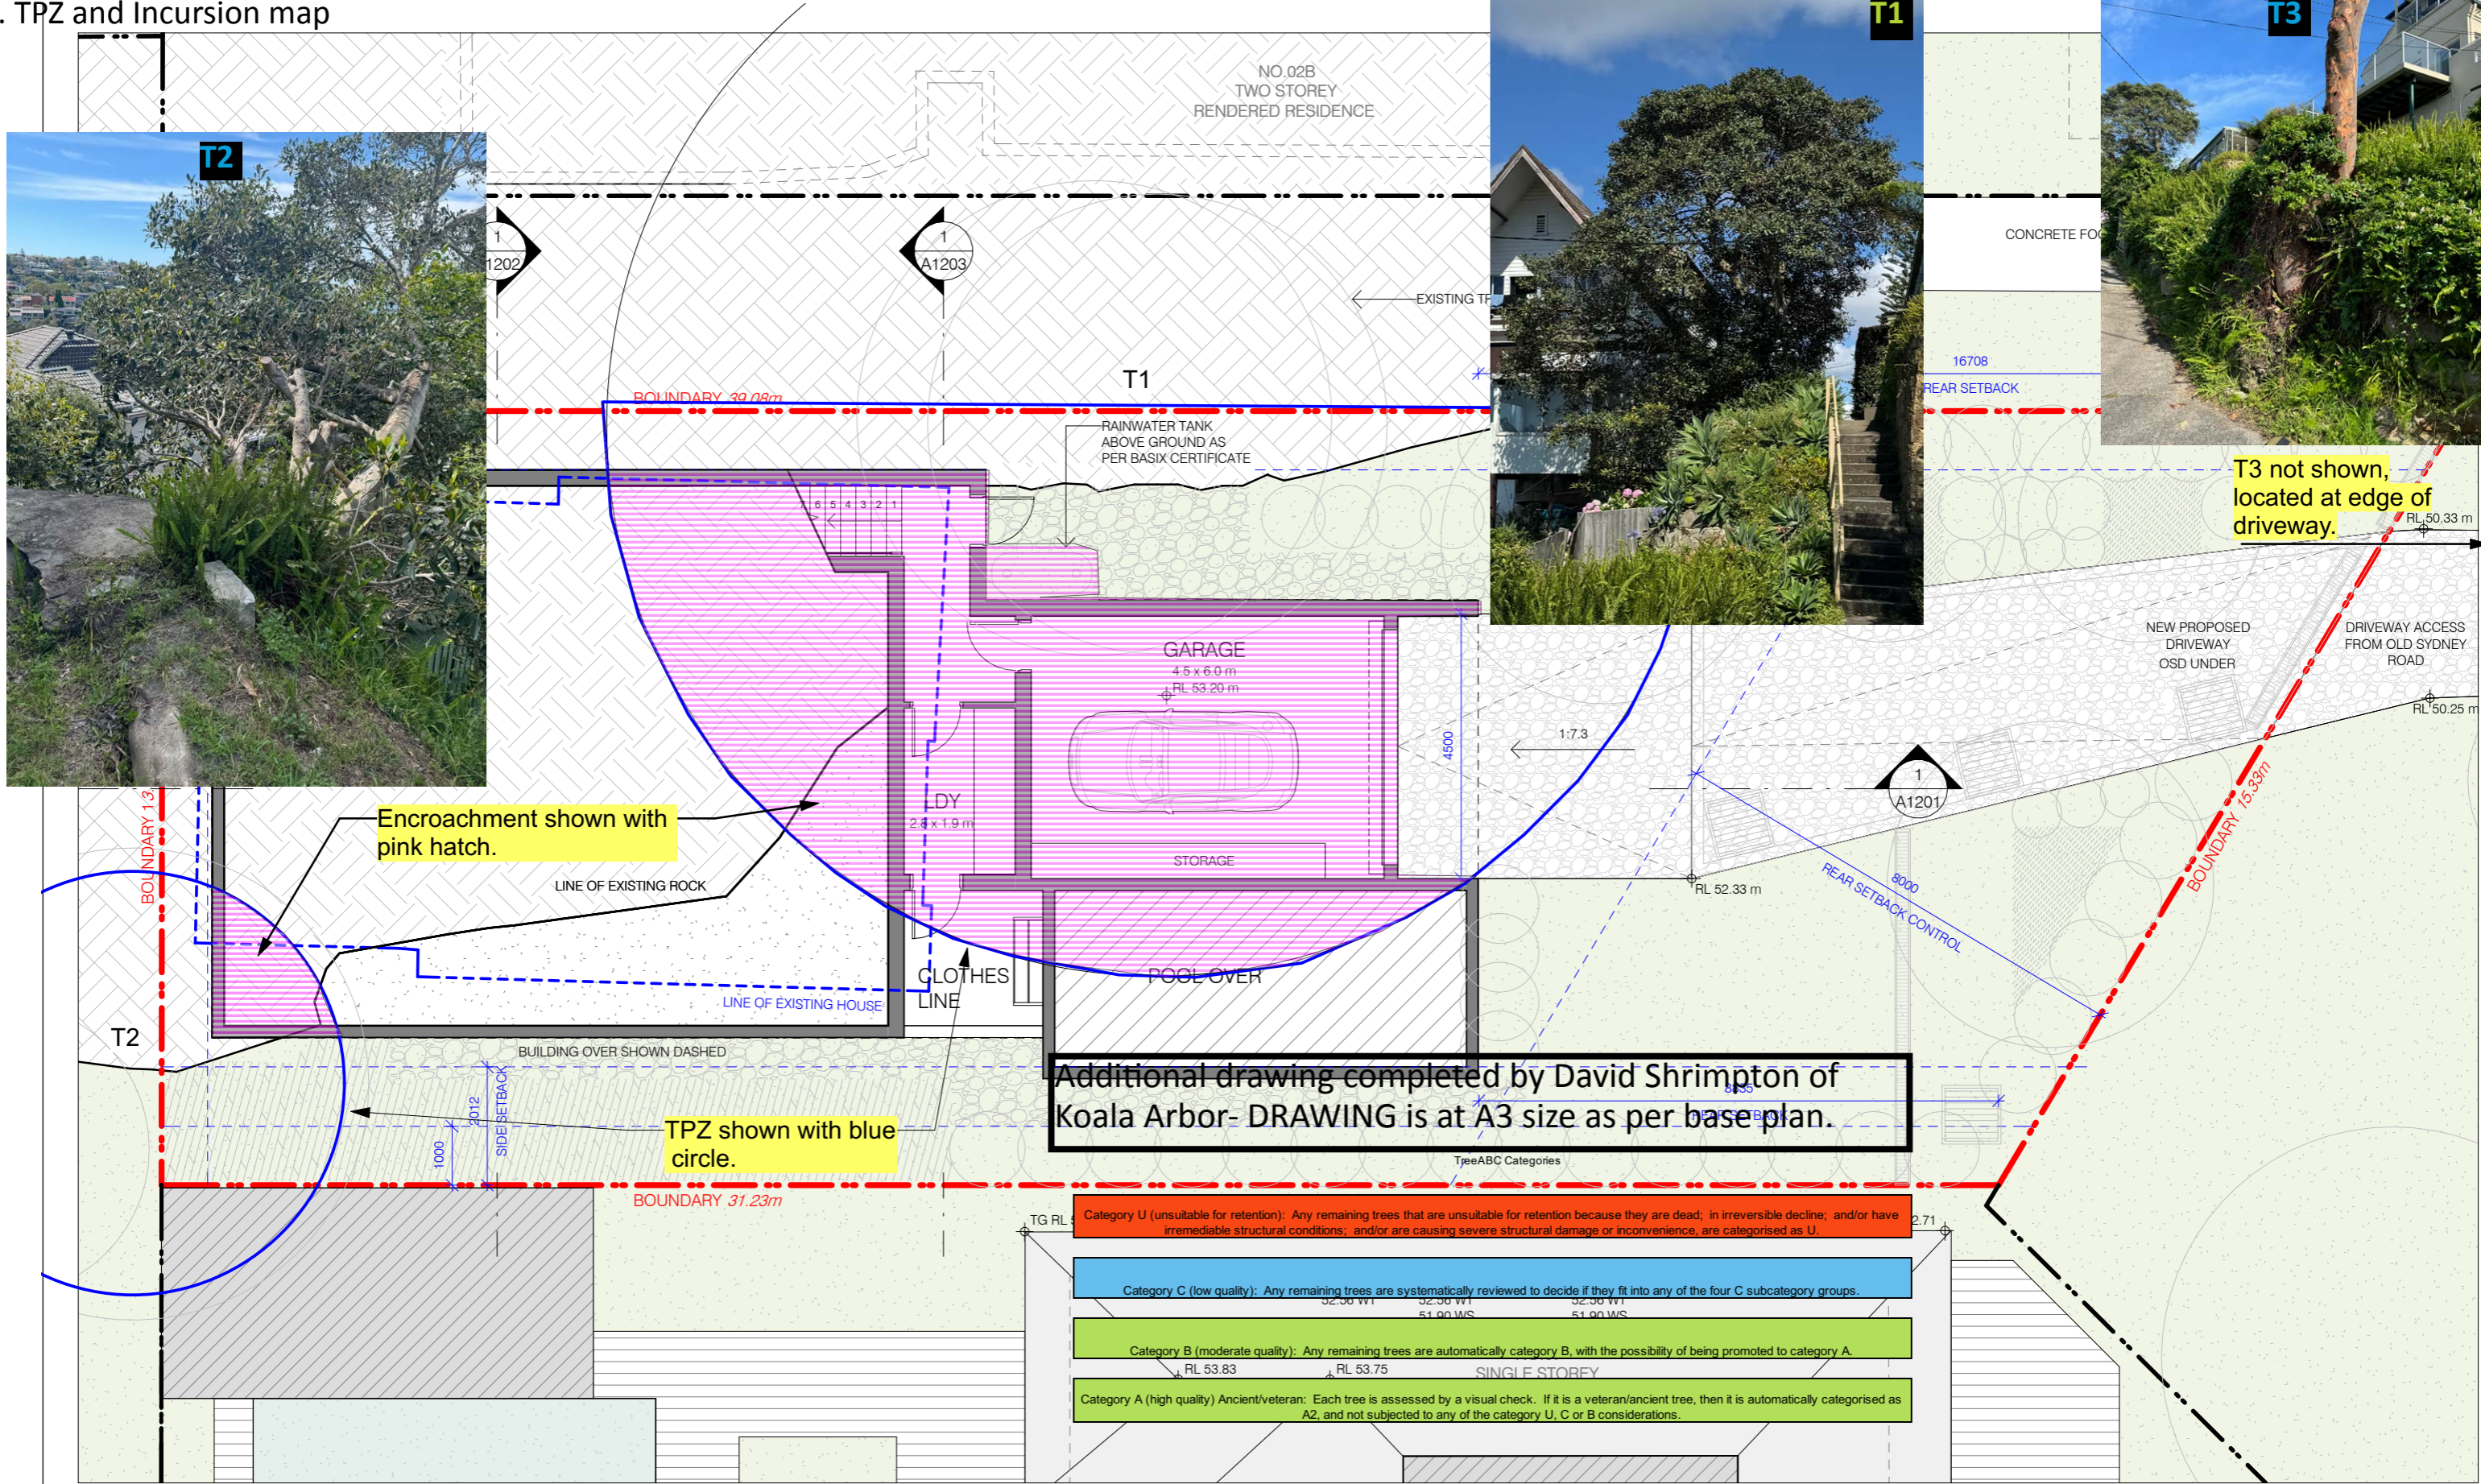
4. TPZ and Incursion map

- **Tree 1** (Category B). Tree is in good health and condition. Tree is growing on a rock face. As per AS4970 clause 3.3.4 (g) the TPZ has been modified. Clause 3.3.5, notes point 5 therefore applies (No SRZ). Species tolerant of root disturbance. Root mapping was completed as best possible parallel to the proposed building line to better understand what possible roots may be present or impacted by the proposed works. A short video showing the root mapping can be found here: <https://app.box.com/s/vwef0ys0jezh39ooyr3x9h57ehk15kip> or refer to Figure 6, 7 and 8. The trench was approx 2m long and up to 600mm deep and followed a sandstone shelf which restricted any deeper digging. One root 70mm \varnothing was located during the mapping. The path of this root was covered by concrete however it is likely to be smaller in size once the proposed building footing which will be excavated 2.2m away from where the root was located. The tree also has other significant roots running along the sandstone wall and assumable into the sandstone itself. The tree is expected to tolerate the level of root disturbance from the major encroachment of 30.2%, which is expected to be significantly less due to the asymmetrical root plate. Also due to the fact that only one notable root was found growing towards the proposed build site. A section of the driveway, gravel path and soft landscaping in front of the tree has not been included in the calculations as part of this will be above the existing grade or can be managed through the site specific tree protection plan. The stormwater line has been designed to run inside garage slab to avoid possible tree roots. <5% canopy pruning also required applying AS4373 Pruning of amenity trees - 7.3.2 Reduction pruning (R). Refer Figure 9. The site specific tree protection plan attached also covers the demolition of garden features which are to be managed through a list of hold points.

- **T2** (Category C). Tree is in fair health and fair condition. Tree is growing on a rock face. As per AS4970 clause 3.3.4 (g). The TPZ has been modified. Clause 3.3.5, notes point 5 therefore applies (No SRZ). Minor impact from encroachment of 5% however it is likely there are no roots present given the natural obstetrical. A large sandstone builder which appears to be coming away from the rock face is present with one large root visible along the surface of the ground. It is recommended that a suitably qualified engineer inspect the rock to confirm if it is

- **T3** (Category C). Tree is in poor health and fair condition. Tree is growing on a rock face. As per AS4970 clause 3.3.4 (g). The TPZ has been modified. Clause 3.3.5, notes point 5 therefore applies (No SRZ). No encroachment but tree is growing out of the rock next to the driveway and could be impacted by accidental damage. The site specific tree protection plan attached is to be managed through a list of hold points.

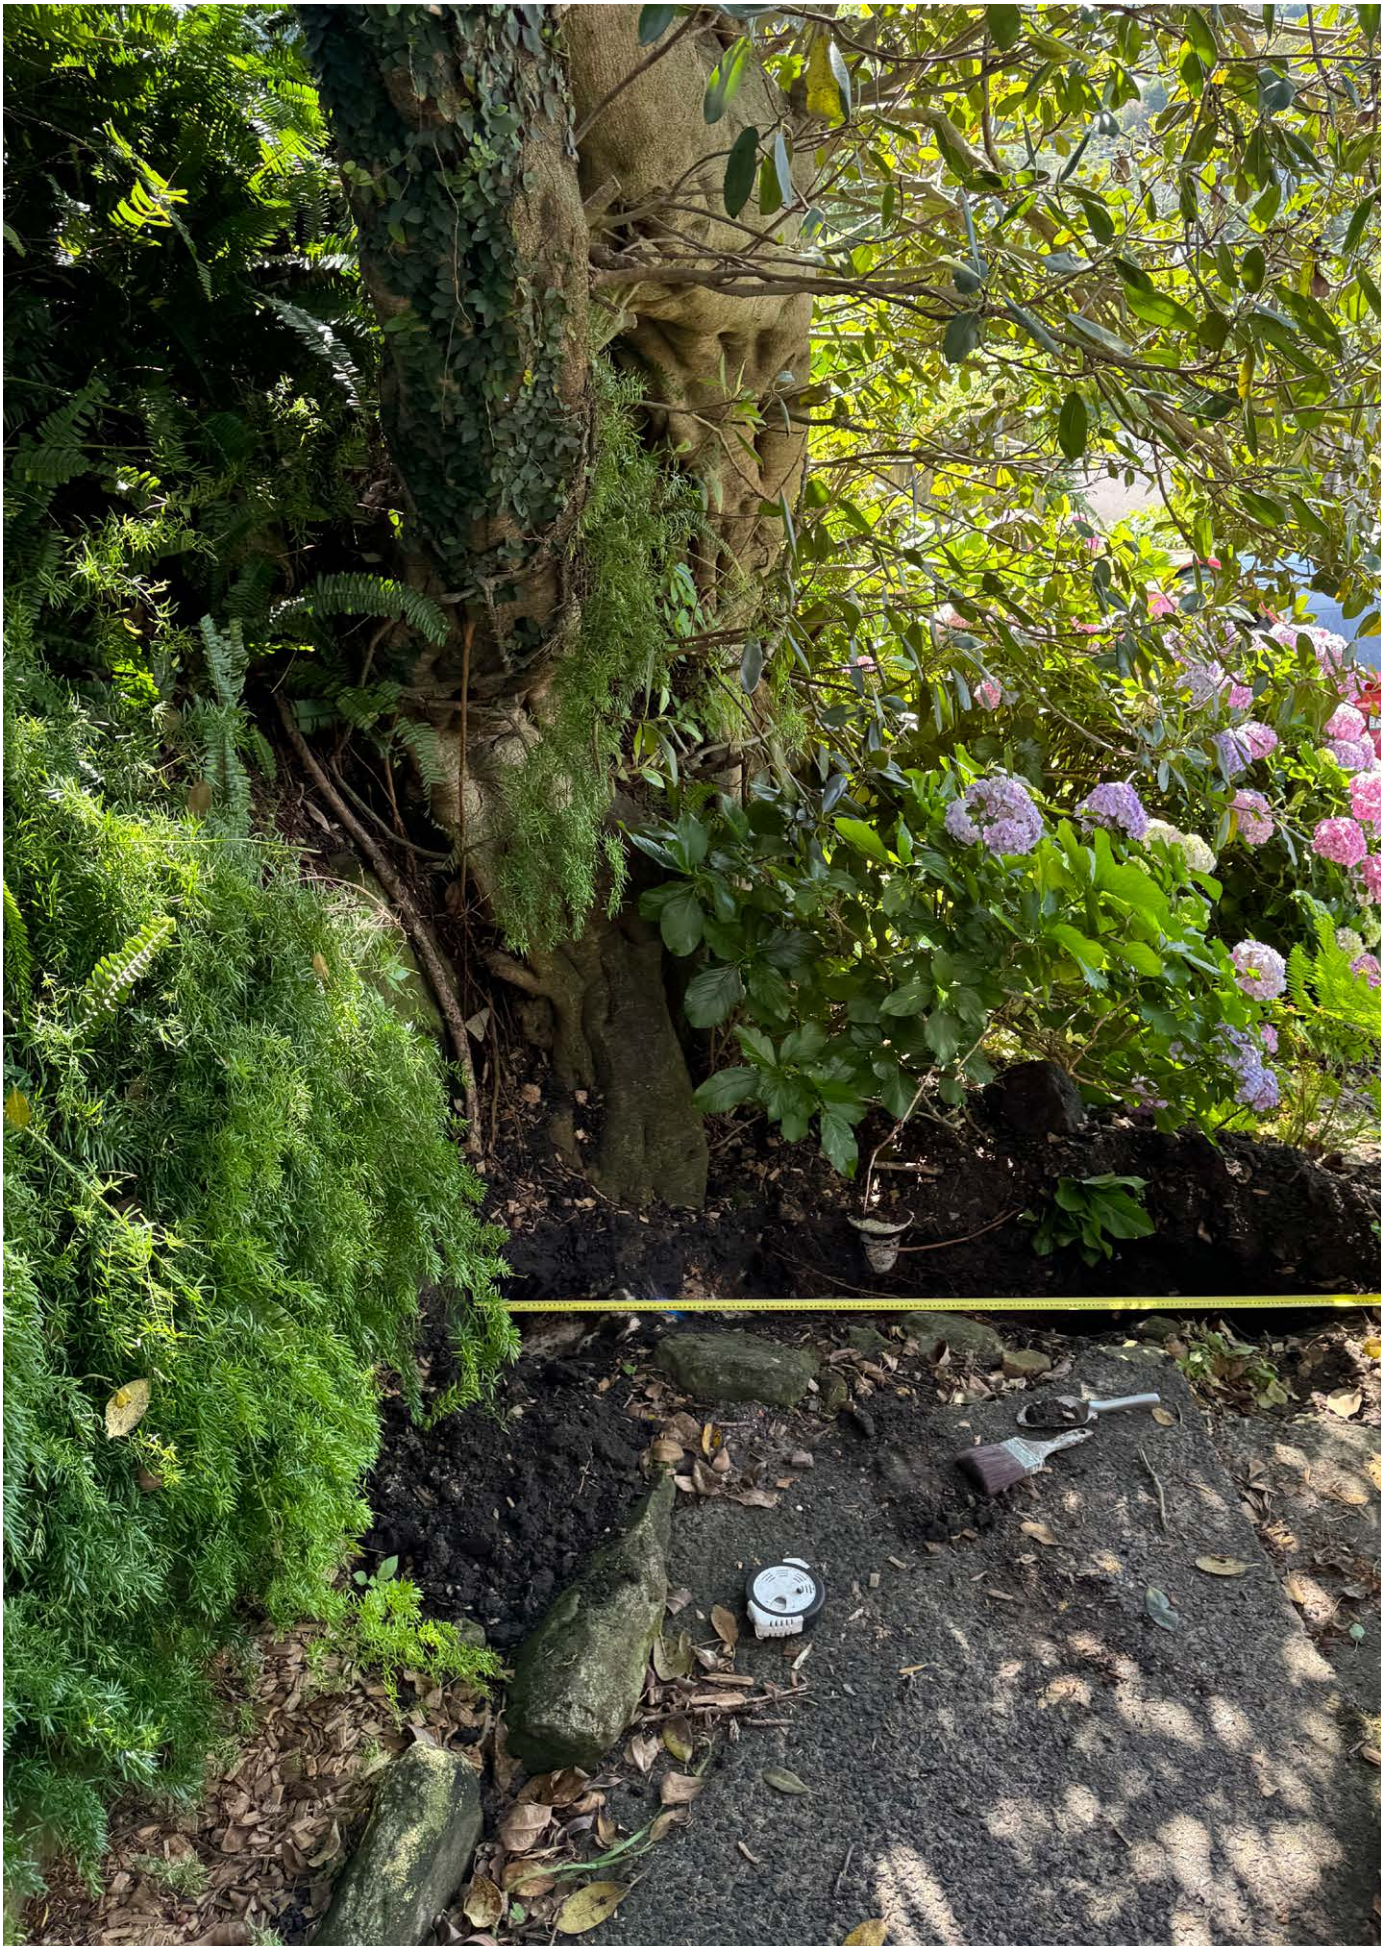
Figure 6. The trench was dug 300mm in front of the tree to the depth of the sandstone shelf below.

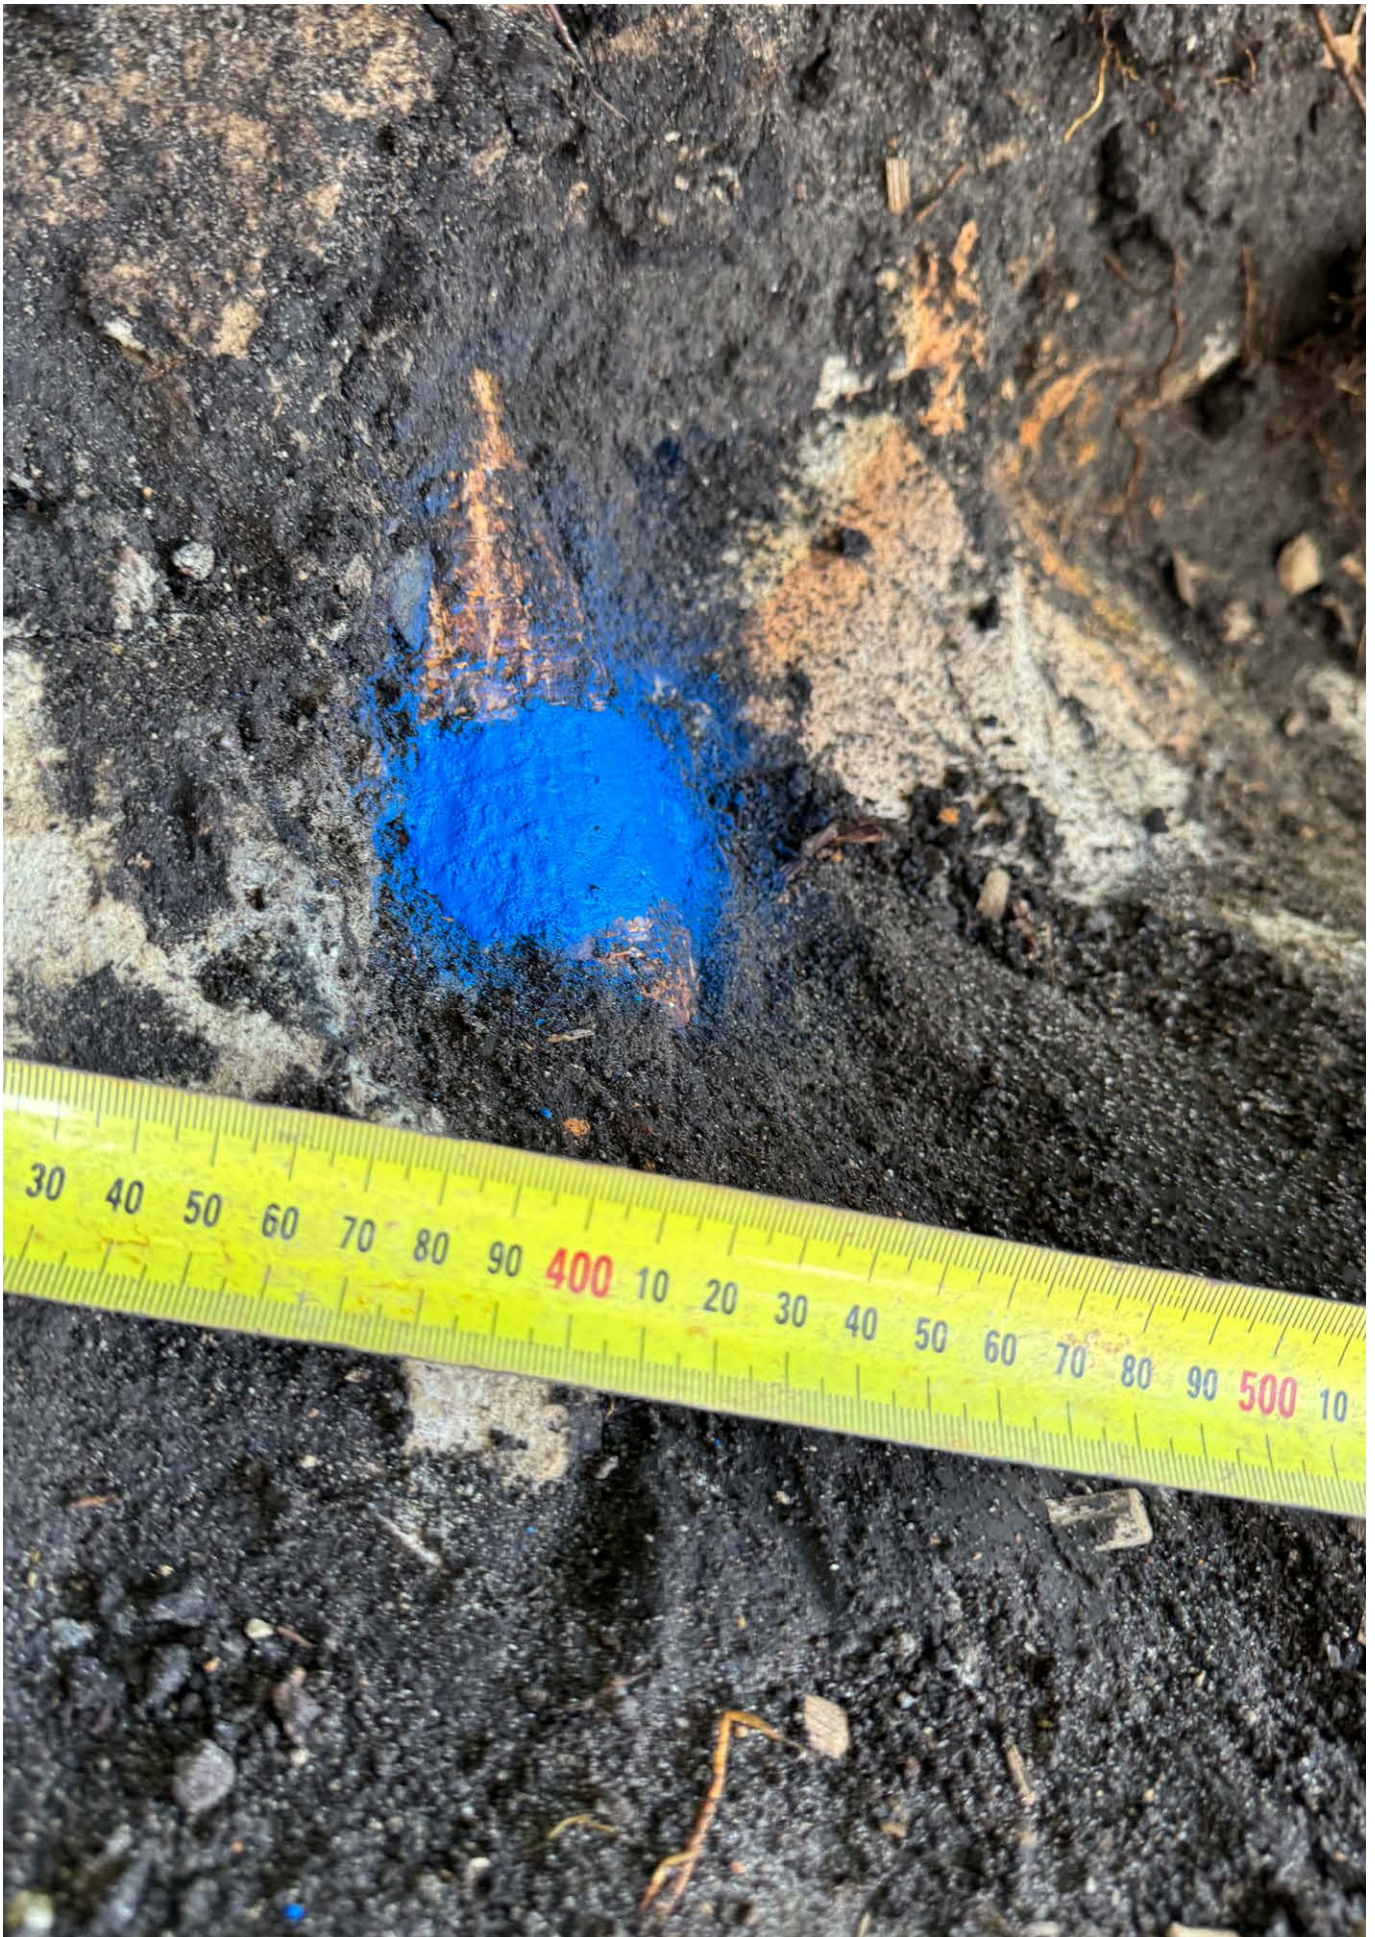
Figure 7. One root was located in the trench 400mm from the starting point. It was approx. 70mm \varnothing and was at a depth of approx. 200mm.

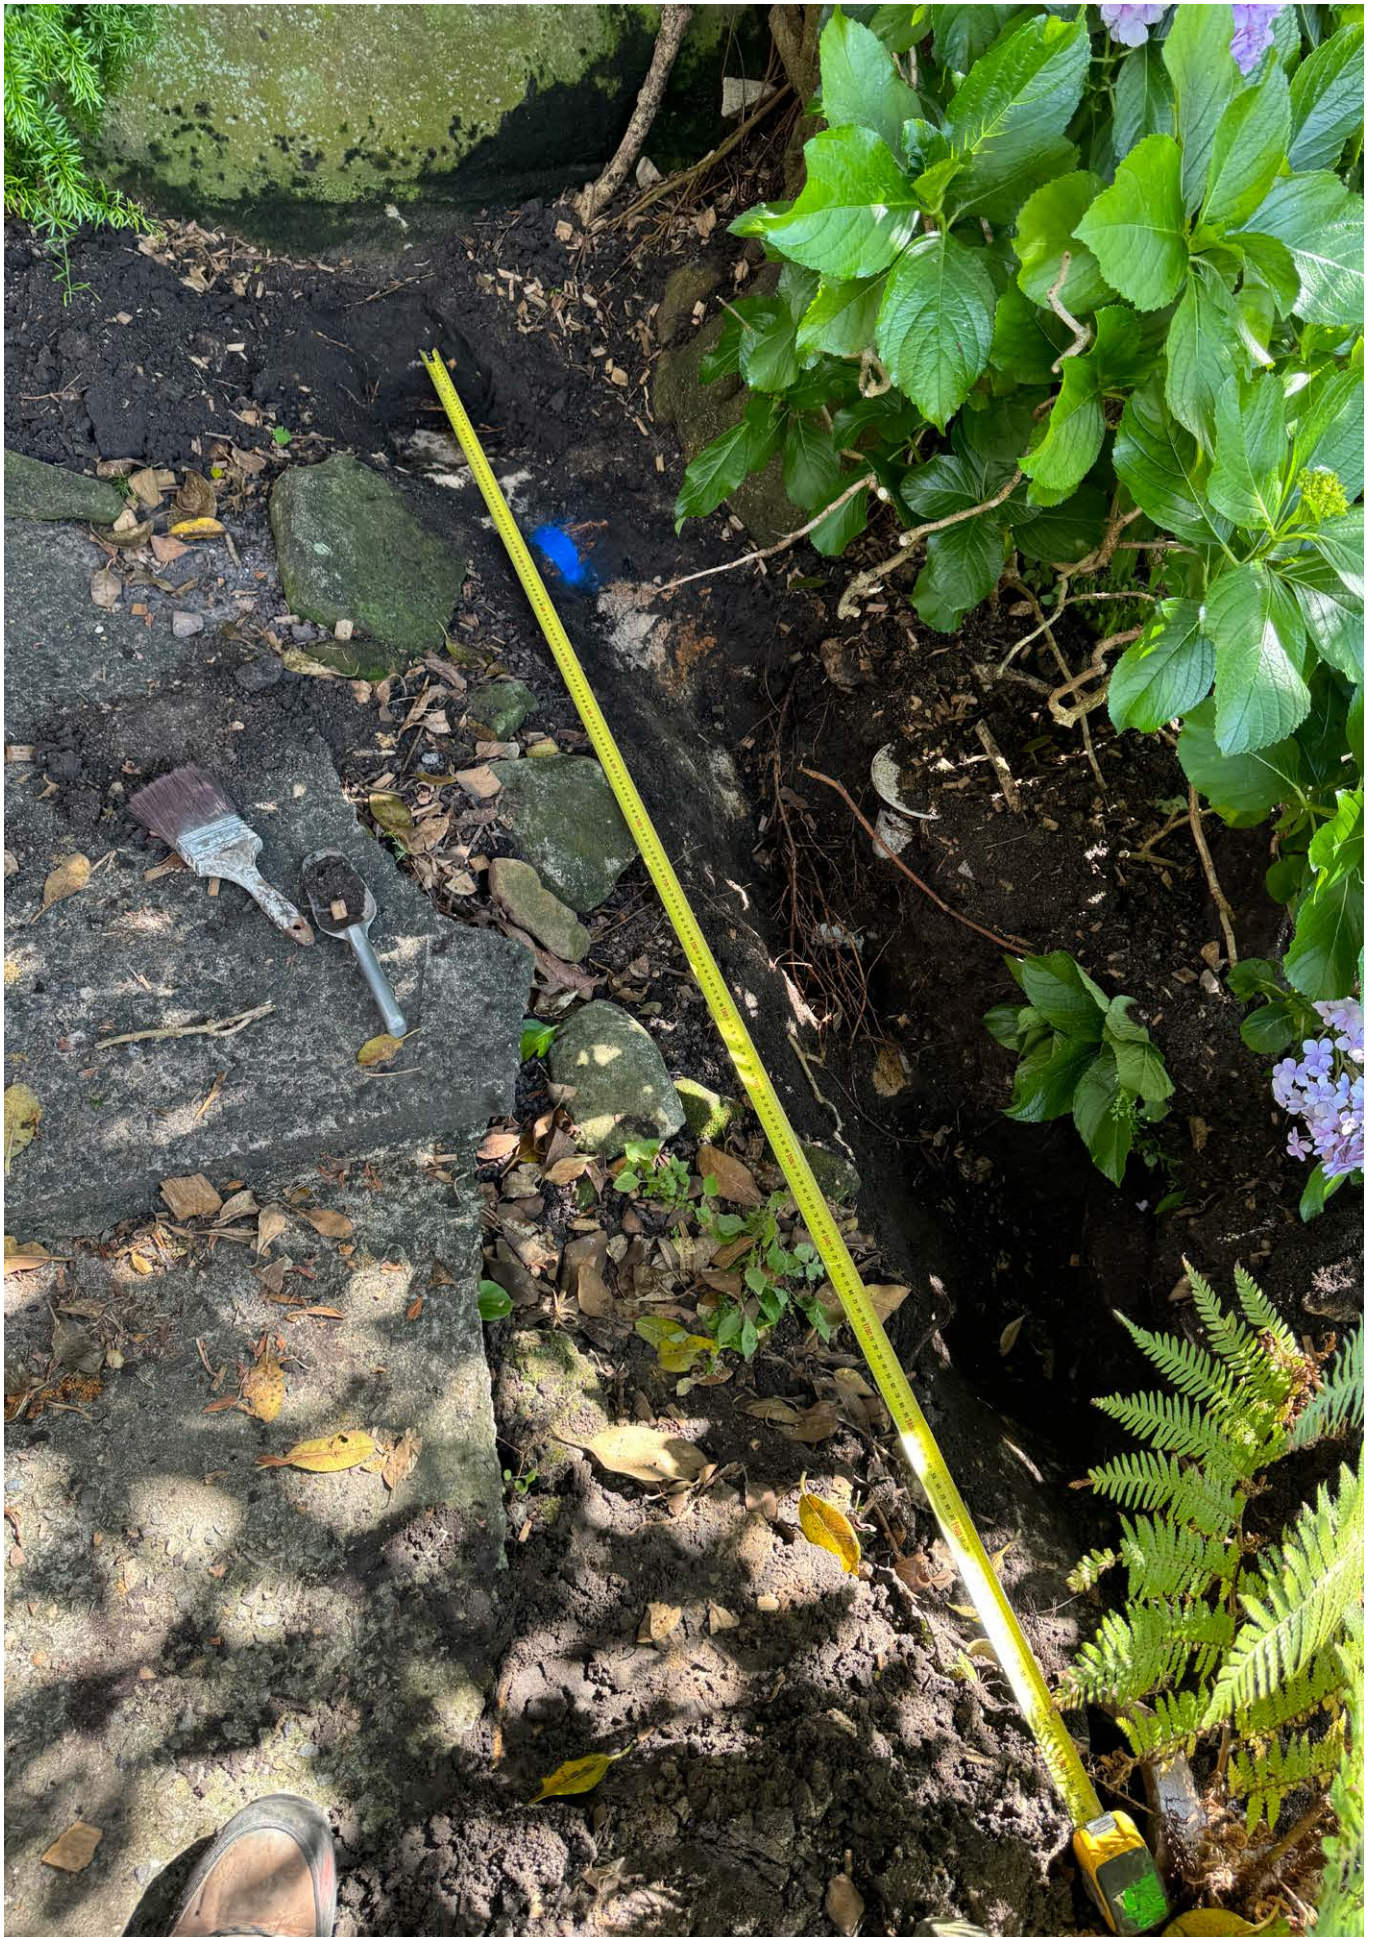
Figure 8. A restricted view of the trench showing the one root located marked in blue.

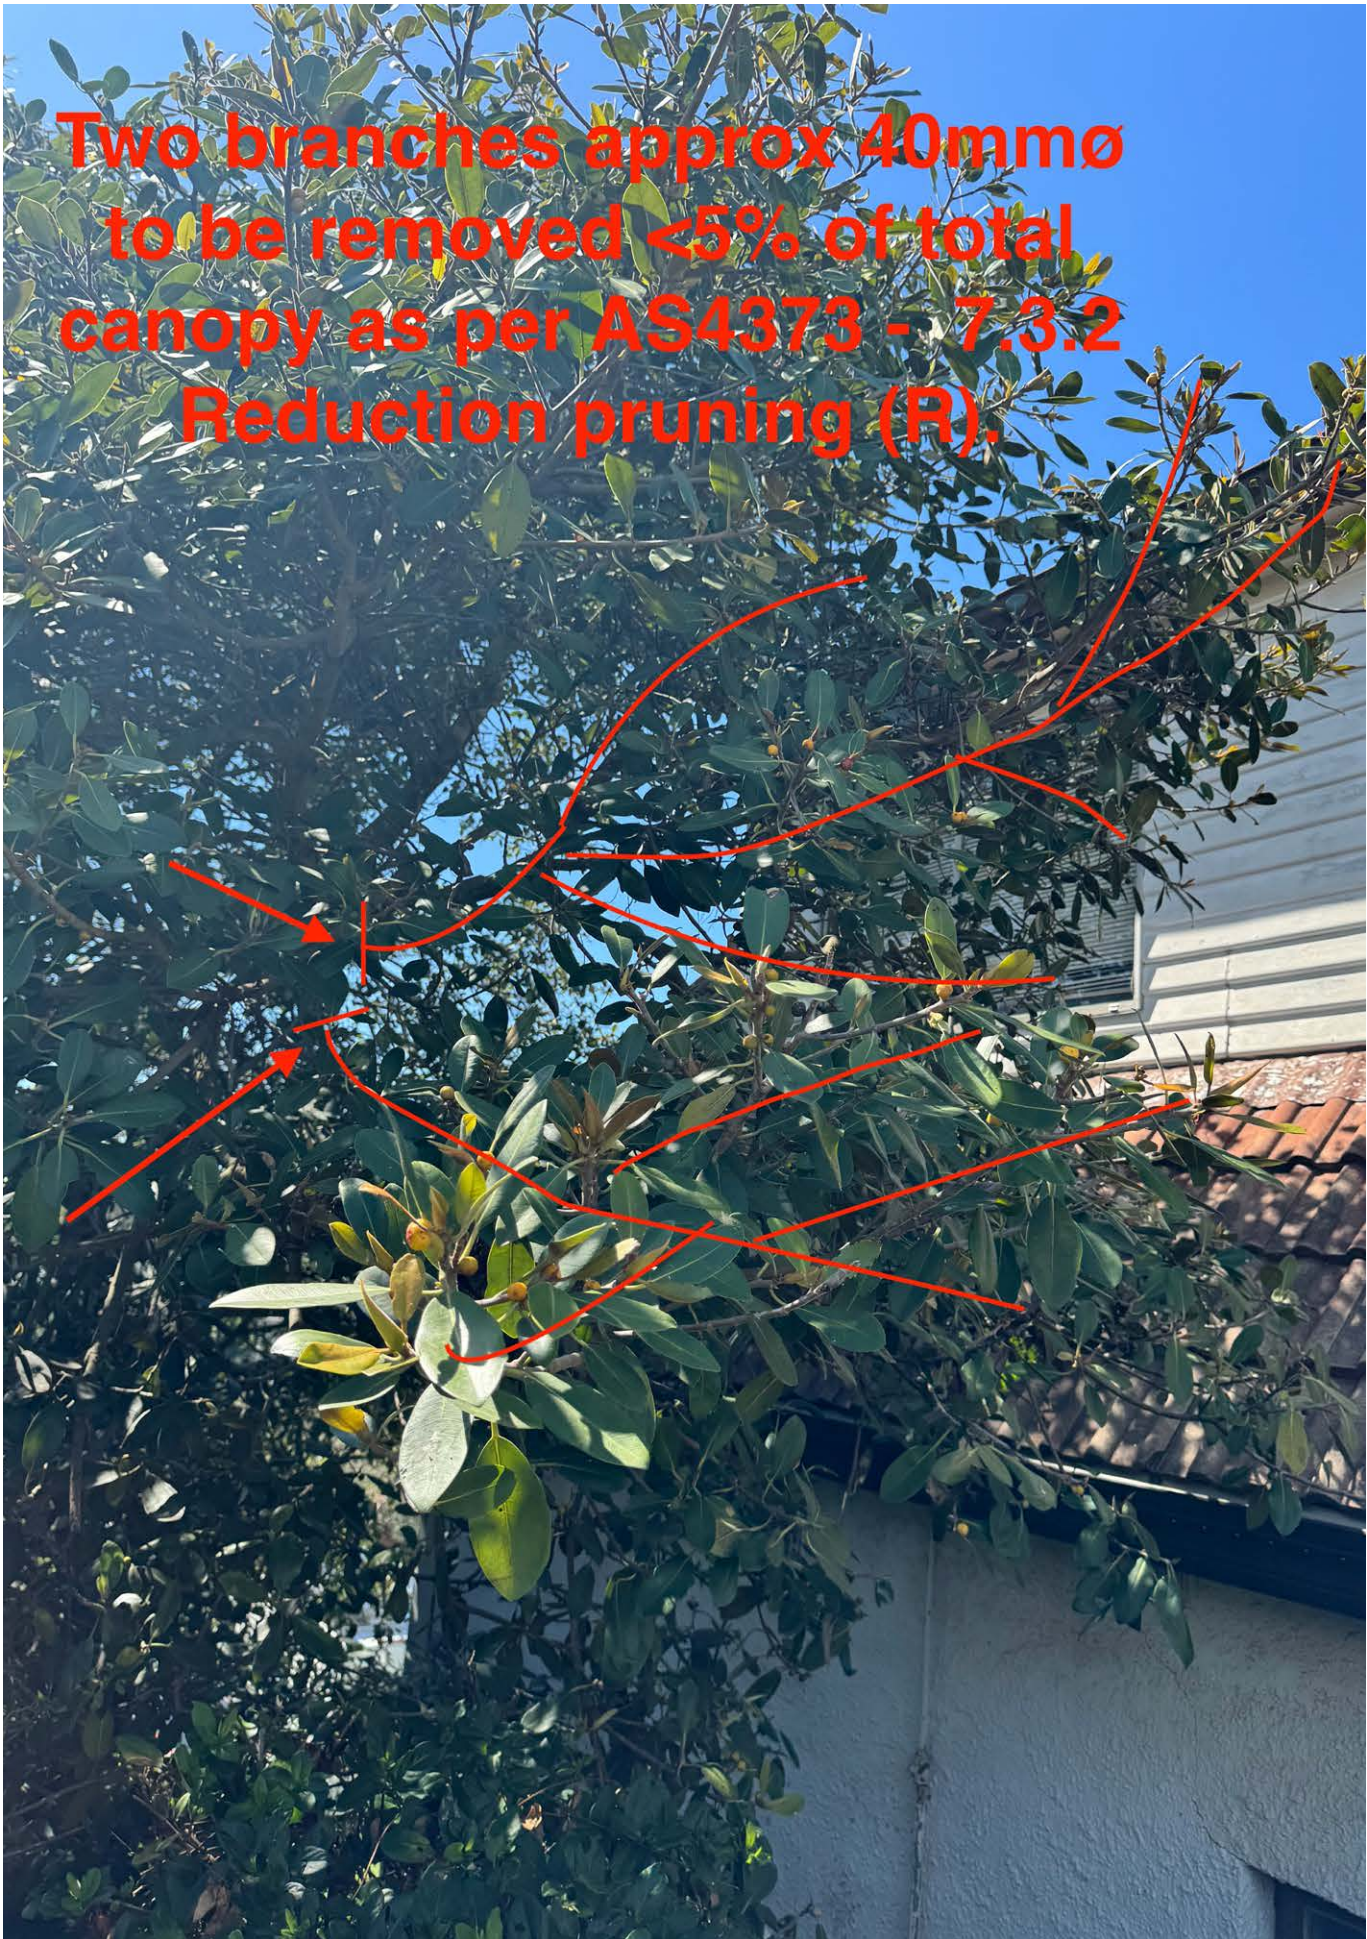
Figure 9. The branches that require removal shown in red including pruning code.

1. Once approved or prior given it is below the Northern Beaches Council allowance of 10% of canopy, the required pruning should be completed by a minimum AQF Level 3 Arborist with all insurances required for undertaking the work in accordance with *AS 4373 - 2007: Pruning of Amenity Trees* and *Safe Work Australia Guide for Managing Risks of Trimming and Removal work (2016)*. Refer Figure 9 for the branches to be pruned.
