13 October 2018

11 WANDEARAH AVENUE – AVALON BEACH, NSW SWIMMING POOL DEVELOPMENT PROPOSAL ARBORICULTURAL ASSESSMENT & IMPACT REPORT

Ref No: RTC-15018

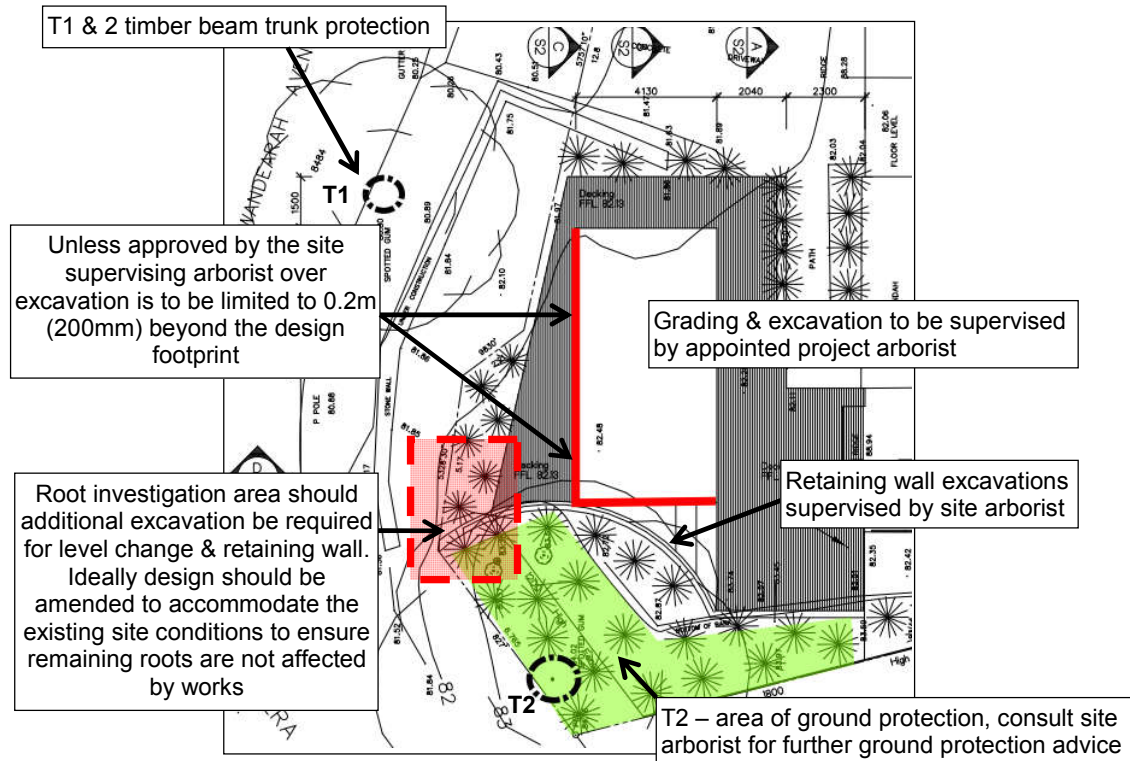
Figure 1, Showing tree management area

Given the existing site conditions the root system of trees 1 & 2 has likely been altered by recent works restricting or altering natural radial root distribution. No further root disturbance is recommended given the amount of root loss that has already occurred.

- 1.3 **Tree 2.** Under limited observations of the existing excavation cut and site grading (leveling) it appears that works have altered any root extension within the proposed construction envelope. Excavations have highly likely removed the extending root zone where the new proposal is unlikely to additionally affect the tree. Based on a notional 11.4m TPZ, pool footprint encroachment would be considered manageable at <15% excavation impact. Due to the existing cut and under the current site conditions the tree should be managed in accordance with any other arboricultural recommendations provided to protect and manage the anchoring root zone. Based on the current works proposed the following recommendations are to be adopted for the purpose of managing the tree during development activities.

1. No additional excavation should occur beyond the existing cut face supporting the Structural Root Zone (SRZ), *the area required for tree stability*.

2. Unless approved by the site supervising arborist over excavation to accommodate the swimming pool cut should be limited to 0.2m (200mm) beyond the pool design footprint. Where site grading (lower) is proposed the arborist shall supervise the entire excavation activity within the 11.4m TPZ.

3. Excavation to accommodate retaining wall footings should be located within the existing disturbed areas only. Should additional cut be required root investigations are recommended to identify the impact on extending and likely critical roots. The treatment of encountered roots should only occur if the root removal has no effect on the tree. Should an effect on tree be identified redesign to ensure the viability of the tree is maintained is recommended.

6. Prior to works timber beam trunk and ground protection is to be installed. Timber beams should be no less than 2.2m in height and protect the circumference of the tree at even spacing. During main work activities ground protection, geotextile fabric or similar is to extend along the top of the upper level soil profile protecting underlying tree roots as shown below.

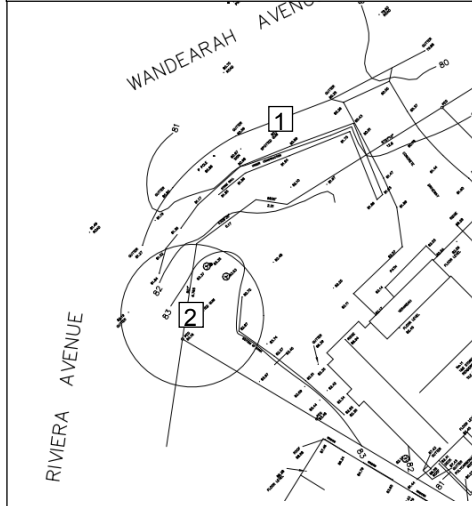
Item 1. Existing – tree Survey location plan

Tree No:	Species	Height x Span	DBH mm	SRZ TPZ	Age	Health	Condition	Significance	VTA	RV	ULE	Comments
1 CV	<i>Corymbia maculata</i> Spotted Gum	15 x 11	450	2.5m	ESM	Fair / Good	Good	3	4/2E	2	2	Environmentally stressed with low foliage volume, minor kerb gutter damage evident
				5.4								
2	<i>Corymbia maculata</i> Spotted Gum	23 x 15	950	3.3	EM	Good	Fair / Good	3	2A	2	2	Located at edge of embankment, restricted radial root development WST side (descending), excavation at 3 – 3.5m EST, NTH/EST, site conditions restricting visual assessment of SRZ
				11.4

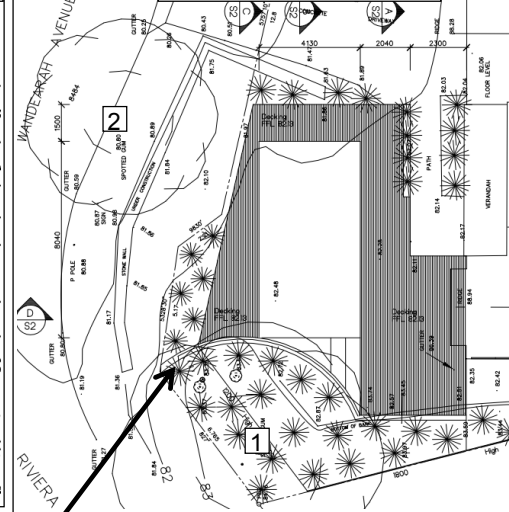
Item 2. Pool location plan

No additional excavation should occur in this area without root investigations, where design should ideally be amended to accommodate existing site conditions.

- Where additional cut is required in the northwestern corner adjacent T2 tree root investigations are recommended to identify impact on remaining tree roots. Given that root disturbances has occurred no further root interference should occur with the design amended to accommodate the existing site conditions.
