19 Marlborough Avenue, Freshwater

Arbor Impact Assessment

Client: Robert Glasson

Luke Smart

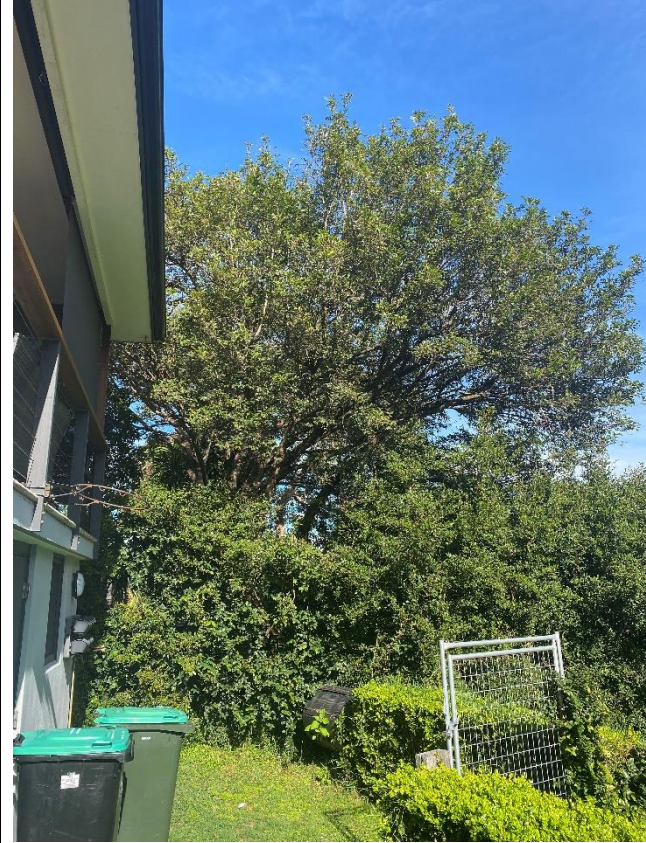
- Tree 1 is a Cheese Tree (*Glochidion ferdinandi*) located in the rear yard of the neighbouring property to the south (No. 21 Marlborough Avenue) and is 2.1m from the proposed new pool area, providing a 14% cut encroachment within the Tree Protection Zone. This tree is considered as having a Medium STARS© Significance rating and must be retained and protected as a neighbouring tree asset.

The excavation required for construction of the new pool with associated coppice and hardstand poses a moderate impact to the tree's root zone with a continuous cut encroachment. However, this may be deemed as sustainable if exploratory root mapping is completed by first digging a narrow trench along the nearest line of cut to the tree to the depth of the proposed hard stand area using appropriate hand-controlled tools under the supervision of a Project Arborist with a minimum AQF5 level qualification. If roots greater than 30mm diameter are identified, the Project Arborist at their discretion should advise whether the root must be retained or should be clean cut with a pruning saw or chainsaw under their direction.

A ground protection weight dispersal system such as geotextile fabric beneath a layer of mulch, or crushed aggregate below rumble boards should be implemented in high traffic areas for work staff and equipment within the measured Tree Protection Zone area (as indicated on the **TREE LOCATION & IMPACT PLAN**, page 18), and must be installed prior to any time this kind of access is proposed.

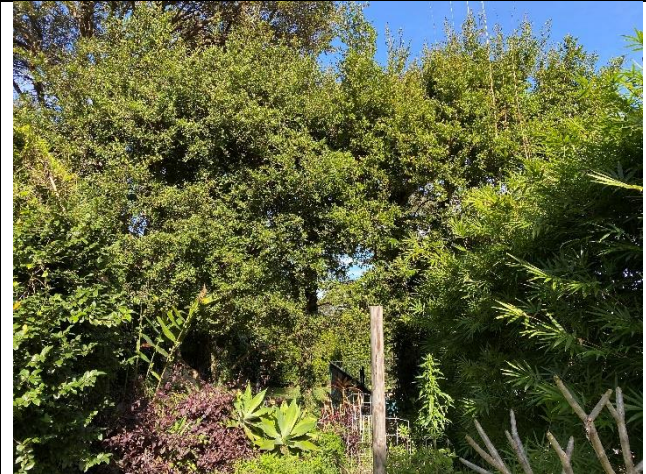
Trees 2, 3, 4 & 5 (Brush Cherry Row)

- Tree No.'s 2, 3, 4 & 5 are a row of Brush Cherries (*Syzgium* sp.) located along the southern boundary of the property on the upper garden level and are approximately 0.4m from the proposed pool area, providing a 19-35% cut encroachment within the Tree Protection Zone that also encroaches within the Structural Root Zone (SRZ). These trees are considered as having a Low STARS© Significance rating and should not be viewed as a constraint on development.

The excavation associated with the construction of the pool area poses a significant and unsustainable impact to tree stability due to the continuous cut encroachment across the measured SRZ of each tree, and they cannot be retained if the development is approved in its current form.

- Tree No.'s 2, 3, 4 & 5 are unsuitable for retention if the proposed development is to proceed due to an unsustainable encroachment being posed to TPZ and SRZ from the excavation associated with the pool area. These trees should be removed prior to site establishment.

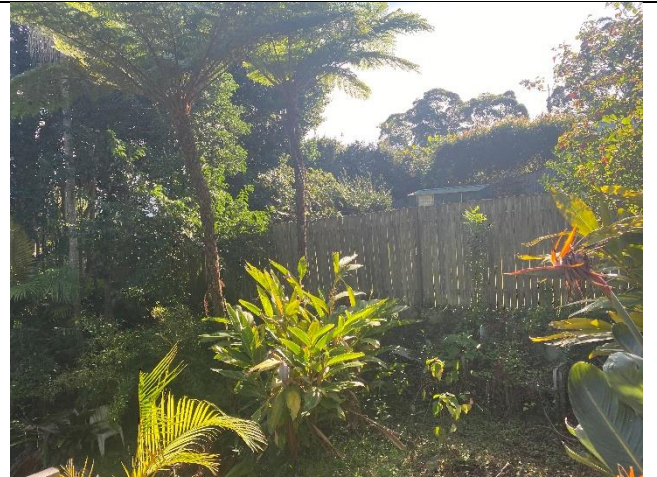
Trees 6 & 7 (from existing stairs)

- Tree 7 is a Lacy Tree Fern (*Cyathea cooperi*) located in the rear yard of the property in the lower garden area, and is 1m from the proposed timber sleeper pathway, providing a negligible cut encroachment within the Tree Protection Zone; and has a proposed granite layer spread around the base of the tree as part of the new landscaping on the lower garden level. This tree is considered as having a Low-Medium STARS© Significance rating and is suitable for retention and protection.

While the construction of the new timber sleeper pathway occurs within the measured TPZ of this tree, the TPZ of Tree Ferns is calculated the same as Palm trees (Tree No.'s 8, 9, 10 & 11). Tree 7's TPZ is also based on providing an offset from the overhead crown, to ensure no damage is posed to the live fronds of the tree; and there is no official calculation for its Structural Root Zone. A Tree Fern's root system generally has small, shallow, fibrous roots that are an extension of the rhizomic trunk, and the tree only requires a small root zone for trunk stability. However, the roots of Tree Ferns are also generally more fragile than Palm roots and are more sensitive to anerobic soil conditions caused by compaction, or the installation of fill over natural ground levels where the roots are located.

- Tree 6 is a Lacy Tree Fern (*Cyathea cooperi*) located in the rear yard of the property in the lower garden area and is within the footprint of the proposed new timber sleeper pathway. This tree is considered as having a Low-Medium STARS© Significance rating and should not be viewed as a constraint on the development.

Revision of the proposed design to accommodate retention of this tree would require the proposed stairs to be redirected away from its current set down, which may also necessitate the removal of a stand of Bamboo the client wishes to retain as a natural screen for the pool area. This tree cannot be retained if the development is approved in its current form.

If the tree is to be retained, consideration should be given to retaining natural ground levels and undisturbed soil within a 1m radius of the base of the tree to assist with tree retention. This undisturbed area should be implemented as a garden bed, with only a thin layer of leaf mulch being installed over existing soil to provide organic matter and moisture retention to the soil.

Establishment of an exclusion zone around the tree with temporary fencing as a protective measure would not be suitable for this specimen due to its proximity to the proposed works. As an alternative measure, the tree should have protective battening installed on the lower trunk (as per **10.3 – OTHER TREE PROTECTION MEASURES**, page 20) that shall consist of internal cushioning and battens strapped together consistent with the Australian Standard for the Protection of Trees on Development Sites (AS 4970 - 2009), Section 4 and paragraph 4.5.2 and Figure 4. The battens shall consist of 2m lengths of 35 x 70mm (or similar to accommodate tree structure) structural timber secured side by side, spaced 50-100mm apart with galvanised steel banding for the full circumference of the trunk and fixed by straps without driving nails or screws into the trunk or branches. This should be installed prior to site establishment and removed after completion of the development.

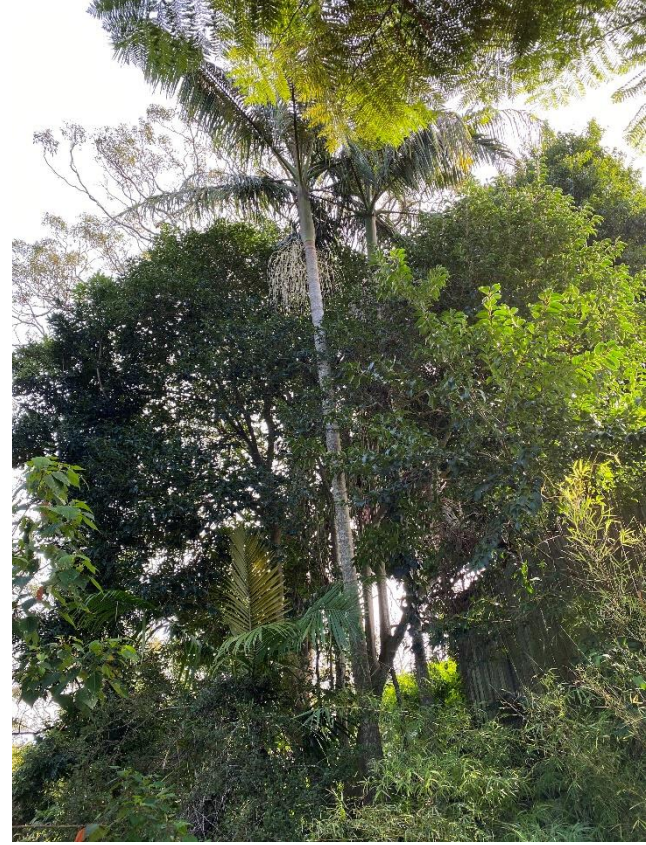
Trees 8 & 9

- Tree No.'s 8, 9, 10 & 11 are Bangalow Palms (*Archontophoenix cunninghamiana*) located at the rear of the property along the western boundary fence line and are 1.3-1.8m from the areas proposed for the installation of a granite and pebble layer, providing a negligible encroachment within the Tree Protection Zone. These trees are species listed on the Northern Beaches exempt tree species list, are considered as having a Low STARS© Significance rating and should not be viewed as a constraint on development.

While the construction of the new dwelling occurs within the measured TPZ of these trees, the TPZ of Palms and monocotyledon tree vegetation are calculated differently to dicotyledons. All four trees' TPZ is based on providing an offset from the overhead crown, to ensure no damage is posed to the live fronds of the tree; and there is no official calculation for its Structural Root Zone. A Palm's root system generally has small, shallow, fibrous roots that are an extension of the rhizomic trunk, and the tree only requires a small root zone for trunk stability. As the proposed new granite/pebble areas and associated construction activities will occur below and well clear of the overhead crown, the impact within the TPZ is most likely sustainable.

A fenced exclusion zone should be implemented in order to protect the trunks and critical root base of these trees, while providing a reasonable offset from the proposed granite and pebble area footprints to allow clear access for construction activities (as indicated in the **TREE LOCATION & IMPACT PLAN**, page 18).
