Tree Impact Assessment Report

Written as per Australian Standard 4970-2009

**28 Lockwood Avenue,
Belrose NSW 2085**

Prepared by Mark Bury Consulting

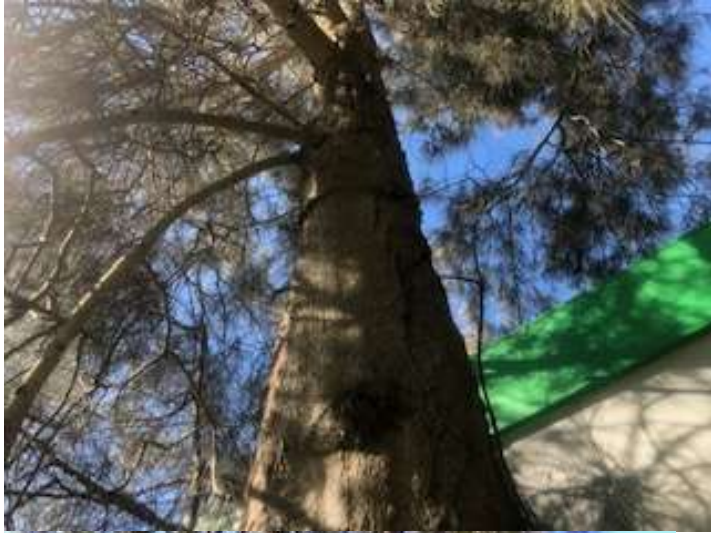
Tree 1 *Casuarina glauca*
Swamp Oak

- 5.1 **Tree 1** (*Casuarina glauca* Swamp Oak) is a tree in good condition Appendix 1 gives a description of the tree as per AS-4970-2009 Section 2. Appendix 2 shows a photograph of the tree; Appendix 4 indicates the location of the tree on a survey plan of the site. The tree was planted within 2 metres of neighboring infrastructure
- 5.2 The tree will be severely affected by the proposed development works (See Appendix 1). The hydrological and soil environments of the tree will be heavily impacted. The TPZ of the tree will have an unacceptable incursion of 50% from the proposed development works.
- 5.3 It would be considered appropriate tree management that the tree be removed and replaced with a more suitable specimen better sited elsewhere on the

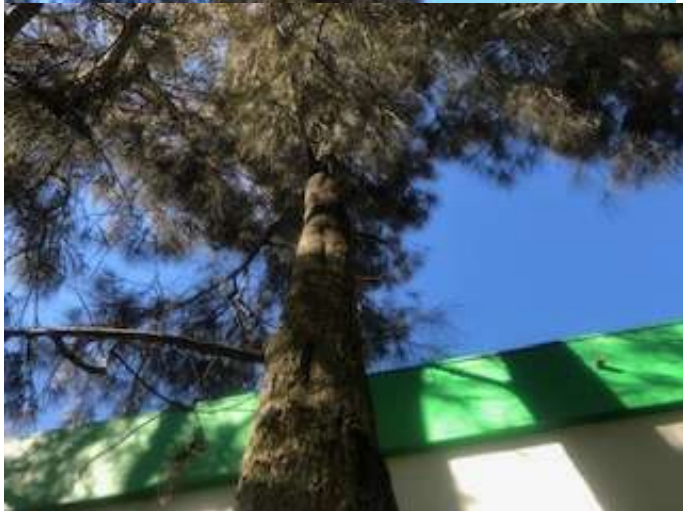
Tree 3 *Casuarina glauca*
Swamp Oak

- 5.8 The tree has good vigour and provides some visual and environmental amenity to the vicinity it is located.
- 5.9 **Tree 3** (*Casuarina glauca* Swamp Oak) is a tree in good condition Appendix 1 gives a description of the tree as per AS-4970-2009 Section 2. Appendix 2 shows a photograph of the tree; Appendix 4 indicates the location of the tree on a survey plan of the site. The tree was planted within 2 metres of neighboring infrastructure

- 5.11 It would be considered appropriate tree management that the tree be removed and replaced with a more suitable specimen better sited elsewhere on the property as part of the Landscape Plan for the site.

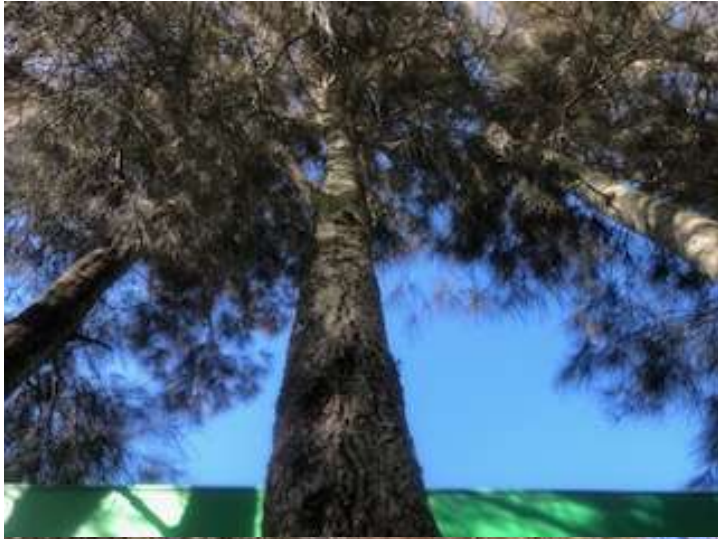
Tree 4 *Casuarina glauca*
Swamp Oak

- 5.12 The tree has good vigour and provides some visual and environmental amenity to the vicinity it is located.
- 5.13 **Tree 4** (*Casuarina glauca* Swamp Oak) is a tree in good condition Appendix 1 gives a description of the tree as per AS-4970-2009 Section 2. Appendix 2 shows a photograph of the tree; Appendix 4 indicates the location of the tree on a survey plan of the site. The tree was planted within 2 metres of neighboring infrastructure

- 5.15 It would be considered appropriate tree management that the tree be removed and replaced with a more suitable specimen better sited elsewhere on the property as part of the Landscape Plan for the site.

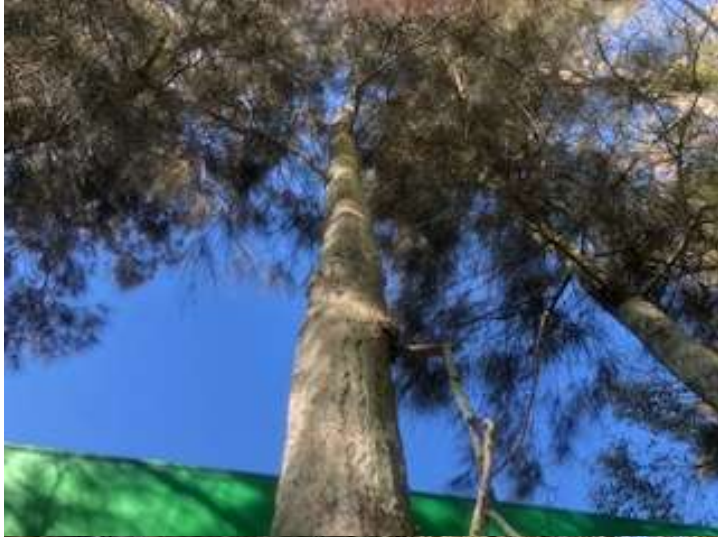
Tree 5 *Casuarina glauca*
Swamp Oak

- 5.16 The tree has good vigour and provides some visual and environmental amenity to the vicinity it is located.
- 5.17 **Tree 5** (*Casuarina glauca* Swamp Oak) is a tree in good condition Appendix 1 gives a description of the tree as per AS-4970-2009 Section 2. Appendix 2 shows a photograph of the tree; Appendix 4 indicates the location of the tree on a survey plan of the site. The tree was planted within 2 metres of neighboring infrastructure

- 5.19 It would be considered appropriate tree management that the tree be removed and replaced with a more suitable specimen better sited elsewhere on the property as part of the Landscape Plan for the site.

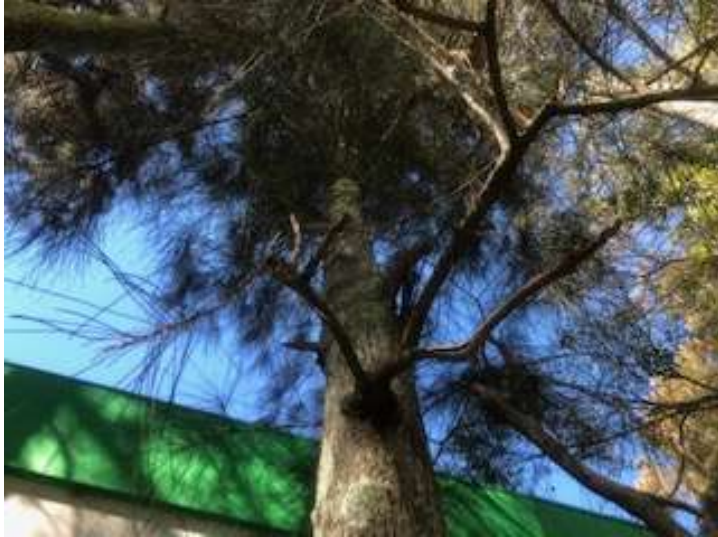
Tree 6 *Casuarina glauca*
Swamp Oak

- 5.20 The tree has good vigour and provides some visual and environmental amenity to the vicinity it is located.
- 5.21 **Tree 6** (*Casuarina glauca* Swamp Oak) is a tree in good condition Appendix 1 gives a description of the tree as per AS-4970-2009 Section 2. Appendix 2 shows a photograph of the tree; Appendix 4 indicates the location of the tree on a survey plan of the site. The tree was planted within 2 metres of neighboring infrastructure

- 5.23 It would be considered appropriate tree management that the tree be removed and replaced with a more suitable specimen better sited elsewhere on the property as part of the Landscape Plan for the site.

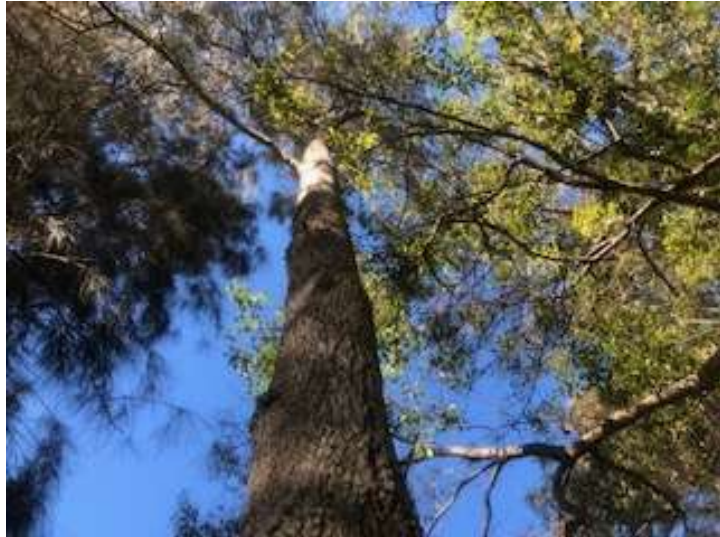
Tree 7 *Casuarina glauca*
Swamp Oak

- 5.24 The tree has good vigour and provides some visual and environmental amenity to the vicinity it is located.
- 5.25 **Tree 7** (*Casuarina glauca* Swamp Oak) is a tree in good condition Appendix 1 gives a description of the tree as per AS-4970-2009 Section 2. Appendix 2 shows a photograph of the tree; Appendix 4 indicates the location of the tree on a survey plan of the site. The tree was planted within 2 metres of neighboring infrastructure

- 5.27 It would be considered appropriate tree management that the tree be removed and replaced with a more suitable specimen better sited elsewhere on the property as part of the Landscape Plan for the site.

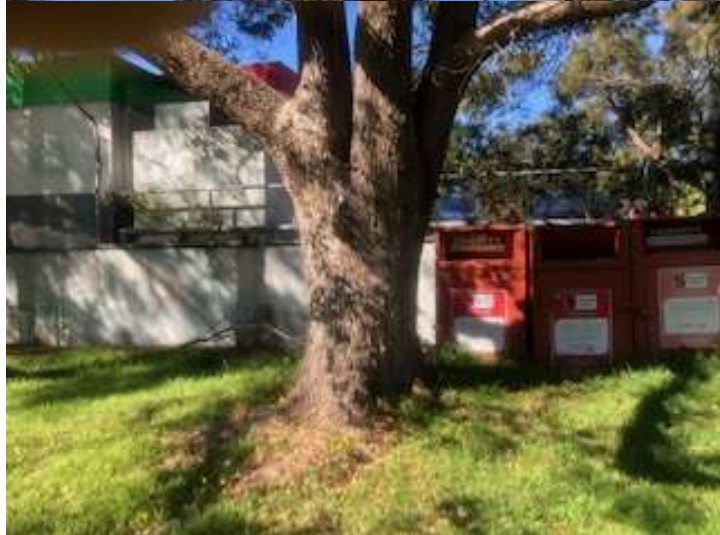
Tree 8 *Cinnamomum camphora*
Camphorlaurel

- 5.28 The tree has good vigour and provides some visual and environmental amenity to the vicinity it is located.
- 5.29 **Tree 8** (*Cinnamomum camphora* Camphorlaurel) is a tree in fair condition Appendix 1 gives a description of the tree as per AS-4970-2009 Section 2. Appendix 2 shows a photograph of the tree; Appendix 4 indicates the location of the tree on a survey plan of the site. The tree was planted within 2 metres of neighboring infrastructure

- 5.31 It would be considered appropriate tree management that the tree be removed and replaced with a more suitable specimen better sited elsewhere on the property as part of the Landscape Plan for the site.

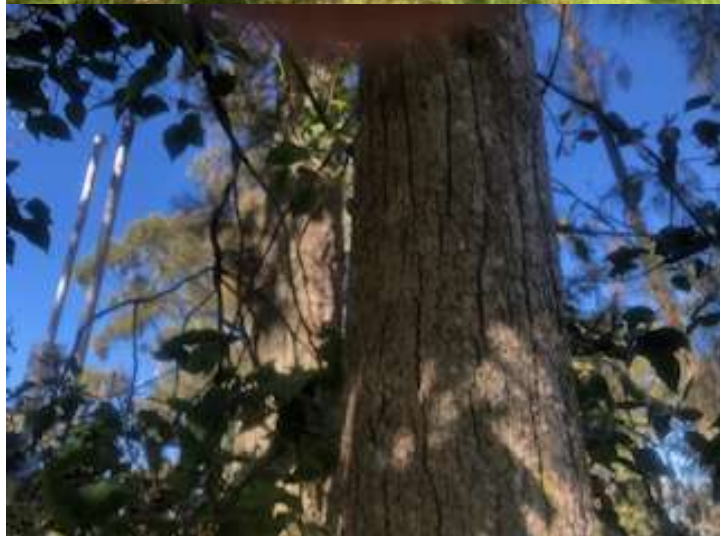
Tree 9 *Casuarina glauca*
Swamp Oak

- 5.33 **Tree 9** (*Casuarina glauca* Swamp Oak) is a tree in good condition Appendix 1 gives a description of the tree as per AS-4970-2009 Section 2. Appendix 2 shows a photograph of the tree; Appendix 4 indicates the location of the tree on a survey plan of the site. The tree was planted within 2 metres of neighboring infrastructure

- 5.35 It would be considered appropriate tree management that the tree be removed and replaced with a more suitable specimen better sited elsewhere on the property as part of the Landscape Plan for the site.

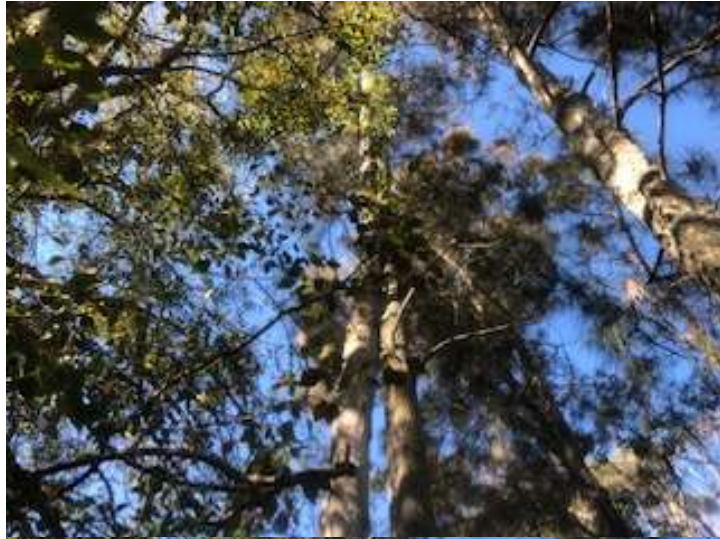
Tree 10 *Casuarina glauca*
Swamp Oak

- 5.36 The tree has good vigour and provides some visual and environmental amenity to the vicinity it is located.
- 5.37 **Tree 10** (*Casuarina glauca* Swamp Oak) is a tree in good condition Appendix 1 gives a description of the tree as per AS-4970-2009 Section 2. Appendix 2 shows a photograph of the tree; Appendix 4 indicates the location of the tree

- 5.39 It would be considered appropriate tree management that the tree be removed and replaced with a more suitable specimen better sited elsewhere on the property as part of the Landscape Plan for the site.

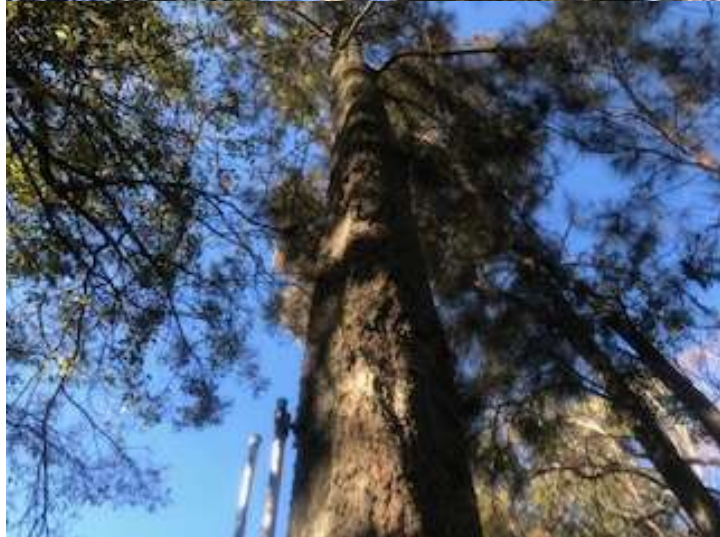
Tree 11 *Casuarina glauca*
Swamp Oak

- 5.40 The tree has good vigour and provides some visual and environmental amenity to the vicinity it is located.
- 5.41 **Tree 11** (*Casuarina glauca* Swamp Oak) is a tree in fair condition Appendix 1 gives a description of the tree as per AS-4970-2009 Section 2. Appendix 2 shows a photograph of the tree; Appendix 4 indicates the location of the tree on a survey plan of the site.

- 5.43 It would be considered appropriate tree management that the tree be removed and replaced with a more suitable specimen better sited elsewhere on the property as part of the Landscape Plan for the site.

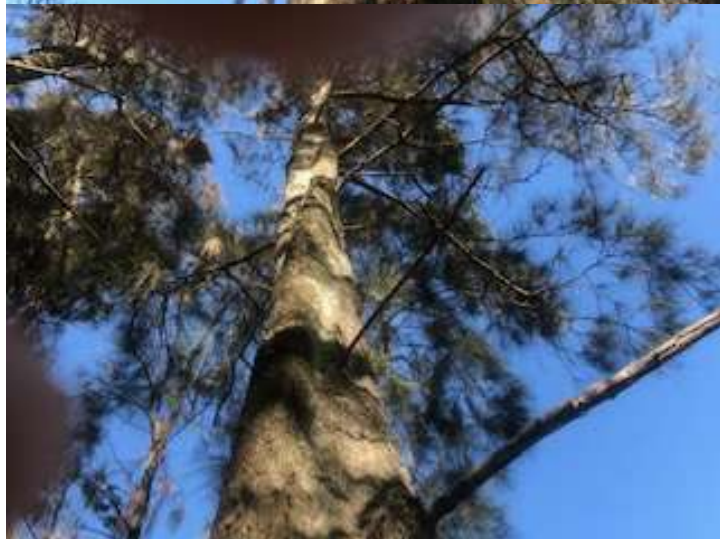
Tree 12 *Casuarina glauca*
Swamp Oak

- 5.44 The tree has normal vigour and provides visual and environmental amenity to the vicinity it is located.
- 5.45 **Tree 12** (*Casuarina glauca* Swamp Oak) is a tree in good condition Appendix 1 gives a description of the tree as per AS-4970-2009 Section 2. Appendix 2 shows a photograph of the tree; Appendix 4 indicates the location of the tree on a survey plan of the site. The tree was planted within 2 metres of neighboring infrastructure

- 5.47 It would be considered appropriate tree management that the tree be removed and replaced with a more suitable specimen better sited elsewhere on the property as part of the Landscape Plan for the site.

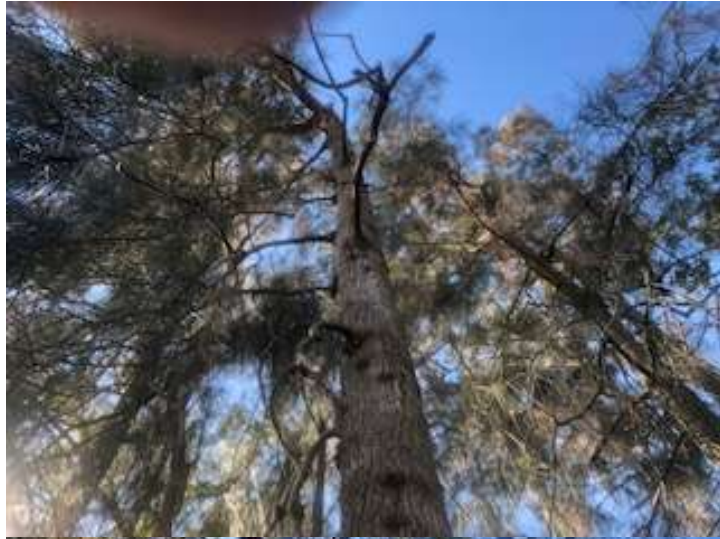
Tree 12a *Casuarina glauca*
Swamp Oak

- 5.48 The tree has good vigour and provides some visual and environmental amenity to the vicinity it is located.
- 5.49 **Tree 12a** (*Casuarina glauca* Swamp Oak) is a tree in good condition Appendix

- 5.51 It would be considered appropriate tree management that the tree be removed and replaced with a more suitable specimen better sited elsewhere on the property as part of the Landscape Plan for the site.

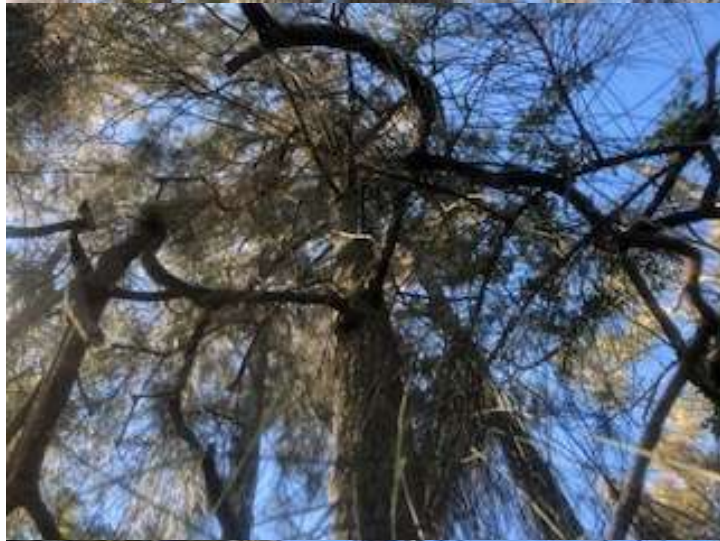
Tree 13 *Casuarina glauca*
Swamp Oak

- 5.56 The tree has good vigour and provides some visual and environmental amenity to the vicinity it is located.
- 5.57 **Tree 13** (*Casuarina glauca* Swamp Oak) is a tree in good condition Appendix 1 gives a description of the tree as per AS-4970-2009 Section 2. Appendix 2 shows a photograph of the tree; Appendix 4 indicates the location of the tree on a survey plan of the site. The tree was planted within 2 metres of neighboring infrastructure

- 5.59 It would be considered appropriate tree management that the tree be removed and replaced with a more suitable specimen better sited elsewhere on the property as part of the Landscape Plan for the site.

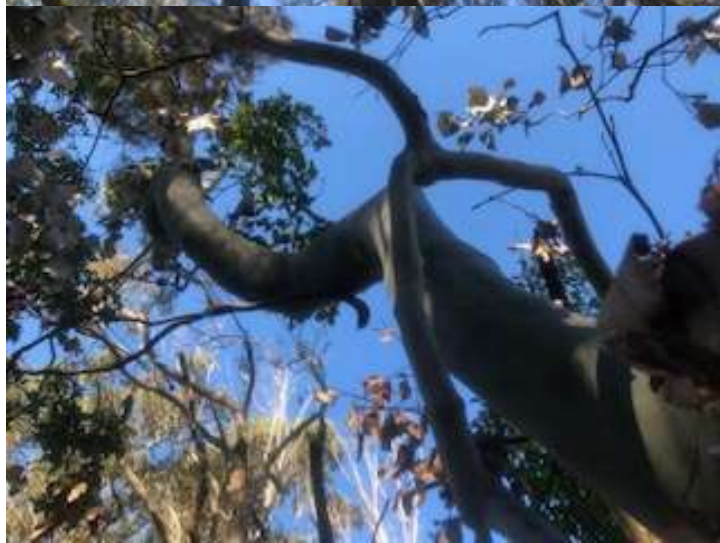
Tree 14 *Corimbya tessellaris*
Carbeen

- 5.61 **Tree 14** (*Corymbia tessellaris* Carbeen) is a tree in fair condition Appendix 1 gives a description of the tree as per AS-4970-2009 Section 2. Appendix 2 shows a photograph of the tree; Appendix 4 indicates the location of the tree on a survey plan of the site.

- 5.63 It would be considered appropriate tree management that the tree be removed and replaced with a more suitable specimen better sited elsewhere on the property as part of the Landscape Plan for the site.

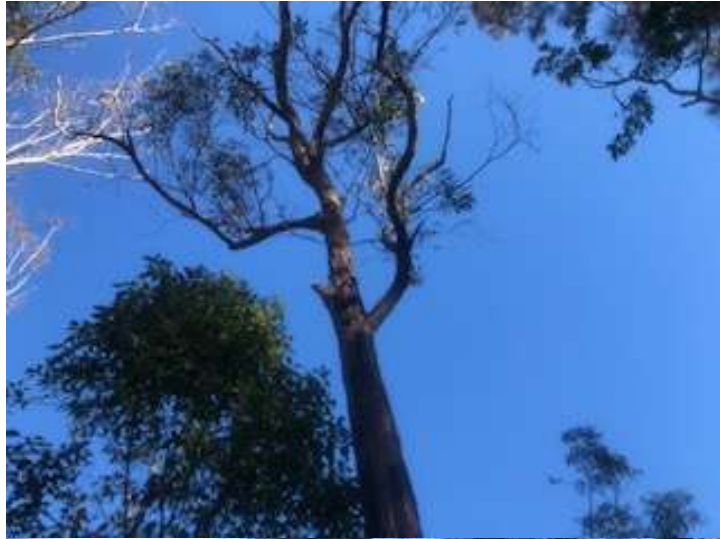
Tree 15 *Eucalyptus resinifera*
Red Mahogany

- 5.64 The tree has poor vigour and provides no visual and environmental amenity to the vicinity it is located.
- 5.65 **Tree 15** (*Eucalyptus resinifera* Red Mahogany) is a tree in poor condition Appendix 1 gives a description of the tree as per AS-4970-2009 Section 2. Appendix 2 shows a photograph of the tree; Appendix 4 indicates the location of the tree on a survey plan of the site.

- 5.68 It would be considered appropriate tree management that the tree be removed and replaced with a more suitable specimen better sited elsewhere on the property as part of the Landscape Plan for the site.

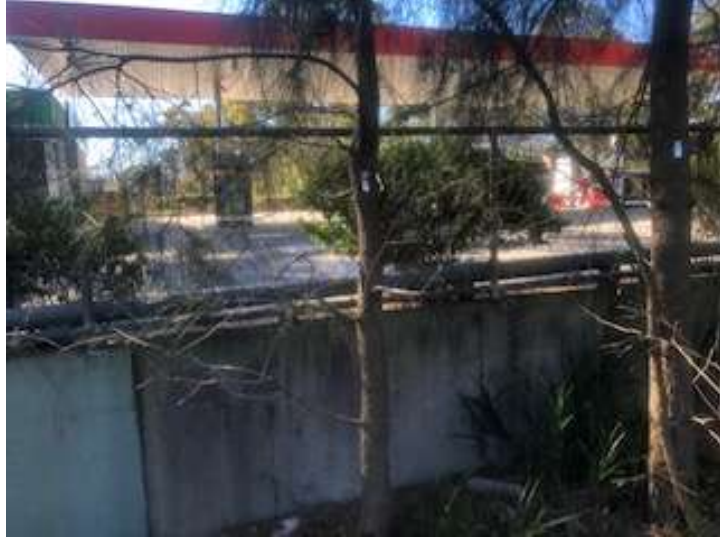
Tree 16 *Casuarina glauca*
Swamp Oak

- 5.69 The tree has poor vigour and provides no visual and environmental amenity to the vicinity it is located.
- 5.70 **Tree 16** (*Casuarina glauca* Swamp Oak) is a tree in good condition Appendix 1 gives a description of the tree as per AS-4970-2009 Section 2. Appendix 2 shows a photograph of the tree; Appendix 4 indicates the location of the tree on a survey plan of the site. The tree was planted within 2 metres of neighboring infrastructure

- 5.72 It would be considered appropriate tree management that the tree be removed and replaced with a more suitable specimen better sited elsewhere on the property as part of the Landscape Plan for the site.

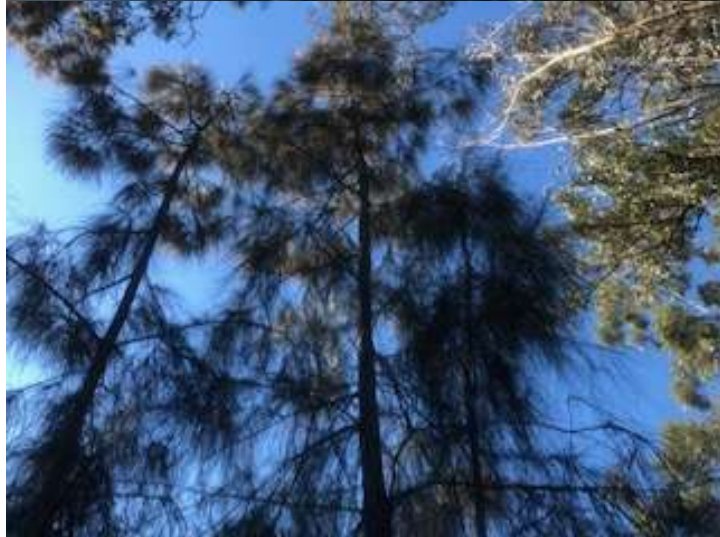
Tree 17 *Casuarina glauca*
Swamp Oak

- 5.73 The tree has good vigour and provides some visual and environmental amenity to the vicinity it is located.
- 5.74 **Tree 17** (*Casuarina glauca* Swamp Oak) is a tree in good condition Appendix 1 gives a description of the tree as per AS-4970-2009 Section 2. Appendix 2 shows a photograph of the tree; Appendix 4 indicates the location of the tree on a survey plan of the site. The tree was planted within 2 metres of neighboring infrastructure

- 5.76 It would be considered appropriate tree management that the tree be removed and replaced with a more suitable specimen better sited elsewhere on the property as part of the Landscape Plan for the site.

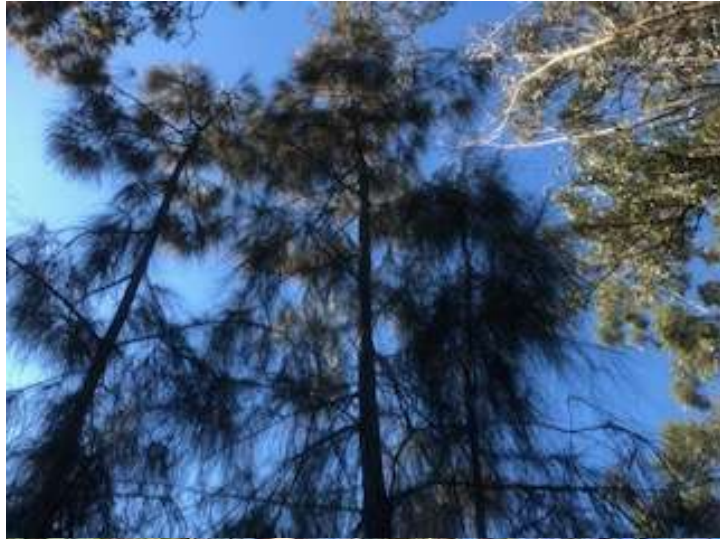
Tree 18 *Casuarina glauca*
Swamp Oak

- 5.77 The tree has good vigour and provides some visual and environmental amenity to the vicinity it is located.
- 5.78 **Tree 18** (*Casuarina glauca* Swamp Oak) is a tree in good condition Appendix 1 gives a description of the tree as per AS-4970-2009 Section 2. Appendix 2 shows a photograph of the tree; Appendix 4 indicates the location of the tree on a survey plan of the site. The tree was planted within 2 metres of neighboring infrastructure

- 5.80 It would be considered appropriate tree management that the tree be removed and replaced with a more suitable specimen better sited elsewhere on the property as part of the Landscape Plan for the site.

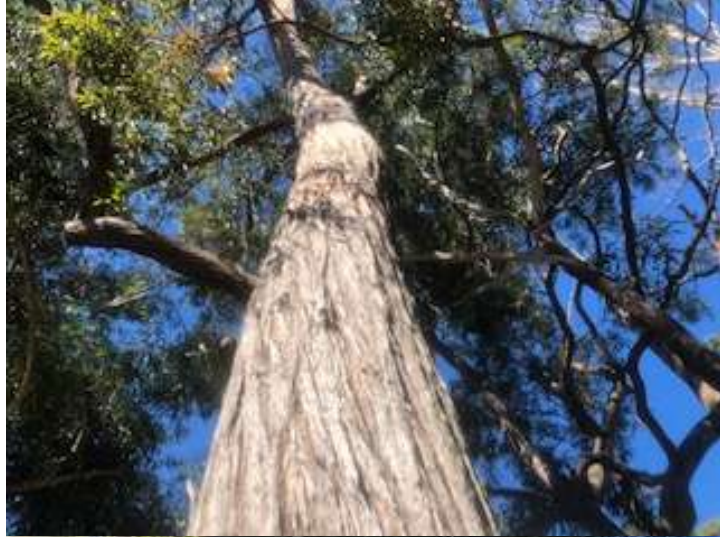
Tree 19 *Angophora floribunda*
Rough Bark Apple

- 5.81 The tree has good vigour and provides some visual and environmental amenity to the vicinity it is located.
- 5.82 **Tree 19** (*Angophora floribunda* Rough Bark Apple) is a tree in good condition Appendix 1 gives a description of the tree as per AS-4970-2009 Section 2. Appendix 2 shows a photograph of the tree; Appendix 4 indicates the location of the tree on a survey plan of the site. The tree was planted within 2 metres of neighboring infrastructure

- 5.84 It would be considered appropriate tree management that the tree be removed and replaced with a more suitable specimen better sited elsewhere on the property as part of the Landscape Plan for the site.

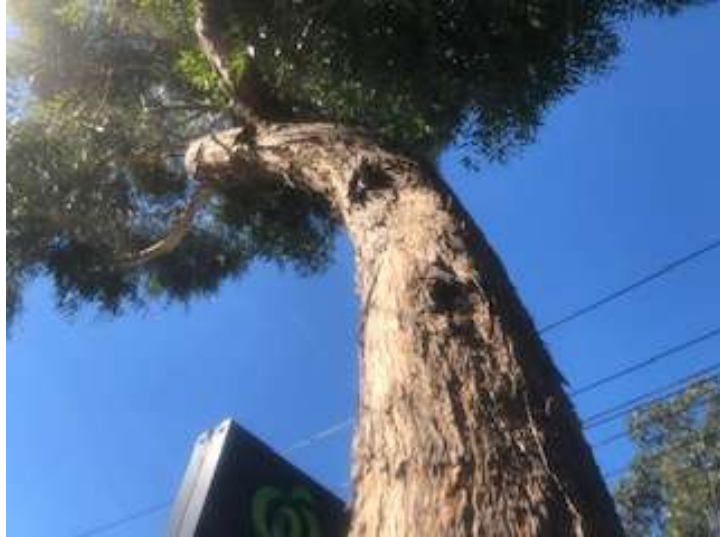
Tree 20 *Eucalyptus pilularis*
Black Butt

- 5.85 The tree has good vigour and provides some visual and environmental amenity to the vicinity it is located.
- 5.86 **Tree 20** (*Eucalyptus pilularis* Blackbutt) is a tree in fair condition Appendix 1 gives a description of the tree as per AS-4970-2009 Section 2. Appendix 2 shows a photograph of the tree; Appendix 4 indicates the location of the tree on a survey plan of the site. The tree was planted within 5 metres of neighboring infrastructure

- 5.89 The tree has fair vigour and provides some visual and environmental amenity to the vicinity it is located. The tree is growing on a lean and has decay throughout the crown.

- 5.88 It would be considered appropriate tree management that the tree be removed and replaced with a more suitable specimen better sited elsewhere on the property as part of the Landscape Plan for the site.

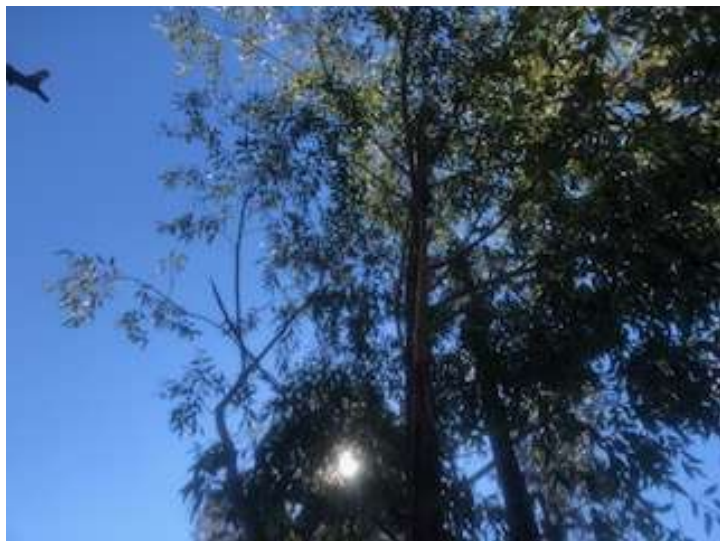
Tree 23 *Eucalyptus pilularis*
Black Butt

- 5.95 **Tree 23** (*Eucalyptus pilularis* Blackbutt) is a tree in fair condition Appendix 1

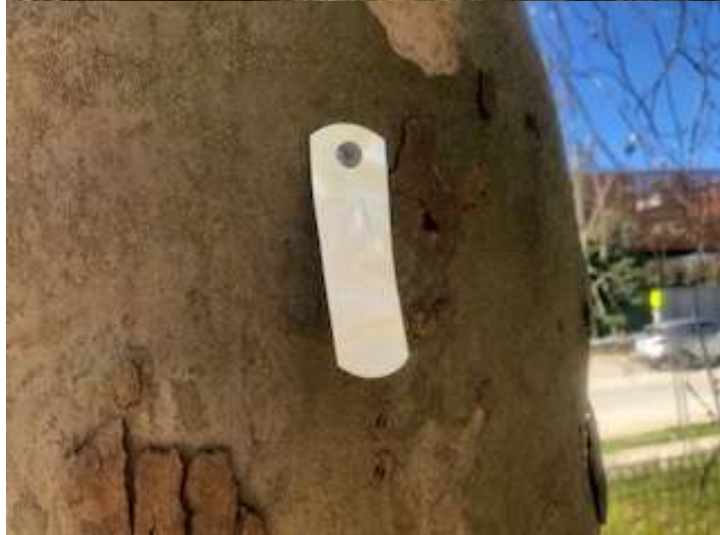
Tree 71 *Platanus x hybrida*
London Plane Tree

- 5.239 **Tree 71** (*Platanus x hybrida* London Plane Tree) is a tree in fair condition,
