Arboricultural Impact Assessment

Proposed new boat shed

**22 Bona Crescent
Morning Bay**

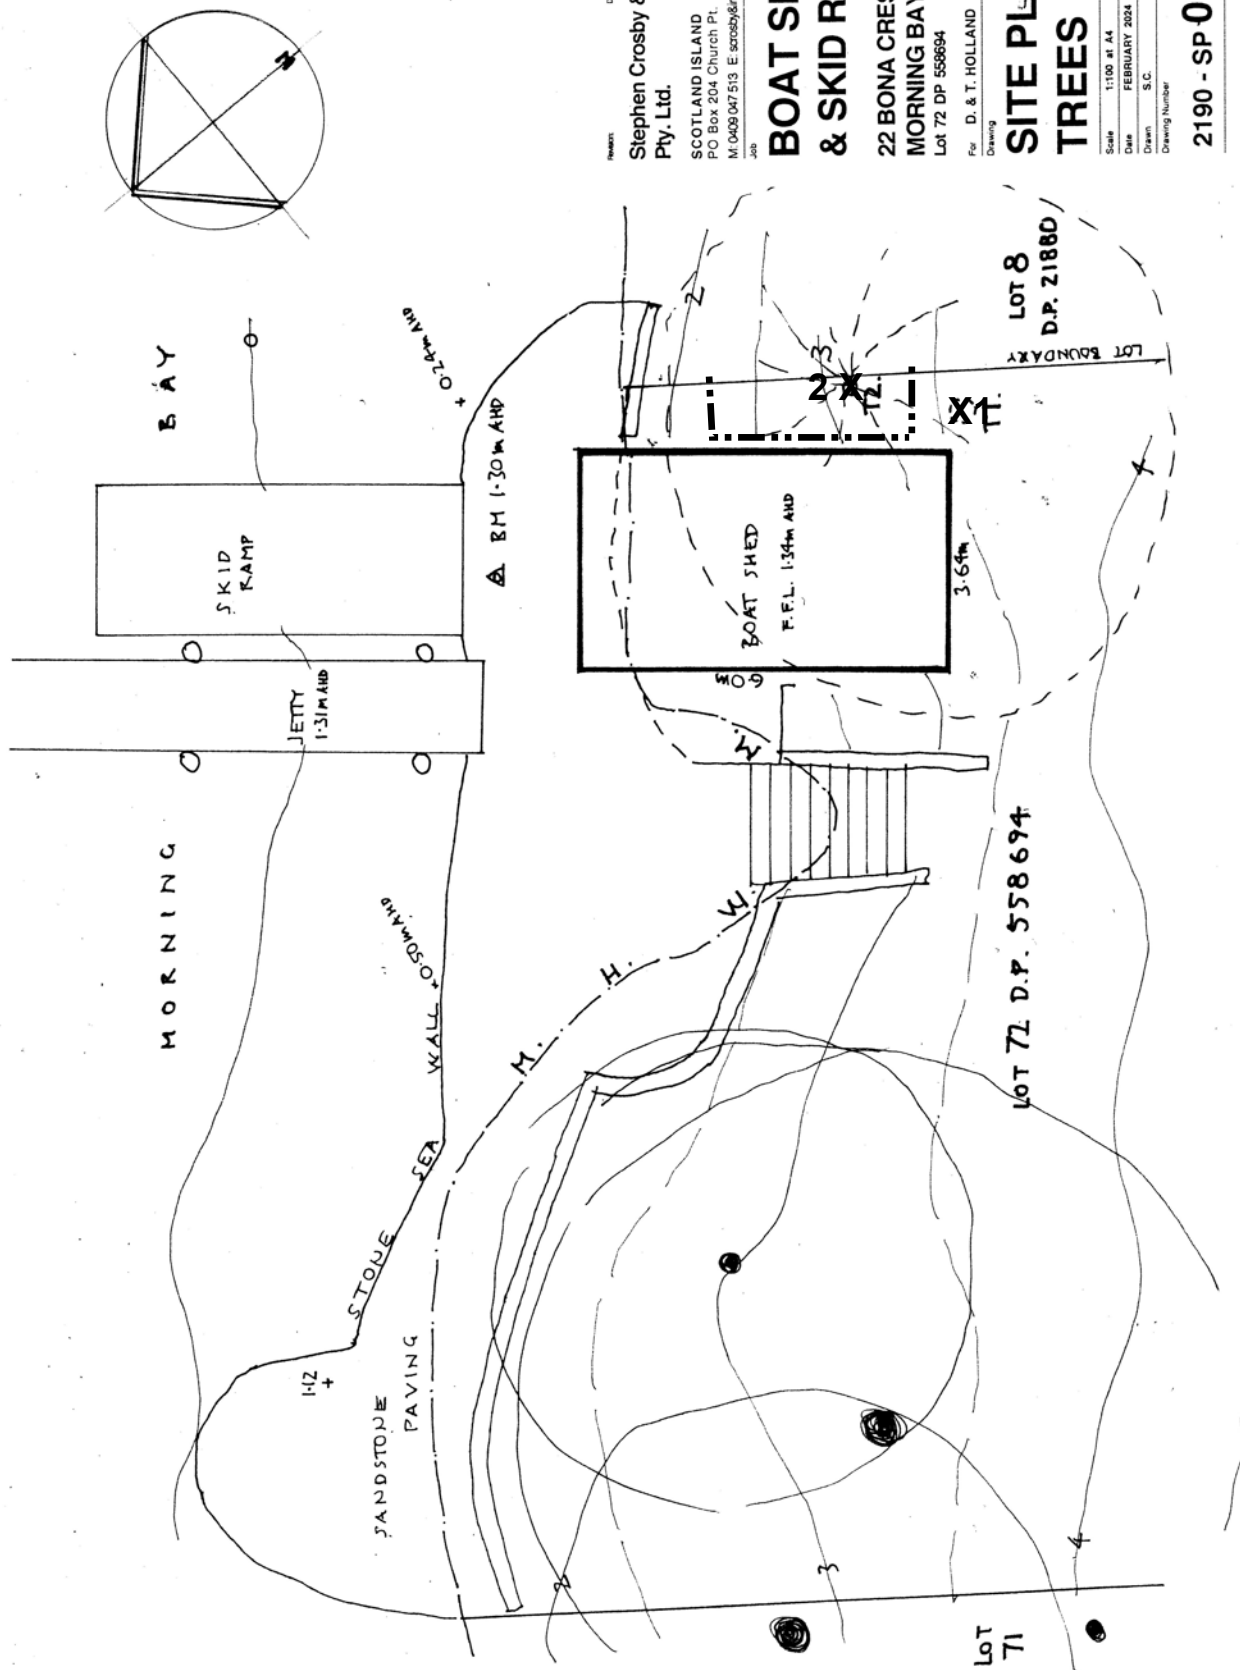
Excavation for proposed boatshed @ 0.5m which is a significant encroachment into the calculated structural root zone of 2.5m.

Tree Survey / Site Plan
22 Bona Crescent
Morning Bay
Boat Shed

- Tree / trunk / soil protective fencing is to be in place prior to commencement of site works (Trees, 2) and is to be maintained for the duration of construction works. Refer to Figure 1 for tree protective / exclusion fencing.

- Tree 1 is recommended for removal to accommodate the proposed development.
- To compensate for tree loss and enhance the ecological values of the site three (3) replacement indigenous trees are to be planted in a suitable location on the property. Suitable replacement species include *Allocasarina torulosa* (Forest oak)

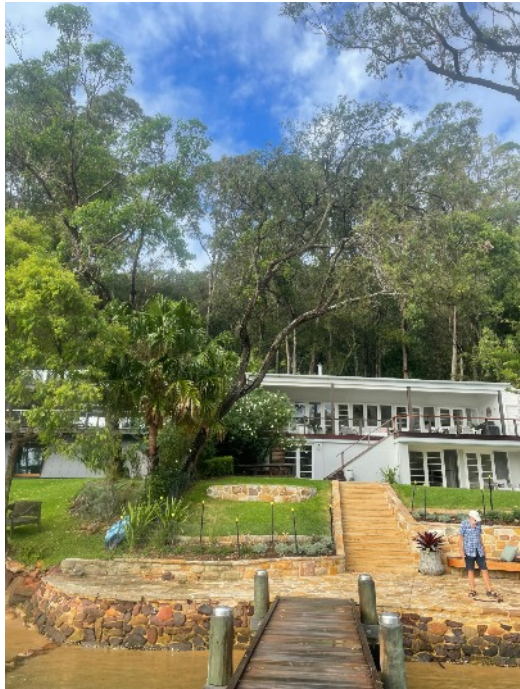
Photo 1 location of proposed boat shed
Trees 1 & 2

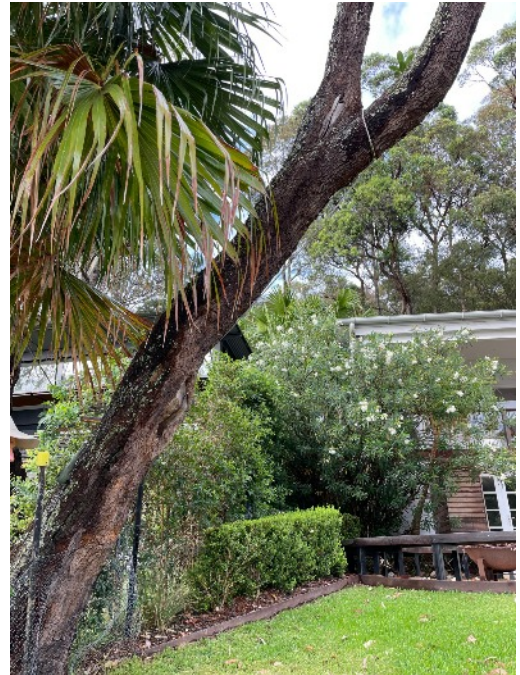
Condition: Fair- Trunk cavity at 1.5m and cavity at branch junction @ 4m

Health & Condition rating: 2/3

Photo 3 Tree 1 *Allocasuarina torulosa*
cavities on trunk & at branch junction

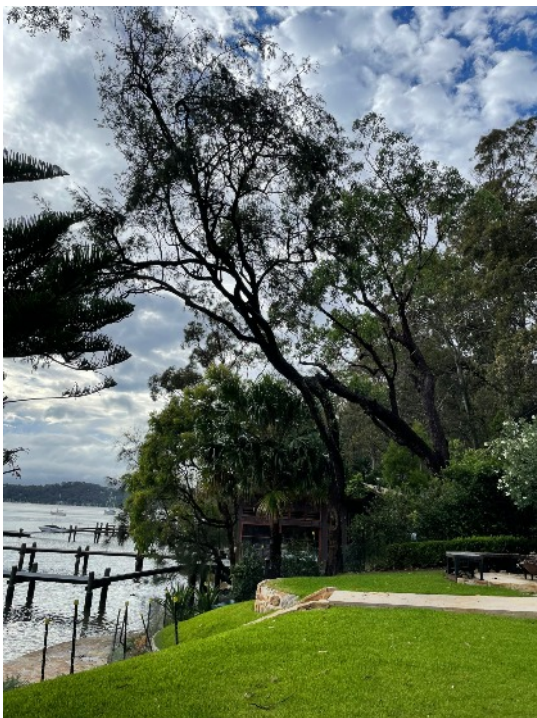
Photo 2 Location of proposed boat shed
Trees 1 & 2

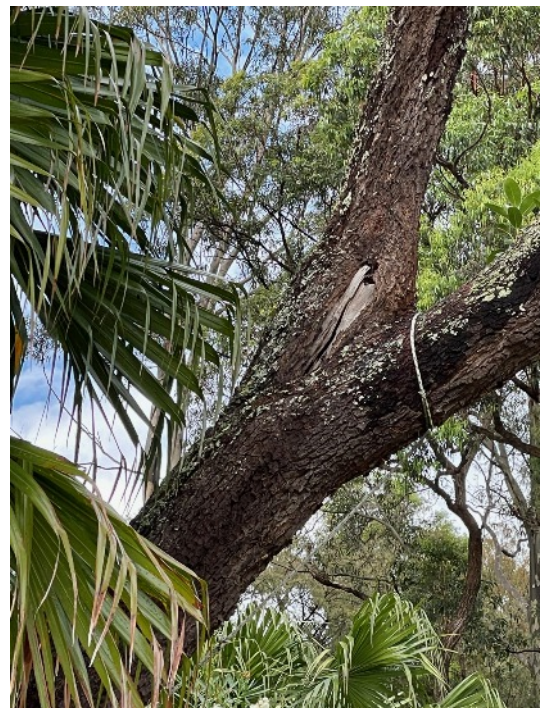
Photo 4 Tree 1 cavity @ branch junction
