# **Tree Impact Assessment Report**

Written as per Australian Standard 4970-2009

**28 Lockwood Avenue,  
Belrose NSW 2085**

**19<sup>th</sup> April 2021**

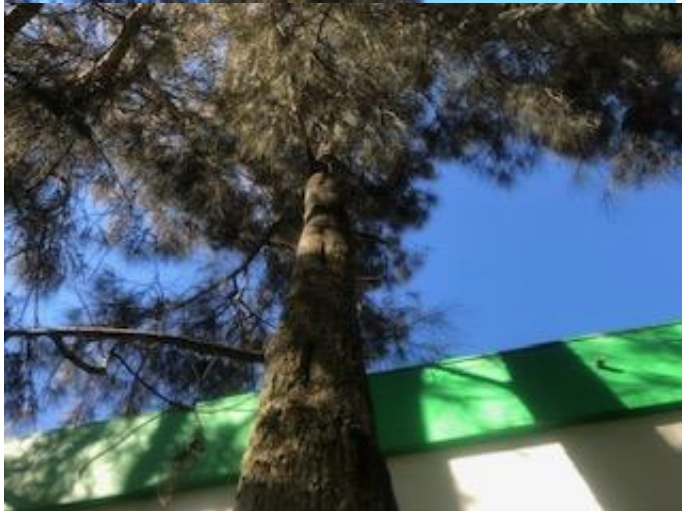
Tree 3 *Casuarina glauca*  
Swamp Oak

- 5.8 The tree has good vigour and provides some visual and environmental amenity to the vicinity it is located.
- 5.9 **Tree 3** (*Casuarina glauca* Swamp Oak) is a tree in good condition Appendix 1 gives a description of the tree as per AS-4970-2009 Section 2. Appendix 2 shows a photograph of the tree; Appendix 4 indicates the location of the tree on a survey plan of the site. The tree was planted within 2 metres of neighboring infrastructure

- 5.11 It would be considered appropriate tree management that the tree be removed and replaced with a more suitable specimen better sited elsewhere on the property as part of the Landscape Plan for the site.

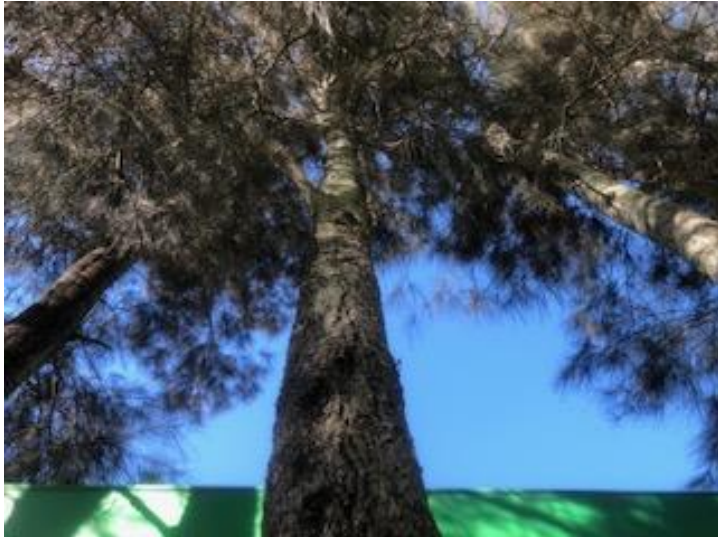
Tree 4 *Casuarina glauca*  
Swamp Oak

- 5.13 **Tree 4** (*Casuarina glauca* Swamp Oak) is a tree in good condition Appendix 1 gives a description of the tree as per AS-4970-2009 Section 2. Appendix 2 shows a photograph of the tree; Appendix 4 indicates the location of the tree on a survey plan of the site. The tree was planted within 2 metres of neighboring infrastructure

- 5.15 It would be considered appropriate tree management that the tree be removed and replaced with a more suitable specimen better sited elsewhere on the property as part of the Landscape Plan for the site.

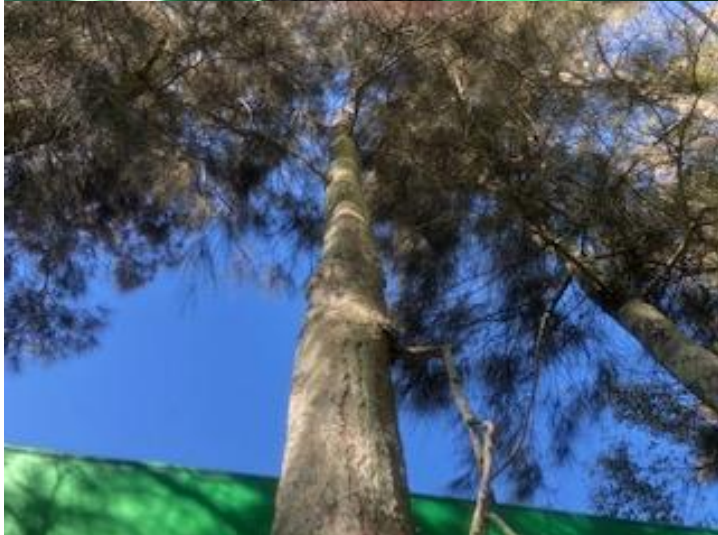
Tree 5 *Casuarina glauca*  
Swamp Oak

- 5.16 The tree has good vigour and provides some visual and environmental amenity to the vicinity it is located.
- 5.17 **Tree 5** (*Casuarina glauca* Swamp Oak) is a tree in good condition Appendix 1 gives a description of the tree as per AS-4970-2009 Section 2. Appendix 2 shows a photograph of the tree; Appendix 4 indicates the location of the tree on a survey plan of the site. The tree was planted within 2 metres of neighboring infrastructure

- 5.19 It would be considered appropriate tree management that the tree be removed and replaced with a more suitable specimen better sited elsewhere on the property as part of the Landscape Plan for the site.

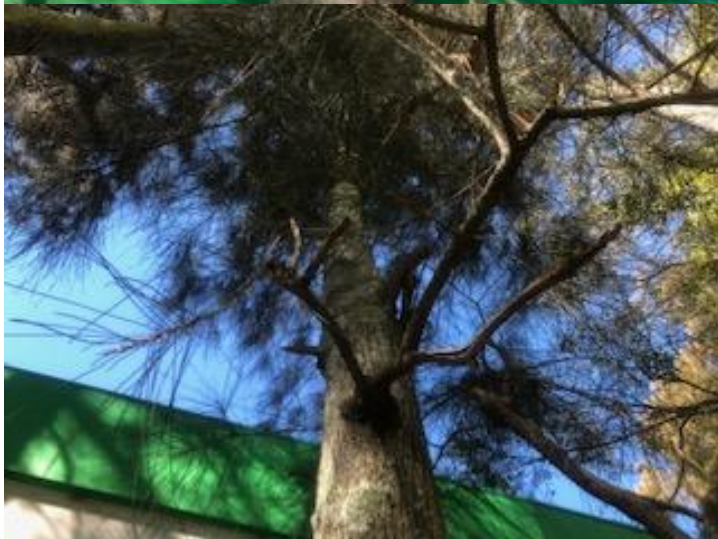
Tree 6 *Casuarina glauca*  
Swamp Oak

- 5.20 The tree has good vigour and provides some visual and environmental amenity to the vicinity it is located.
- 5.21 **Tree 6** (*Casuarina glauca* Swamp Oak) is a tree in good condition Appendix 1 gives a description of the tree as per AS-4970-2009 Section 2. Appendix 2 shows a photograph of the tree; Appendix 4 indicates the location of the tree on a survey plan of the site. The tree was planted within 2 metres of neighboring infrastructure

- 5.23 It would be considered appropriate tree management that the tree be removed and replaced with a more suitable specimen better sited elsewhere on the property as part of the Landscape Plan for the site.

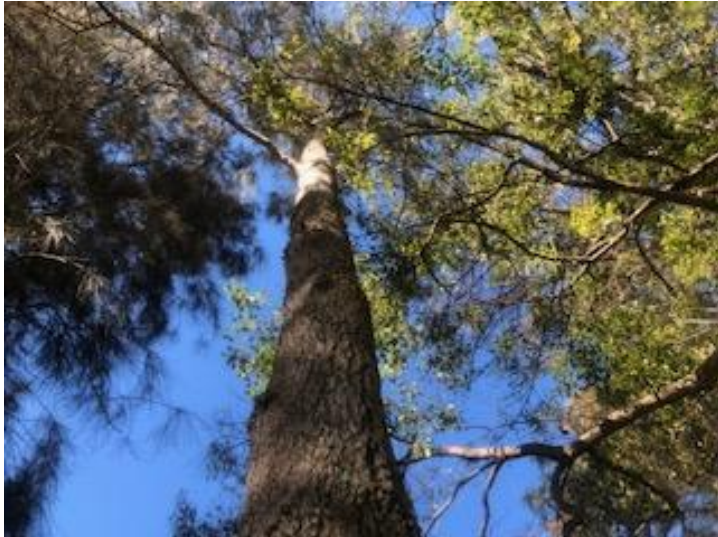
Tree 7 *Casuarina glauca*  
Swamp Oak

- 5.24 The tree has good vigour and provides some visual and environmental amenity to the vicinity it is located.
- 5.25 **Tree 7** (*Casuarina glauca* Swamp Oak) is a tree in good condition Appendix 1 gives a description of the tree as per AS-4970-2009 Section 2. Appendix 2 shows a photograph of the tree; Appendix 4 indicates the location of the tree on a survey plan of the site. The tree was planted within 2 metres of neighboring infrastructure

- 5.27 It would be considered appropriate tree management that the tree be removed and replaced with a more suitable specimen better sited elsewhere on the property as part of the Landscape Plan for the site.

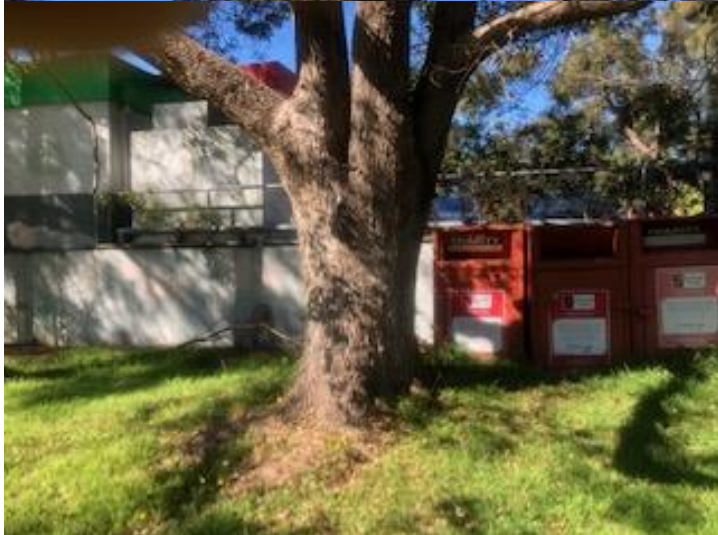
Tree 8 *Cinnamomum camphora*  
Camphorlaurel

- 5.28 The tree has good vigour and provides some visual and environmental amenity to the vicinity it is located.
- 5.29 **Tree 8** (*Cinnamomum camphora* Camphorlaurel) is a tree in fair condition Appendix 1 gives a description of the tree as per AS-4970-2009 Section 2. Appendix 2 shows a photograph of the tree; Appendix 4 indicates the location of the tree on a survey plan of the site. The tree was planted within 2 metres of neighboring infrastructure

- 5.31 It would be considered appropriate tree management that the tree be removed and replaced with a more suitable specimen better sited elsewhere on the property as part of the Landscape Plan for the site.

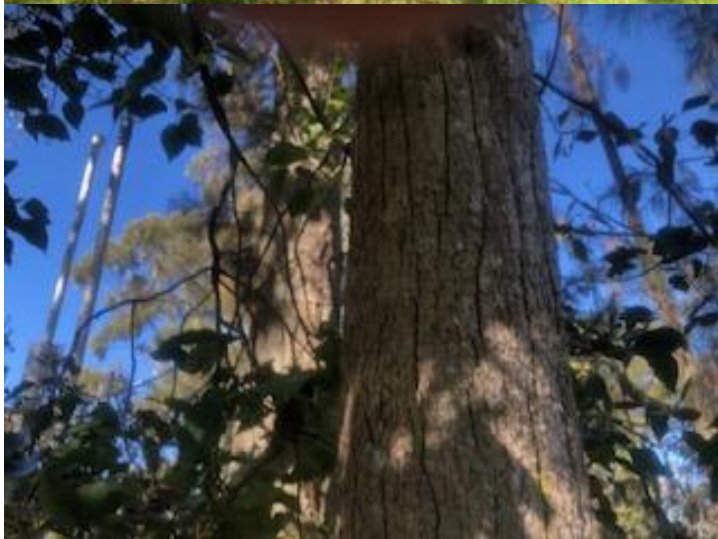
Tree 9 *Casuarina glauca*  
Swamp Oak

- 5.33 **Tree 9** (*Casuarina glauca* Swamp Oak) is a tree in good condition Appendix 1 gives a description of the tree as per AS-4970-2009 Section 2. Appendix 2 shows a photograph of the tree; Appendix 4 indicates the location of the tree on a survey plan of the site. The tree was planted within 2 metres of neighboring infrastructure

- 5.35 It would be considered appropriate tree management that the tree be removed and replaced with a more suitable specimen better sited elsewhere on the property as part of the Landscape Plan for the site.

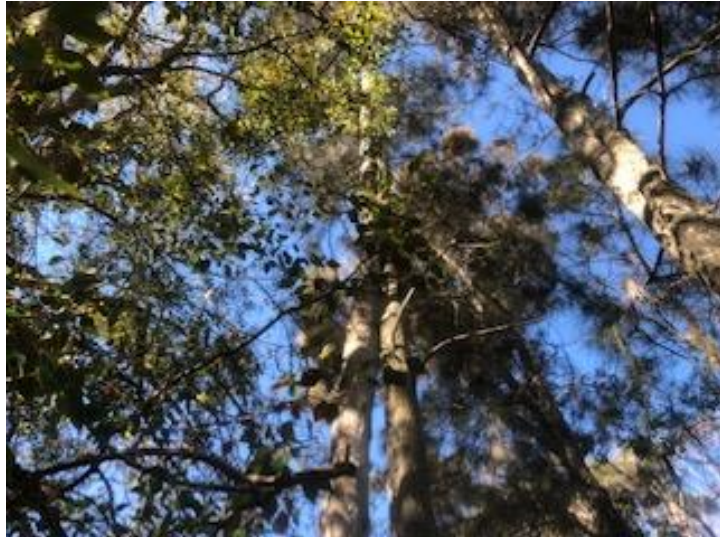
Tree 10 *Casuarina glauca*  
Swamp Oak

- 5.36 The tree has good vigour and provides some visual and environmental amenity to the vicinity it is located.
- 5.37 **Tree 10** (*Casuarina glauca* Swamp Oak) is a tree in good condition Appendix 1 gives a description of the tree as per AS-4970-2009 Section 2. Appendix 2 shows a photograph of the tree; Appendix 4 indicates the location of the tree on a survey plan of the site. The tree was planted within 2 metres of neighboring infrastructure

- 5.39 It would be considered appropriate tree management that the tree be removed and replaced with a more suitable specimen better sited elsewhere on the property as part of the Landscape Plan for the site.

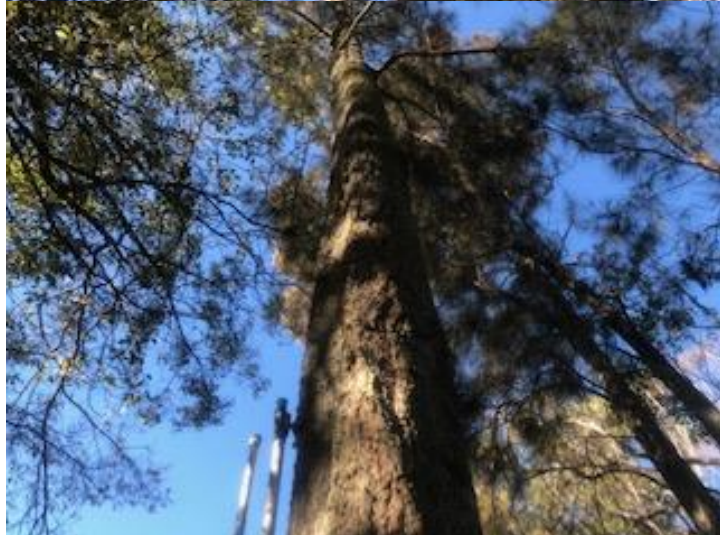
Tree 11 *Casuarina glauca*  
Swamp Oak

- 5.40 The tree has good vigour and provides some visual and environmental amenity to the vicinity it is located.
- 5.41 **Tree 11** (*Casuarina glauca* Swamp Oak) is a tree in fair condition Appendix 1 gives a description of the tree as per AS-4970-2009 Section 2. Appendix 2 shows a photograph of the tree; Appendix 4 indicates the location of the tree on a survey plan of the site.

- 5.43 It would be considered appropriate tree management that the tree be removed and replaced with a more suitable specimen better sited elsewhere on the property as part of the Landscape Plan for the site.

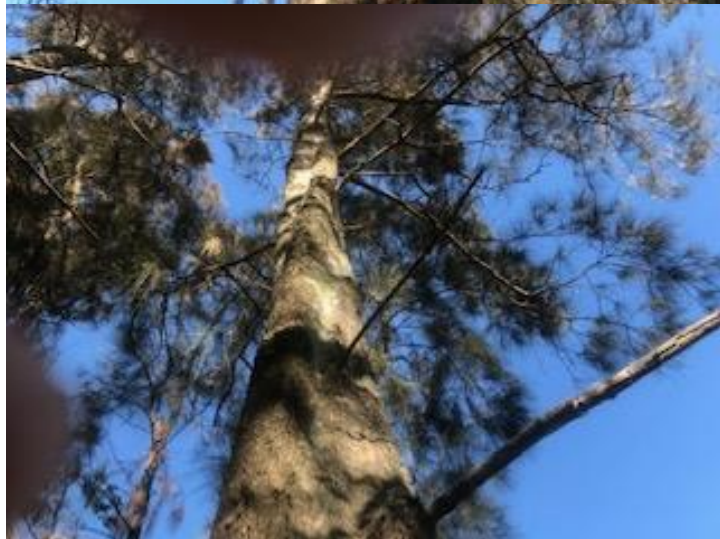
Tree 12 *Casuarina glauca*  
Swamp Oak

- 5.44 The tree has normal vigour and provides visual and environmental amenity to the vicinity it is located.
- 5.45 **Tree 12** (*Casuarina glauca* Swamp Oak) is a tree in good condition Appendix 1 gives a description of the tree as per AS-4970-2009 Section 2. Appendix 2 shows a photograph of the tree; Appendix 4 indicates the location of the tree on a survey plan of the site. The tree was planted within 2 metres of neighboring infrastructure

- 5.47 It would be considered appropriate tree management that the tree be removed and replaced with a more suitable specimen better sited elsewhere on the property as part of the Landscape Plan for the site.

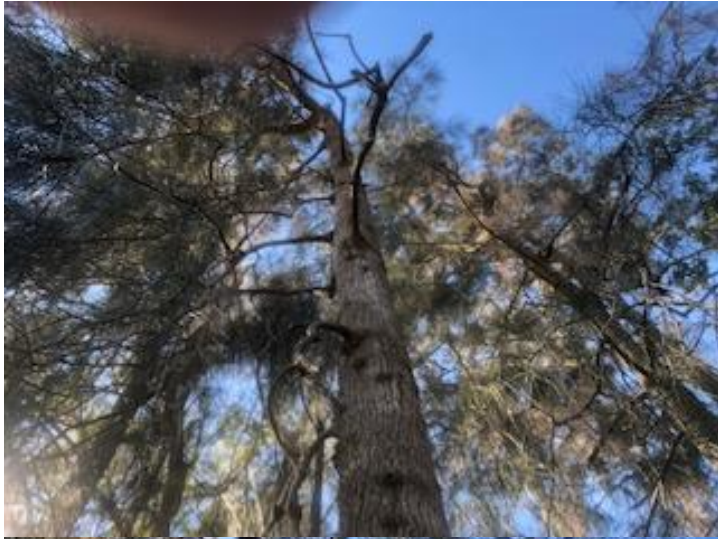
Tree 12a *Casuarina glauca*  
Swamp Oak

- 5.48 The tree has good vigour and provides some visual and environmental amenity to the vicinity it is located.
- 5.49 **Tree 12a** (*Casuarina glauca* Swamp Oak) is a tree in good condition Appendix 1 gives a description of the tree as per AS-4970-2009 Section 2. Appendix 2 shows a photograph of the tree; Appendix 4 indicates the location of the tree on a survey plan of the site. The tree was planted within 2 metres of neighboring infrastructure

- 5.51 It would be considered appropriate tree management that the tree be removed and replaced with a more suitable specimen better sited elsewhere on the property as part of the Landscape Plan for the site.

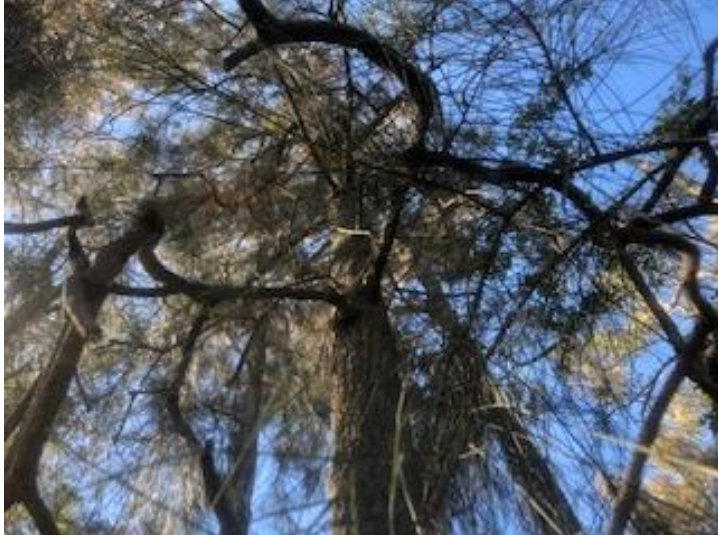
Tree 13 *Casuarina glauca*  
Swamp Oak

- 5.56 The tree has good vigour and provides some visual and environmental amenity to the vicinity it is located.
- 5.57 **Tree 13** (*Casuarina glauca* Swamp Oak) is a tree in good condition Appendix 1 gives a description of the tree as per AS-4970-2009 Section 2. Appendix 2 shows a photograph of the tree; Appendix 4 indicates the location of the tree on a survey plan of the site. The tree was planted within 2 metres of neighboring infrastructure. The tree should be protected and managed as per the tree management plan in appendix 6

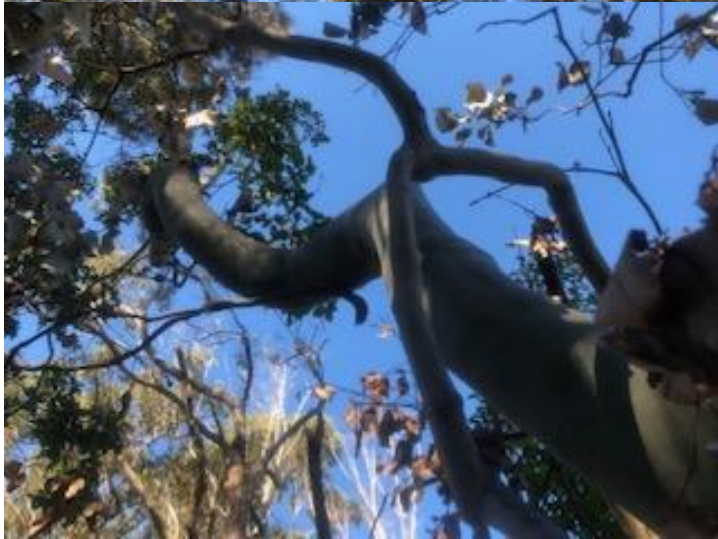
Tree 14 *Corimbya tessellaris*  
Carbeen

- 5.61 **Tree 14** (*Corymbia tessellaris* Carbeen) is a tree in fair condition Appendix 1 gives a description of the tree as per AS-4970-2009 Section 2. Appendix 2 shows a photograph of the tree; Appendix 4 indicates the location of the tree on a survey plan of the site. The tree was planted within 2 metres of neighboring infrastructure. The tree should be protected and managed as per the tree management plan in appendix 6

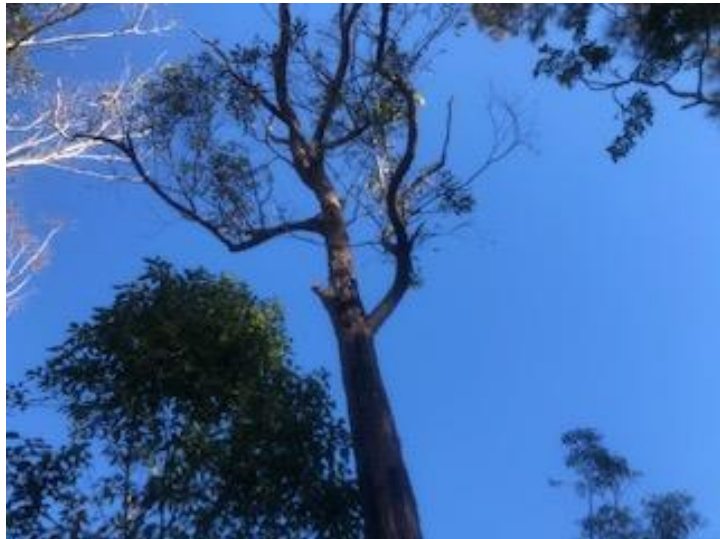
Tree 15 *Eucalyptus resinifera*  
Red Mahogany

- 5.65 **Tree 15** (*Eucalyptus resinifera* Red Mahogany) is a tree in poor condition Appendix 1 gives a description of the tree as per AS-4970-2009 Section 2. Appendix 2 shows a photograph of the tree; Appendix 4 indicates the location of the tree on a survey plan of the site. The tree was planted within 2 metres of neighboring infrastructure. The tree should be protected and managed as per the tree management plan in appendix 6

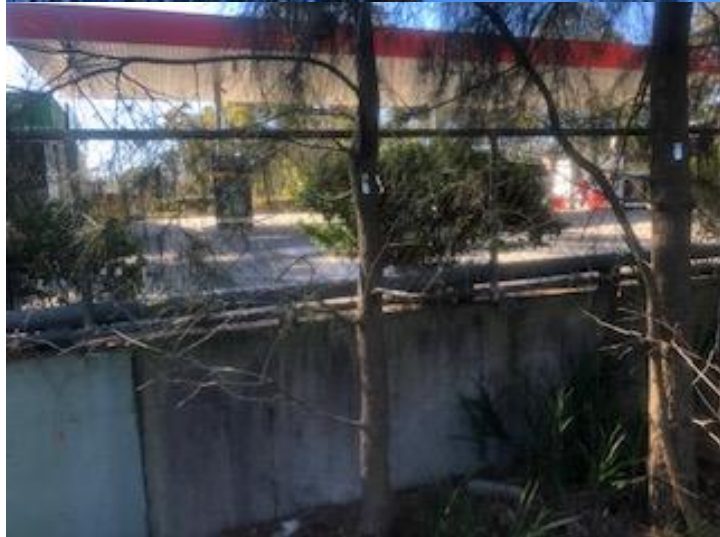
Tree 16 *Casuarina glauca*  
Swamp Oak

- 5.67 **Tree 16** (*Casuarina glauca* Swamp Oak) is a tree in good condition Appendix 1 gives a description of the tree as per AS-4970-2009 Section 2. Appendix 2 shows a photograph of the tree; Appendix 4 indicates the location of the tree on a survey plan of the site. The tree was planted within 2 metres of neighboring infrastructure. The tree should be protected and managed as per the tree

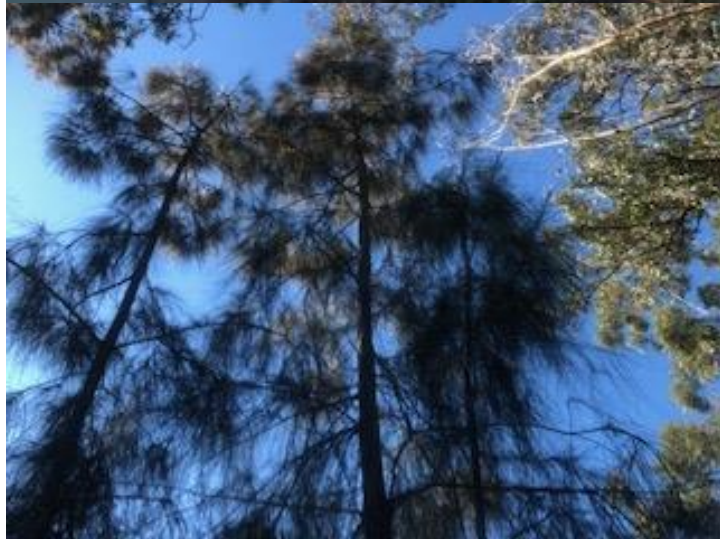
Tree 17 *Casuarina glauca*  
Swamp Oak

- 5.71 **Tree 17** (*Casuarina glauca* Swamp Oak) is a tree in good condition Appendix 1 gives a description of the tree as per AS-4970-2009 Section 2. Appendix 2 shows a photograph of the tree; Appendix 4 indicates the location of the tree on a survey plan of the site. The tree was planted within 2 metres of neighboring infrastructure. The tree should be protected and managed as per the tree management plan in appendix 6

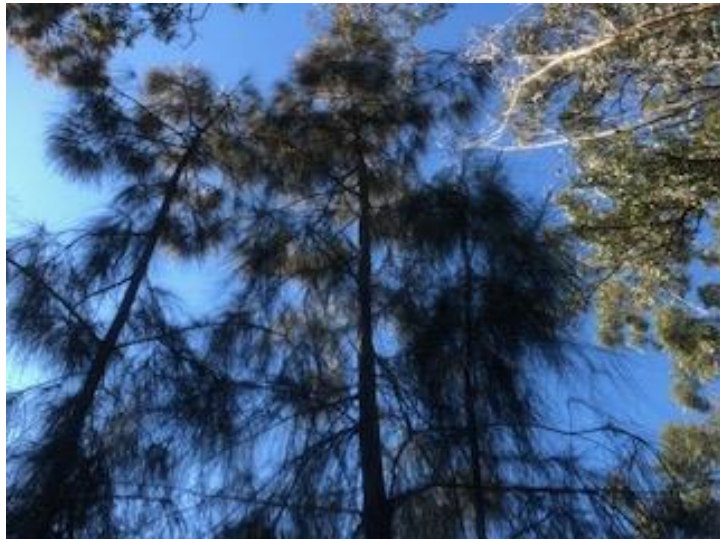
Tree 18 *Casuarina glauca*  
Swamp Oak

- 5.75 **Tree 18** (*Casuarina glauca* Swamp Oak) is a tree in good condition Appendix 1 gives a description of the tree as per AS-4970-2009 Section 2. Appendix 2 shows a photograph of the tree; Appendix 4 indicates the location of the tree on a survey plan of the site. The tree was planted within 2 metres of neighboring infrastructure. The tree should be protected and managed as per the tree management plan in appendix 6

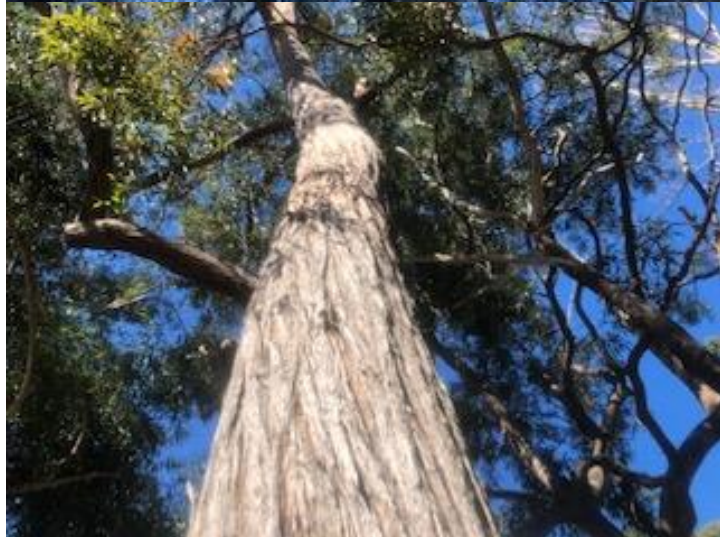
Tree 19 *Angophora floribunda*  
Rough Bark Apple

- 5.79 **Tree 19** (*Angophora floribunda* Rough Bark Apple) is a tree in good condition Appendix 1 gives a description of the tree as per AS-4970-2009 Section 2.

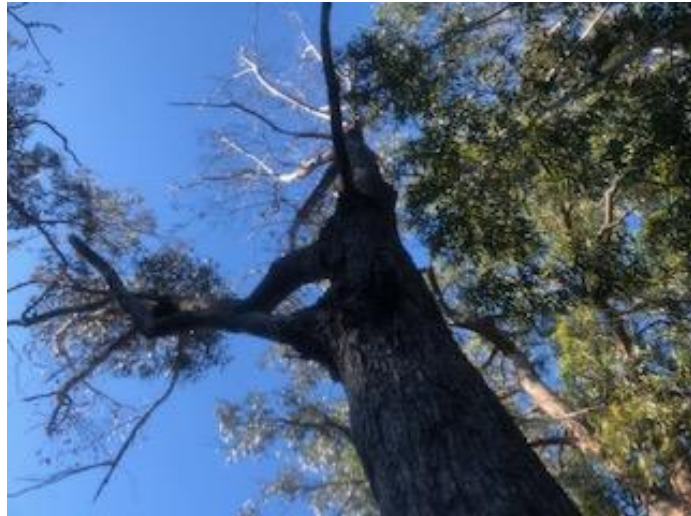
Tree 22 *Eucalyptus* Species

- 5.91 **Tree 22** (*Eucalyptus Species*) the tree is dead and should be removed
- 5.92 **Tree 23** (*Eucalyptus pilularis* Blackbutt) is a tree in fair condition Appendix 1 gives a description of the tree as per AS-4970-2009 Section 2. Appendix 2 shows a photograph of the tree; Appendix 4 indicates the location of the tree on a survey plan of the site.

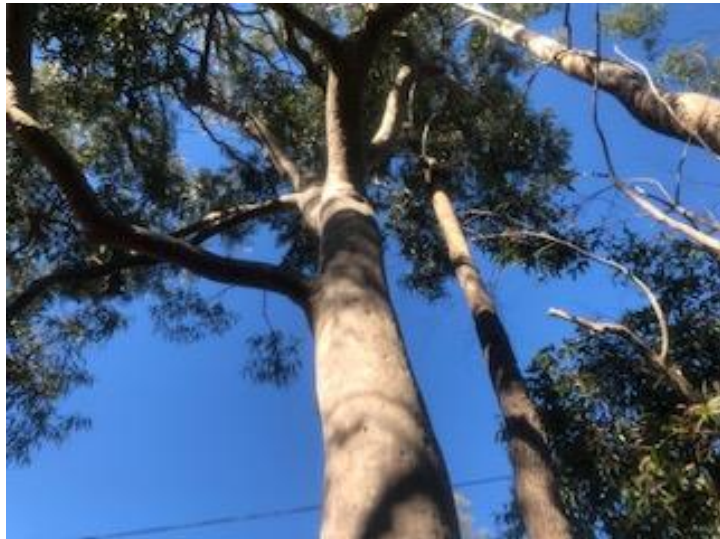
Tree 24 *Angophora costata*  
Sydney Red Gum

- 5.95 The tree has fair vigour and provides some visual and environmental amenity to the vicinity it is located.
- 5.96 **Tree 24** *Angophora costata* (Sydney Red Gum) is a tree in fair condition Appendix 1 gives a description of the tree as per AS-4970-2009 Section 2. Appendix 2 shows a photograph of the tree; Appendix 4 indicates the location of the tree on a survey plan of the site.

- 5.98 It would be considered appropriate tree management that the tree be removed and replaced with a more suitable specimen better sited elsewhere on the property as part of the Landscape Plan for the site. The tree has fair vigour and provides some visual and environmental amenity to the vicinity it is located

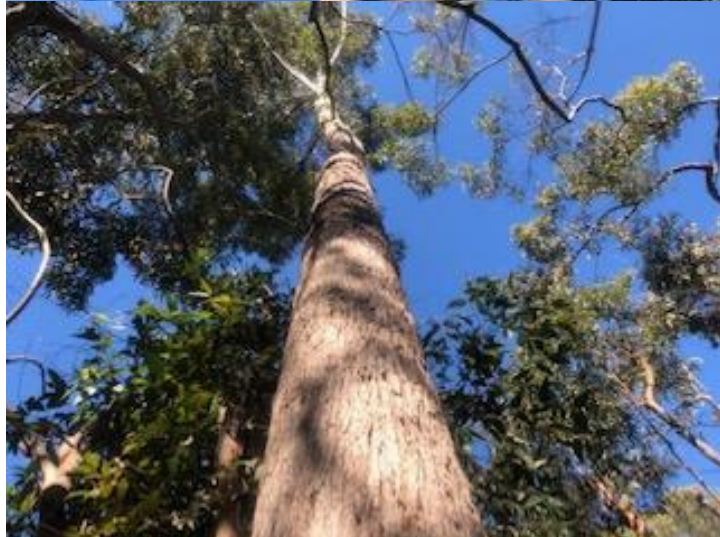
Tree 25 *Eucalyptus pilularis*  
Black Butt

- 5.99 **Tree 25** (*Eucalyptus pilularis* Blackbutt) is a tree in poor condition Appendix 1 gives a description of the tree as per AS-4970-2009 Section 2. Appendix 2 shows a photograph of the tree; Appendix 4 indicates the location of the tree on a survey plan of the site.

- 5.101 It would be considered appropriate tree management that the tree be removed and replaced with a more suitable specimen better sited elsewhere on the property as part of the Landscape Plan for the site. The tree has fair vigour and provides some visual and environmental amenity to the vicinity it is located
