15 JUBILEE AVENUE

WARRIEWOOD, NSW

ARBORICULTURAL IMPACT ASSESSMENT REPORT

Report Ref No- 3521

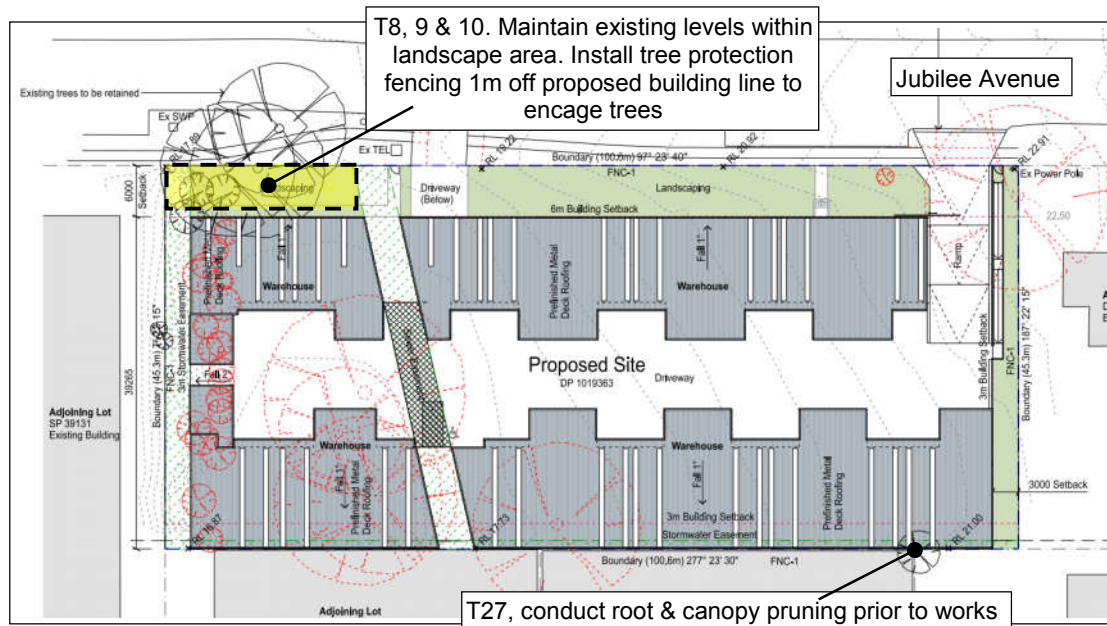
Figure 1, showing tree removal & protection areas

1.3.1 Fifteen (15) prescribed (LGA protected) or part neighbouring trees require removal to accommodate design. The fifteen trees are identified as trees:

- T1, 2, 3, 13, 14, 15, 16, 18, 19, 20, 21, 22, 23, 24 & 25.

1.4.4 Trees which fall within the building footprint and require removal to accommodate design are identified as trees: 3, 13, 14, 15, 16, 18, 19, 20, 21, 22, 23, 24 & 25 as shown within Plan DA100.

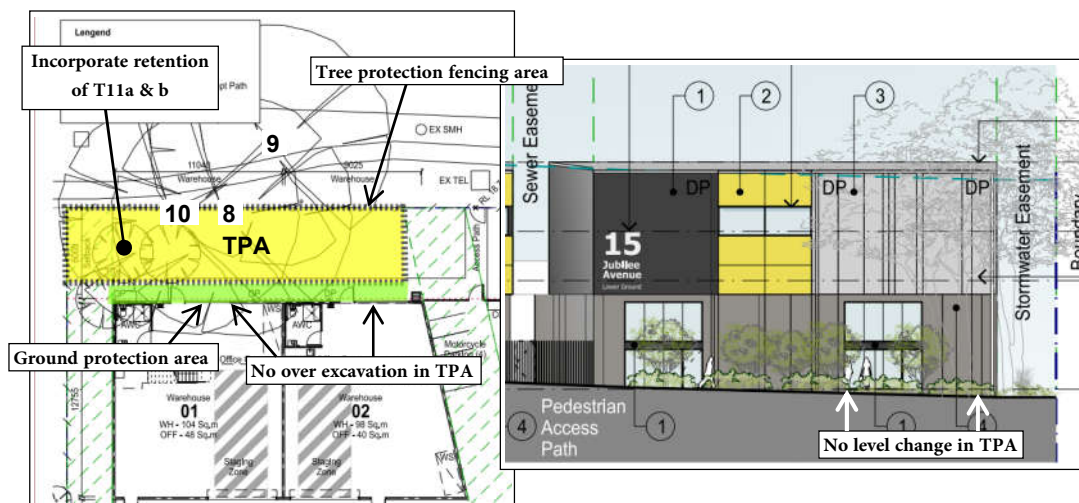
Figure 2, showing T8, 9 & 10 protection area

1.4.1 Tree 9 & part T8 & 10 located on the boundary. Given the building setback T9 receives minor to negligible impact by the design footprint provided landscape levels are maintained without excavation cut to at or near the building line. Tree 8 & 10 receiver higher TPZ encroachments with the following recommendations provided to mitigate impacts by design:

- There is to be no level change or excavation within SRZ radiuses at or near 3m from the trees. The Structural Root Zone (SRZ) being the area required for tree stability is to remain a development (excavation) exclusion zone. Where excavations are required within the SRZ tree root investigations are to be conducted to identify potential conflicts to critical underlying tree roots.

- There is to be no over excavation or fill (batter) beyond the building footprint to mitigate further encroachment and impacts within the Tree Protection Zone (TPZ). The proposed construction methodology shall be reviewed and endorsed by an appointed arborist prior to works.

- As shown within Figure 2 the building setback to the boundary is to be retained as a Tree Protection Area (TPA) and be protected with tree protection fencing located 1m off the building line, or as directed by an appointed arborist utilising ground & root protection mats.

- Civil work (pathway) plans shall be reviewed and endorsed by an appointed arborist prior to works with footpath constructed utilizing tree sensitive design as not to disrupt underlying tree roots.
