1 Tabalum Road, Balgowlah Heights

GEOTECHNICAL INVESTIGATION:

New House and Pool at 1 Tabalum Road, Balgowlah Heights

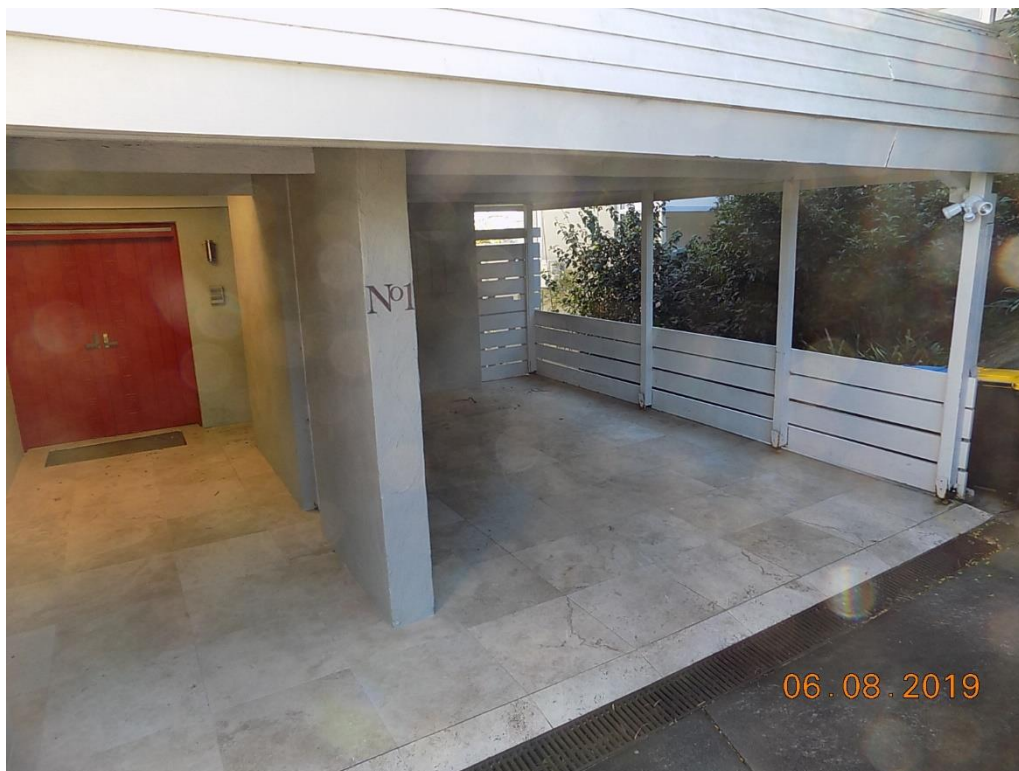
Photo 1

- 2.3** At the road frontage to Tabalum Road, a concrete driveway runs to a carport attached to the uphill side of the house (Photo 1). Competent Medium Strength Sandstone bedrock was observed to be outcropping on both sides of this driveway (Photo 2). Between the road frontage and the house is a gently sloping garden area (Photo 3). At the road frontage to Cutler Road, a concrete driveway runs to a garage on the lower ground floor of the house (Photo 4). The cut for the driveway has been partially taken through outcropping sandstone (Photo 5). The remainder of the cut is supported by a timber retaining wall. The part three-storey rendered brick house was
