**REPORT ON GEOTECHNICAL INVESTIGATION
AND RISK ASSESSMENT**

PROPOSED NEW RESIDENTIAL APARTMENT BUILDING

25-27 KEVIN AVENUE, AVALON BEACH, NSW

Project No.: 2023-156

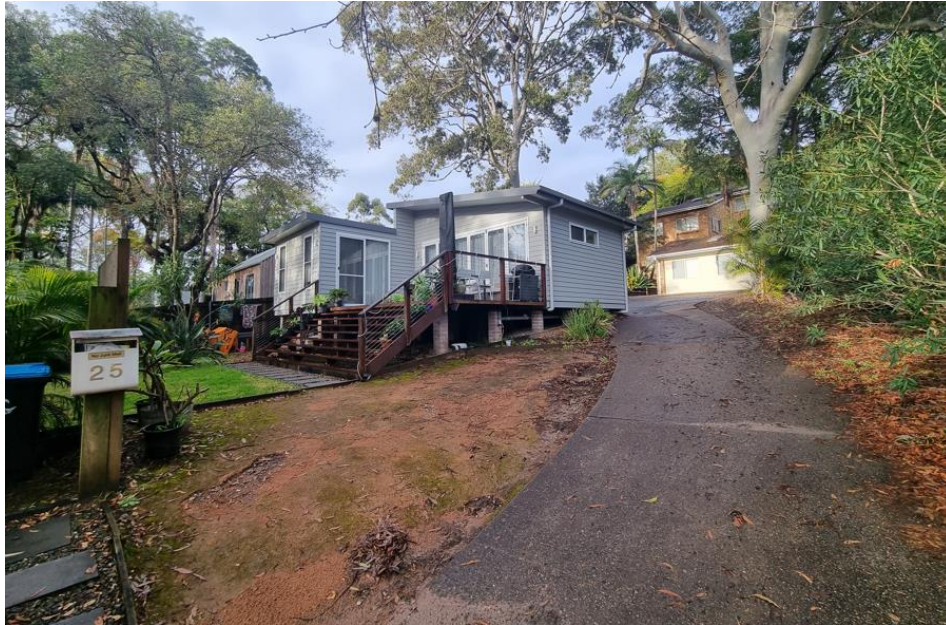
Photograph-2: View of front of 25 Kevin Avenue. View looking south-west from the roadway.

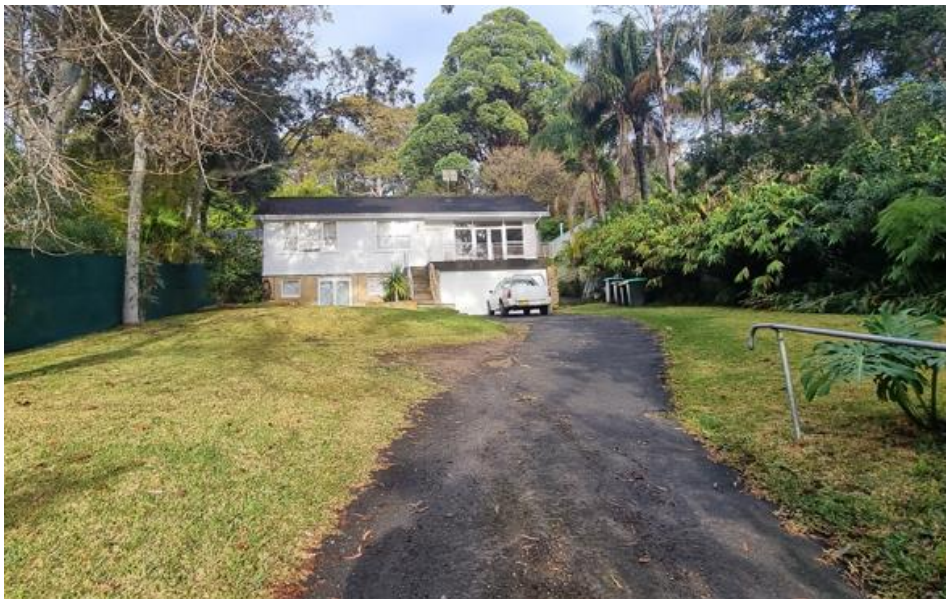
Photograph-3: View of front area of 27 Kevin Avenue. View looking south-west from the roadway.

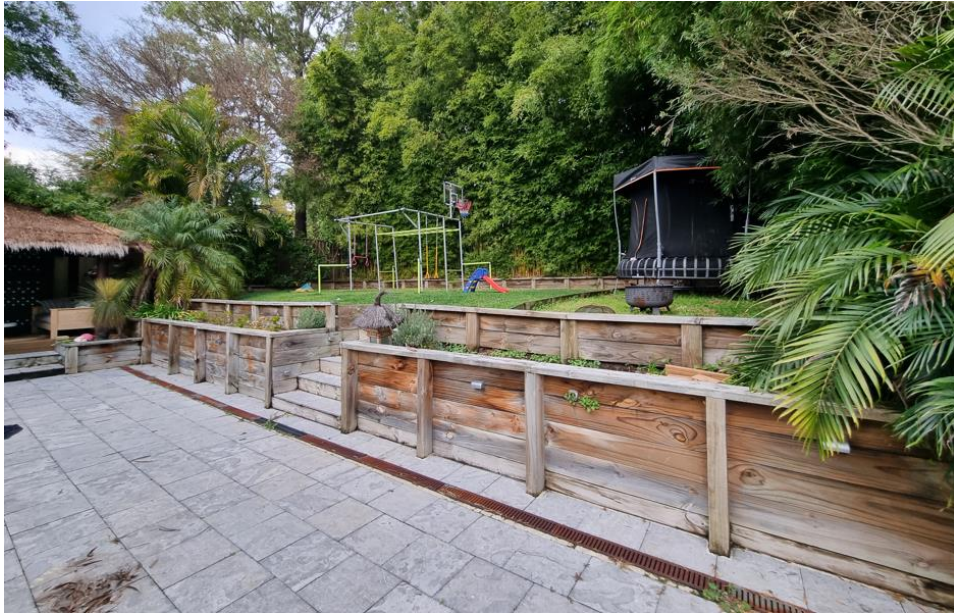
Photograph-4: View of rear area of 25 Kevin Avenue. View looking south from the rear yard.

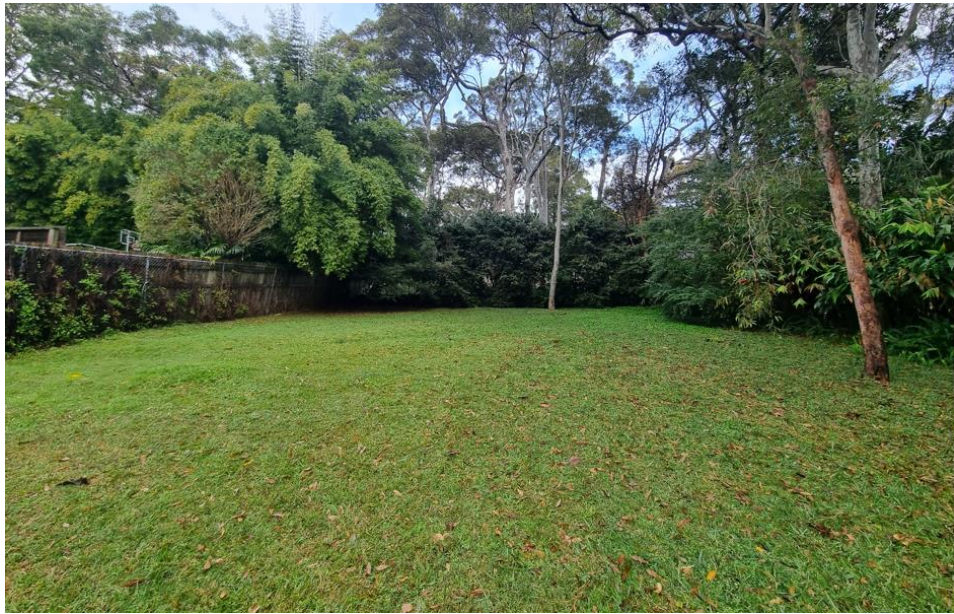
Photograph-5: View of rear area of 27 Kevin Avenue. View looking south-west from the rear yard.

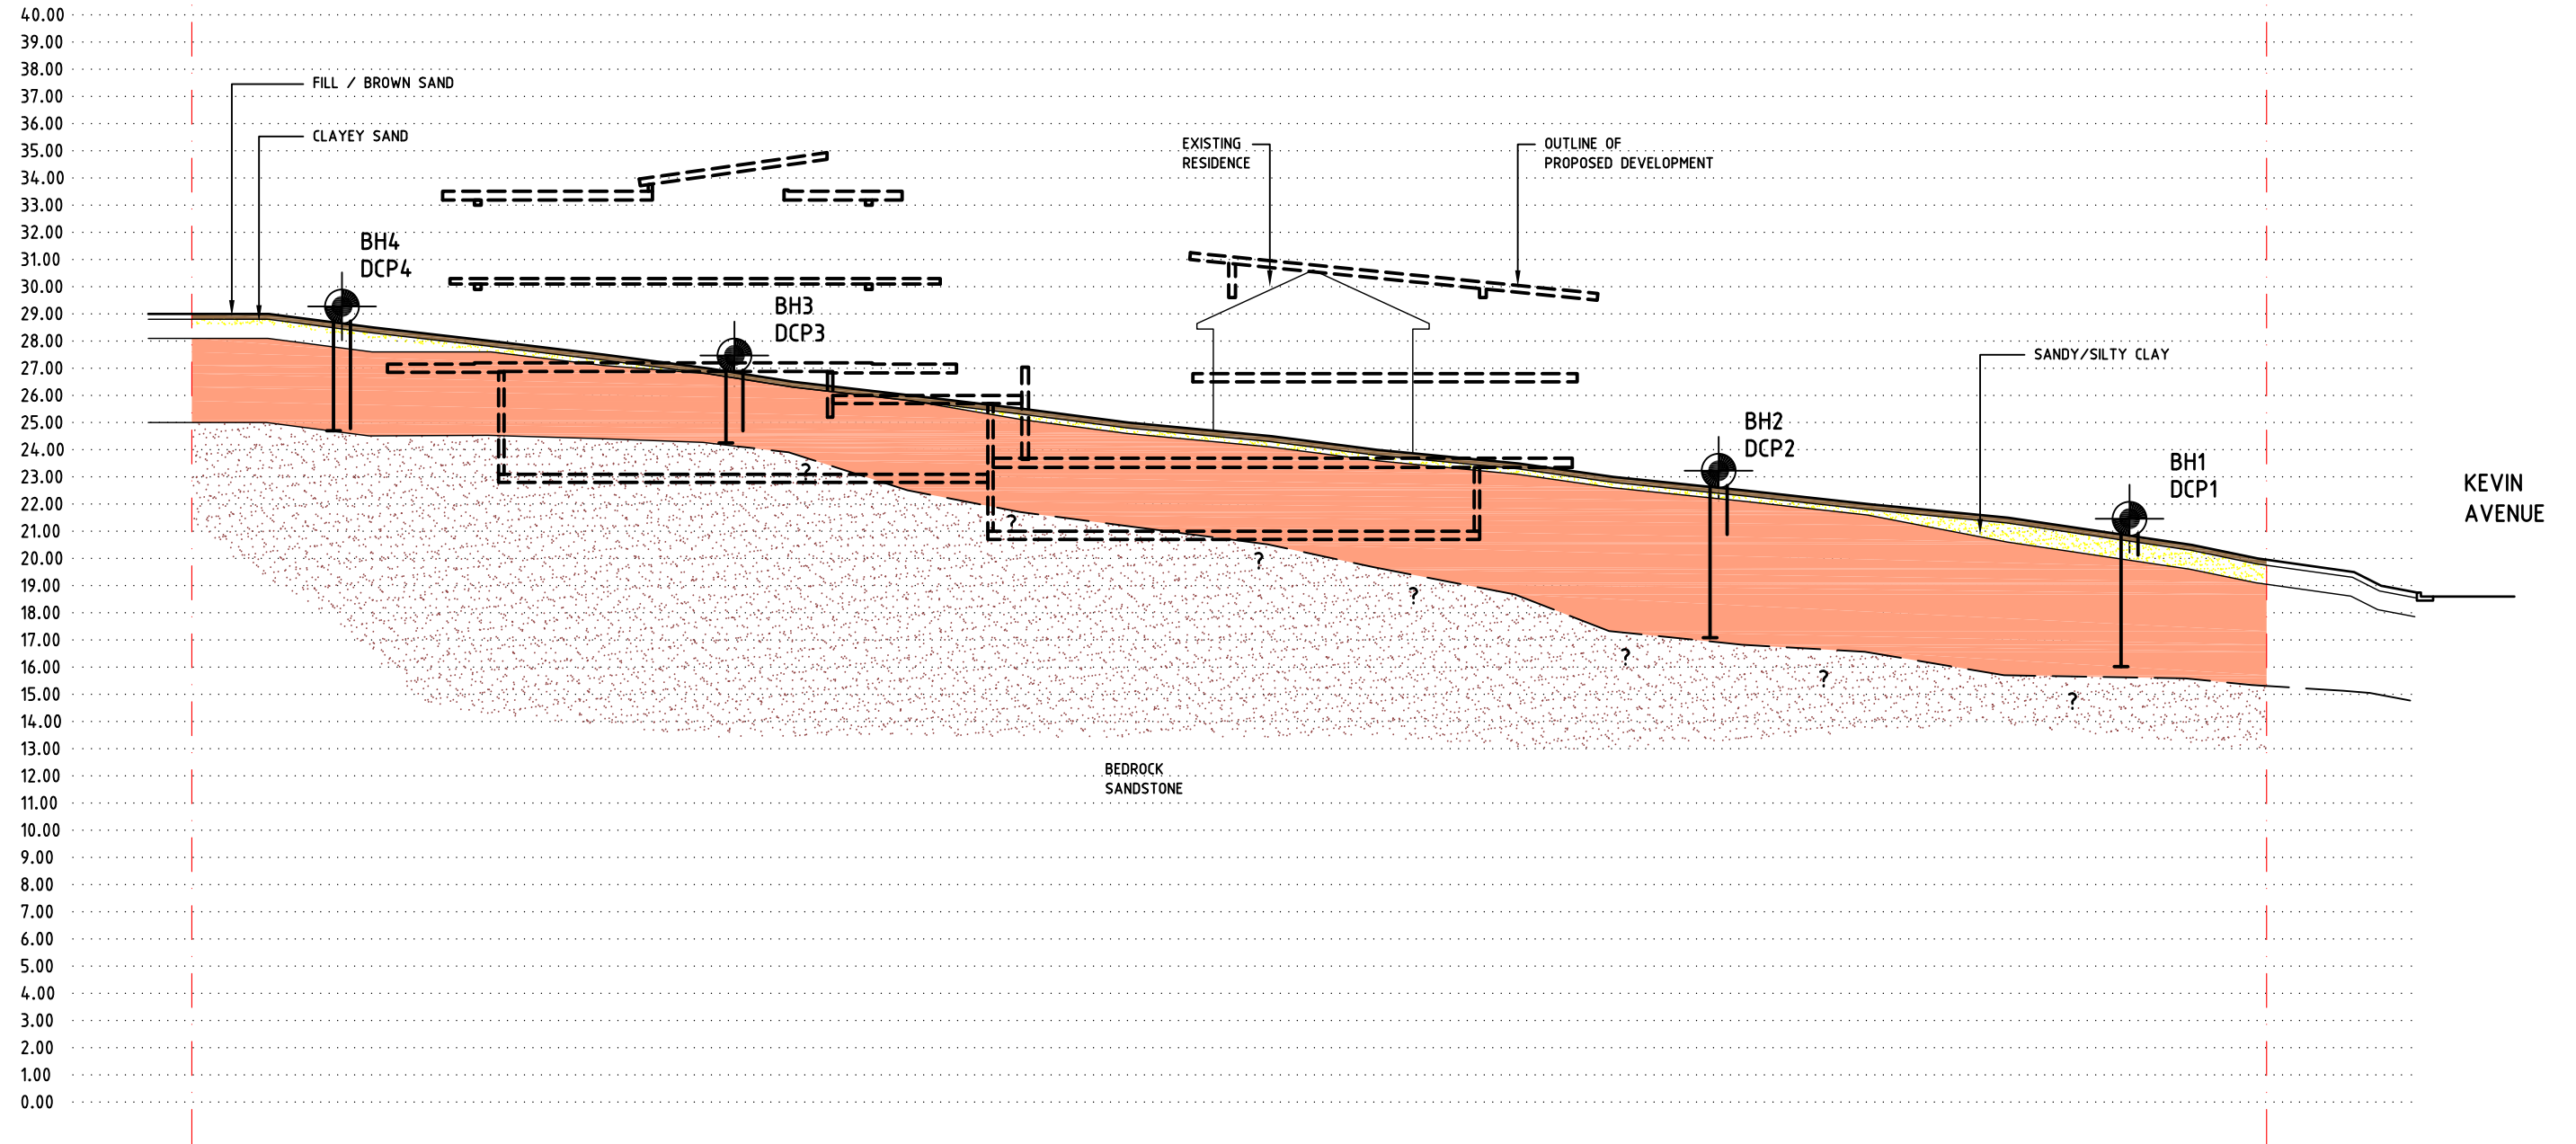
FIGURE 2

GEOLOGICAL MODEL

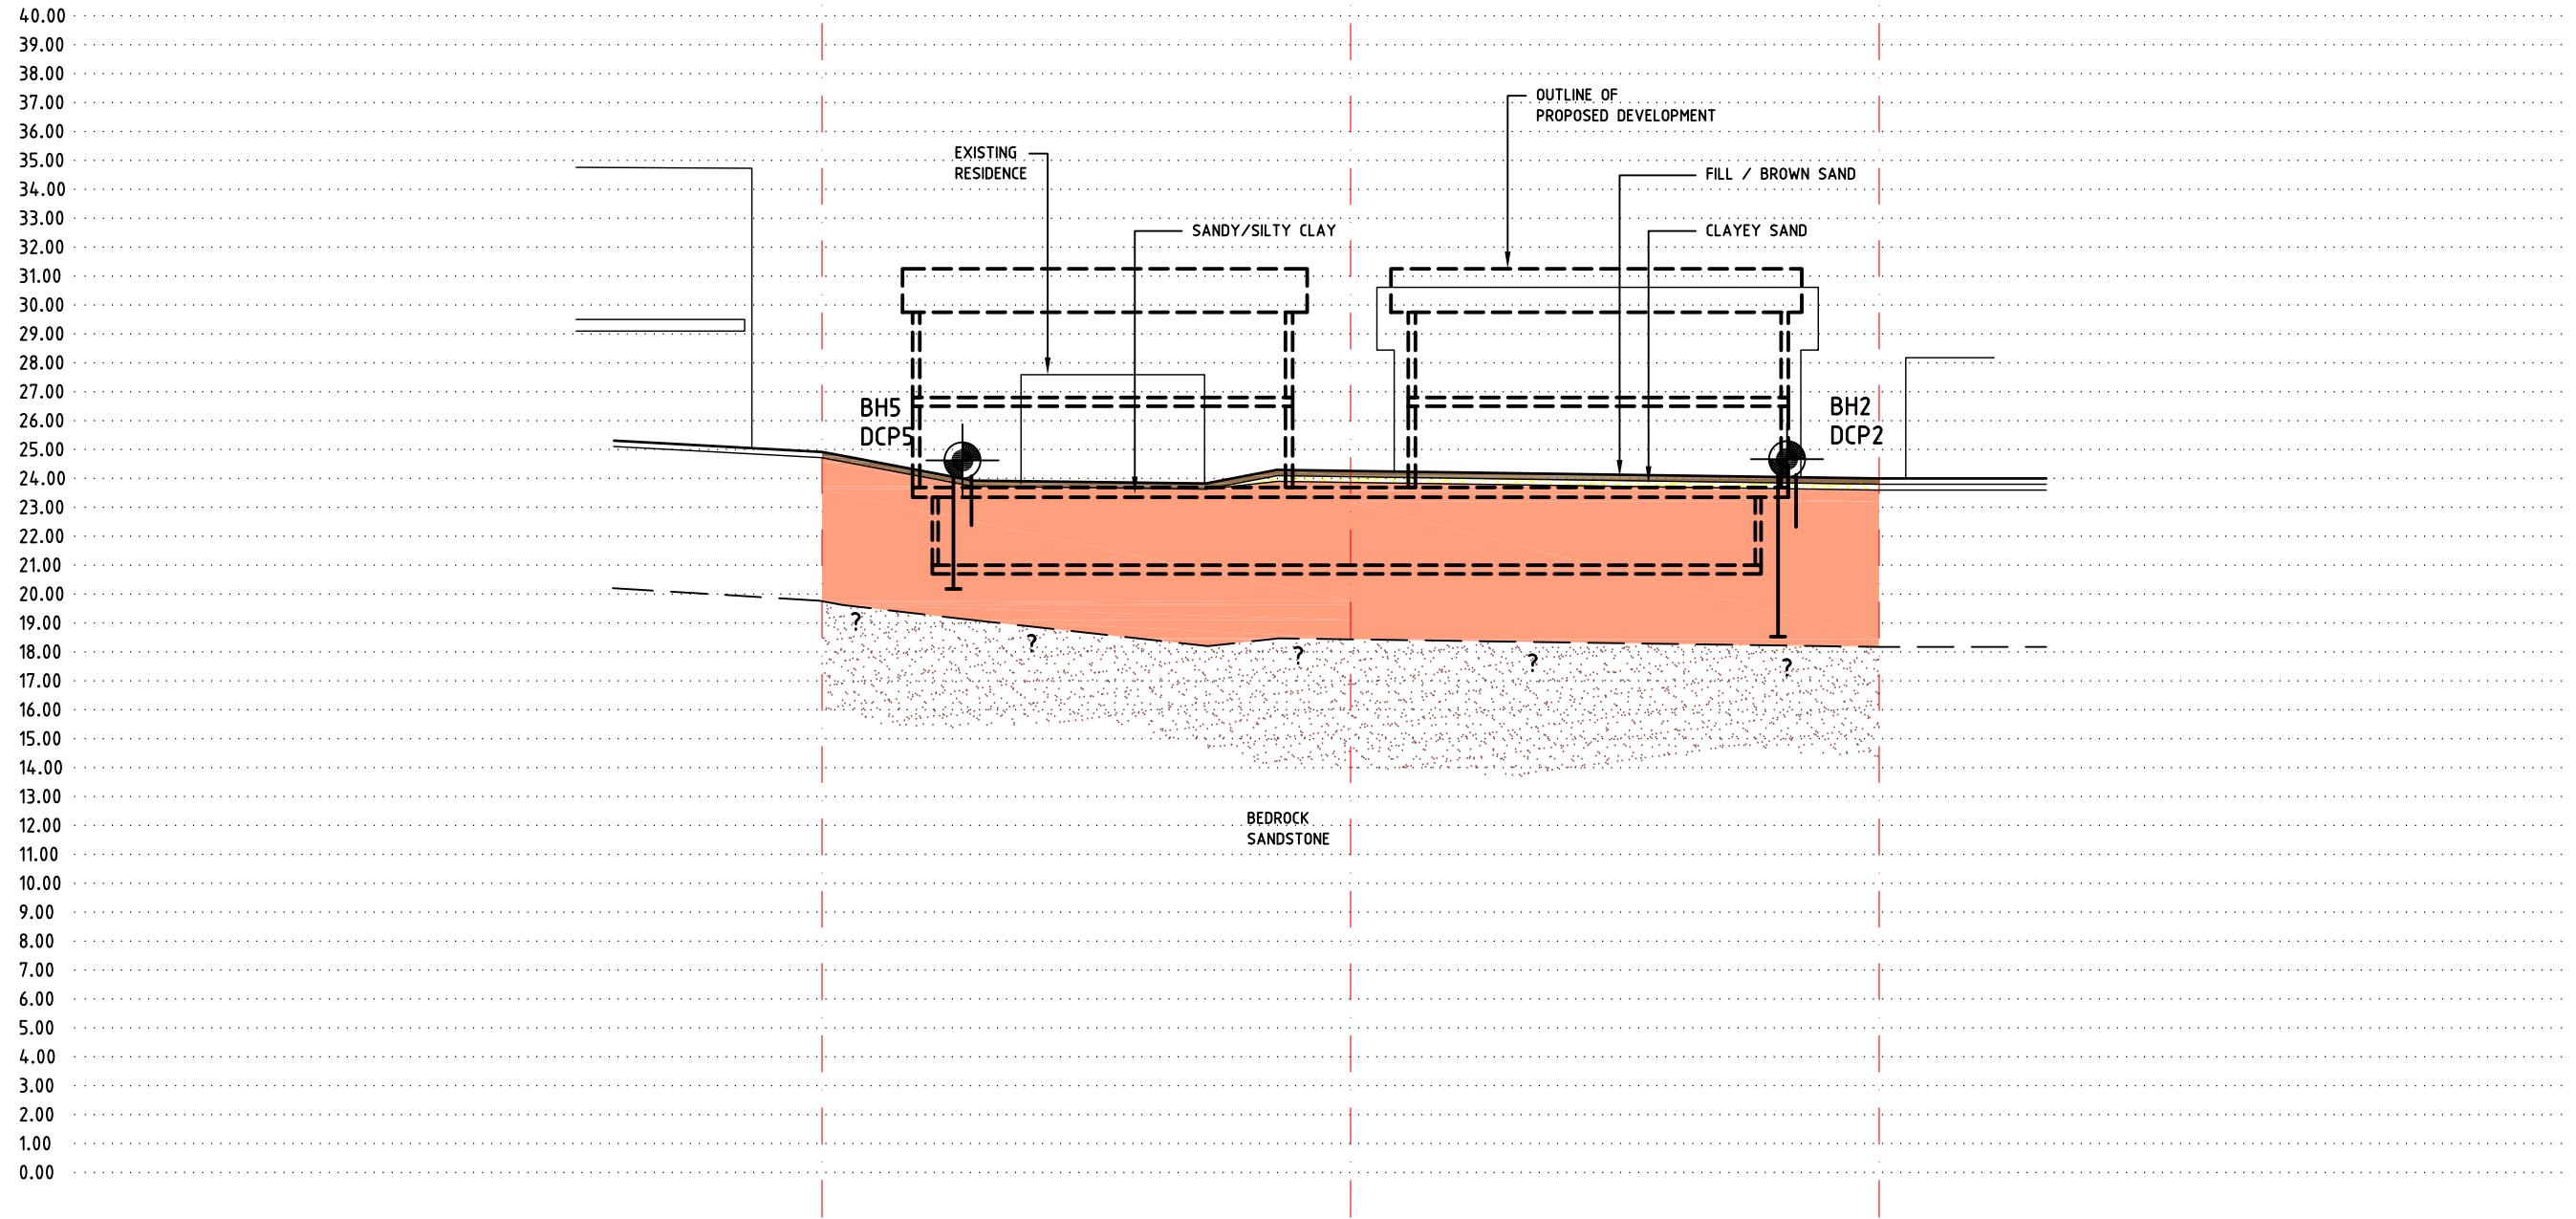
FIGURE 3

GEOLOGICAL MODEL
