# ARBORICULTURAL IMPACT ASSESSMENT REPORT

relating to construction of a new dwelling (House D) and driveway at

# 64 POWDERWORKS ROAD NORTH NARRABEEN NSW 2101

Prepared for Somers Isles Pty Ltd 6 December 2023

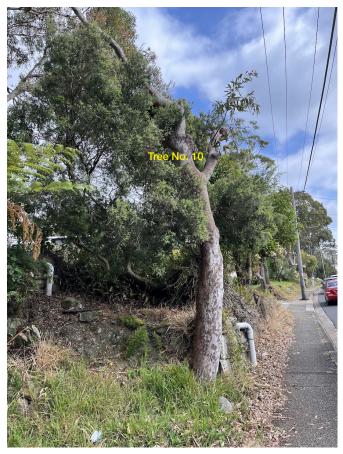
Figure 5 (above): Photograph viewing west to Tree No. 10 (Smooth barked Apple) which is located on the council verge. (Photo: J Willis)

### v) Tree No. 10 (Smooth-barked Apple) - council owned tree

The driveway crossover is located within the TPZ and SRZ of Tree No. 10, representing an encroachment in the TPZ and SRZ of 19% which is above the acceptable threshold. The excavation required for the driveway crossover may result in the severance of large woody roots that are providing anchorage and stability for the tree. The tree is a poorly formed specimen due to pruning of the canopy for overhead electrical wire clearance. Overall the tree is considered to hold a moderate retention value. It is the author's opinion it would be acceptable to remove the tree, providing compensatory tree planting is undertaken on the council verge as part of the works.

It is the author's opinion the driveway and crossover works will necessitate the removal of Tree No. 6 (Cheese tree) and the council owned Tree No. 10 (Smooth-barked Apple). The excavation proposed within the SRZ of both trees will potentially result in the severance of large structural roots that may well render the trees unviable. Both trees are considered to hold a moderate retention value. To compensate for loss of canopy, two replacement trees should be planted. The replacement trees should be the same species being removed or another locally occurring species to the area.

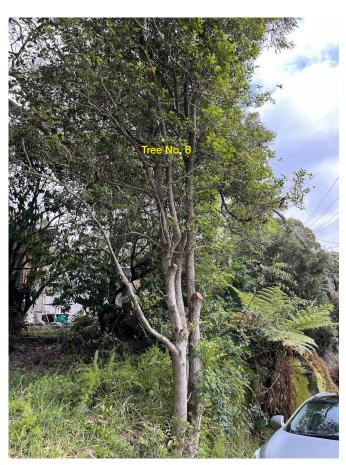
Figure 6 (above): Photograph viewing west to Tree No. 6 (Cheese tree) which is located immediately adjacent to the front boundary. (Photo: J Willis)

### iii) Tree No. 6 (Cheese tree)

The new driveway and crossover represent a major encroachment of 23% in the TPZ and SRZ of Tree No. 6. It is assumed excavation will be required in the TPZ and SRZ to accommodate the new driveway. As such, the proposed works will potentially result in an adverse impact upon the tree. The tree is a fair specimen with ecological significance and overall is considered to hold a moderate retention value. It is the author's opinion it would be acceptable to remove the tree, providing compensatory tree planting is undertaken on the site following the works.

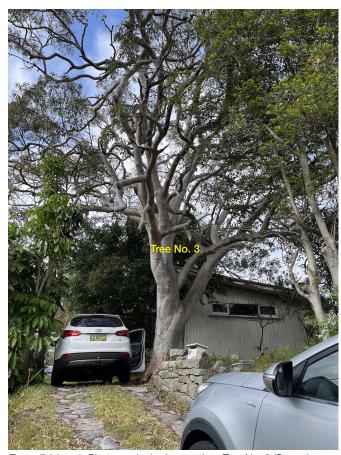
Figure 7 (above): Photograph viewing south to Tree No. 3 (Smooth barked Apple) which is located in the front of the dwelling. (Photo: J Willis)

#### i) Tree No. 3 (Smooth-barked Apple)

The proposed driveway area and crossover represent an encroachment in the TPZ and SRZ of 12%. With consideration to the new dwelling located in the TPZ of the tree, the combined encroachment of both dwelling and driveway totals 24%. The tree is considered to have a high retention value on the basis of its crown volume, ecological significance and a long estimated life expectancy. The owner is seeking permission from Council to remove the tree. The repositioning of the driveway and crossover to the northern side of the tree and the associated excavation works required will potentially result in a moderate to high level of impact upon the tree. If the tree is retained as part of the future works, details relating to the finished driveway levels would need addressed to ensure excavation within the TPZ is kept to a minimum and therefore mitigate any potential impact upon the tree.

The owner is seeking permission from Council to remove Tree No. 3 (Smooth-barked Apple) as part of the application. The tree is a mature specimen that exhibits low vigour and fair condition. Overall the tree holds a high retention value. The excavation required for the driveway and crossover area will potentially result in a moderate to high level of impact to the root system of the tree. Should Council not grant permission for the tree's removal, the driveway and crossover design would need to be addressed to minimise the extent of excavation required in the TPZ. Additionally, the incorporation of a permeable surface for the driveway area should be considered to ensure water infiltration and gaseous exchange to the root system of the tree is maintained wherever possible.

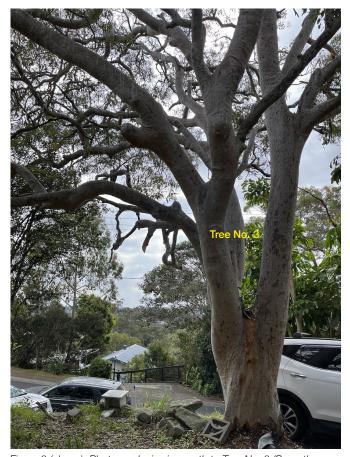
Figure 8 (above): Photograph viewing north to Tree No. 3 (Smooth barked Apple) which is located in the front yard of the property. (Photo: J Willis)

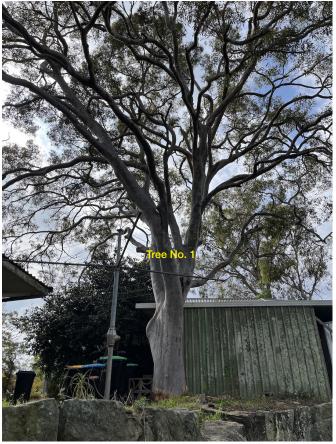
Figure 9 (above): Photograph viewing east to Tree No. 1 (Smooth barked Apple) which is located to the rear of the dwelling. (Photo: J Willis)

### 4.4 New dwelling encroachment in TPZ of Tree No. 1 (Smooth-barked Apple)

Tree No. 1 is located to the rear of the existing dwelling. On the basis of crown volume, ecological significance and a long estimated life expectancy, the tree is considered to hold a high retention value. The existing dwelling represents a numerical encroachment of 11% in the TPZ of the tree. The new dwelling represents an additional 5% encroachment, making a combined numerical encroachment of 16% in the TPZ of the tree. In order to minimise any potential impact upon the tree, the footing layout for the dwelling should consist of isolated piers in the TPZ. If the placement of all new footings in the TPZ does not result in the severance of any woody roots, the placement of the new dwelling should not result in any long term impact upon the tree.

- i) Footing design/layout should consist of isolated piers in the TPZ and avoid the use of continuous strip footings. Excavation for piers/footings should be undertaken by non-destructive root investigation methods (such as hand digging or hydro excavation) unless rock is encountered. The final location of all piers and footings must ensure there is no cutting of any woody roots greater than 30mm diameter. Where woody roots greater than 30mm diameter are encountered and the foundation cannot be relocated, further advice must be sought from a qualified Arborist prior to root severance. Any roots less than 30mm in diameter shall be cut cleanly with sharp pruning implement.

- ii) The tree is located in the area identified as private open space to the rear of the dwelling. It is recommended a decking material or alternative permeable surface is utilised for this area to ensure infiltration of water and gaseous exchange rates to the tree's root system are maintained.

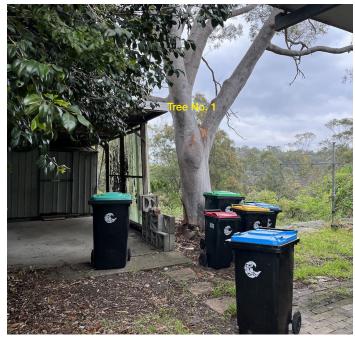
Figure 10 (above): Photograph viewing south to the carport and Tree No. 1 (Smooth barked Apple) which is located to the rear of the dwelling and adjacent to the existing carport. (Photo: J Willis)
