PO Box 1020 PENRITH NSW 2751 Tel: 02 4744 5800 Mob: 0425 833 893 info@bfcs.com.au www.bfcs.com.au Our Ref J21/1023 19 September 2023

Bushfire Statement of Compliance of APZ at 231-233 McCarrs Creek Road Church Point (Address)

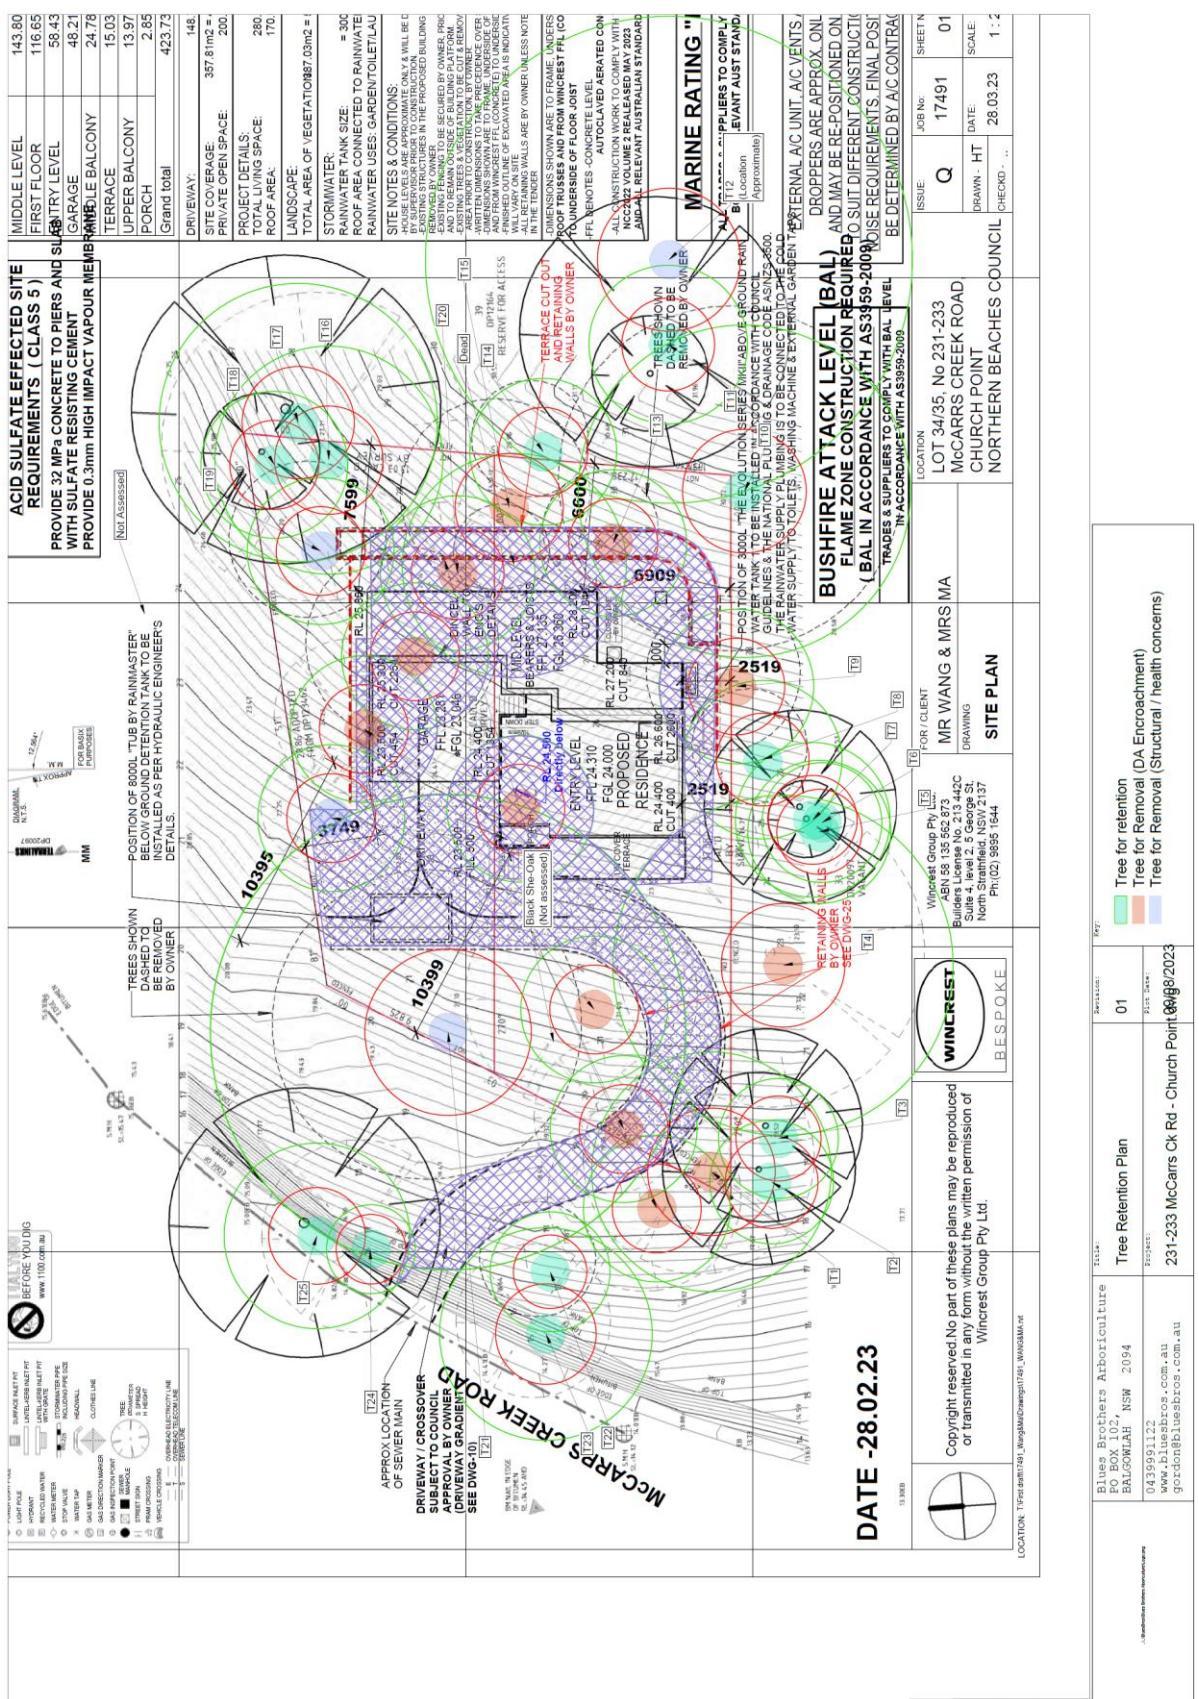
Planning For Bushfire Protection 2019	Annendix A Asset Protection Zone				
requirements	Appendix 4 Asset Protection 20ne				
Trees					
tree canopy cover should be less than 15% at maturity	Not Achievable without further significant tree removal				
	The trees nominated for retention in the Arborist Report are: • T2 • T3 • T5 • T6 • T7 • T8 • T10 • T11 • T14 • T16 • T17 • T18 Calculations of canopy cover based on the Tree Retention Plan, Rev 01, dated 09/08/2023 contained within the Arborist Report are as follows: Total tree canopy cover required by PBP: = $15\% \times 744.84m^2$ (site area) = $111.7m^2$ Total Tree Canopy Cover of trees to be retained from Tree Retention Plan: = $533.1m^2 / 744.84m^2$ = 71.6%				
	The Tree Retention Plan prepared by the Arborist nominates the following trees for removal:				
	• T1, T4, T9, T12, T13, T15, T19, T20, T21

Planning For Bushfire Protection 2019	Appendix 4 Asset Protection Zone					
requirements						
	It is therefore determined that the 15% tree canopy cover requirement is not achievable without significant further tree removal.					
trees at maturity should not touch or overhang the building	Not Achieved					
	Provide a plan note that trees will be pruned so that they do not touch or overhang the building. We recommend consultant with the Arborist and/or Council as the majority of overhanging branches belong to trees outside the subject site boundaries and that pruning large portions of some trees may compromise their health and stability such as T7, T8 &16.					
lower limbs should be removed up to a height of 2m above the ground	Add notation to the plans					
tree canopies should be separated by 2 to 5m and	Not Achieved – The tree canopy cover is all connected, there is no 2-5m tree canopy separation indicated by the Tree Retention Plan. As such, we recommend the Arborist provides for
