APPLICATION FOR BUILDING CERTIFICATE

12 ILYA AVENUE, BAYVIEW

GEOTECHNICAL RISK MANAGEMENT POLICY FOR PITTWATER - 2009
FORM NO. 4 (As per Pittwater Council's Geotechnical Risk Management Policy) – To be submitted
with Application for a Building Certificate/Response to an Order

RISK ANALYSIS & MANAGEMENT IN RESPONSE TO ORDER AT 12 ILYA AVENUE, BAYVIEW

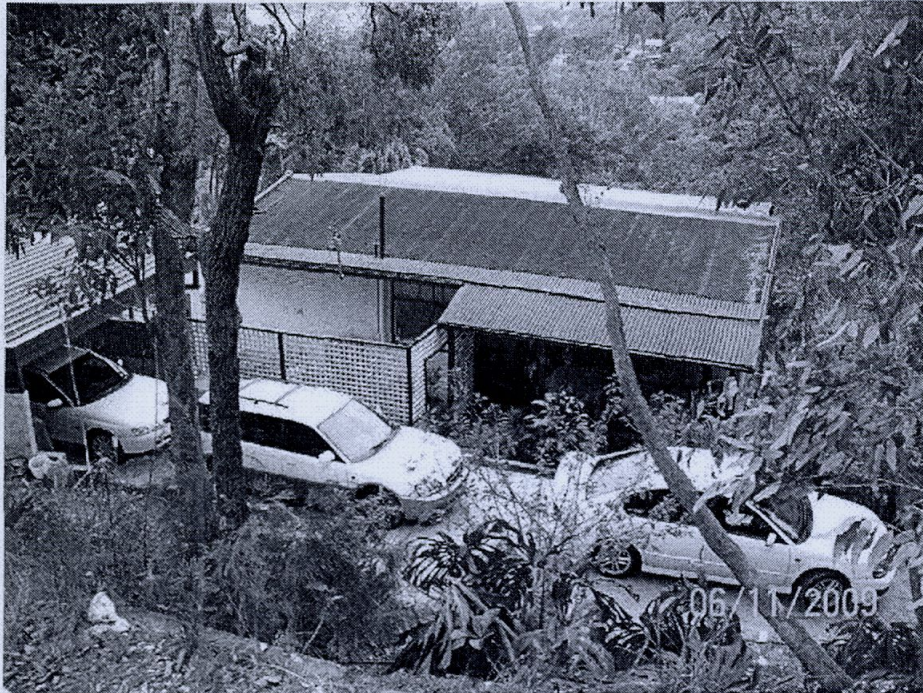
Photo 1

3.2 This property has a south easterly aspect and is on the low side of the road. It is located on the slope that rises from Pittwater to the plateau at Bayview Heights. The surface drops from the road at angles of 25 degrees across the property (Photo 1). This slope extends above the site at similar angles for some 50 metres before the grade eases at the top of the plateau and extends below at similar angles for some 60 metres before easing gradually to Pittwater.

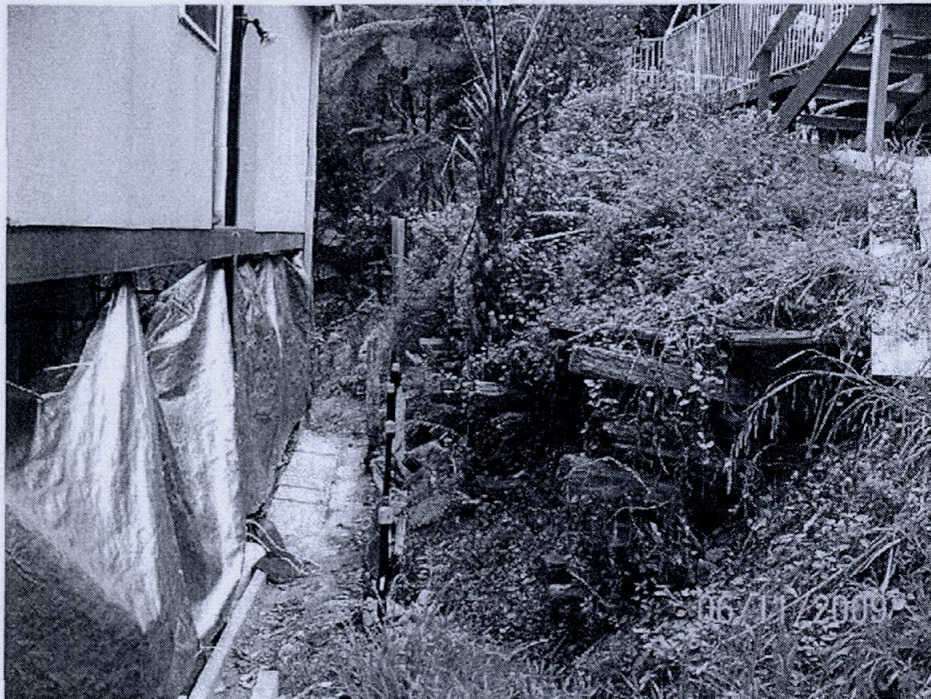
Photo 2

3.3 The crib style sleeper wall that is the reason for the commissioning of this report is located near the lower boundary close to the neighbouring house below (Photo 2). It has recently been partially cleared of weeds and creeper that were obscuring the structure from full view. It supports a fill that was placed on the slope after the construction of a concrete pool. The wall is old and the sleepers are in a state of decay (Photo 3). It has moved slightly in some areas (Photo 4). On the fill above pavers have been laid and these show signs of settlement (Photo 5). From the water level on the pool tiles it appears the pool has settled in the southern corner some 30mm (Photo 6). It is likely this movement occurred shortly after construction and is not currently active but this should be monitored over time to confirm this is the case. Work has been carried out to replace old decking with new decking at the northern side of the pool. Not all the footings for this decking appear to be in place but those complete show no sign of movement (Photo 7).

7.1 The old crib style sleeper retaining wall is a potential hazard (**HAZARD ONE**).

The wall is old and the sleepers making up the wall are in a state of decay. Some movement has occurred in the wall. Some settlement has occurred in the fill supported by the wall. The likelihood of the wall failing and impacting on the house below is assessed as 'Possible' (10^{-3}). The consequences to property of such a failure are assessed as 'Minor' (8%). The risk to property is 'Moderate' (5×10^{-5}).

To move risk to 'Acceptable' levels the old wall is to be replaced with a wall constructed to current engineering standards.

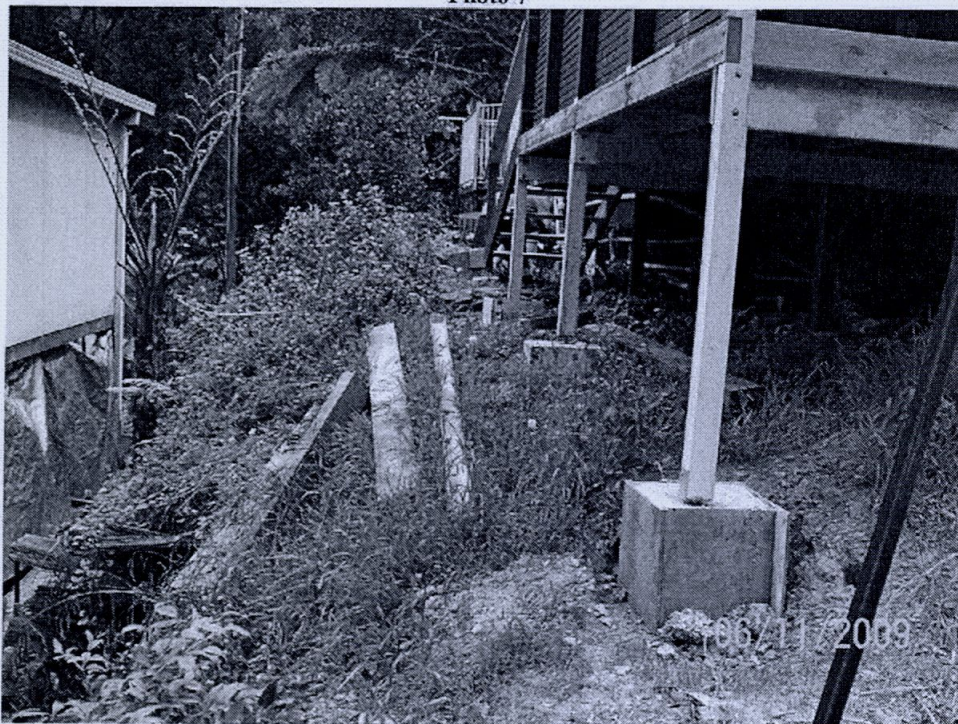
Photo 8

3.4 The two storey brick timber and fibre board house is in reasonable condition for its age (Photo 8). On the uphill side the cut batter to fit the house is supported by a concrete and sandstone block wall that is in good condition. The house is supported on brick walls, concrete pads and steel posts that show no evidence of ground movement that could be related to landslides (Photo 9).
