J3619. 13th August, 2021 Page 1.

187 Riverview Road, Avalon Beach

Minor Works Assessment

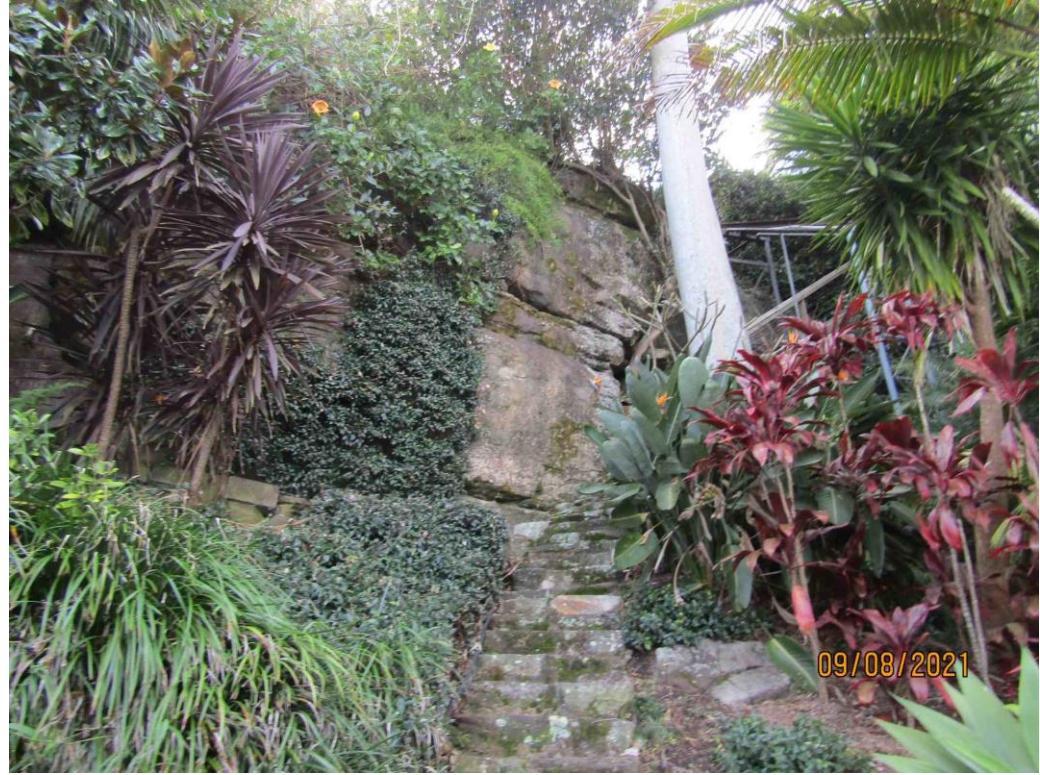
Photo 3

appear to be stable. A sandstone rock face up to ~6m high is located downhill of the house (Photo 3). The rock face appears to be currently stable. Large sandstone joint blocks are located in stable positions on the slope below the rock face near the waterfront (Photo 4). A concrete block boatshed in good condition is located at the waterfront. Low stone and gabion basket retaining walls support filled garden areas above the boatshed. A concrete block retaining wall ~1.8m high supports a cut beside the boatshed.
