SEASONED TREE CONSULTING

ARBORICULTURAL IMPACT ASSESSMENT REPORT

Site Address-
**129 Upper Clontarf Street
Seaforth NSW 2092**

| <u>Date</u> | 15 November 2019 |

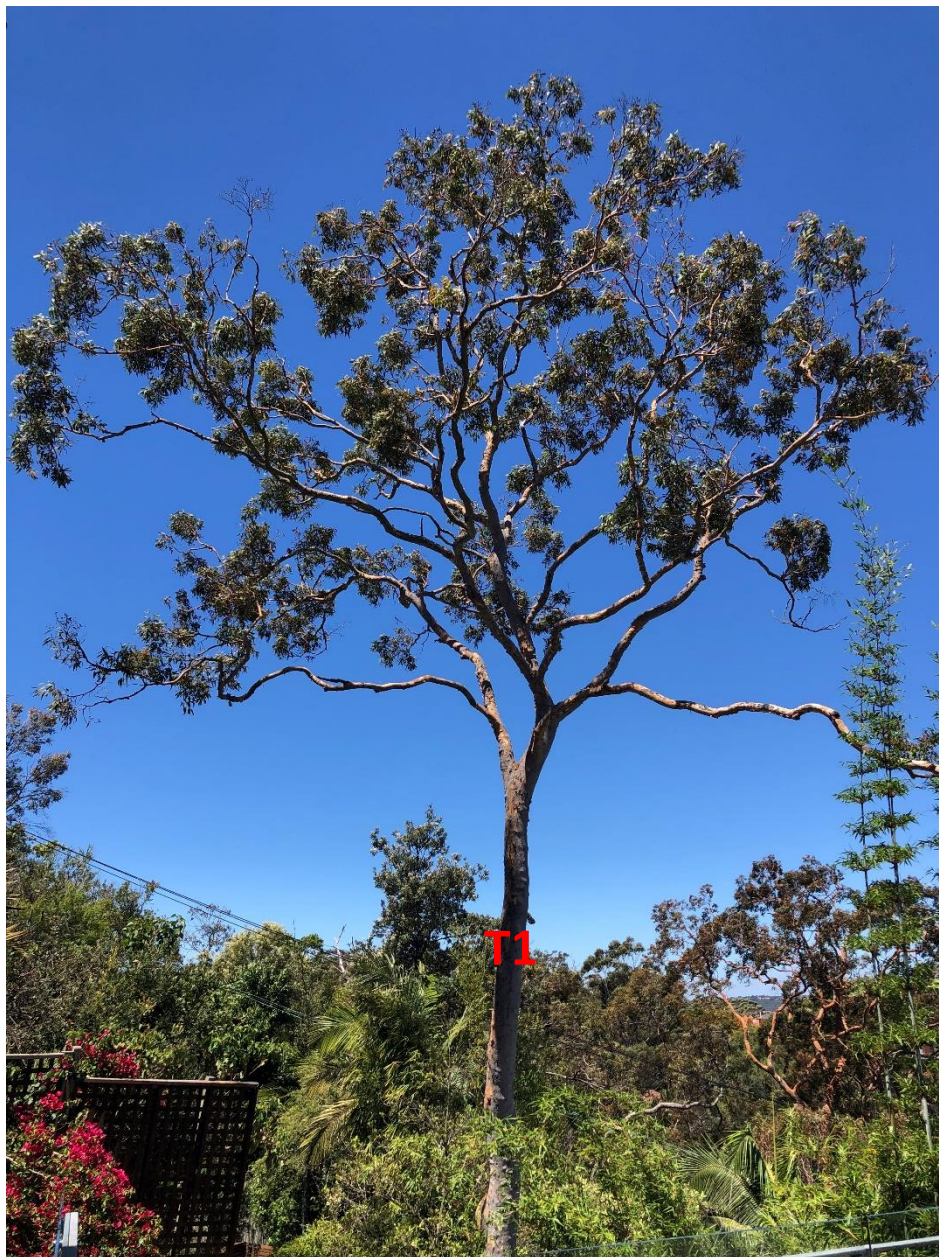
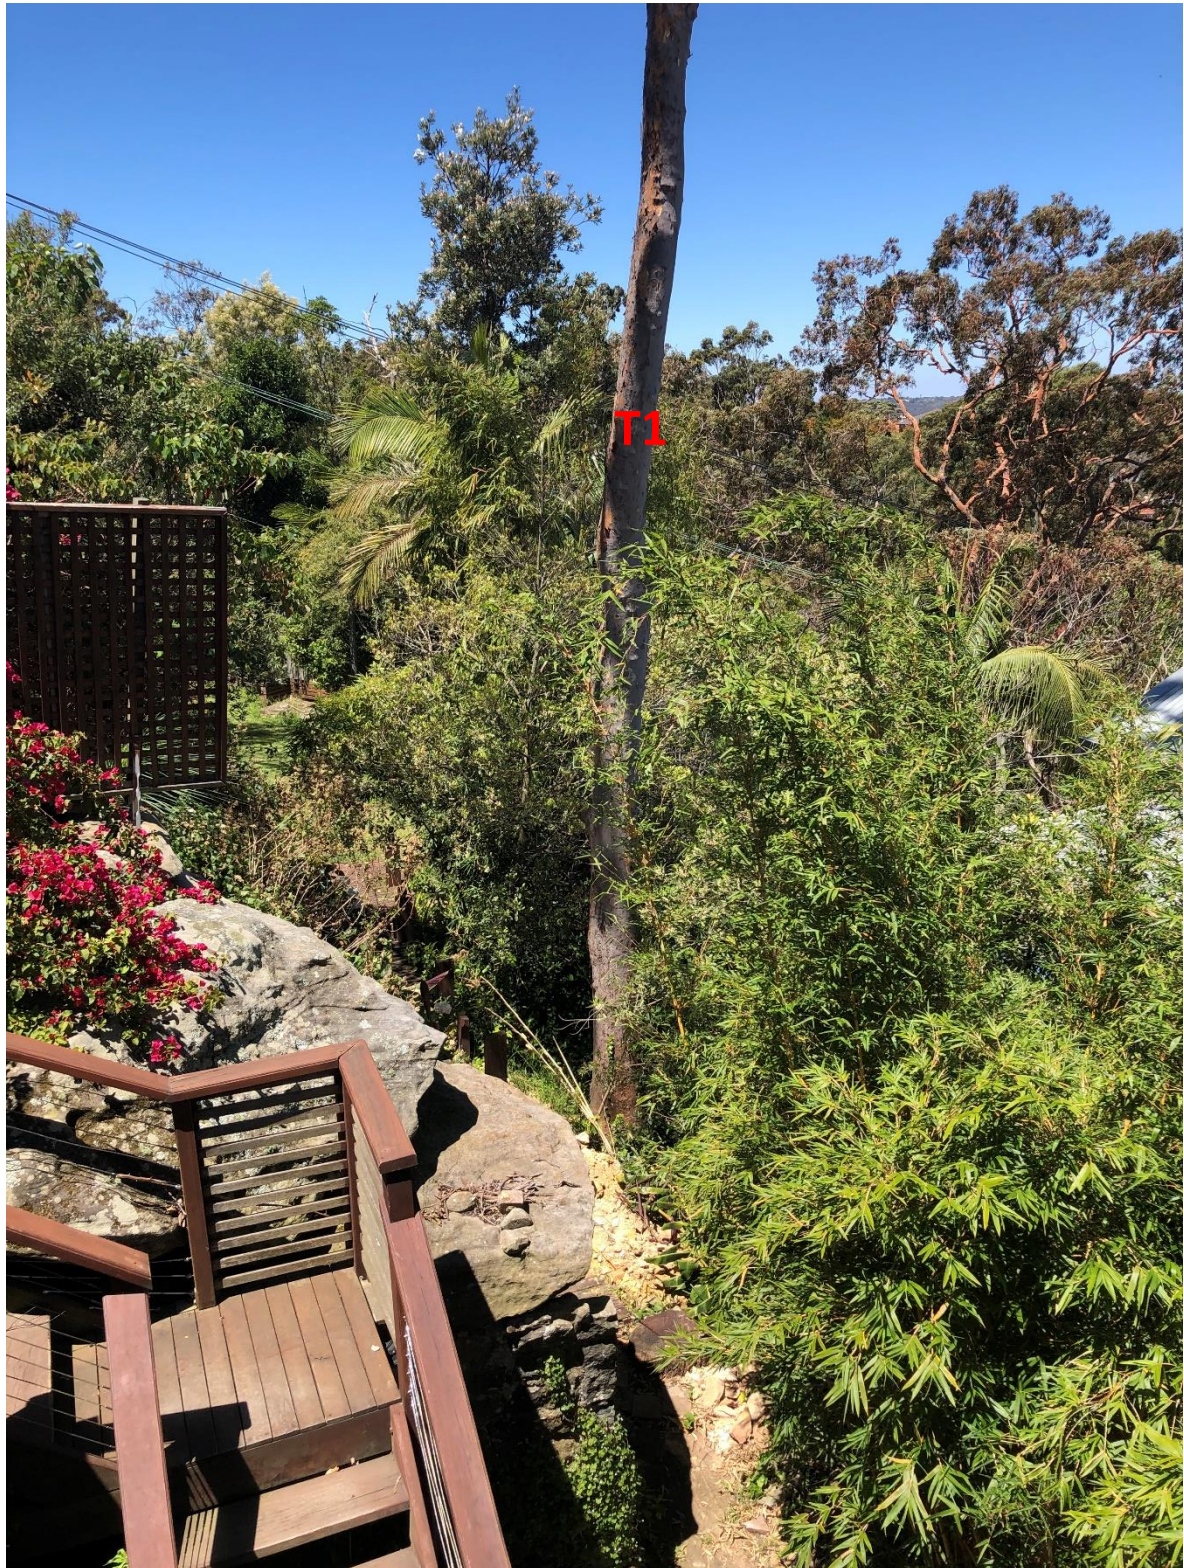
Tree #1 is located on the lowest level of the front yard and is a healthy mature *Angophora costata* (Sydney Red Gum). The tree possesses a Very High Landscape Significance Rating and subsequently a very high retention value and must be retained and protected. The clients love this tree and want it retained with no impact.

| Tree ref no. | Species | Age Class | DBH (cm) | DARB (cm) | Height (m) x Canopy spread (m) | Vigour/ Physiological Condition | Structural Condition (See Appendix D) | Landscape Significance Value (See Appendix E) | Useful Life Expectancy (ULE) (See Appendix F) | Comments |
|---|---|---|---|---|---|---|--|--|--|---|
| 1 | <i>Angophora costata</i> Sydney Red Gum | Mature | 46 | 53 | 15 x 14 | Good | Good | High | Long | Good condition, minor deadwood through crown. Some soil build up surrounding base of tree trunk. |

| Tree ID no. | Recommendations | Reasons |
|---|---|---|
| 1 | <p>Tree to be retained and protected to the AS4970 with Tree protection fencing to be installed as per the Tree Protection Plan (Page 15)</p> <p>Arboricultural supervision will be required during any demolition/excavation/ground works within the TPZ.</p> <p>Posts for the proposed stairs will need to be installed on a flexible post placement, under supervision by a project arborist.</p> <p>All excavation work within the calculated TPZ and SRZ must be undertaken by hand (manual shovel excavation)</p> | Tree is in good overall condition and has a high landscape significance rating. |

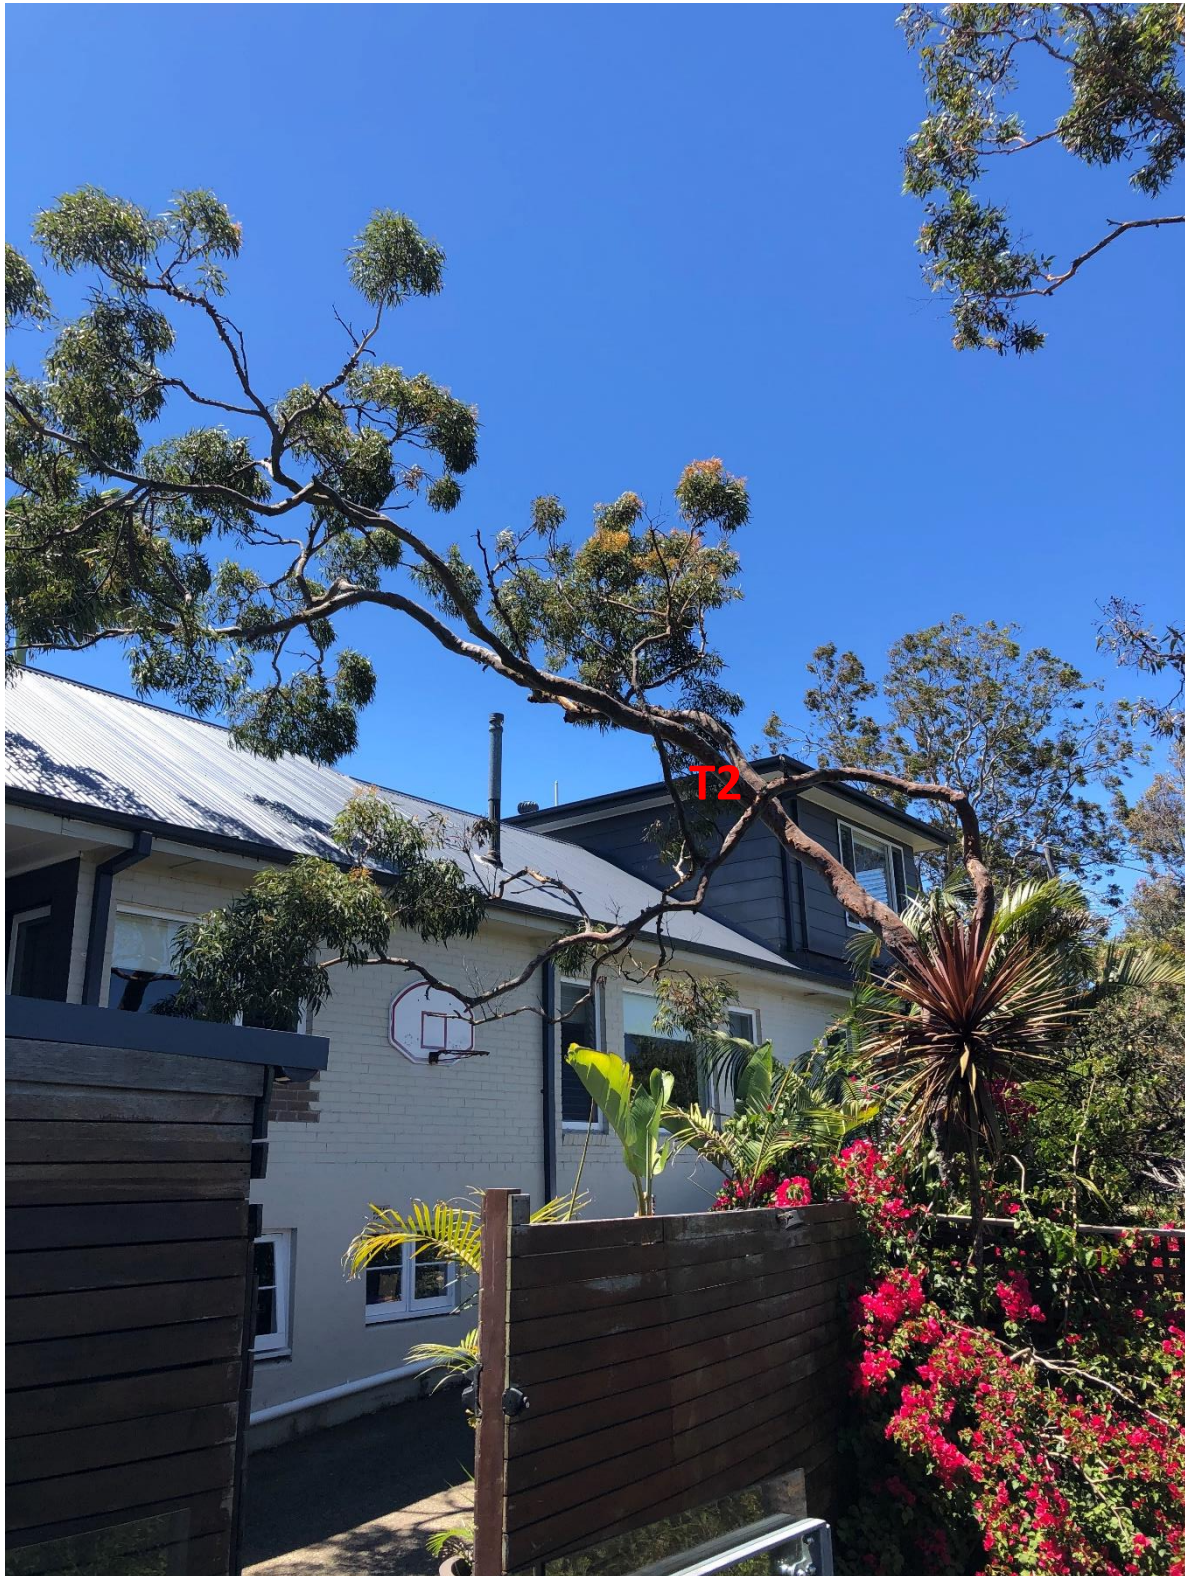
Tree # 2 is located beside the existing driveway. The tree is a semi-mature *Angophora costata* (Sydney Red Gum), showing fair to poor form due to its extremely lopsided structure. The tree currently knocks on the neighbours roof during windy weather. This tree is recommended for removal and replacement.

| Tree ref no. | Species | Age Class | DBH (cm) | DARB (cm) | Height (m) x Canopy spread (m) | Vigour/ Physiological Condition | Structural Condition (See Appendix D) | Landscape Significance Value (See Appendix E) | Useful Life Expectancy (ULE) (See Appendix F) | Comments |
|---|---|---|---|---|---|---|--|--|--|---|
| 2 | <i>Angophora costata</i> Sydney Red Gum | Semi-Mature | 26 | 30 | 7 x 7 | Good | Fair | Moderate | Short | Fair structural condition due to poor form of tree (has been suppressed its life by a previously removed tree) Remove and replant. |

| Tree ID no. | Recommendations | Reasons |
|---|---|---|
| 2 and 4 | Both trees recommended for removal | Due to poor form (Tree #2), end of life (Tree #4). |

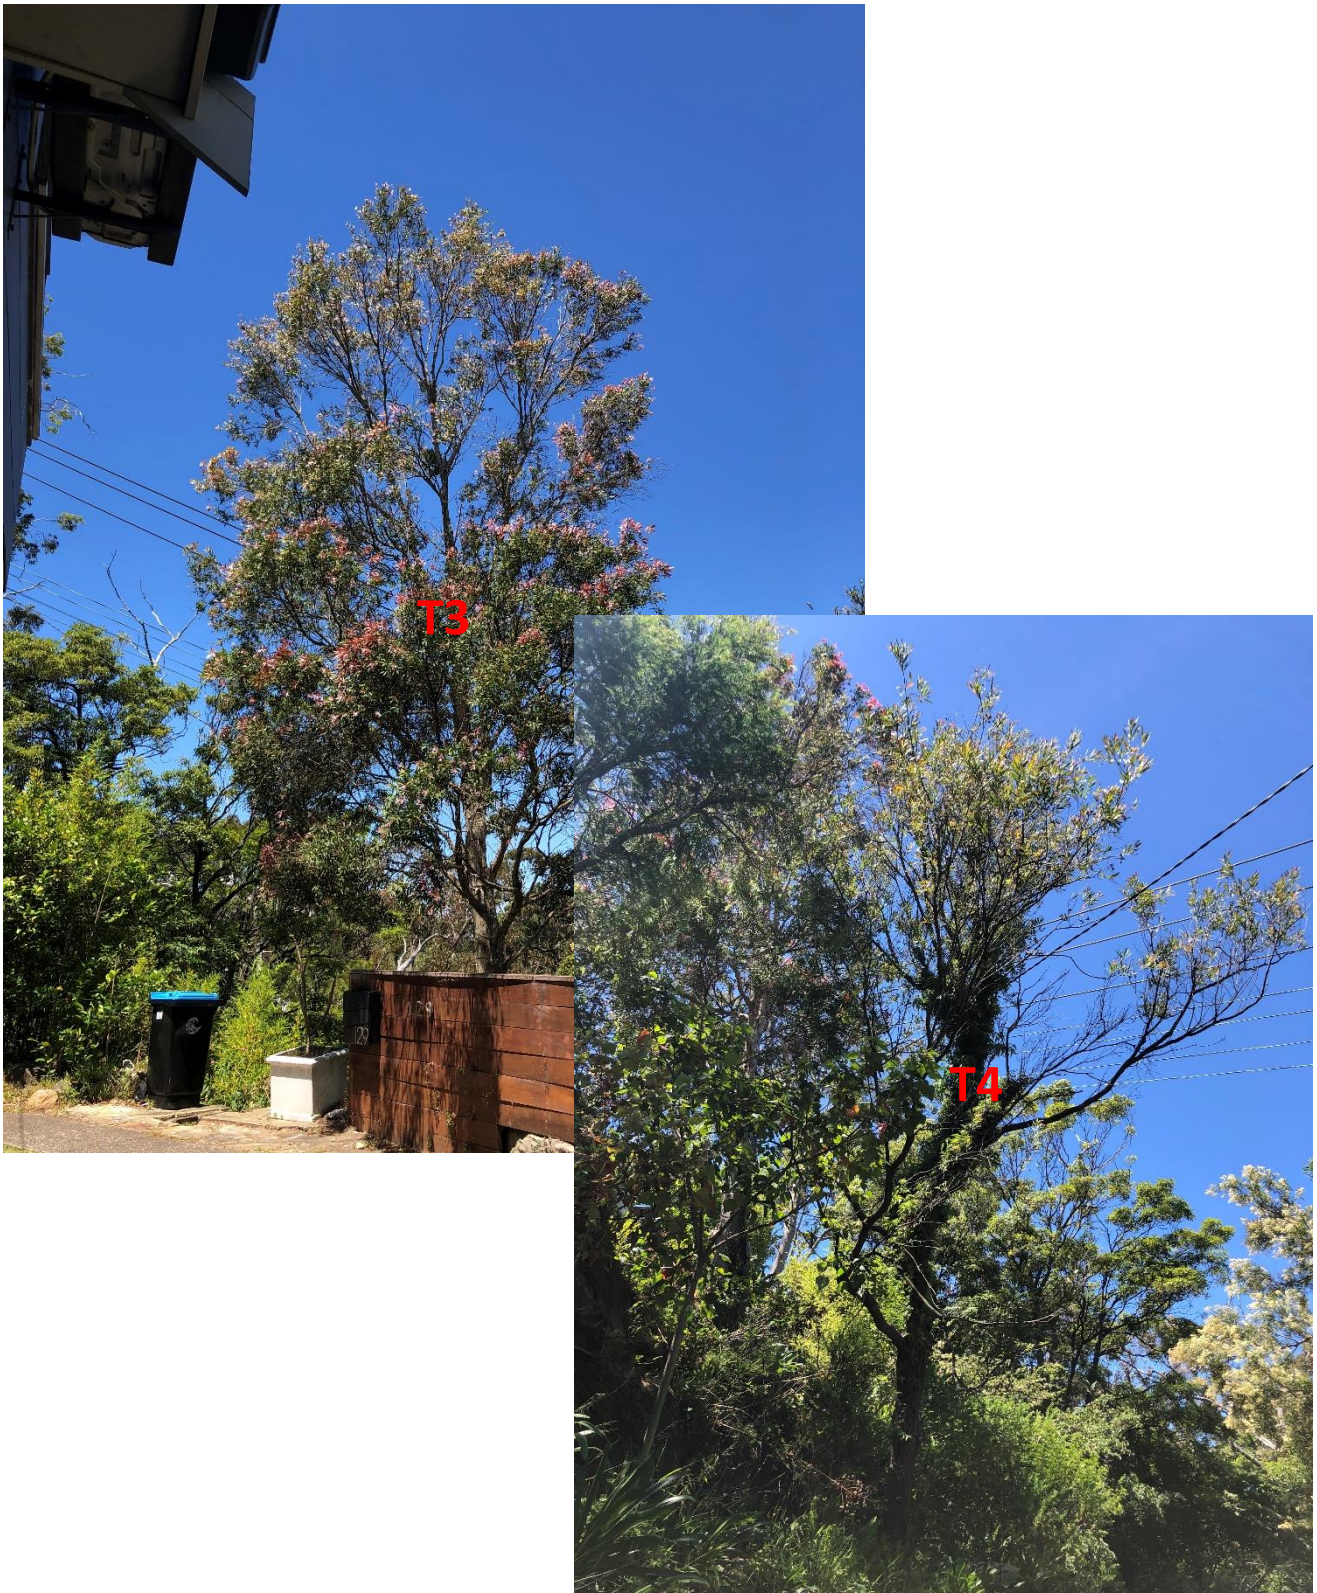
Tree # 3 and # 4 are both located below the driveway on the way in. The owners want to retain Tree # 3 and this is easily attainable as there will be low impact to this tree from the replacement driveway.

Tree #4 is recommended for removal due to the species (Hakea), known to be short lived, and the tree is at the end of its life.

| Tree ref no. | Species | Age Class | DBH (cm) | DARB (cm) | Height (m) x Canopy spread (m) | Vigour/ Physiological Condition | Structural Condition (See Appendix D) | Landscape Significance Value (See Appendix E) | Useful Life Expectancy (ULE) (See Appendix F) | Comments |
|---|---|---|---|---|---|---|--|--|--|---|
| 4 | <i>Hakea spp.</i> Hakea | Mature | 35 | 38 | 7 x 3 | Fair | Fair | Low | Transient | End of life, remove and replant. |

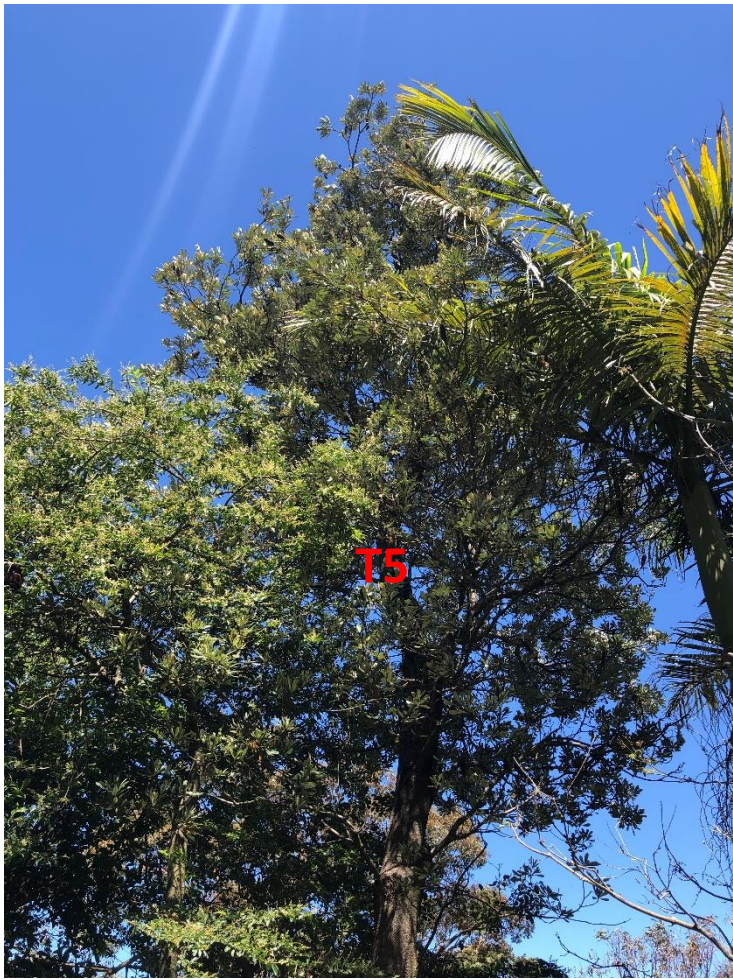
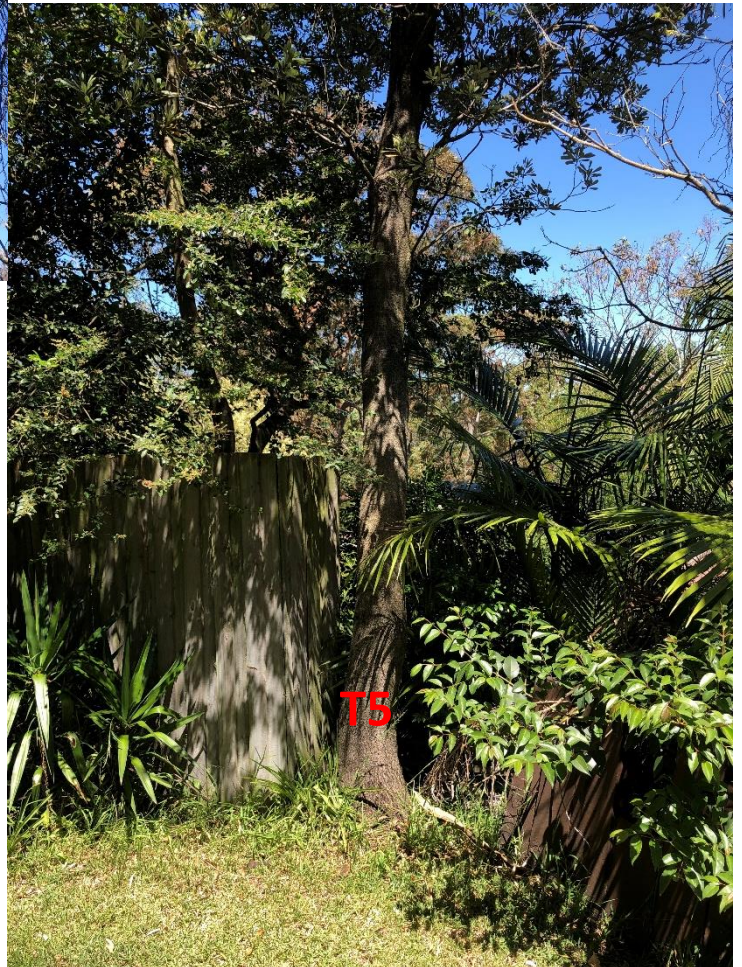
Tree #5 is located on the lowest level of the front yard beside the large Angophora.

The tree is a healthy mature *Banksia integrifolia* (Coast Banksia) and is located away from proposed construction.

| Tree ref no. | Species | Age Class | DBH (cm) | DARB (cm) | Height (m) x Canopy spread (m) | Vigour/ Physiological Condition | Structural Condition (See Appendix D) | Landscape Significance Value (See Appendix E) | Useful Life Expectancy (ULE) (See Appendix F) | Comments |
|---|---|---|---|---|---|---|--|--|--|---|
| 5 | <i>Banksia integrifolia</i> Coast Banksia | Semi Mature | 25 | 30 | 8 x 4 | Good | Good | Moderate | Medium- 15-40 years | Good condition, well away from proposed works |

| Tree ID no. | Recommendations | Reasons |
|---|---|---|
| 5 | Tree to be retained and protected to the AS4970 with Tree protection fencing to be installed as per the Tree Protection Plan (Page 15) | Tree is in good condition, no works planned near the trees. |

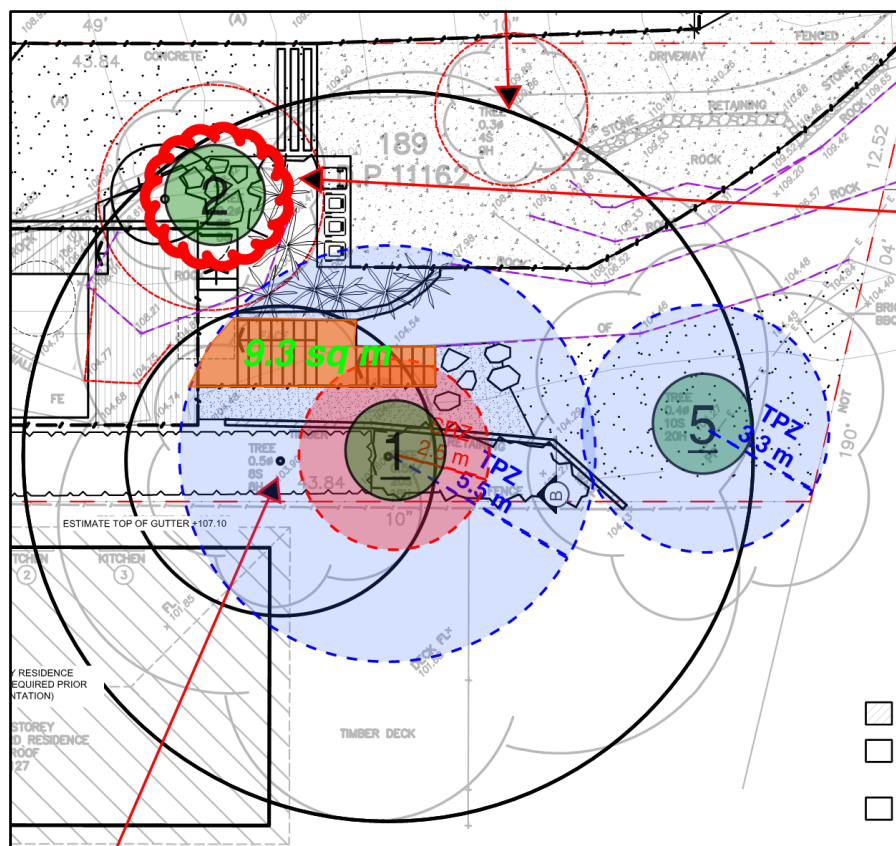
Tree # 1 has a calculated amount of impact of just under 10% (9.3 sq metres- see diagram below). This is due to the proposed new steps. This is an impact rating of low, but as the proposed steps jut into the SRZ, the impact rating becomes major. As long as the steps are placed on small posts/piers (with a flexible post placement in case there is a root over 50mm in the position), this should be a low impact.

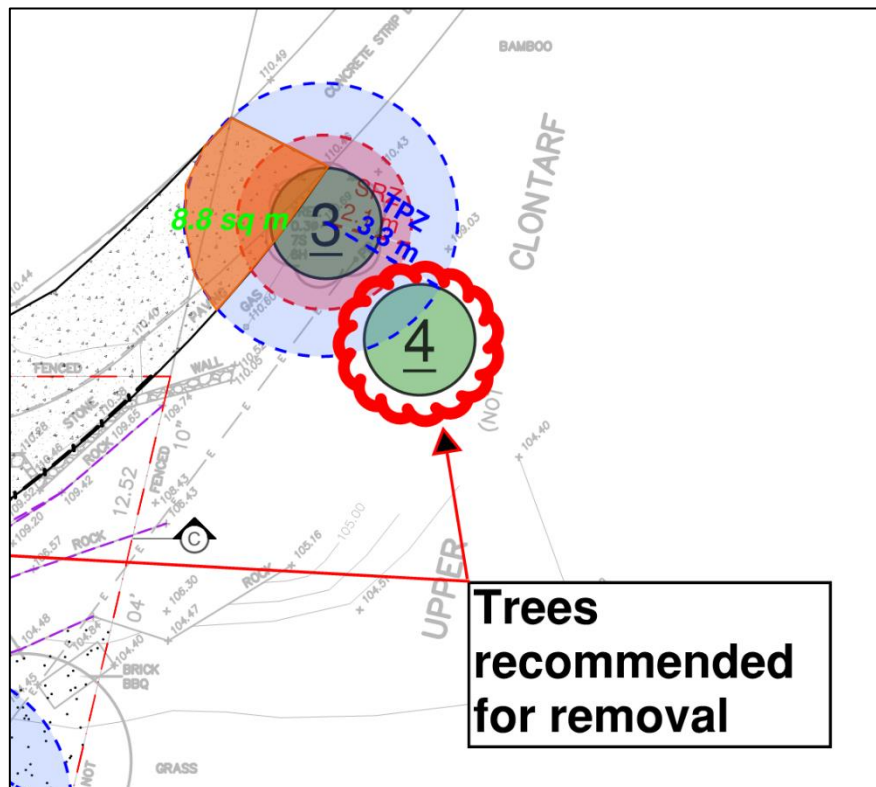
Tree # 3 has a moderate to high amount of encroachment into the TPZ/SRZ of 24% (8.8 sq m- see diagram below) due to the proposed ground floor alteration and addition (see diagram below).

This calculated impact is deemed to be a major encroachment. In this case as there is an existing driveway in place (which is being replaced in a similar layout to the existing), the calculated impact would be minimal. Recommendations are made to further lower any impact.

| Tree ID no. | Recommendations | Reasons |
|---|---|---|
| 3 | <p>Tree to be retained and protected to the AS4970 with Tree protection fencing to be installed as per the Tree Protection Plan (Page 15)</p> <p>All demolition work and reforming/ pouring new concrete driveway within the calculated TPZ must be undertaken by hand/manual excavation, under direct supervision of a project arborist.</p> | <p>Tree is in good condition and home owners want to retain.</p> <p>Moderate to high impacts from proposed construction, can be easily lowered to negligible.</p> |
