ARBORICULTURAL DEVELOPMENT IMPACT ASSESSMENT

32 CLARKE ST, NARRABEEN NSW 2101

M. + A. DOOLAN

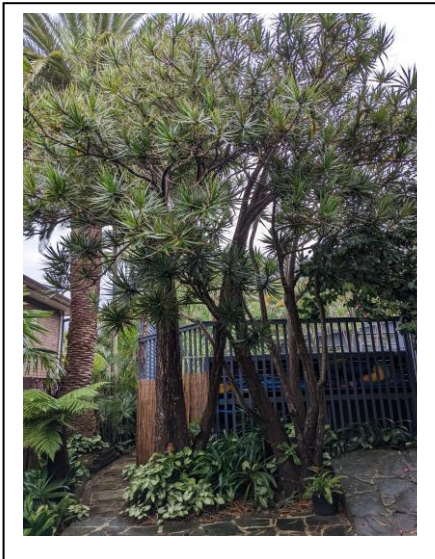
TREE 1
DRACAENA MARGINATA

SPECIES	CATEGORY	DETAILS	OBSERVATIONS + RECOMMENDATIONS
T1 <i>Dracaena marginata</i> (Madagascar Dragon Tree)	DESCRIPTION	Multi-stemmed tree-like exotic foliage plant	Good Health + Vigour No Visible Signs of Pest or Disease Located within proximity of existing swimming pool
	HEIGHT + SPREAD	6m x 6m	
	TRUNK	Multi-trunked 300, 150mm diam. (TPZ 4.1m, SRZ 2.5m) 2x75 ,2x150 ,200mm (TPZ 3.7m, SRZ 2.5m)	Edge of new pool proposed to be located 3800mm from centre of trunk(s)
	MATURITY	Mature	New pool approximately 1m further from T1 than existing pool. Light weight timber deck similar to existing proposed.
	AGE	20 yrs +	Deck posts proposed to be supported by individual concrete post footings.
	HEALTH CONDITION / STRUCTURE	Good Good	
	USEFUL LIFE EXPECTANCY LANDSCAPE SIGNIFICANT RETENTION VALUE	MEDIUM LOW LOW	NO ADVERSE IMPACT ANTICIPATED RETENTION RECOMMENDED

Trees / palms 1, 2 + 3 are located within the zone of impact from the proposed construction works. Trees 1 + 3 were planted after construction of the existing pool and Tree 2 was on site prior. The proposed new pool is located further away from Trees 1, 2 + 3 than the existing pool and all are species that tolerate root disturbance. No changes in soil level are proposed. Trees 2 + 3 are exempt palm species.

All three (3) trees / palms have matured to be healthy specimens within proximity of the existing pool and would be expected to continue to thrive under the improved root conditions of the new construction, providing adequate tree protection measures are undertaken during the construction phase.

T1 *Dracaena marginata*, T2 *Phoenix canariensis*, T3 *Archontophoenix cunninghamiana*

can be adequately retained within the proposed development provided general tree protection measures are implemented throughout the works to ensure their continued health and vigour.

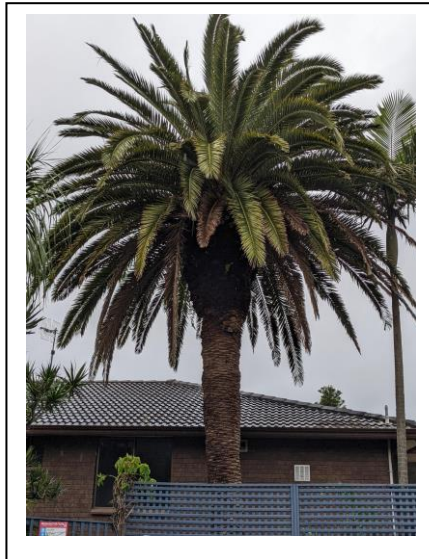
TREES 2 + 3 (T 3 to right of T2)
PHOENIX CANARIENSIS
ARCHONTOPHOENIX CUNNINGHAMIANA

<p>T2 <i>Phoenix</i> <i>Canariensis</i> (Canary Island Palm)</p>	<p>DESCRIPTION</p> <p>HEIGHT + SPREAD</p> <p>TRUNK</p> <p>MATURITY</p> <p>AGE</p> <p>HEALTH CONDITION / STRUCTURE</p> <p>USEFUL LIFE EXPECTANCY LANDSCAPE SIGNIFICANT RETENTION VALUE</p>	<p>Exotic Palm Exempt Species</p> <p>9m x 7m</p> <p>DBH 500mm, DAB 600mm diam. (TPZ 6m, SRZ 2.7m)</p> <p>Mature</p> <p>20 yrs +</p> <p>Good Good</p> <p>MEDIUM MODERATE MODERATE</p>	<p>Good Health + Vigour No Visible Signs of Pest or Disease Located within proximity of existing swimming pool</p> <p>Edge of new pool proposed to be located 3500mm from centre of trunk</p> <p>New pool further from T2 than existing pool with light weight timber deck similar to existing. Posts proposed to be supported by individual concrete post footings.</p> <p>NO ADVERSE IMPACT ANTICIPATED RETENTION RECOMMENDED</p>
<p>T3 <i>Archontophoenix</i> <i>cunninghamiana</i> (Bangalow Palm)</p>	<p>DESCRIPTION</p> <p>HEIGHT + SPREAD</p> <p>TRUNK</p> <p>MATURITY</p> <p>HEALTH CONDITION / STRUCTURE</p> <p>USEFUL LIFE EXPECTANCY LANDSCAPE SIGNIFICANT RETENTION VALUE</p>	<p>Exotic Palm Exempt Species</p> <p>8m x 3m</p> <p>120mm diameter (TPZ 2m, SRZ 2m)</p> <p>Mature</p> <p>Good Good</p> <p>MEDIUM LOW VERY LOW</p>	<p>Good Health + Vigour No Visible Signs of Pest or Disease Located within proximity of existing swimming pool</p> <p>Edge of new pool proposed to be located 3500mm from centre of trunk</p> <p>New pool further from T3 than existing pool with light weight timber deck similar to existing. Posts proposed to be supported by individual concrete post footings.</p> <p>NO ADVERSE IMPACT ANTICIPATED RETENTION RECOMMENDED</p>

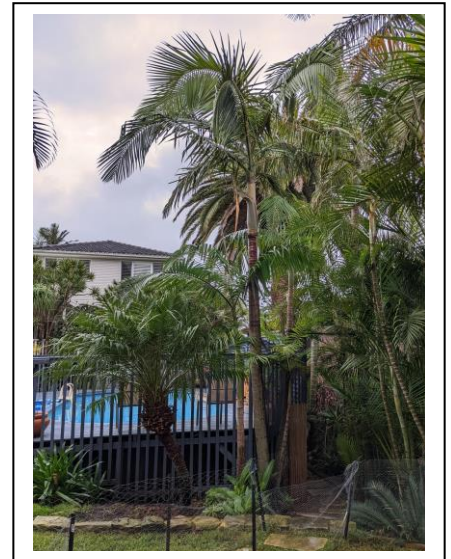
TREE 4
ARCHONTOPHOENIX CUNNINGHAMIANA

<p>T4 <i>Archontophoenix</i> <i>cunninghamiana</i> (Bangalow Palm)</p>	<p>DESCRIPTION</p> <p>HEIGHT + SPREAD</p> <p>TRUNK</p> <p>MATURITY</p> <p>HEALTH CONDITION / STRUCTURE</p> <p>USEFUL LIFE EXPECTANCY LANDSCAPE SIGNIFICANT RETENTION VALUE</p>	<p>Group of 3 Exotic Palms Exempt Species</p> <p>6m x 4m, 3m x 2m, 2m x 2m</p> <p>120, 75, 50mm diameters (TPZ 2m, SRZ 2m)</p> <p>Semi-Mature</p> <p>Good Good</p> <p>SHORT LOW VERY LOW</p>	<p>Good Health + Vigour No Visible Signs of Pest or Disease</p> <p>Located within proximity of existing swimming pool.</p> <p>Trunk locations conflict with location of proposed pool deck and retention of palms is not possible.</p> <p>ADVERSE IMPACT ANTICIPATED EXEMPT SPECIES REMOVAL RECOMMENDED</p>

Tree 4 is a group of 3 palms (*Archontophoenix cunninghamiana*) which are exempt from protection under Warringah DCP. They will be adversely impacted by the proposed works and are recommended for removal.

T4 *Archontophoenix cunninghamiana* (group of 3 palms)

cannot be adequately retained within the proposed development. These palms are recommended for removal.
