Geotechnical Assessment

Project: Alterations and Additions 271 Whale Beach Road, Whale Beach, NSW.

REF: AG 19061 28th August, 2019

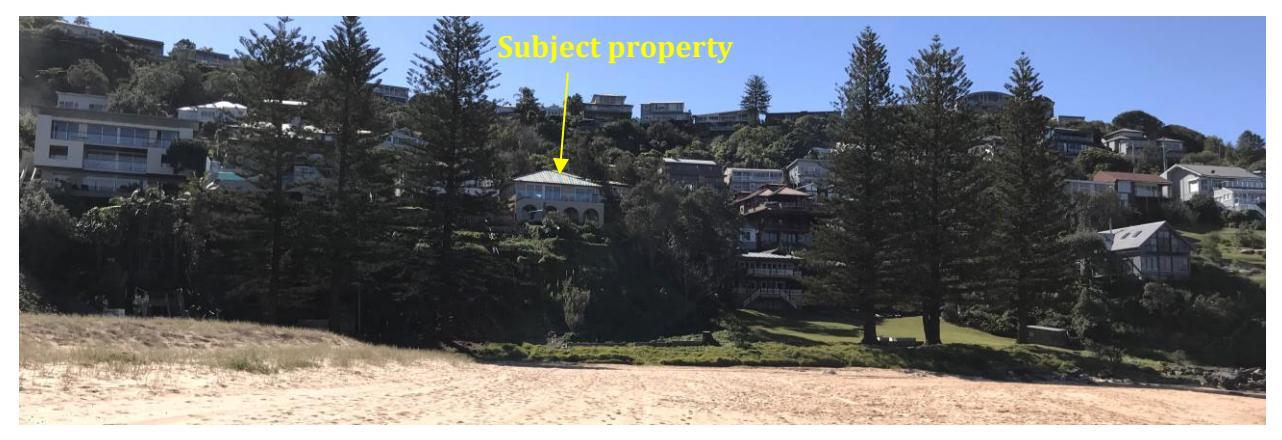
Figure 1: Broad view of subject property from Whale Beach on 7 August 2019, looking NNE

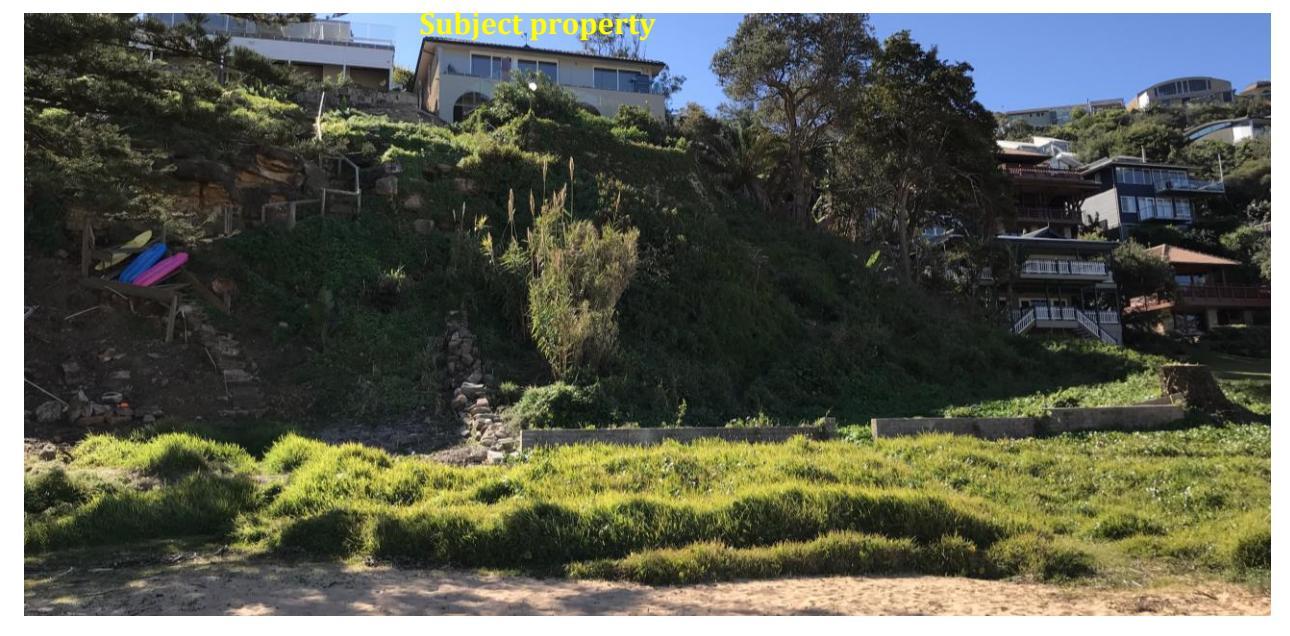
Figure 2: Close view of subject property from Whale Beach on 7 August 2019, looking north

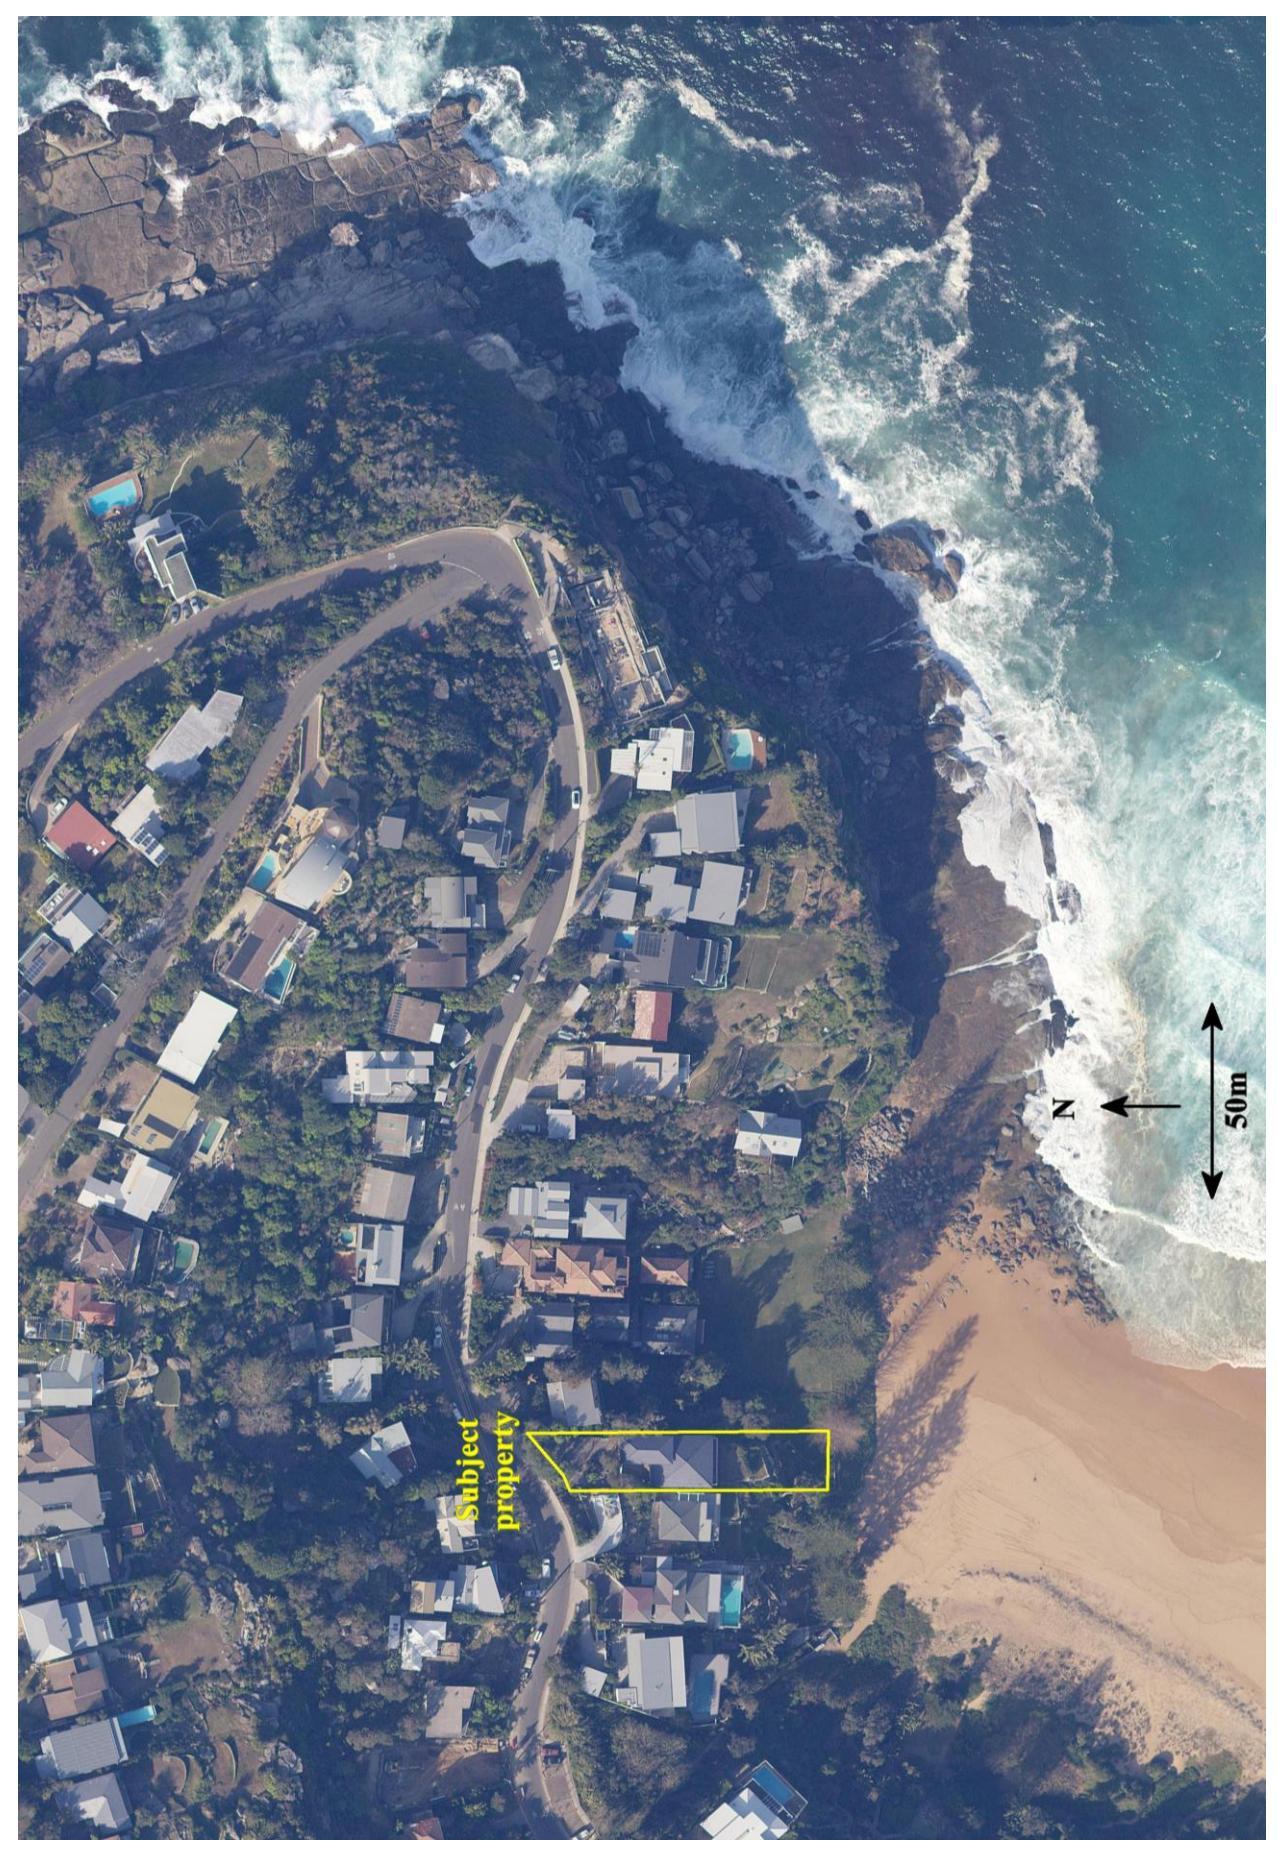
Figure 3: Aerial view of subject property on 30 August 2018

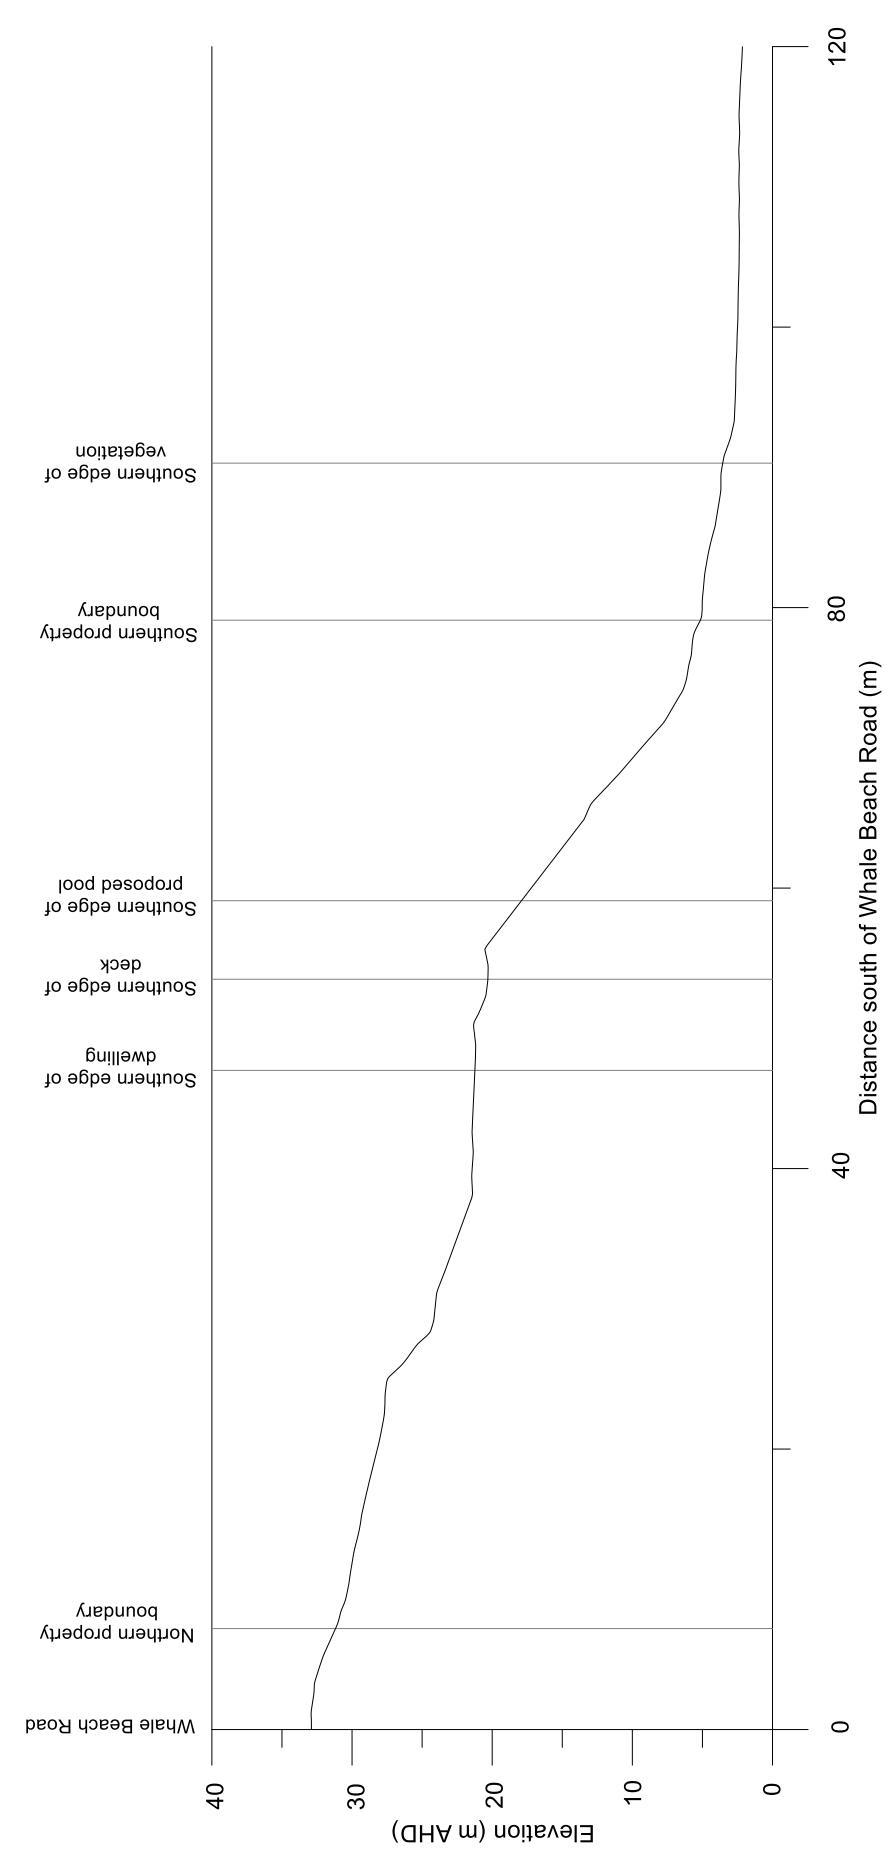
Figure 4: Cross-section through subject property
