Arboricultural Impact Statement Report

**130-132 Elanora Road
Elanora Heights
NSW 2101**

Prepared by Mark Bury Consulting

14th October 2019

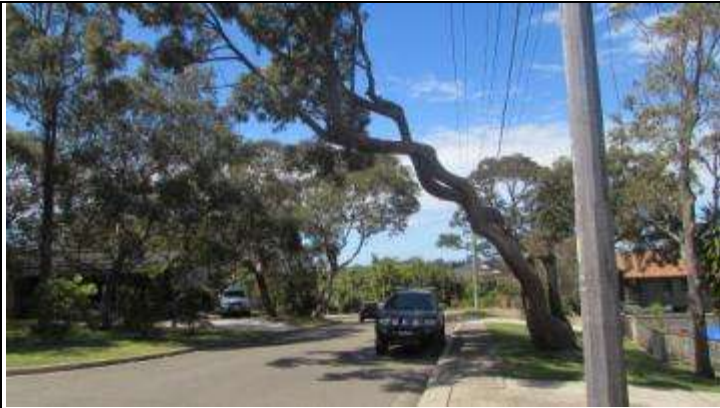
Tree 1
Eucalyptus microcorys
Tallowood

- 5.1 **Tree 1** (*Eucalyptus microcorys* Tallowood **Street Tree**) is a tree in poor condition Appendix 1 gives a description of the tree as per AS-4970-2009 Section 2. Appendix 4 gives the location of the tree on the property.

Tree Number	1
Species	<i>Eucalyptus microcorys</i> Street Tree
Common Name	Tallowood
Vigour	Low vigour- Reduced ability of a tree to sustain its life processors. This may be evident by the a typical growth of leaves, reduced crown cover and reduced crown density, branches, roots and trunk, and a deterioration of their function with reduced resistance to predation. This is independent of the condition of a tree but may impact upon it , and especially the ability of a tree to sustain itself against predation
Structure	Poor Condition- Tree is of good habit or misshapen, a form that may be severely restricted for space and light , exhibits symptoms of advanced and irreversible decline such as fungal or bacterial infestation, major dieback in the branch and Foilage crown , structural deterioration from insect damage . Deterioration physically often characterised by a gradual and continuous reduction on vigour but maybe I dependant of a change in vigour but characterised by a proportionate increase in susceptibility to and predation by pests and diseases against which the tree cannot be sustained. Such conditions may also be evident in trees of advanced senescence due to normal phenological processors, without modifications to the growing environment or physical damage having been inflicted upon the tree. This may be dependant from or contributed to by vigour

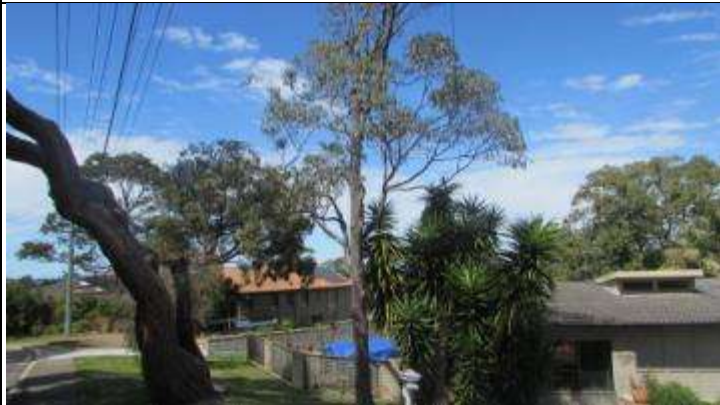
Tree 2
Angophora costata
Sydney Red Gum

- 5.4 **Tree 2** (*Angophora costata* Sydney Red Gum **Street Tree**) is a tree in poor condition Appendix 1 gives a description of the tree as per AS-4970-2009 Section 2. Appendix 4 gives the location of the tree on the property.

Tree Number	2
Species	<i>Angophora costata</i> Street Tree
Common Name	Sydney Red Gum
Vigour	Low vigour- Reduced ability of a tree to sustain its life processors. This may be evident by the a typical growth of leaves, reduced crown cover and reduced crown density, branches, roots and trunk, and a deterioration of their function with reduced resistance to predation. This is independent of the condition of a tree but may impact upon it , and especially the ability of a tree to sustain itself against predation
Structure	Poor Condition- Tree is of good habit or misshapen, a form that may be severely restricted for space and light , exhibits symptoms of advanced and irreversible decline such as fungal or bacterial infestation, major dieback in the branch and Foilage crown , structural deterioration from insect damage . Deterioration physically often characterised by a gradual and continuous reduction on vigour but maybe I dependant of a change in vigour but characterised by a proportionate increase in susceptibility to and predation by pests and diseases against which the tree cannot be sustained. Such conditions may also be evident in trees of advanced senescence due to normal phenological processors, without modifications to the growing environment or physical damage having been inflicted upon the tree. This may be dependant from or contributed to by vigour

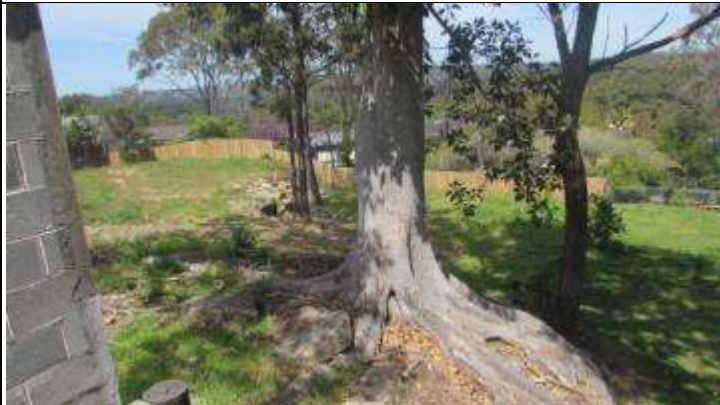
Tree 3
Ficus rubignosa
Port Jackson Fig

- 5.7 **Tree 3** (*Ficus rubiginosa* Port Jackson Fig) is a tree in fair condition Appendix 1 gives a description of the tree as per AS-4970-2009 Section 2. Appendix 4 gives the location of the tree on the property.

Tree Number	3
Species	<i>Ficus rubignosa</i>
Common Name	Port Jackson Fig Tree
Vigour	Normal Vigour- Ability of a tree to maintain and sustain its life processes. This may be evident by the typical growth of leaves, crown cover and crown density, branches, roots and trunk and resistance to predation. This is independent of the condition of a tree but may impact upon it , and especially the ability of a tree but may impact upon it , and especially the ability of a tree to sustain itself against predation
Structure	Fair Condition - tree is of good habit or misshapen, a form not severely restricted for space and light has some physical indication of decline due to the early effects of predation by pests and diseases, fungal, bacterial, or insect infestation, or has suffered physical injury to itself that may be contributing to instability or structural weaknesses, or its basic survival. Such a tree may recover with remedial works where appropriate, or without intervention may stabilise or improve over time where appropriate, or without intervention may stabilise or improve over time, or in response to the implementation of beneficial changes to its local environment. This may be independent from, or contributed to by vigour.

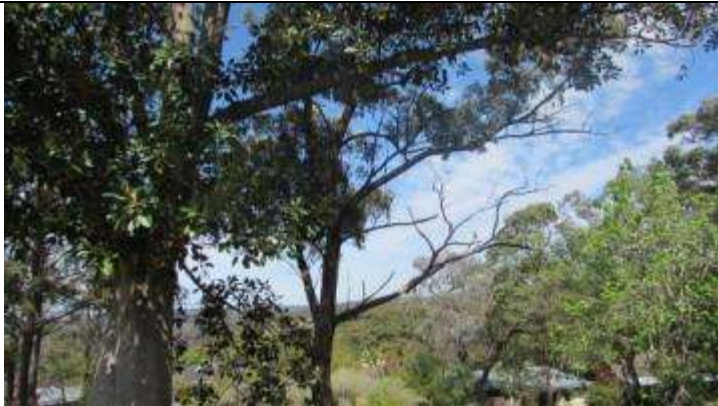
Tree 4
Eucalyptus microcorys
Tallowood

- 5.10 **Tree 4** (*Eucalyptus microcorys* Tallowood) is a tree in fair condition Appendix 1 gives a description of the tree as per AS-4970-2009 Section 2. Appendix 4 gives the location of the tree on the property.

Tree Number	4
Species	<i>Eucalyptus microcorys</i>
Common Name	Tallowood
Vigour	Normal Vigour- Ability of a tree to maintain and sustain its life processes. This may be evident by the typical growth of leaves, crown cover and crown density, branches, roots and trunk and resistance to predation. This is independent of the condition of a tree but may impact upon it , and especially the ability of a tree but may impact upon it , and especially the ability of a tree to sustain itself against predation
Structure	Fair Condition - tree is of good habit or misshapen, a form not severely restricted for space and light has some physical indication of decline due to the early effects of predation by pests and diseases, fungal, bacterial, or insect infestation, or has suffered physical injury to itself that may be contributing to instability or structural weaknesses, or its basic survival. Such a tree may recover with remedial works where appropriate, or without intervention may stabilise or improve over time where appropriate, or without intervention may stabilise or improve over time, or in response to the implementation of beneficial changes to its local environment. This may be independent from, or contributed to by vigour.

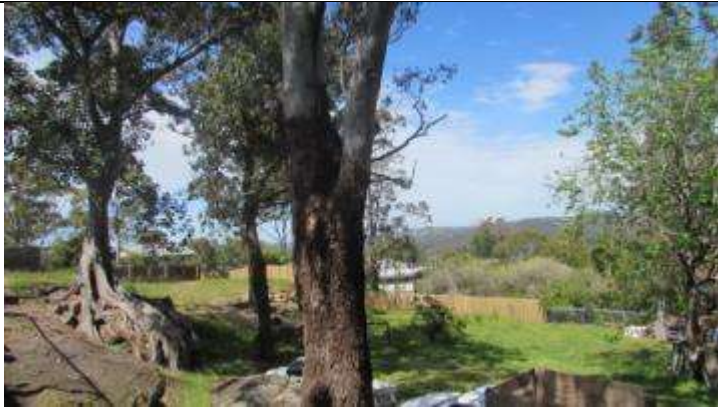
Tree 5
Eucalyptus saligna
Sydney Blue Gum

- 5.13 **Tree 5** (*Eucalyptus saligna* Sydney Blue Gum) is a tree in fair condition Appendix 1 gives a description of the tree as per AS-4970-2009 Section 2. Appendix 4 gives the location of the tree on the property.

Tree Number	5
Species	<i>Eucalyptus saligna</i>
Common Name	Sydney Blue Gum
Vigour	Normal Vigour- Ability of a tree to maintain and sustain its life processes. This may be evident by the typical growth of leaves, crown cover and crown density, branches, roots and trunk and resistance to predation. This is independent of the condition of a tree but may impact upon it , and especially the ability of a tree but may impact upon it , and especially the ability of a tree to sustain itself against predation
Structure	Fair Condition - tree is of good habit or misshapen, a form not severely restricted for space and light has some physical indication of decline due to the early effects of predation by pests and diseases, fungal, bacterial, or insect infestation, or has suffered physical injury to itself that may be contributing to instability or structural weaknesses, or its basic survival. Such a tree may recover with remedial works where appropriate, or without intervention may stabilise or improve over time where appropriate, or without intervention may stabilise or improve over time, or in response to the implementation of beneficial changes to its local environment. This may be independent from, or contributed to by vigour.

- 5.15 The tree should be replaced in the proposed landscape plan for the site.
- 5.16 **Tree 6** (*Eucalyptus microcorys* Tallowood) is a tree in fair condition Appendix 1 gives a description of the tree as per AS-4970-2009 Section 2. Appendix 4 gives the location of the tree on the property.

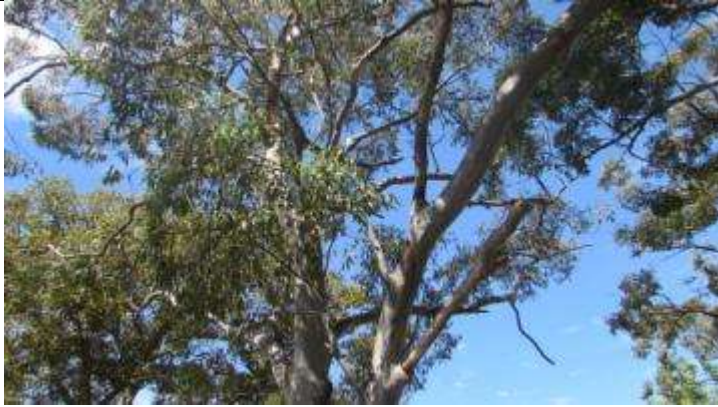
Tree 6
Eucalyptus microcorys
Tallowood

- 5.17 The tree will be affected by the proposed development (See Appendix 6 Construction Impact Statement). The trees soil and hydrological environments will be affected by the proposed development. Appropriate tree management in this situation would be the removal and replacement of the tree as per the aims of the Development Control plan for Northern Beaches Council in the landscape plan for the site with a suitable replacement species in better sited location

Tree Number	6
Species	<i>Eucalyptus microcorys</i>
Common Name	Tallowood
Vigour	Low vigour- Reduced ability of a tree to sustain its life processors. This may be evident by the a typical growth of leaves, reduced crown cover and reduced crown density, branches, roots and trunk, and a deterioration of their function with reduced resistance to predation. This is independent of the condition of a tree but may impact upon it , and especially the ability of a tree to sustain itself against predation
Structure	Poor Condition- Tree is of good habit or misshapen, a form that may be severely restricted for space and light , exhibits symptoms of advanced and irreversible decline such as fungal or bacterial infestation, major dieback in the branch and Foilage crown , structural deterioration from insect damage . Deterioration physically often characterised by a gradual and continuous reduction on vigour but maybe I dependant of a change in vigour but characterised by a proportionate increase in susceptibility to and predation by pests and diseases against which the tree cannot be sustained. Such conditions may also be evident in trees of advanced senescence due to normal phenological processors, without modifications to the growing environment or physical damage having been inflicted upon the tree. This may be dependant from or contributed to by vigour

- 5.18 The tree should be replaced in the proposed landscape plan for the site
- 5.19 If the tree is to be preserved it should be managed as per appendix 7 (Tree Protection Plan) and regular compliance inspections should be carried out to ensure trees root zone is not being impacted by the proposed works and trunk protection works have been carried out

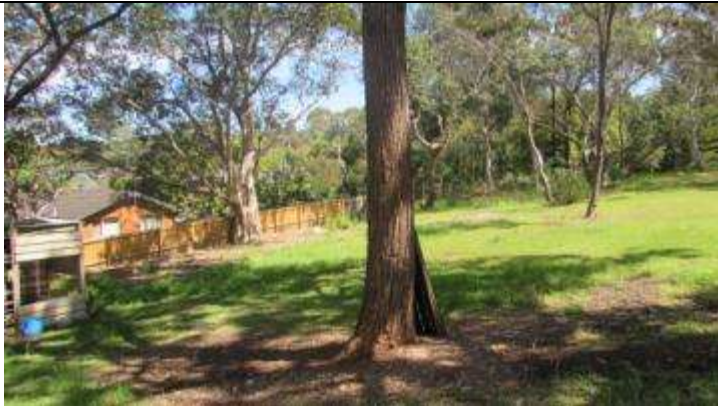
Tree 7
Eucalyptus microcorys
Tallowood

- 5.20 **Tree 7** (*Eucalyptus microcorys* Tallowood) is a tree in fair condition Appendix 1 gives a description of the tree as per AS-4970-2009 Section 2. Appendix 4 gives the location of the tree on the property.

- 5.21 The tree will be affected by the proposed development (See Appendix 6 Construction Impact Statement). The trees soil and hydrological environments will be affected by the proposed development. Appropriate tree management in this situation would be the removal and replacement of the tree as per the aims of the Development Control plan for Northern Beaches Council in the landscape plan for the site with a suitable replacement species in better sited

Tree Number	7
Species	<i>Eucalyptus microcorys</i>
Common Name	Tallowood
Vigour	Low vigour- Reduced ability of a tree to sustain its life processors. This may be evident by the a typical growth of leaves, reduced crown cover and reduced crown density, branches, roots and trunk, and a deterioration of their function with reduced resistance to predation. This is independent of the condition of a tree but may impact upon it , and especially the ability of a tree to sustain itself against predation
Structure	Poor Condition- Tree is of good habit or misshapen, a form that may be severely restricted for space and light , exhibits symptoms of advanced and irreversible decline such as fungal or bacterial infestation, major dieback in the branch and Foilage crown , structural deterioration from insect damage . Deterioration physically often characterised by a gradual and continuous reduction on vigour but maybe I dependant of a change in vigour but characterised by a proportionate increase in susceptibility to and predation by pests and diseases against which the tree cannot be sustained. Such conditions may also be evident in trees of advanced senescence due to normal phenological processors, without modifications to the growing environment or physical damage having been inflicted upon the tree. This may be dependant from or contributed to by vigour

- 5.22 The tree should be replaced in the proposed landscape plan for the site
- 5.23 If the tree is to be preserved it should be managed as per appendix 7 (Tree Protection Plan) and regular compliance inspections should be carried out to ensure trees root zone is not being impacted by the proposed works and trunk protection works have been carried out

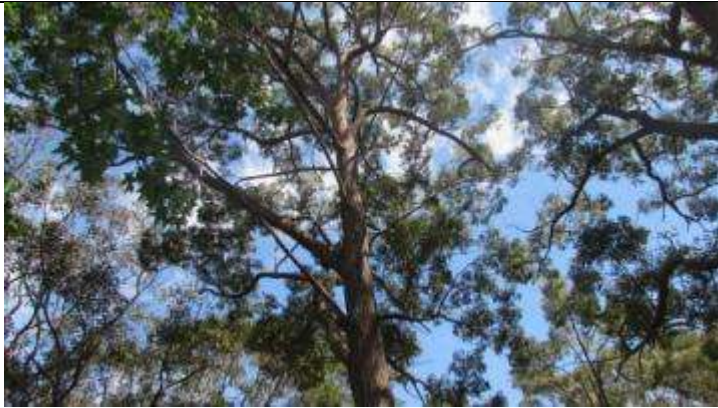
Tree 8
Eucalyptus microcorys
Tallowood

- 5.24 **Tree 8** (*Eucalyptus microcorys* Tallowood) is a tree in fair condition Appendix 1 gives a description of the tree as per AS-4970-2009 Section 2. Appendix 4 gives the location of the tree on the property.

- 5.25 The tree will be affected by the proposed development (See Appendix 6 Construction Impact Statement). The trees soil and hydrological environments will be affected by the proposed development. Appropriate tree management in this situation would be the removal and replacement of the tree as per the aims of the Development Control plan for Northern Beaches in the landscape plan for the site with a suitable replacement species in better sited location

Tree Number	8
Species	<i>Eucalyptus microcorys</i>
Common Name	Tallowood
Vigour	Low vigour- Reduced ability of a tree to sustain its life processors. This may be evident by the a typical growth of leaves, reduced crown cover and reduced crown density, branches, roots and trunk, and a deterioration of their function with reduced resistance to predation. This is independent of the condition of a tree but may impact upon it , and especially the ability of a tree to sustain itself against predation
Structure	Poor Condition- Tree is of good habit or misshapen, a form that may be severely restricted for space and light , exhibits symptoms of advanced and irreversible decline such as fungal or bacterial infestation, major dieback in the branch and Foilage crown , structural deterioration from insect damage . Deterioration physically often characterised by a gradual and continuous reduction on vigour but maybe I dependant of a change in vigour but characterised by a proportionate increase in susceptibility to and predation by pests and diseases against which the tree cannot be sustained. Such conditions may also be evident in trees of advanced senescence due to normal phenological processors, without modifications to the growing environment or physical damage having been inflicted upon the tree. This may be dependant from or contributed to by vigour

- 5.26 The tree should be replaced in the proposed landscape plan for the site
- 5.27 If the tree is to be preserved it should be managed as per appendix 7 (Tree Protection Plan) and regular compliance inspections should be carried out to ensure trees root zone is not being impacted by the proposed works and trunk protection works have been carried out.

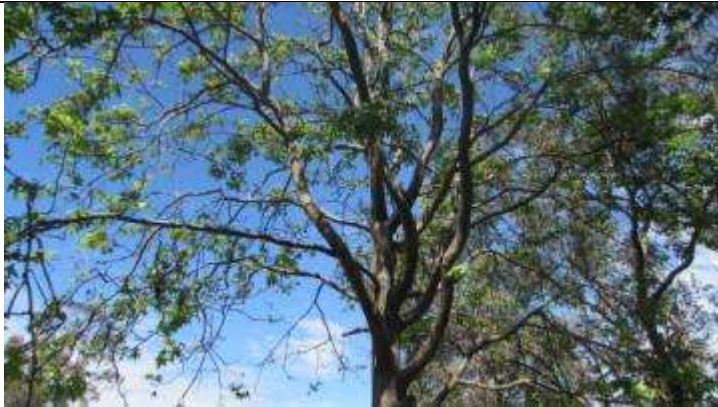
Tree 9
Liquidambar styraciflua
Liquidamber

- 5.28 **Tree 9** (*Liquidambar styraciflua* Liquidamber) is a tree in fair condition Appendix 1 gives a description of the tree as per AS-4970-2009 Section 2. Appendix 4 gives the location of the tree on the property.

Tree Number	9
Species	<i>Liquidamber styraciflua</i>
Common Name	Liquidambar
Vigour	Low vigour- Reduced ability of a tree to sustain its life processors. This may be evident by the a typical growth of leaves, reduced crown cover and reduced crown density, branches, roots and trunk, and a deterioration of their function with reduced resistance to predation. This is independent of the condition of a tree but may impact upon it , and especially the ability of a tree to sustain itself against predation
Structure	Poor Condition- Tree is of good habit or misshapen, a form that may be severely restricted for space and light , exhibits symptoms of advanced and irreversible decline such as fungal or bacterial infestation, major dieback in the branch and Foilage crown , structural deterioration from insect damage . Deterioration physically often characterised by a gradual and continuous reduction on vigour but maybe I dependant of a change in vigour but characterised by a proportionate increase in susceptibility to and predation by pests and diseases against which the tree cannot be sustained. Such conditions may also be evident in trees of advanced senescence due to normal phenological processors, without modifications to the growing environment or physical damage having been inflicted upon the tree. This may be dependant from or contributed to by vigour

- 5.29 The tree should be replaced in the proposed landscape plan for the site
- 5.30 If the tree is to be preserved it should be managed as per appendix 7 (Tree Protection Plan) and regular compliance inspections should be carried out to ensure trees root zone is not being impacted by the proposed works and trunk protection works have been carried out

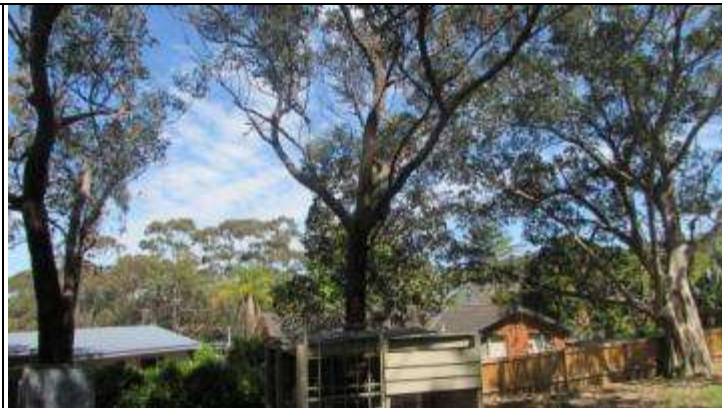
Tree 10
Eucalyptus microcorys
Tallowood

- 5.32 **Tree 10** (*Eucalyptus microcorys* Tallowood) is a tree in fair condition Appendix 1 gives a description of the tree as per AS-4970-2009 Section 2. Appendix 4 gives the location of the tree on the property.

- 5.33 The tree will be affected by the proposed development (See Appendix 6 Construction Impact Statement). The trees soil and hydrological environments will be affected by the proposed development. Appropriate tree management in this situation would be the removal and replacement of the tree as per the aims

of the Development Control plan for Northern Beaches Council in the landscape plan for the site with a suitable replacement species in better sited location

Tree Number	10
Species	<i>Eucalyptus microcorys</i>
Common Name	Tallowood
Vigour	Low vigour- Reduced ability of a tree to sustain its life processors. This may be evident by the a typical growth of leaves, reduced crown cover and reduced crown density, branches, roots and trunk, and a deterioration of their function with reduced resistance to predation. This is independent of the condition of a tree but may impact upon it , and especially the ability of a tree to sustain itself against predation
Structure	Poor Condition- Tree is of good habit or misshapen, a form that may be severely restricted for space and light , exhibits symptoms of advanced and irreversible decline such as fungal or bacterial infestation, major dieback in the branch and Foliage crown , structural deterioration from insect damage . Deterioration physically often characterised by a gradual and continuous reduction on vigour but maybe I dependant of a change in vigour but characterised by a proportionate increase in susceptibility to and predation by pests and diseases against which the tree cannot be sustained. Such conditions may also be evident in trees of advanced senescence due to normal phenological processors, without modifications to the growing environment or physical damage having been inflicted upon the tree. This may be dependant from or contributed to by vigour

- 5.34 The tree should be replaced in the proposed landscape plan for the site
- 5.35 If the tree is to be preserved it should be managed as per appendix 7 (Tree Protection Plan) and regular compliance inspections should be carried out to ensure trees root zone is not being impacted by the proposed works and trunk protection works have been carried out.

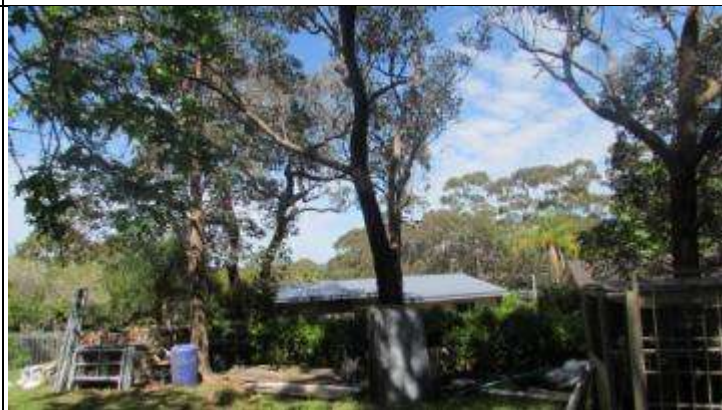
Tree 11
Corimbya gummifera
Red Bloodwood

- 5.36 **Tree 11** (*Corimbya gummifera* Red Bloodwood) is a tree in fair condition Appendix 1 gives a description of the tree as per AS-4970-2009 Section 2. Appendix 4 gives the location of the tree on the property.

Tree Number	11
Species	<i>Corimbya gummifera</i>
Common Name	Red Bloodwood
Vigour	Normal Vigour- Ability of a tree to maintain and sustain its life processes. This may be evident by the typical growth of leaves, crown cover and crown density, branches, roots and trunk and resistance to predation. This is independent of the condition of a tree but may impact upon it , and especially the ability of a tree but may impact upon it , and especially the ability of a tree to sustain itself against predation
Structure	Fair Condition - tree is of good habit or misshapen, a form not severely restricted for space and light has some physical indication of decline due to the early effects of predation by pests and diseases, fungal, bacterial, or insect infestation, or has suffered physical injury to itself that may be contributing to instability or structural weaknesses, or its basic survival. Such a tree may recover with remedial works where appropriate, or without intervention may stabilise or improve over time where appropriate, or without intervention may stabilise or improve over time, or in response to the implementation of beneficial changes to its local environment. This may be independent from, or contributed to by vigour.

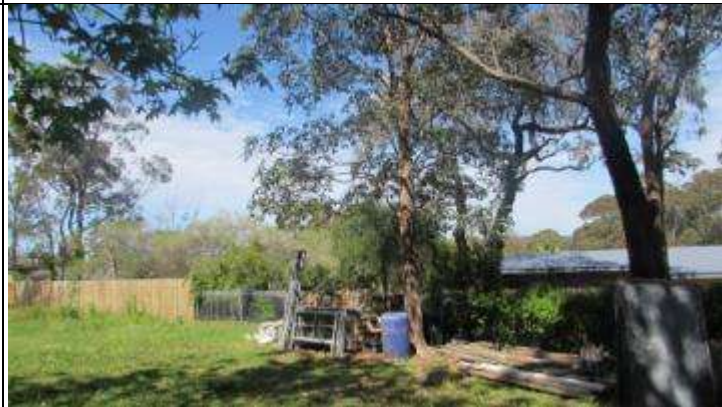
Tree 12
Lophostemon confertus
Brushbox

- 5.39 **Tree 12** (*Lophostemon confertus* Brushbox) is a tree in fair condition Appendix 1 gives a description of the tree as per AS-4970-2009 Section 2. Appendix 4 gives the location of the tree on the property.

Tree Number	12
Species	<i>Lophostemon confertus</i>
Common Name	Brush Box
Vigour	Normal Vigour- Ability of a tree to maintain and sustain its life processes. This may be evident by the typical growth of leaves, crown cover and crown density, branches, roots and trunk and resistance to predation. This is independent of the condition of a tree but may impact upon it , and especially the ability of a tree but may impact upon it , and especially the ability of a tree to sustain itself against predation
Structure	Fair Condition - tree is of good habit or misshapen, a form not severely restricted for space and light has some physical indication of decline due to the early effects of predation by pests and diseases, fungal, bacterial, or insect infestation, or has suffered physical injury to itself that may be contributing to instability or structural weaknesses, or its basic survival. Such a tree may recover with remedial works where appropriate, or without intervention may stabilise or improve over time where appropriate, or without intervention may stabilise or improve over time, or in response to the implementation of beneficial changes to its local environment. This may be independent from, or contributed to by vigour.

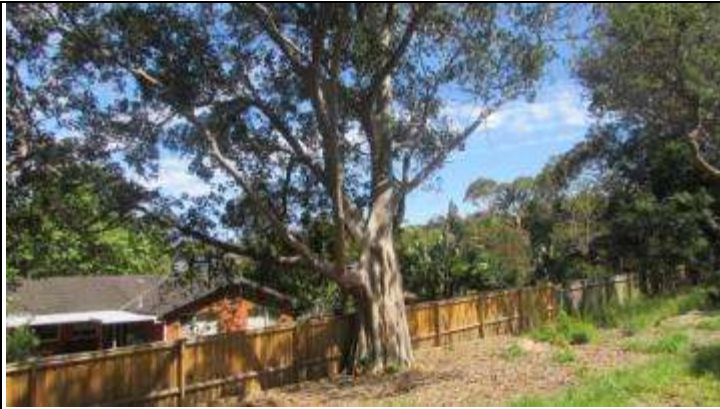
Tree 13
Ficus rubignosa
Port Jackson Fig

- 5.42 **Tree 13** (*Ficus rubiginosa* Port Jackson Fig) is a tree in fair condition Appendix 1 gives a description of the tree as per AS-4970-2009 Section 2. Appendix 4 gives the location of the tree on the property.

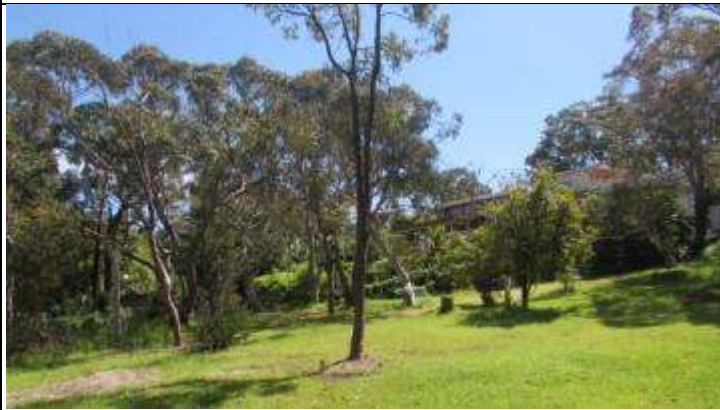
Tree 14
Eucalyptus paniculata
Grey Ironbark

- 5.45 **Tree 14** (*Eucalyptus paniculata* Grey Ironbark) is a tree in fair condition Appendix 1 gives a description of the tree as per AS-4970-2009 Section 2. Appendix 4 gives the location of the tree on the property.

- 5.46 The tree will be affected by the proposed development (See Appendix 6 Construction Impact Statement). The trees soil and hydrological environments will be affected by the proposed development. Appropriate tree management in this situation would be the removal and replacement of the tree as per the aims of the Development Control plan for Northern Beaches in the landscape plan for the site with a suitable replacement species in better sited location

- 5.47 The tree should be replaced in the proposed landscape plan for the site
- 5.48 If the tree is to be preserved it should be managed as per appendix 7 (Tree Protection Plan) and regular compliance inspections should be carried out to ensure trees root zone is not being impacted by the proposed works and trunk protection works have been carried out

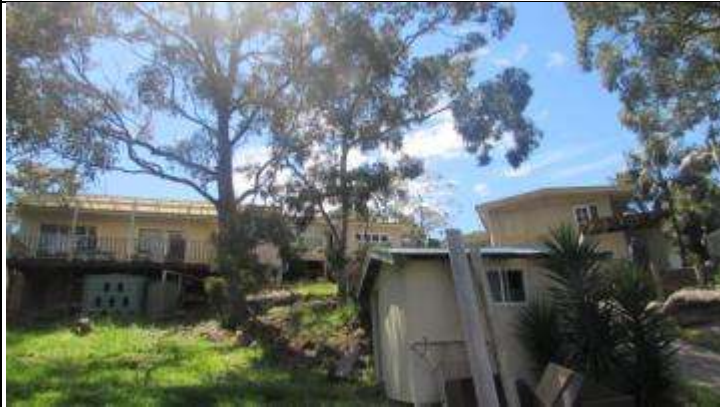
Tree 15
Angophora costata
Sydney Red Gum

- 5.49 **Tree 15** (*Angophora costata* Sydney Red Gum) is a tree in fair condition Appendix 1 gives a description of the tree as per AS-4970-2009 Section 2. Appendix 4 gives the location of the tree on the property.

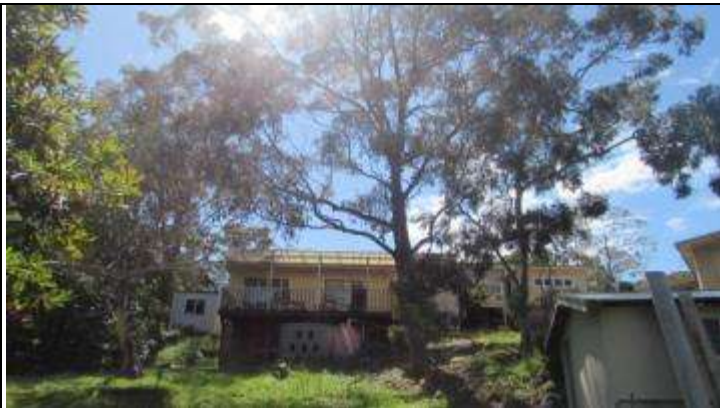
Tree 16
Angophora costata
Sydney Red Gum

- 5.52 **Tree 16** (*Angophora costata* Sydney Red Gum) is a tree in fair condition Appendix 1 gives a description of the tree as per AS-4970-2009 Section 2. Appendix 4 gives the location of the tree on the property.

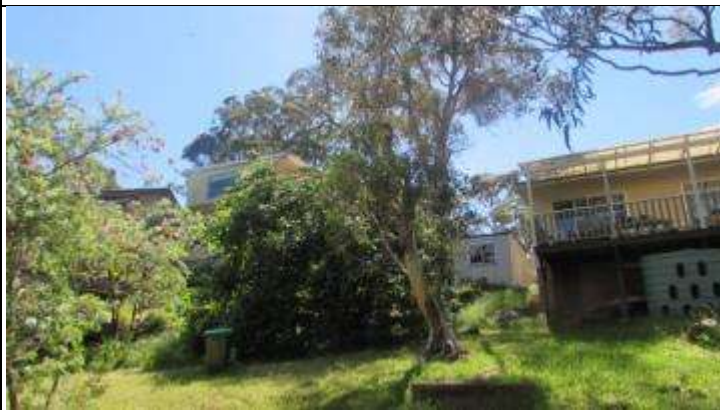
Tree 17
Eucalyptus haemastoma
Scribbly Gum

- 5.55 **Tree 17** (*Eucalyptus haemastoma* Scribbly Gum) is a tree in poor condition (Dead/Dying) Appendix 1 gives a description of the tree as per AS-4970-2009 Section 2. Appendix 4 gives the location of the tree on the property.

- 5.56 The tree will not be affected by the proposed development (See Appendix 6 Construction Impact Statement). The trees soil and hydrological environments will not be affected by the proposed development. Appropriate tree management in this situation would be the preservation of the tree for development, for its removal because of its poor condition a separate application under Northern Beaches Council Tree Preservation Order would be required.

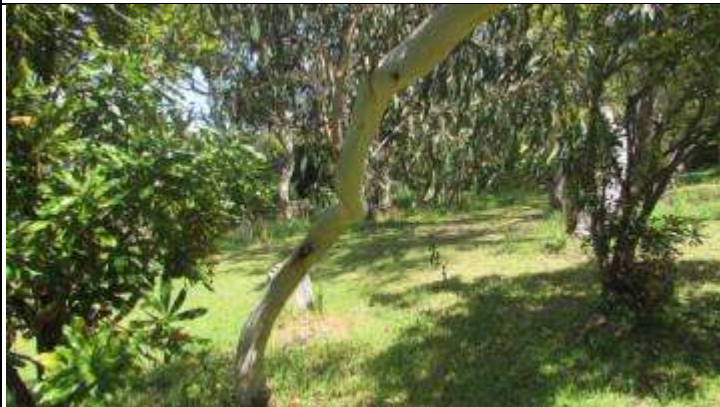
Tree 18
Eucalyptus haemastoma
Scribbly Gum

- 5.58 **Tree 18** *Eucalyptus haemastoma* Scribbly Gum) is a tree in poor condition (Dead/Dying) Appendix 1 gives a description of the tree as per AS-4970-2009 Section 2. Appendix 4 gives the location of the tree on the property.

- 5.59 The tree will not be affected by the proposed development (See Appendix 6 Construction Impact Statement). The trees soil and hydrological environments will not be affected by the proposed development. Appropriate tree management in this situation would be the preservation of the tree for development, for its removal because of its poor condition a separate application under Northern Beaches Council Tree Preservation Order would be required.

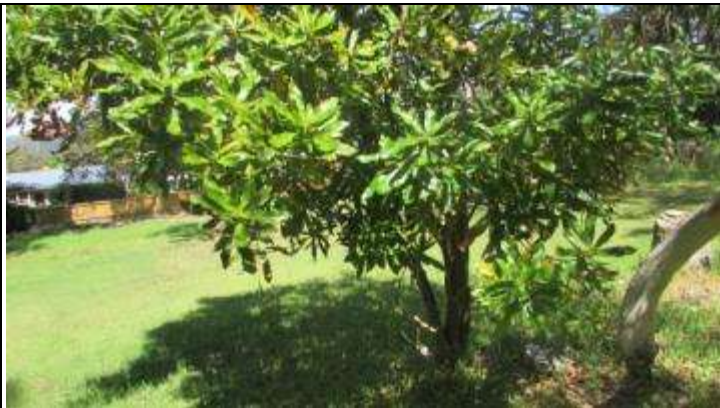
Tree 19
Macadamia integrifolia
Macadamia Nut Tree

- 5.61 **Tree 19** (*Macadamia integrifolia* Macadamia) is a tree in fair condition Appendix 1 gives a description of the tree as per AS-4970-2009 Section 2. Appendix 4 gives the location of the tree on the property.

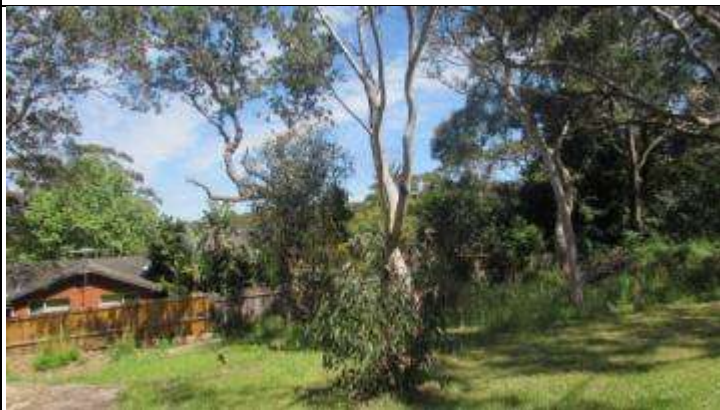
Tree 20
Eucalyptus haemastoma
Scribbly Gum

- 5.64 **Tree 20** (*Eucalyptus haemastoma* Scribbly Gum) is a tree in poor condition (Dead/Dying) Appendix 1 gives a description of the tree as per AS-4970-2009 Section 2. Appendix 4 gives the location of the tree on the property.

will not be affected by the proposed development. Appropriate tree management in this situation would be the preservation of the tree for development, for its removal because of its poor condition a separate application under Northern Beaches Council Tree Preservation Order would be required.

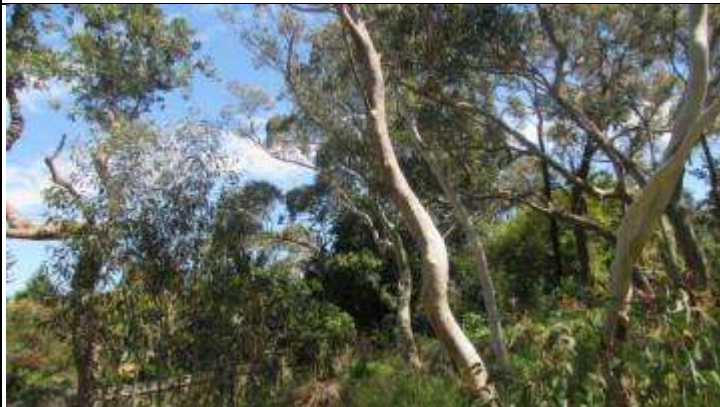
Tree 21
Eucalyptus haemastoma
Scribbly Gum

- 5.67 **Tree 21** (*Eucalyptus haemastoma* Scribbly Gum) is a tree in poor condition (Dead/Dying) Appendix 1 gives a description of the tree as per AS-4970-2009 Section 2. Appendix 4 gives the location of the tree on the property.

- 5.68 The tree will not be affected by the proposed development (See Appendix 6 Construction Impact Statement). The trees soil and hydrological environments will not be affected by the proposed development. Appropriate tree management in this situation would be the preservation of the tree for development, for its removal because of its poor condition a separate application under Northern Beaches Council Tree Preservation Order would be required.

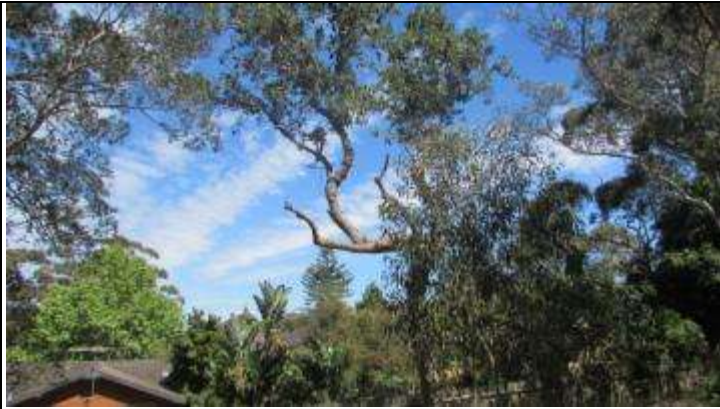
Tree 22
Banksia serrata
Old Man Banksia

- 5.70 **Tree 22** (*Banksia serrata* Old Man Banksia) is a tree in fair condition Appendix 1 gives a description of the tree as per AS-4970-2009 Section 2. Appendix 4 gives the location of the tree on the property.

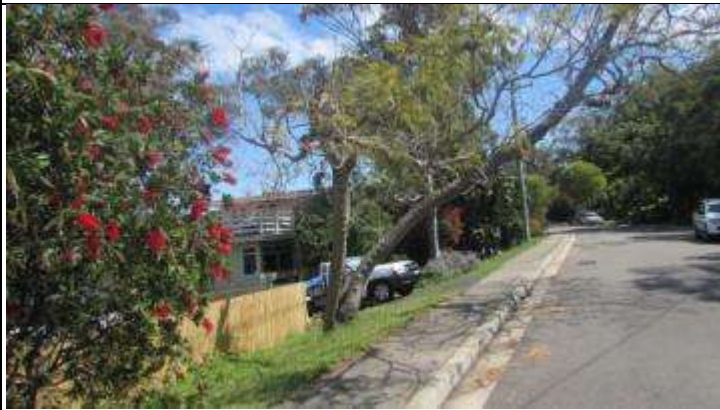
Tree 23
Jacaranda mimosifolia
Jacaranda

- 5.73 **Tree 23** (*Jacaranda mimosifolia* Jacaranda) is a tree in fair condition Appendix 1 gives a description of the tree as per AS-4970-2009 Section 2. Appendix 4 gives the location of the tree on the property.
