Construction Impact & Management Statement for soon to be Lodged Development Application

September 2019

Site:	Lot 3 in DP 116				
	15A Mons Avenue				
	NORTH BALGOWLAH, NSW				
Client:	Marcus & Nora Waugh				
	c/- Jamie King				
	84 Palmgrove Road				
125	AVALON BEACH, NSW				
	Phone: 61 421 517 991				
Parkers	Email: Jamie@jamieking.com.au				
Author:	Kyle A Hill				
	Registered (Arb Aus #1884) Practising & Consulting Arboris				
	Post Graduate Certificate in Arboriculture, Uni of Melb				
	Diploma of Horticulture-Arboriculture TAFE, Grow SA				
	Certificate of Horticulture, TAFE				
	Certificate Advanced Tree Care TAFE				
	Founder -Growing My Way Tree Services (1977)				
	Member of International Society of Arboriculture				
	Member of Arboriculture Australia

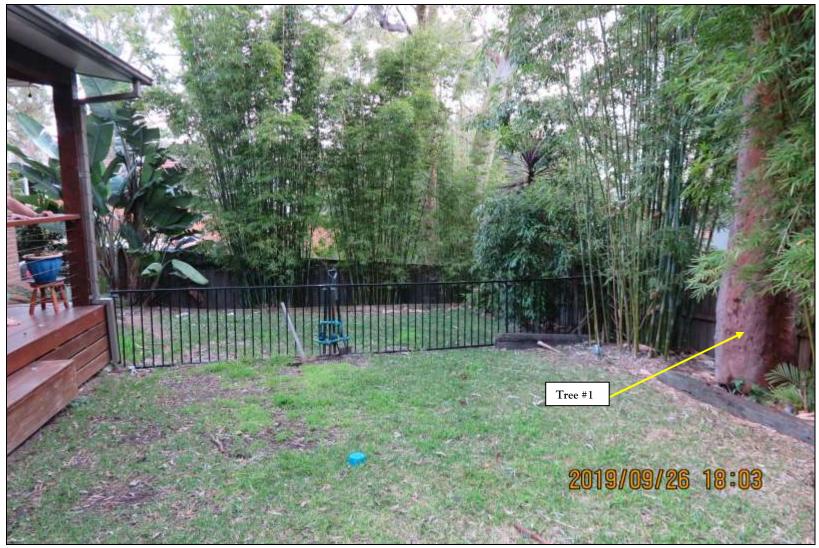
Figure 3: Illustrates location of the discussed Tree #1.

<u>Tree #1</u> has a TPZ total surface area of approximately $152.18m^2$. The maximum impacted upon TPZ surface area is approximately $17.00 m^2 (11.2\%)$. Depending on the determined approval & taking into account excavation can be reduced by 'cantilevering' the swimming pool surrounds edges closest to the tree trunk centre the breach can be reduced to the lower end of a 'Major Encroachment'. This would equate to a breach of total TPZ surface of less than $17.00m^2$. (These numbers are conditional upon the existing ground levels with the TPZ radial distance not being changed in any manner.)

On the basis the proposed inground swimming pool & surrounds are on the downhill side of the tree trunk, gravitational & hydroscopic water within the soil is less impacted upon than if the proposal was uphill of the tree trunk.

Tree #1 will be specified to have a 'Tree Trunk Guard' installed around its trunk to a minimum height od 2.50m so as to isolate the tree trunk from any excavation equipment. Additionally, 'rumble boards', (TrakMats[®] or similar) are specified to be placed on the ground that is within the tree's TPZ radial distance of 6.96m. Once the excavation process has been completed the 'rumble boards' are to be replaced with a 'native mulch' within the TPZ radial distance. The 'native mulch' is to be maintained at a thickness of between 50 & 100mm for the duration of the pool construction phases.

No builders' materials of any description (including soil stockpiled for backfilling) can be stored within the Tree #1 TPZ radial distance of 6.96m.

• Protected Tree #1 is to be Retained, Managed & Protected.

For Australian Standard (AS4970–2009 Protection of trees on development sites) compliance an 'exclusion zone' is to be created by installation of a 'Tree Trunk Guard' & 'Rumble Boards' (TrakMats[®] or similar) within the TPZ radial distance of 6.96m.

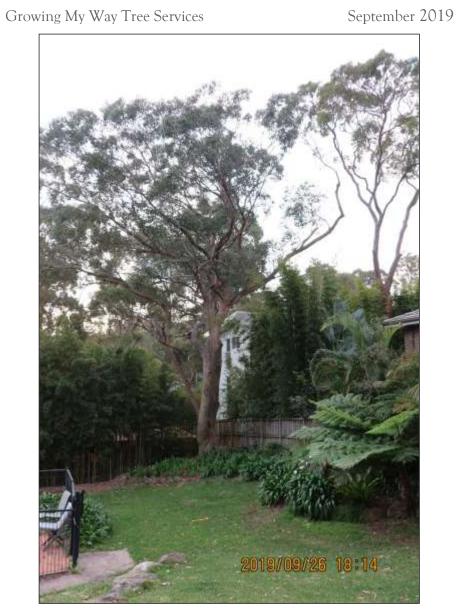
Figure 4: Illustrates the location of the discussed Tree #2.

<u>Tree #2</u> has a TPZ total surface area of approximately $461.48m^2$. The maximum impacted upon TPZ total surface area is approximately $35.00m^2$ (7.8%). Depending on the determined approval & taking into account excavation required will be reduced by 'cantilevering' the swimming pool surrounds edges closest to the tree trunk centre the breach can be defined a 'Minor Encroachment'. This would equate to a breach of total

TPZ surface of less than 35.00m². (These numbers are conditional upon the existing ground levels with the TPZ radial distance not being changed in any manner.)

Considering the proposed inground swimming pool & surrounds are partially on the uphill side of the tree trunk, gravitational & hydroscopic water within the soil is not considered to be majorly impacted upon as the slope of the ground within the property where the tree is located slopes from the front of the site downhill to where the tree is located. Simply, this reduces any concern relative to gravitational & hydroscopic water within the proposal was totally uphill of the tree trunk.

Tree #2 is very efficiently isolated from the proposed works by the common boundary fence. As such, only the installation of a 'native mulch' within the subject site between the common boundary fence & the line of excavation is specified as a measure to protect/preserve any 'live tree roots' from Tree #2 within the subject site. The 'native mulch' is to be maintained at a thickness of between 50 & 100mm for the duration of the pool construction phases.

• Protected Tree #2 is to be Retained, Managed & Protected.

For Australian Standard (AS4970–2009 Protection of trees on development sites) compliance an 'exclusion zone' already exists by virtue of the common boundary dividing fence

A 'native mulch', installed & maintained to a thickness of between 50mm & 75mm is specified to be instated within the subject site & the required line of excavation. This must be instated prior to the commencement of works & maintained throughout the inground swimming pool & surrounds construction phases. (See Appendix C.)

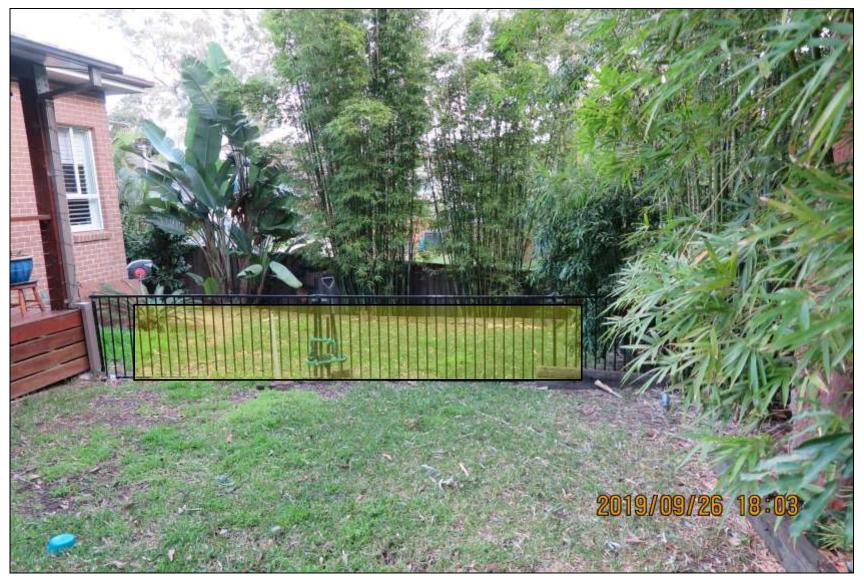
Figure 5: Yellow area is proposed inground swimming pool location.
