# ARBORICULTURAL IMPACT ASSESSMENT REPORT

relating to the proposed inclinor at

**106 PRINCE ALFRED PARADE  
NEWPORT NSW 2106**

22 November 2023  
Revision A

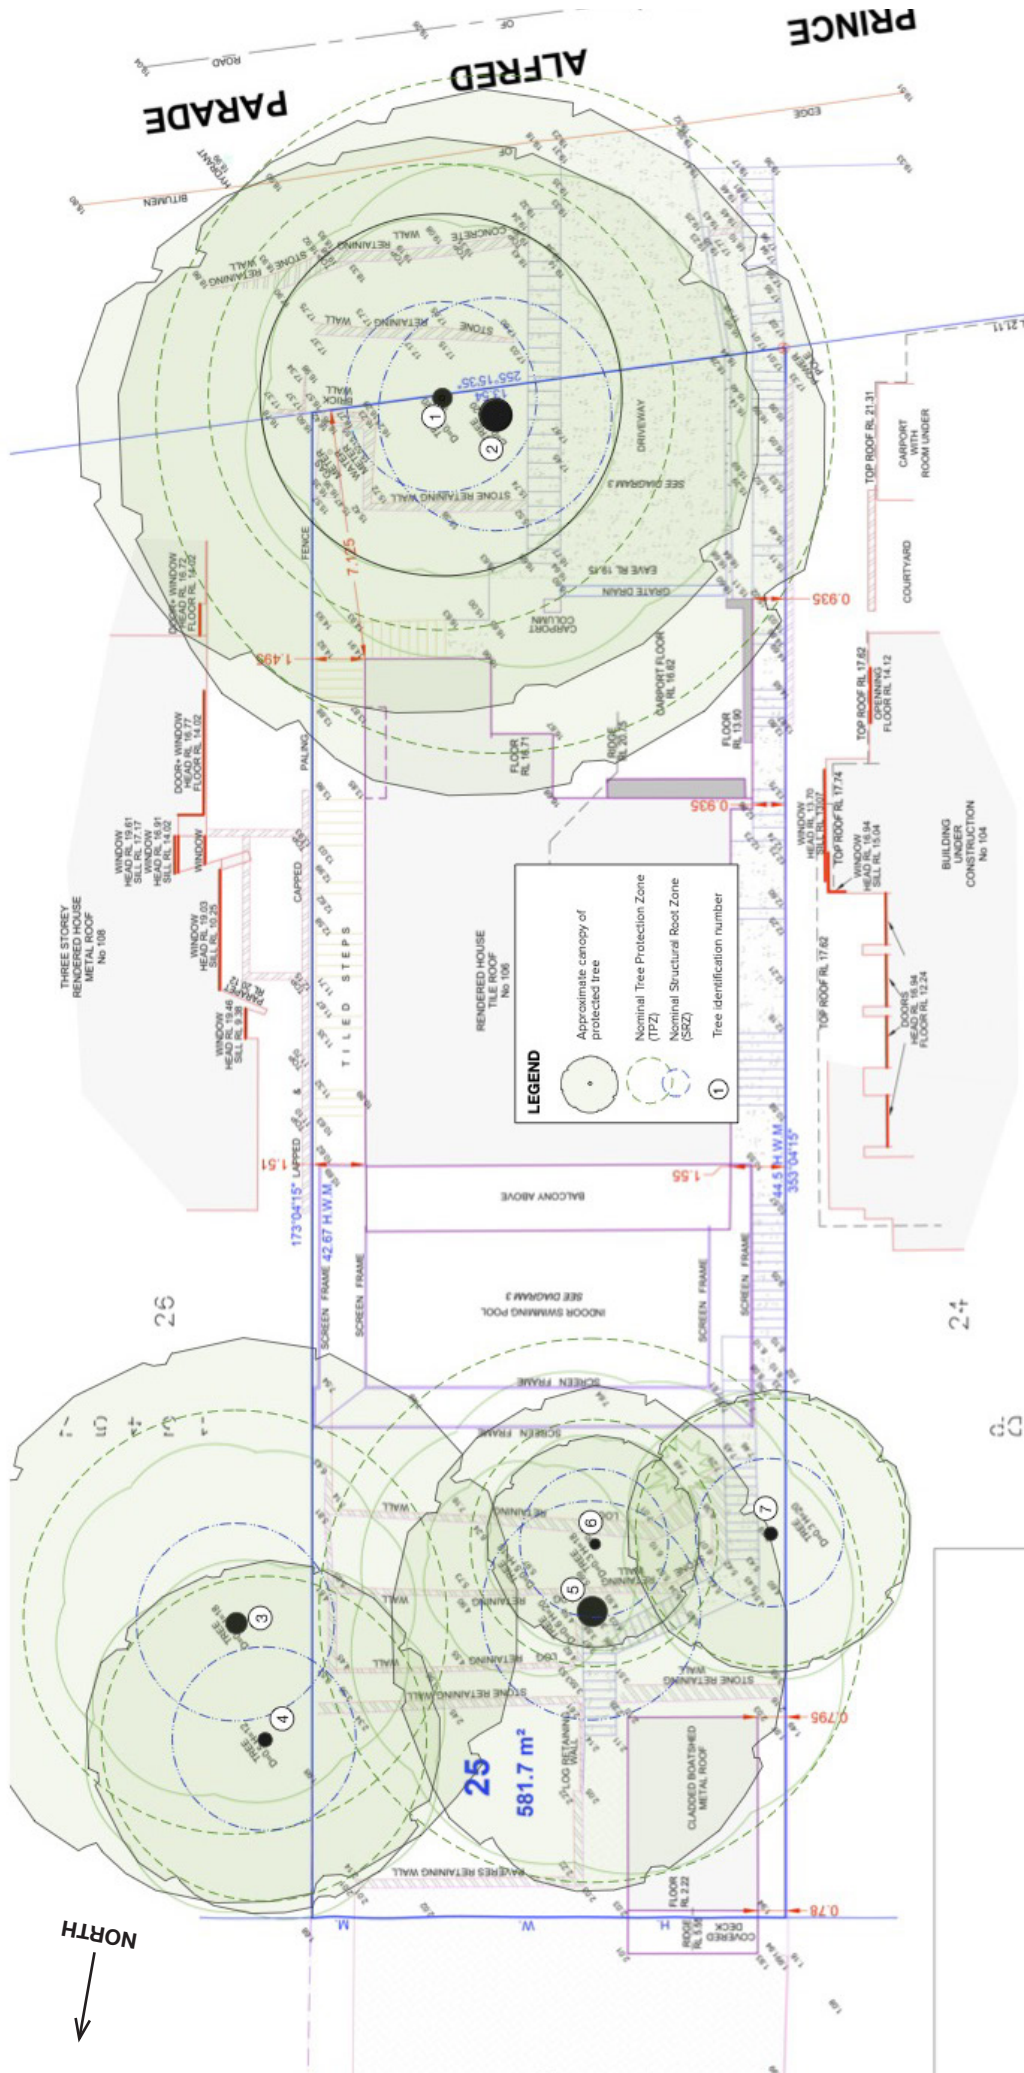
Figure 3: Tree Location Plan showing the existing trees located on the site using the survey plan as a base layer. Note, do not measure from drawings.

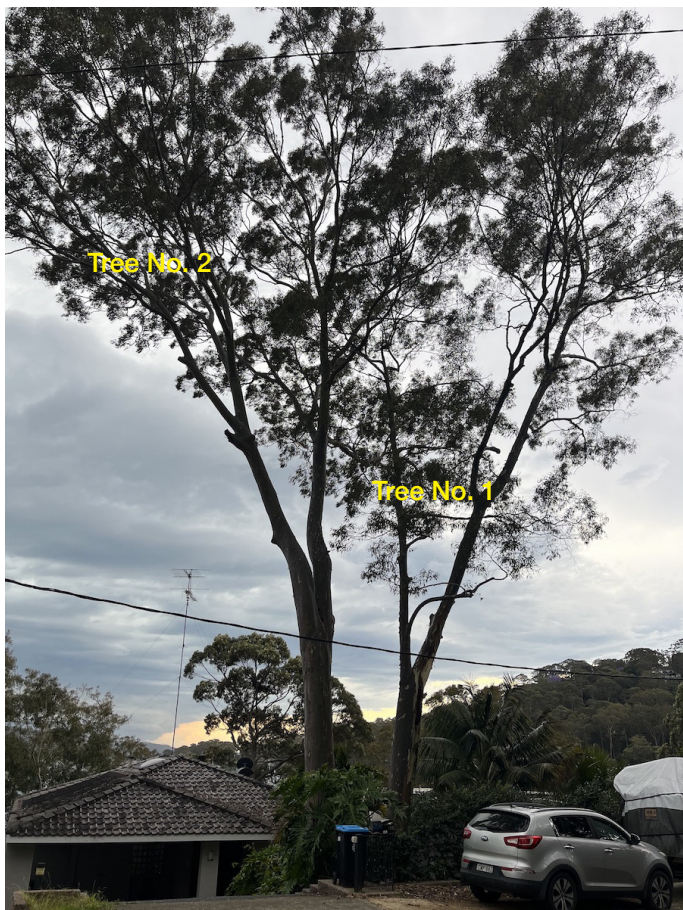
Figure 4 (above): Photograph viewing north to Tree No. 1 & No. 2 (Spotted Gum) from Prince Alfred Parade. (Photo: J Willis)

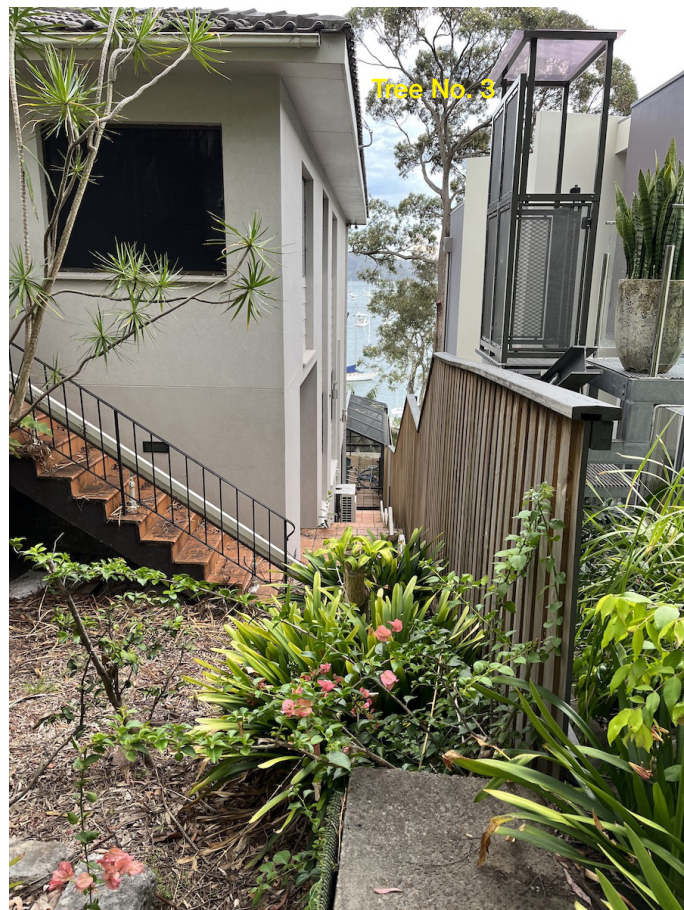
Figure 5 (above): Photograph viewing north along the eastern boundary from the front of the site. The neighbouring Tree No. 3 (Grey Ironbark) is visible in the background. (Photo: J Willis)

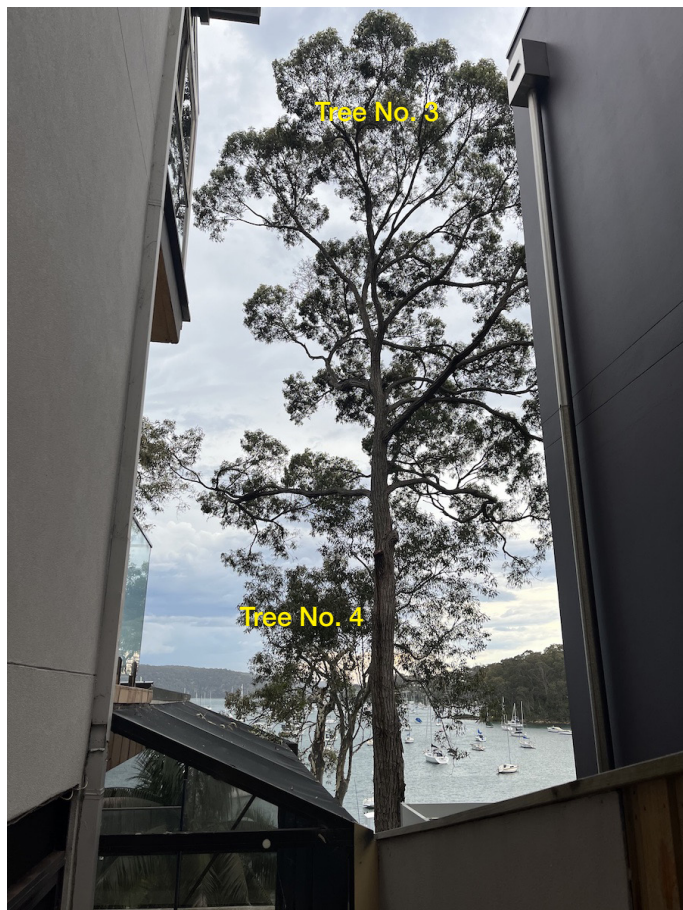
Figure 6 (left): Photograph viewing east to Tree No. 3 (Grey Ironbark) and No. 4 (Spotted Gum) located on the neighbouring site at No. 108 Prince Alfred Parade. (Photo: J Willis)

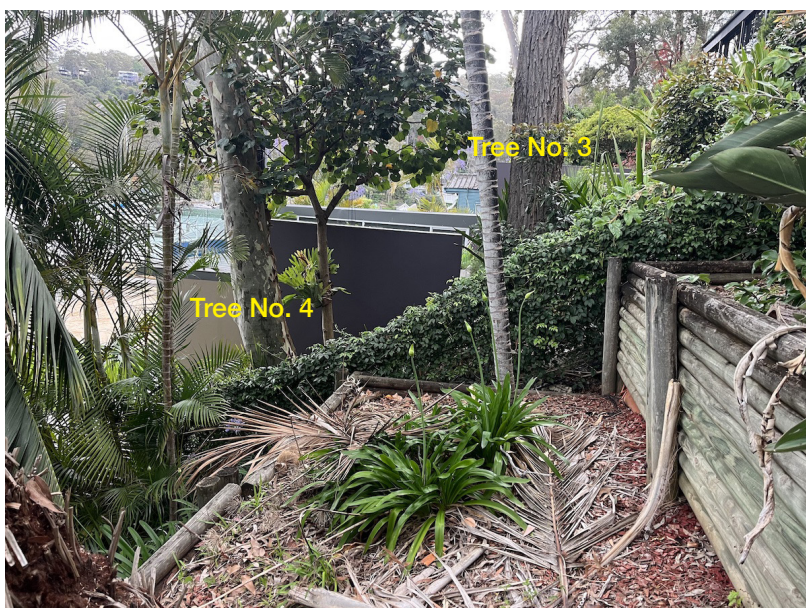
Figure 9 (left): Photograph viewing east to Tree No. 3 (Grey Ironbark) and No. 4 (Spotted Gum) located on the neighbouring land. (Photo: J Willis)

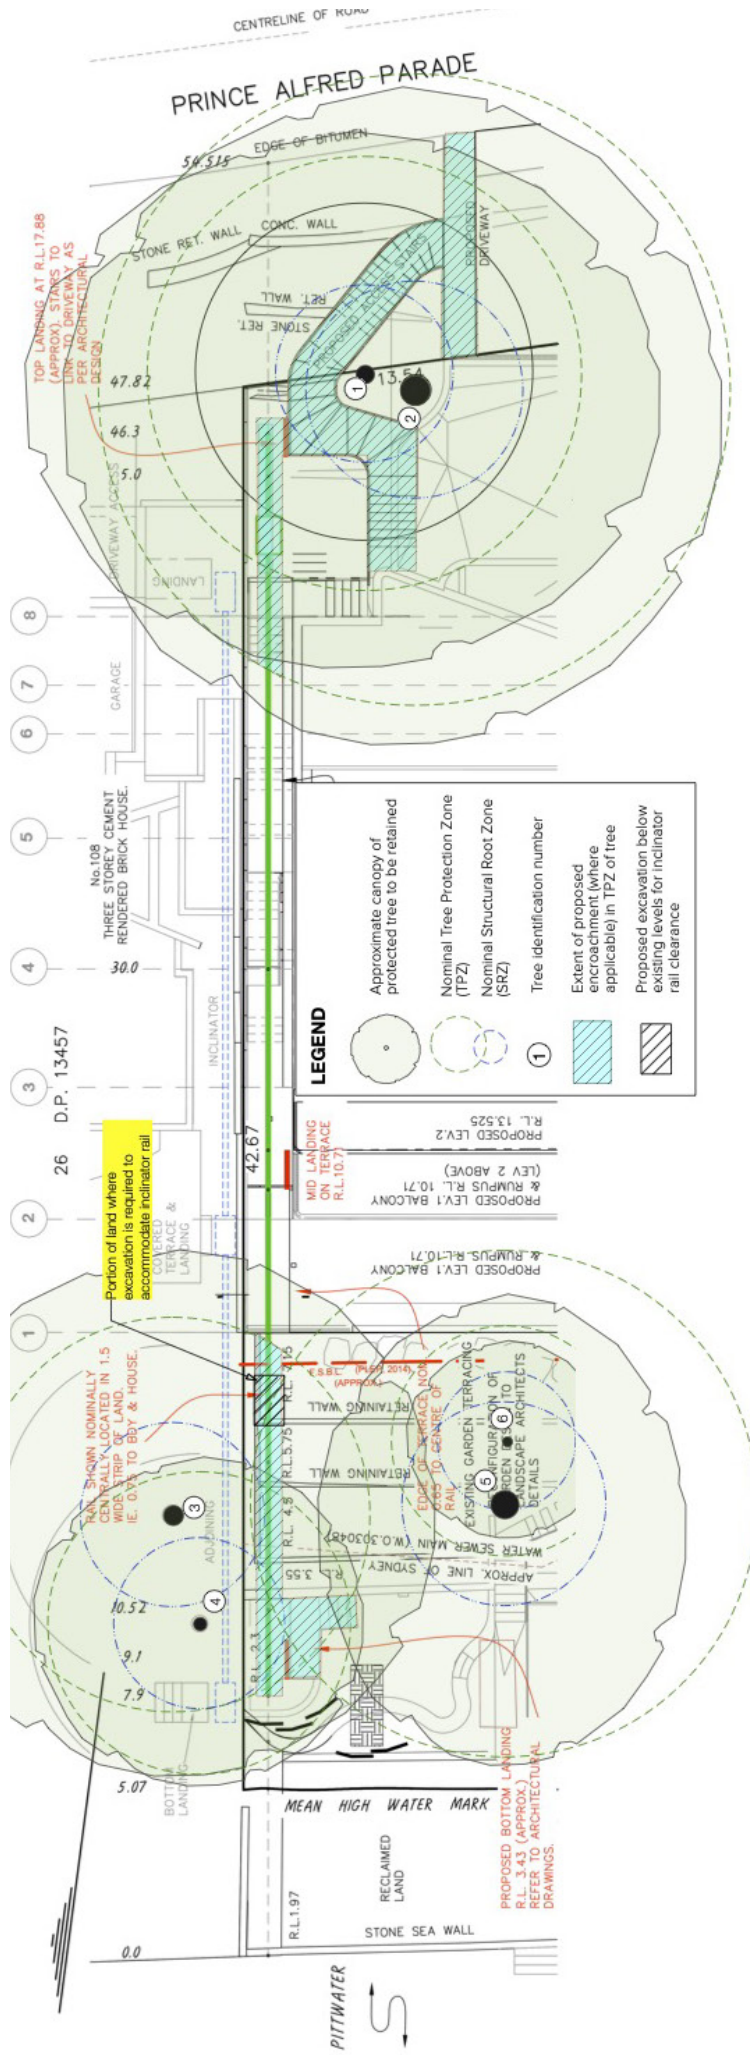
- a) The inclinator rail extends over the TPZ of Tree No. 1, 2, 3, 4 and 5. The lower section of inclinator rail extends over the SRZ of one of the neighbouring Tree No. 4.

- b) The upper landing is located in the TPZ of Tree No. 1 and 2, and the bottom landing is located in the TPZ of neighbouring trees, No. 3 and 4. The landings shall be a light weight structure supported on post footings.

Figure 10: Proposed Inclinator Design including an overlay of the TPZ and SRZ of the trees. The extent of encroachment is indicated as blue hatching. Note, not to scale.

Overall, the inclinator works are considered acceptable providing the final position of all footings and piers are determined on site following preliminary hand digging. Should a woody root equal to or greater than 40mm diameter be uncovered, the footing should be relocated. All footings should be positioned outside the SRZ of the above mentioned trees. Providing no large woody roots are severed as part of the excavation works, the proposed inclinator and associated works should not result in any adverse impact upon the trees.

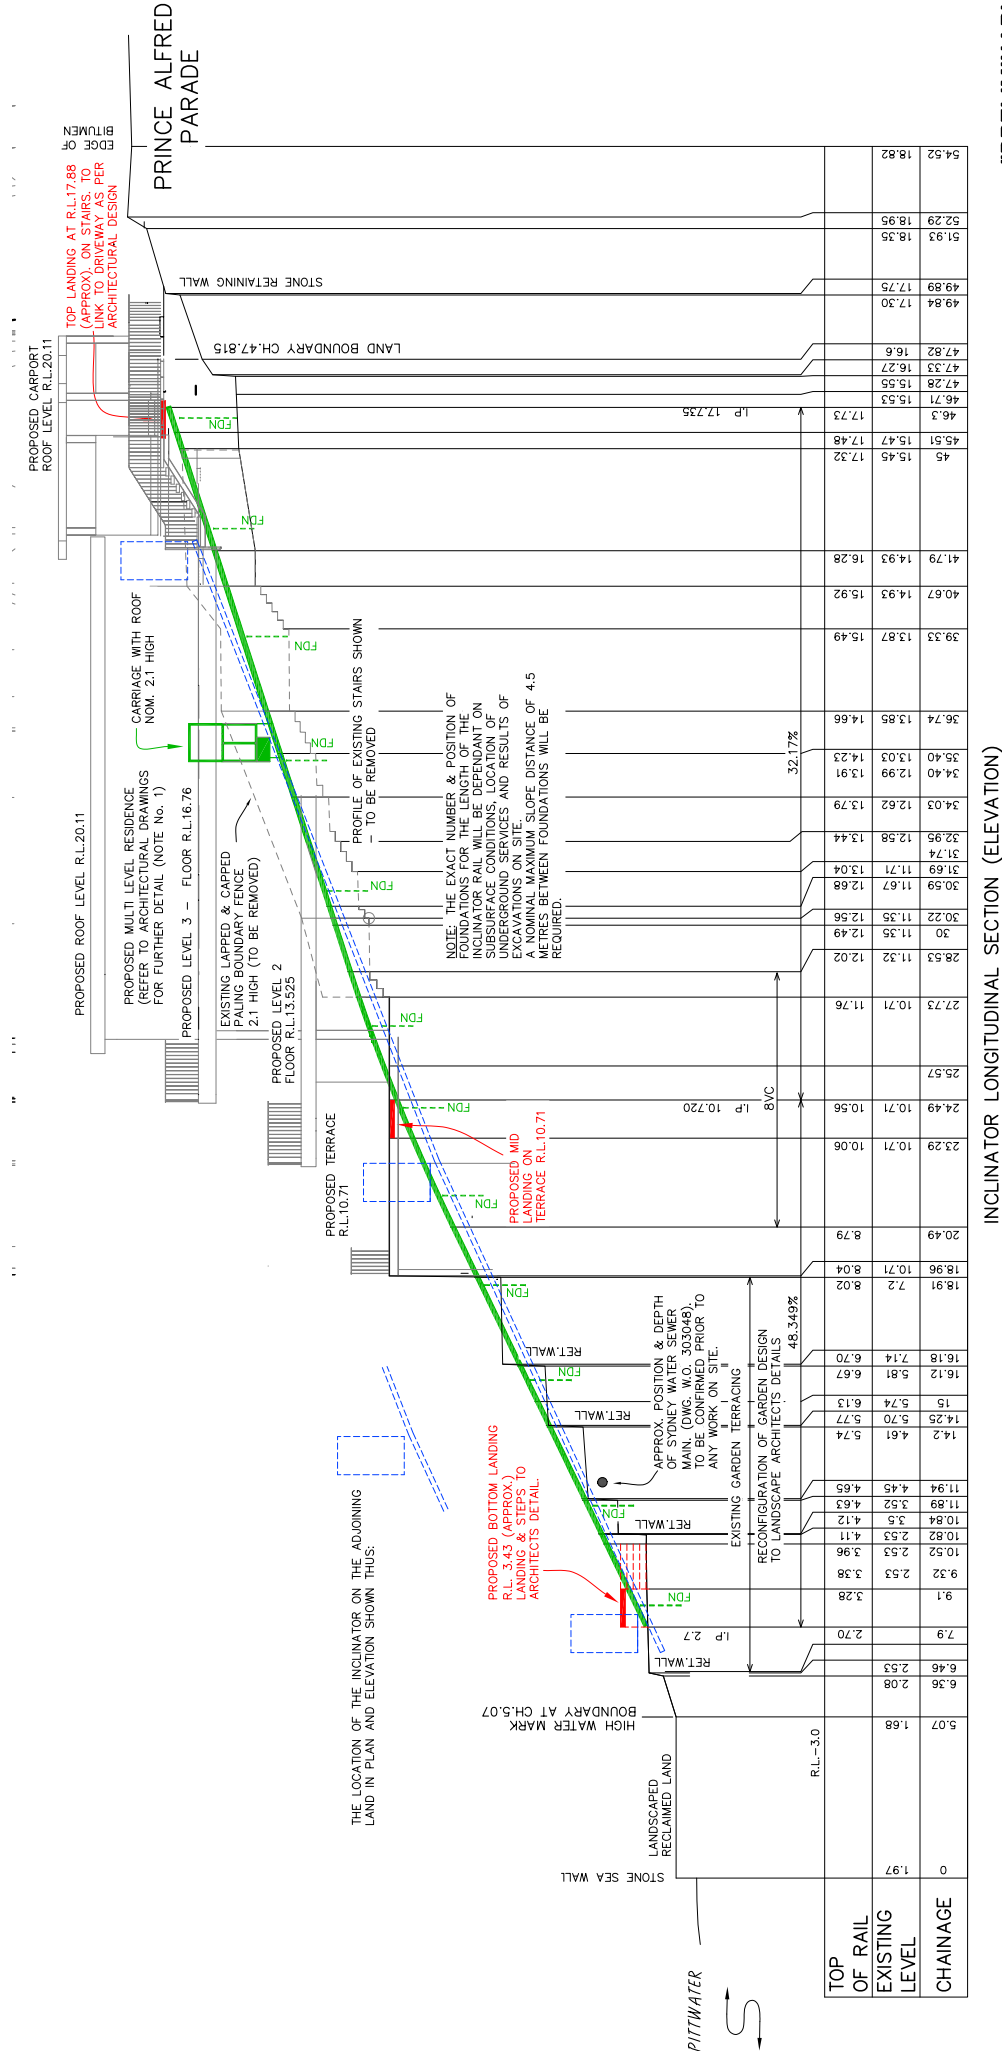
- c) Based on the longitudinal section drawing (refer to **Figure 11**) the inclinator rail shall be elevated above existing ground levels with exception to a small portion of the existing terraced garden area (RL 7.15) which is located in the TPZ of neighbouring Tree No. 3 (refer to **Figure 10**). The section drawing indicates minor excavation to achieve clearance between the ground level and the inclinator rail. With consideration to the existing retaining walls and associated level changes located within the TPZ of Tree No. 3, it is the author's opinion it is unlikely the root system of the tree will be impacted upon by the adjustment to the retaining wall level.

Figure 11: Inclinator Longitudinal Section drawing (provided by YSCO Geomatics) indicating the proposed works in relation to the existing ground levels. Note, not to scale.
