Arboricultural Impact Assessment

Tree Protection Plan

Site: 918 Barrenjoey Road Palm Beach 2108

Date of review: 24 March 2022

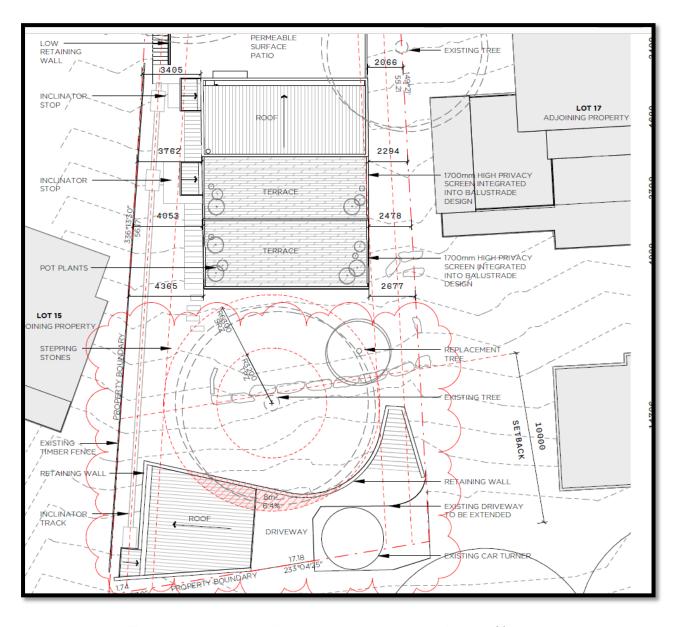
6.4.1 Review The proposed garage, driveway entrance, retaining wall and pathway, have been significantly re-designed. The modifications have been applied resulting in a minor incursion of the TPZ only. The incursion has been calculated to be 6.4% of the outer perimeter of the TPZ. The impact to the tree will be negligible to the health and vitality to the tree.

Tree 4 – redesign will result in a minor incursion 6.4%

- Tree 3 The tree is recommended to be retained.
- Tree 4 Works will result in a minor incursion of 6.4% of the TPZ. No adverse impact will result from the works.
