# Vertical Tree Management & Consultancy

## *Arboricultural Impact Assessment*

Site: 55 Kangaroo Road Collaroy Plateau 2097

Date of Inspection: 4 August 2021

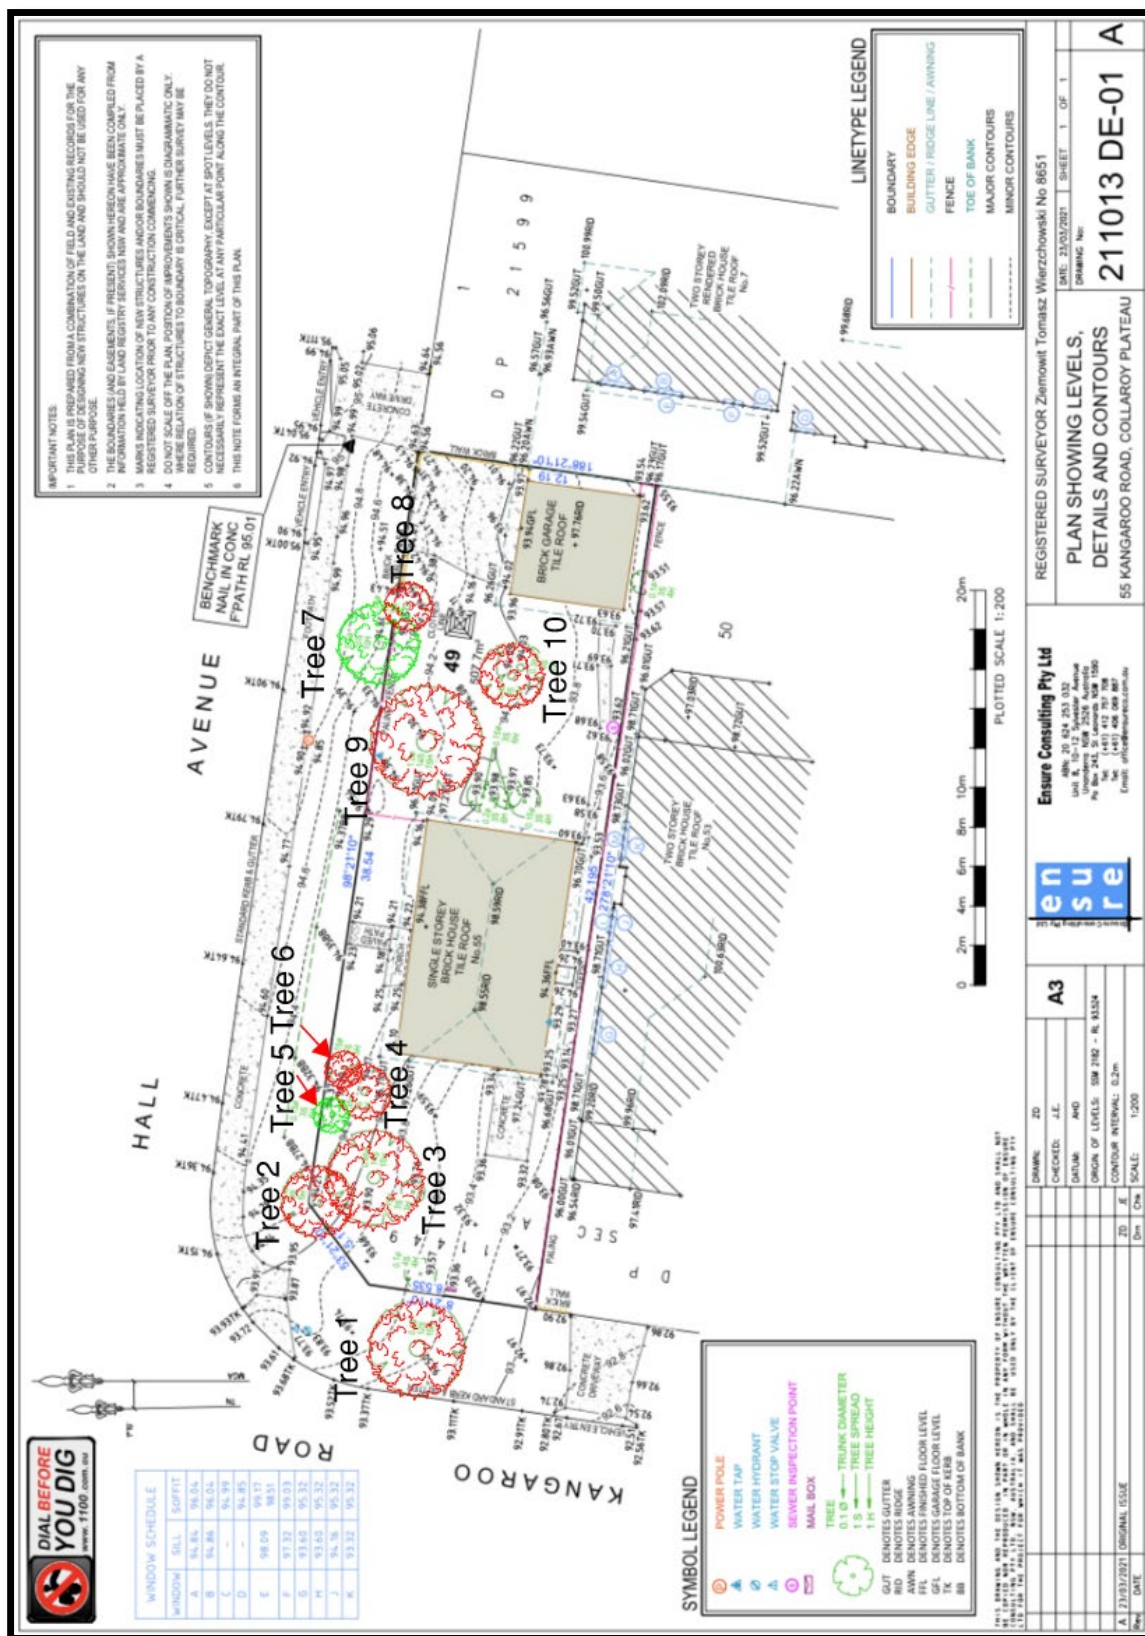
### **Tree Removal Retention Plan (figure 5)**

- Trees 1, 2, 3, 4, 6, 8, 9, 10 are a Priority for Removal.
- Trees 5, 7 are a Priority for Retention and require Tree Protection Fencing and Signage
