## 75 Victor Road, Dee Why

Arbor Impact Assessment  
Version 1.0

Client: Mr & Mrs Bloch  
c/- Niwa Designs

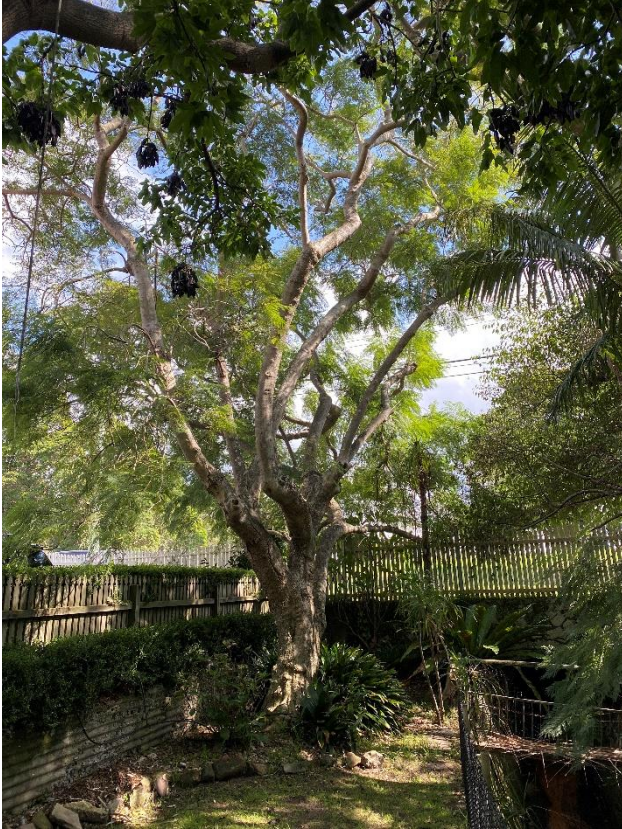
| NO# | Genus | Species | Common Name | Age | Vigor | Growth Habit | Crown Form | Height (m) | Canopy Spread (m) | DBH 1 (mm) | DBH 2 (mm) | Avg DBH (mm) | DRB (mm) | SRZ (mm) | TPZ (mm) | STARS® Rating | Defects & Attributes | General Comments | Encroachment |
|---|---|---|---|---|---|---|---|---|---|---|---|---|---|---|---|---|---|---|---|
| 1 | Jacaranda | mimosifolia | Jacaranda | M | G | CD, L | Skew, Sp | 12 | 12 | 540 | | 540 | 690 | 2832 | 6480 | M | Basal sweep to W, correcting @ 1.4m. Spreading laterals favouring SW. Low laterals overhanging nature strip and driveway. | Tree located on lower garden level below proposed development gradient (approx 650mm) | Located 180mm from proposed new boardwalk posing a <b>6%</b> discontinuous cut encroachment within the TPZ and SRZ |

- Tree 1 is a Jacaranda (*Jacaranda mimosifolia*) located in the side yard of the property and is 180mm from the proposed new boardwalk, providing a 6% discontinuous cut encroachment within the Tree Protection Zone and Structural Root Zone. This tree is considered as having a Medium STARS© Significance rating and should be retained and protected.

root must be retained and the post relocated, or it should be clean cut with a pruning saw or chainsaw under their direction.

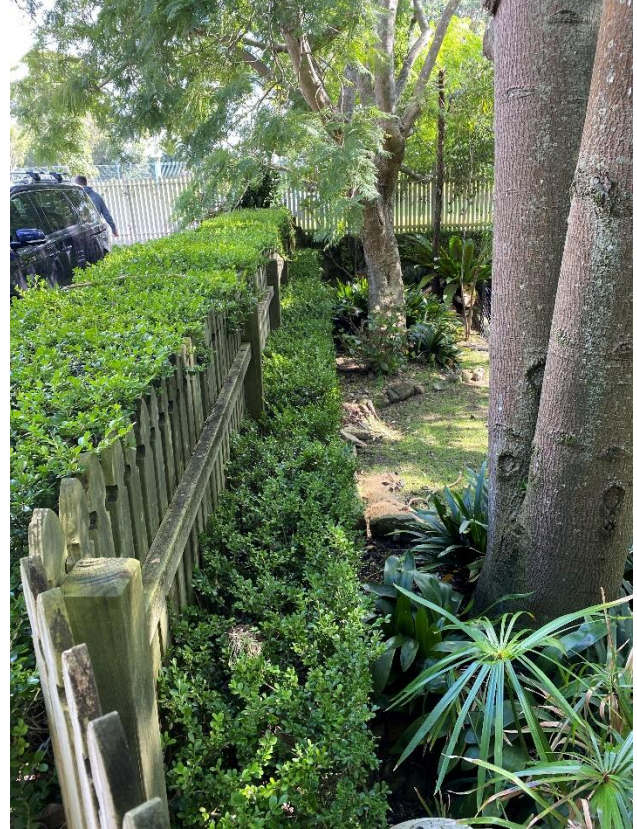
Proximity of Tree 1 & 2 to upper level

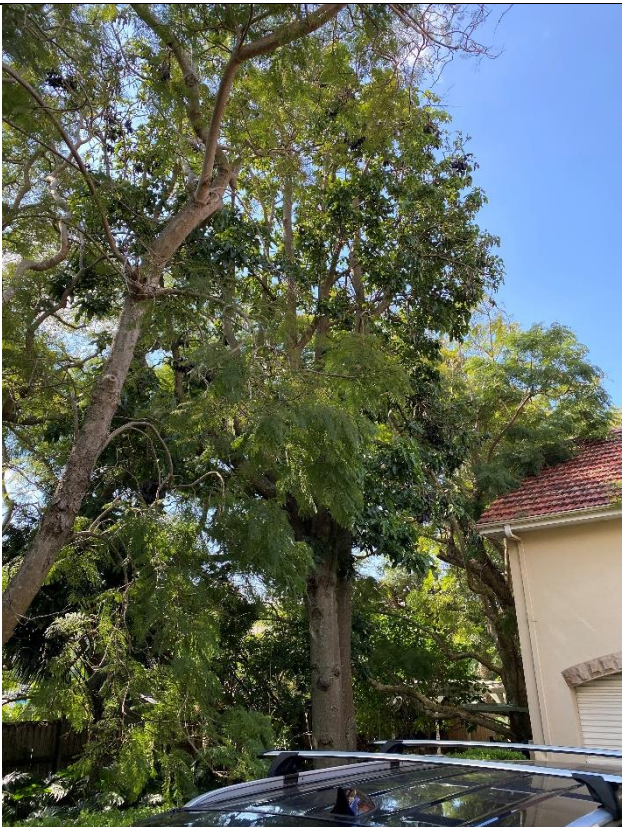
Tree 2

| NO# | Genus | Species | Common Name | Age | Vigor | Growth Habit | Crown Form | Height (m) | Canopy Spread (m) | DBH 1 (mm) | DBH 2 (mm) | Avg DBH (mm) | DRB (mm) | SRZ (mm) | TPZ (mm) | STARS® Rating | Defects & Attributes | General Comments | Encroachment |
|---|---|---|---|---|---|---|---|---|---|---|---|---|---|---|---|---|---|---|---|
| 2 | Brachychiton | acerifolius | Illawarra Flame Tree | M | G | CD, U | As, Dom | 14 | 8.5 | 380 | 400 | 552 | 560 | 2594 | 6624 | M-H | Corominant leaders from 0.8m, included typical for species. Most dominant crown. | Tree located on lower garden level below proposed development gradient (approx 650mm) | Located 280mm from proposed new boardwalk posing an <b>11%</b> discontinuous cut encroachment within the TPZ and SRZ |

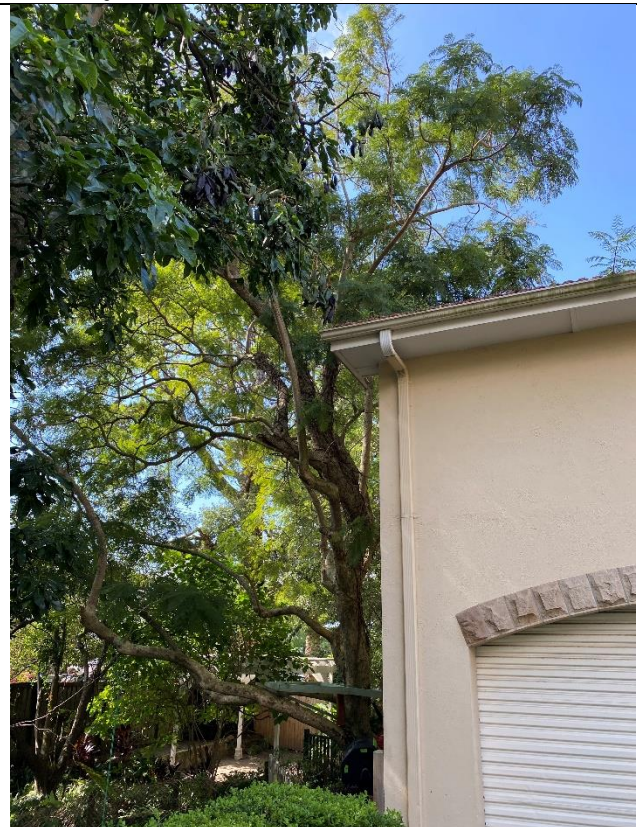
Tree 3

| NO# | Genus | Species | Common Name | Age | Vigor | Growth Habit | Crown Form | Height (m) | Canopy Spread (m) | DBH 1 (mm) | DBH 2 (mm) | Avg DBH (mm) | DRB (mm) | SRZ (mm) | TPZ (mm) | STARS® Rating | Defects & Attributes | General Comments | Encroachment |
|---|---|---|---|---|---|---|---|---|---|---|---|---|---|---|---|---|---|---|---|
| 3 | Jacaranda | mimosifolia | Jacaranda | M | Av-G | CD, L | As, Sp | 11 | 11 | 320 | 350 | 475 | 480 | 2431 | 5700 | M | Codominant spreading leaders from 0.9m. S side of lower crown suppressed from existing premises. Small timber cubby foundations resting in lower crown. | Tree located on same gradient as proposed works. | Located 380mm from proposed new boardwalk posing an <b>14%</b> discontinuous cut encroachment within the TPZ and SRZ |

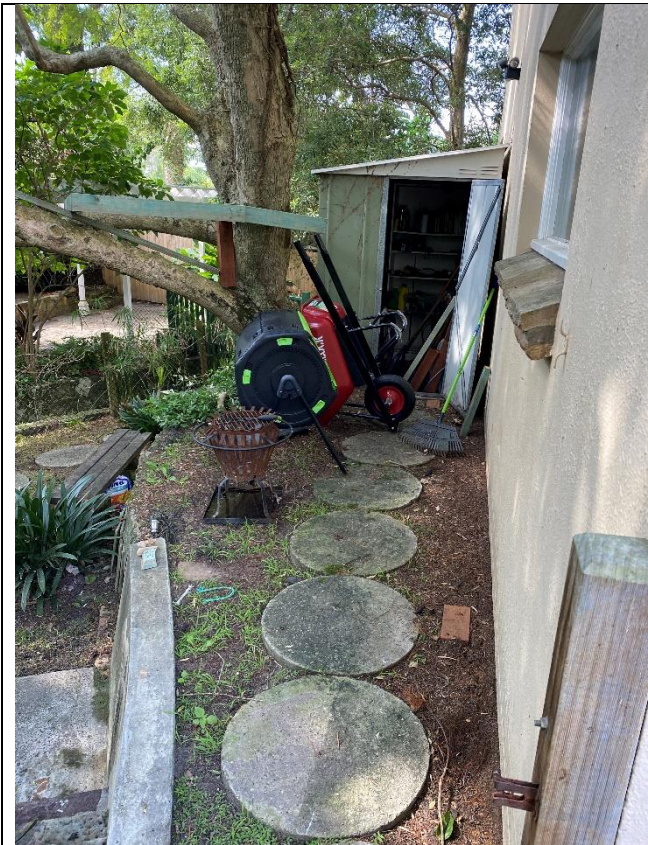
Proximity of Tree 3 to existing premises

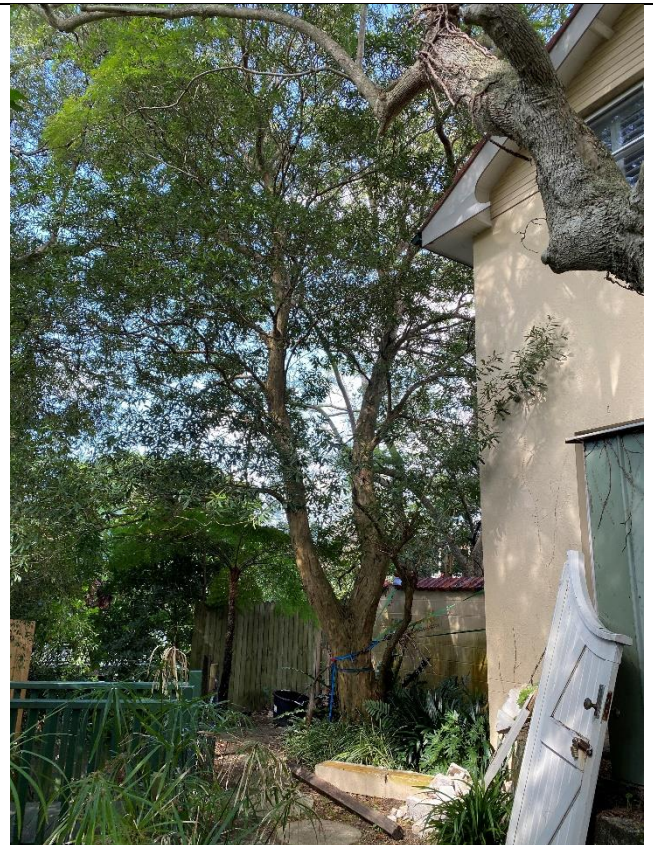
Tree 4

| NO# | Genus | Species | Common Name | Age | Vigor | Growth Habit | Crown Form | Height (m) | Canopy Spread (m) | DBH 1 (mm) | DBH 2 (mm) | Avg DBH (mm) | DRB (mm) | SRZ (mm) | TPZ (mm) | STARS® Rating | Defects & Attributes | General Comments | Encroachment |
|---|---|---|---|---|---|---|---|---|---|---|---|---|---|---|---|---|---|---|---|
| 4 | Tristaniaopsis | laurina | Water Gum | M | G | CD, U | As, Skew | 10 | 7 | 420 | | 420 | 570 | 2613 | 5040 | M | Straps on lower trunk attached as support for adjacent cinderblock wall. Minor upper crown suppression from neighbouring specimens. | Tree located on lower garden level below proposed development gradient (approx 700mm) | Located 0.5m from proposed new boardwalk and steps posing a <b>9%</b> discontinuous cut encroachment; and 1.6m from proposed new lawn posing an <b>18%</b> fill encroachment within the TPZ and SRZ. |

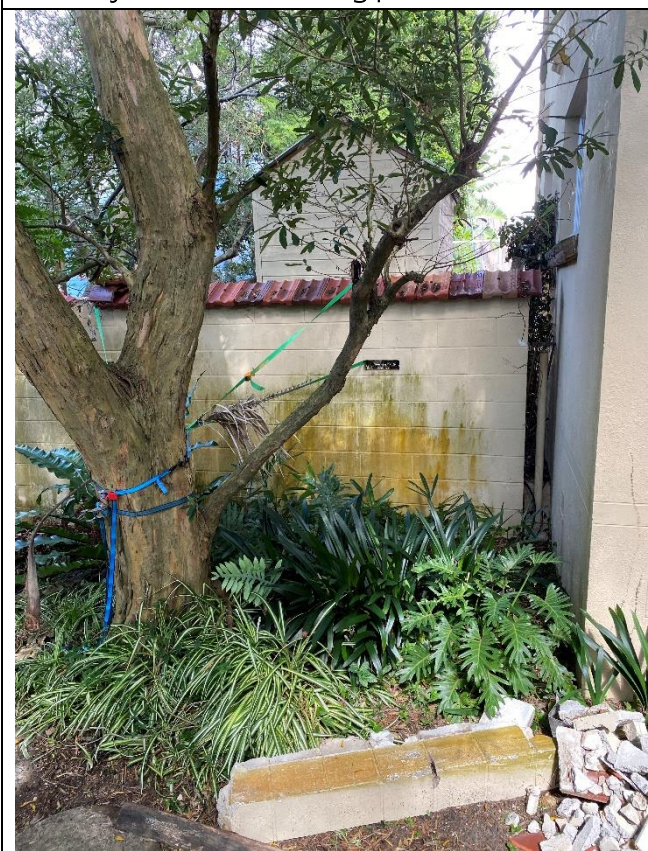
Proximity of Tree 4 to existing premises

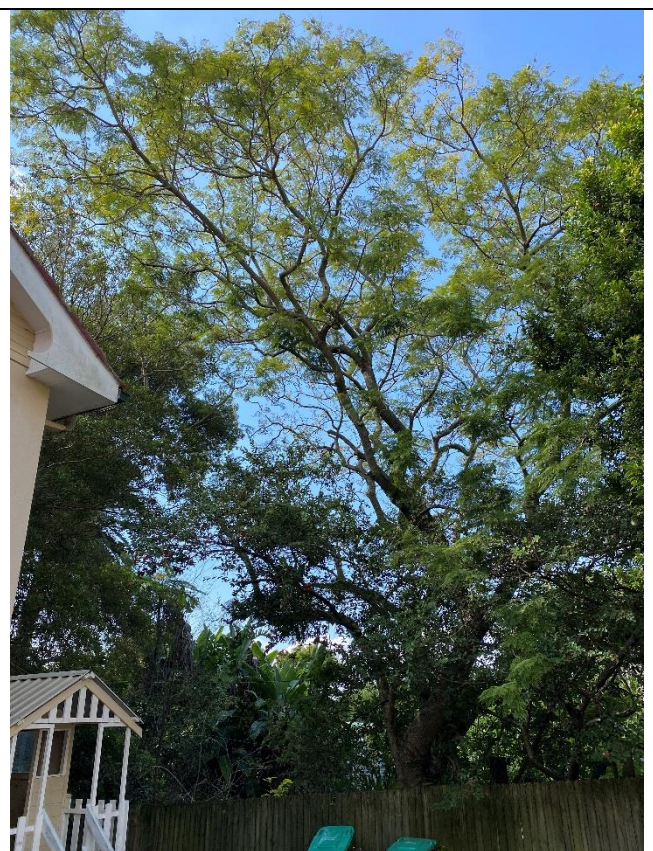
Tree 5

| NO# | Genus | Species | Common Name | Age | Vigor | Growth Habit | Crown Form | Height (m) | Canopy Spread (m) | DBH 1 (mm) | DBH 2 (mm) | Avg DBH (mm) | DRB (mm) | SRZ (mm) | TPZ (mm) | STARS® Rating | Defects & Attributes | General Comments | Encroachment |
|---|---|---|---|---|---|---|---|---|---|---|---|---|---|---|---|---|---|---|---|
| 5 | Jacaranda | mimosifolia | Jacaranda | M | Av-G | CD, L | As, Sp, Skew | 11 | 13 | 450 | | 450 | 550 | 2575 | 5400 | M | Cotoneaster growing up through lower crown. Overhanging above existing premises roofline. | Tree located in neighbouring property to E (1 Lewis St). DBH and DRB estimated due to access. | Located 1.8m from proposed new lawn posing a <b>10%</b> fill encroachment; and 2.8m from proposed new concrete steps and hardstand posing a <b>7%</b> cut encroachment within the TPZ |

- A fenced exclusion zone must be implemented that extends around as much of the TPZ within the client's property as feasible for Tree 5, while providing a minimum 0.5m offset from the proposed stairs and hardstand to allow clear access for construction activities (as indicated on the **TREE LOCATION & IMPACT PLAN**, page 20). This exclusion zone must be installed as per **10.2- TREE PROTECTION FENCING**, page 21 of this report.

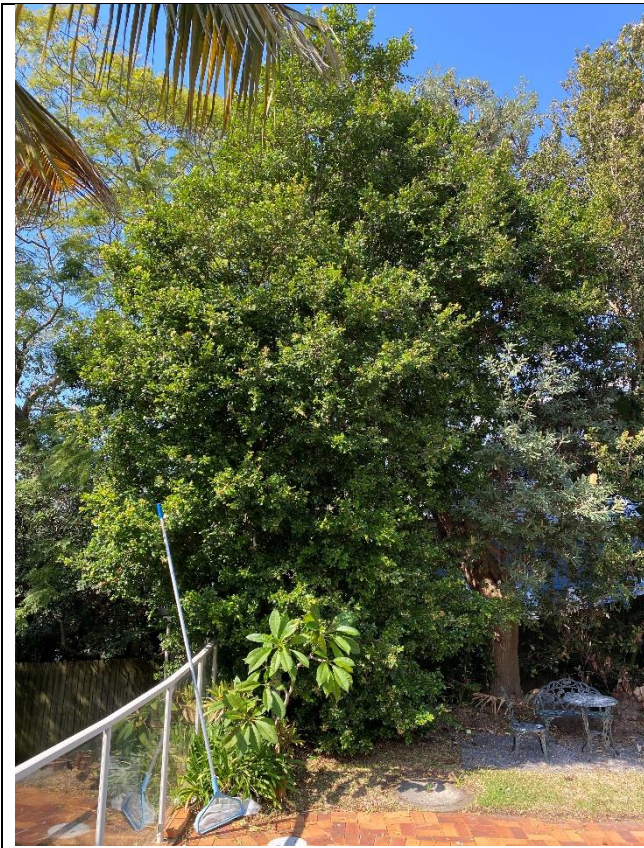
Tree 6

| NO# | Genus | Species | Common Name | Age | Vigor | Growth Habit | Crown Form | Height (m) | Canopy Spread (m) | DBH 1 (mm) | DBH 2 (mm) | Avg DBH (mm) | DRB (mm) | SRZ (mm) | TPZ (mm) | STARS® Rating | Defects & Attributes | General Comments | Encroachment |
|---|---|---|---|---|---|---|---|---|---|---|---|---|---|---|---|---|---|---|---|
| 6 | Syzigium | sp. | Brush Cherry | M | G | CD, U | As | 9 | 4 | 180 | 140 | 229 | 220 | 1752 | 2748 | L | 2 x stems. Suppressed to E from T7 | | No measurable impact |

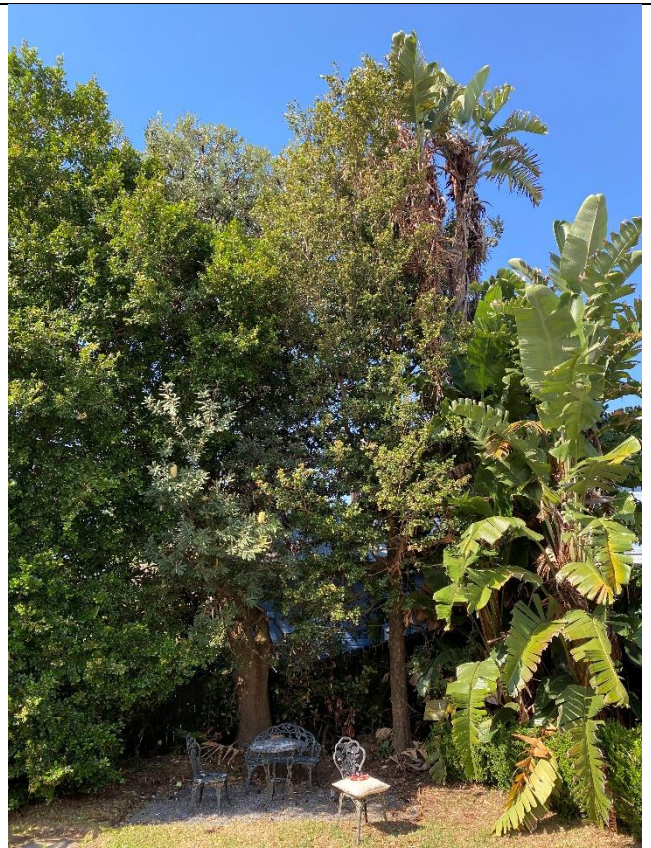
Trees 7 & 8

| NO# | Genus | Species | Common Name | Age | Vigor | Growth Habit | Crown Form | Height (m) | Canopy Spread (m) | DBH 1 (mm) | DBH 2 (mm) | Avg DBH (mm) | DRB (mm) | SRZ (mm) | TPZ (mm) | STARS® Rating | Defects & Attributes | General Comments | Encroachment |
|---|---|---|---|---|---|---|---|---|---|---|---|---|---|---|---|---|---|---|---|
| 7 | Banksia | integrifolia | Coastal Banksia | M | Av-G | CD, L | As, Skew | 10 | 6 | 430 | | 430 | 560 | 2594 | 5160 | L-M | Buttress located on lower gradient to pool enclosure surface. Crown favouring E. | | No measurable impact |
| 8 | Syzigium | Sp. | Brush Cherry | M | Av | U | As | 9 | 3 (NW) | 190 | | 190 | 210 | 1718 | 2280 | L | Lower crown suppression from Bird of Paradise to S. | | No measurable impact |
