**Subject:** Development Application Enquiry: N0279/16

## **41 Marine Parade, Avalon**

### **Response to Stability Assessment**

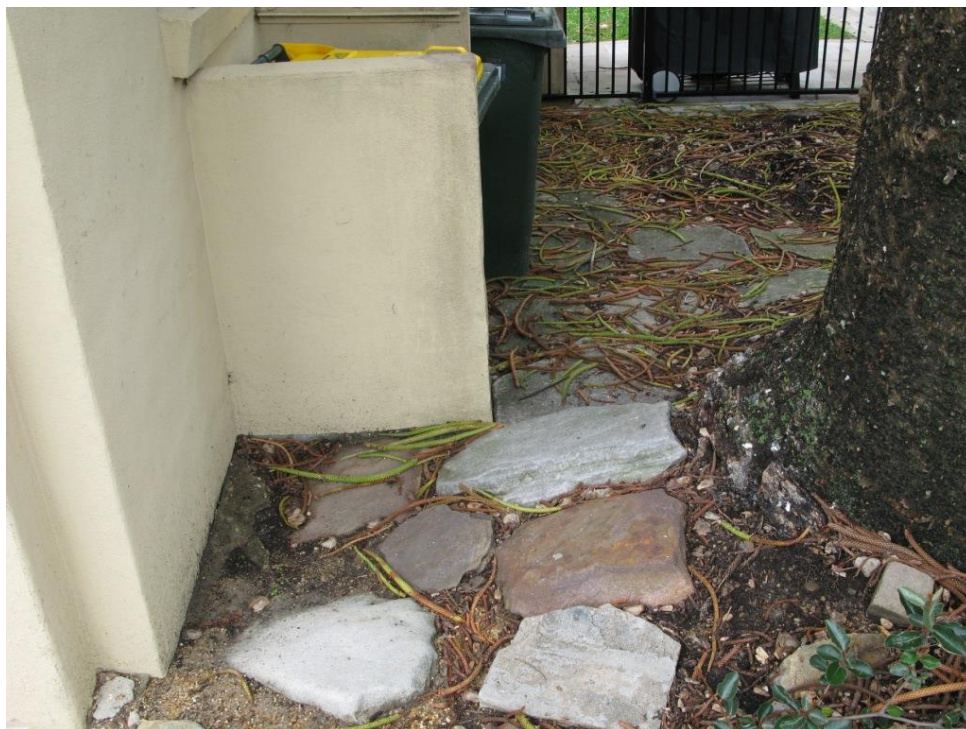
**Figure 4: Illustrates tree trunk location & existing competing structures.**

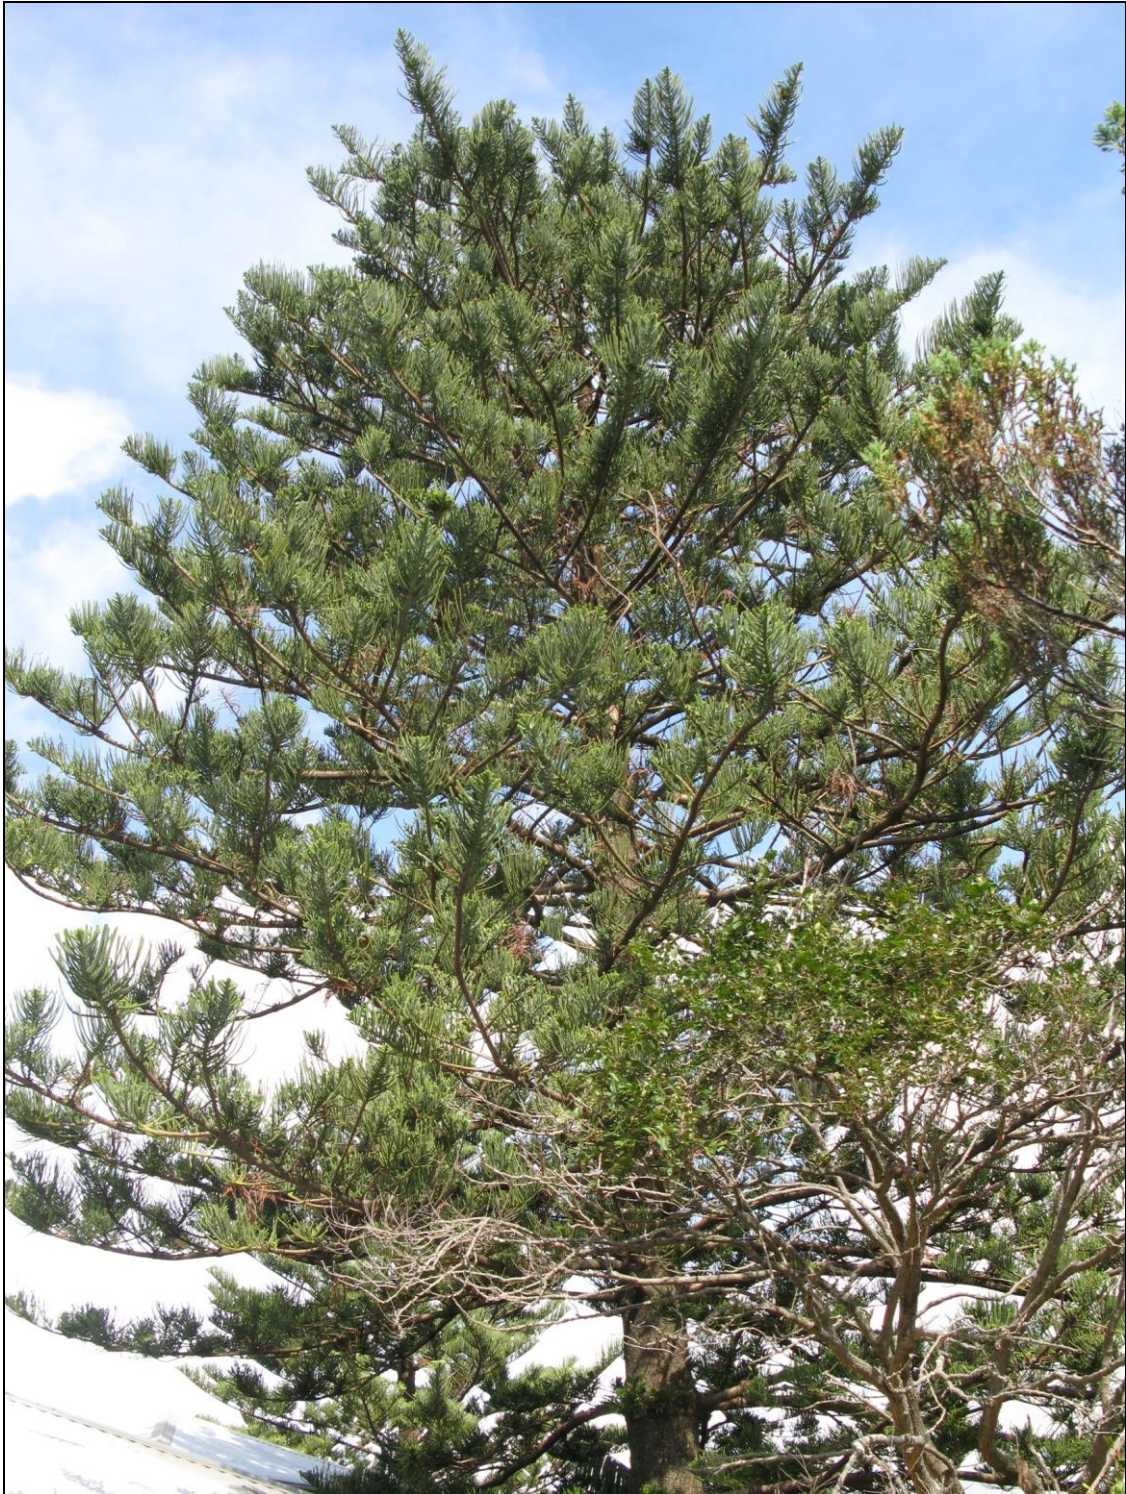
**Figure 5: Illustrates discussed tree canopy.**

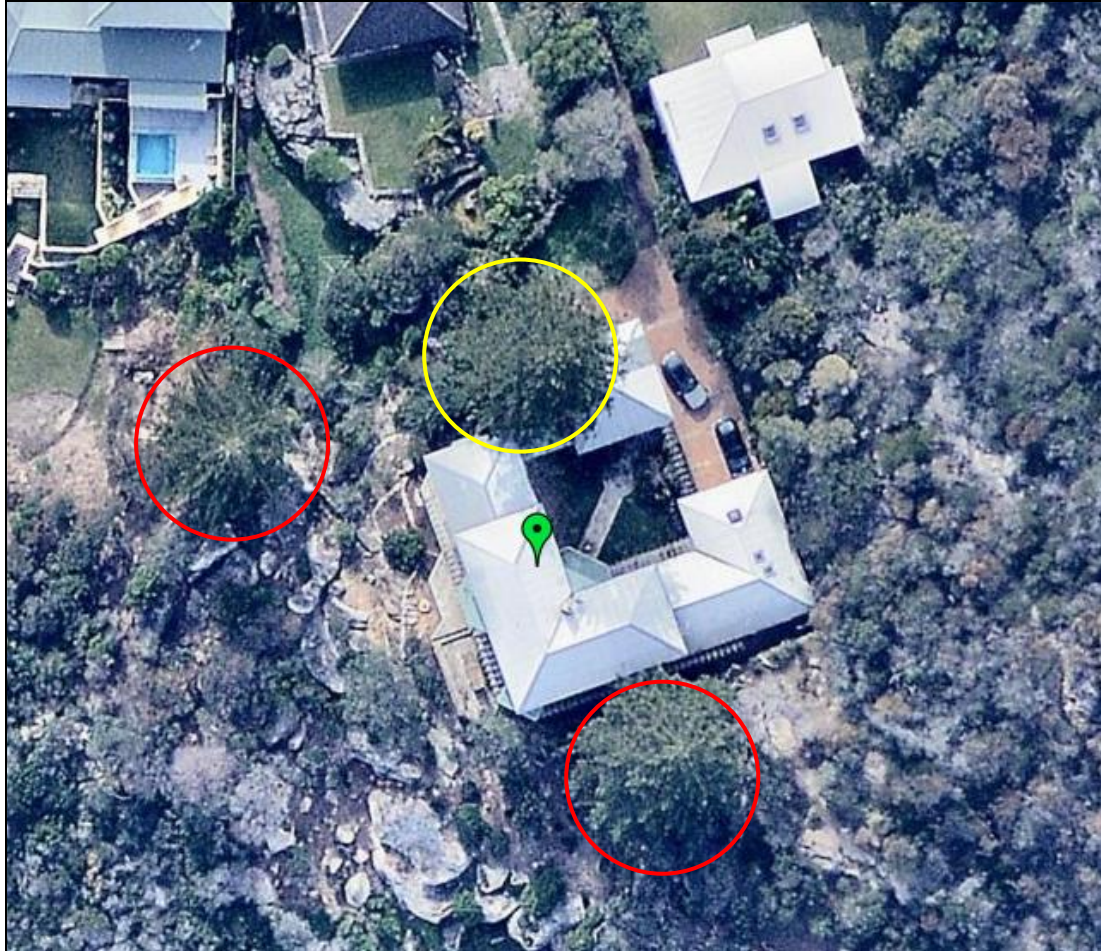
*The two (2) A.h. trees within the subject site (41 Marine Parade) are presumed to have long term Useful Life Expectancies. A third same specie tree is planted within the 37/39 Marine Parade properties. It is also presumed to have a long term Useful Life Expectancy. This tree is noted to be very close to the common boundary shared with the 41 Marine Parade property but is well away from any impact that could reasonably be predicted to compromise its Useful Life Expectancy.*

*The proposed (by lodged DA submission) new residence requires an 18.15m<sup>2</sup> breach of the total 222.00m<sup>2</sup> Tree Protection Zone surface area. This equates to a less than 10% (i.e. 8.2%) total Tree Protection Zone surface area (222.00m<sup>2</sup>) breach by definitions within the Australian Standard (AS4970-2009 Protection of trees on development sites). As such the breach is considered to be minor & therefore*

*acceptable with implementation of a “Site Specific Tree Management Plan”.*

**Figure 7: Illustrates subject tree (yellow circle) plus same specie trees within or near the subject site (red circles). Photo courtesy of NearMap 4 July 2016.**

- Install temporary metal mesh fencing as close to 8.40m TPZ radial distance as site restrictions/proposed works allow.
- Prior to the proposed demolition of existing structures install a “Tree Trunk Guard” (see Appendix C) to a height not less than first whorls of branches (approximately 3.00m). Photographic evidence is essential.
- No demolition or builder’s material of any description (including loose soil) is to be stored within the 8.40m TPZ radial distance.
- Any excavation required within TPZ radial distance, i.e. the identified 8.2% breach of total TPZ surface area **MUST BE UNDERTAKEN MANUALLY**. Photographic evidence is essential.

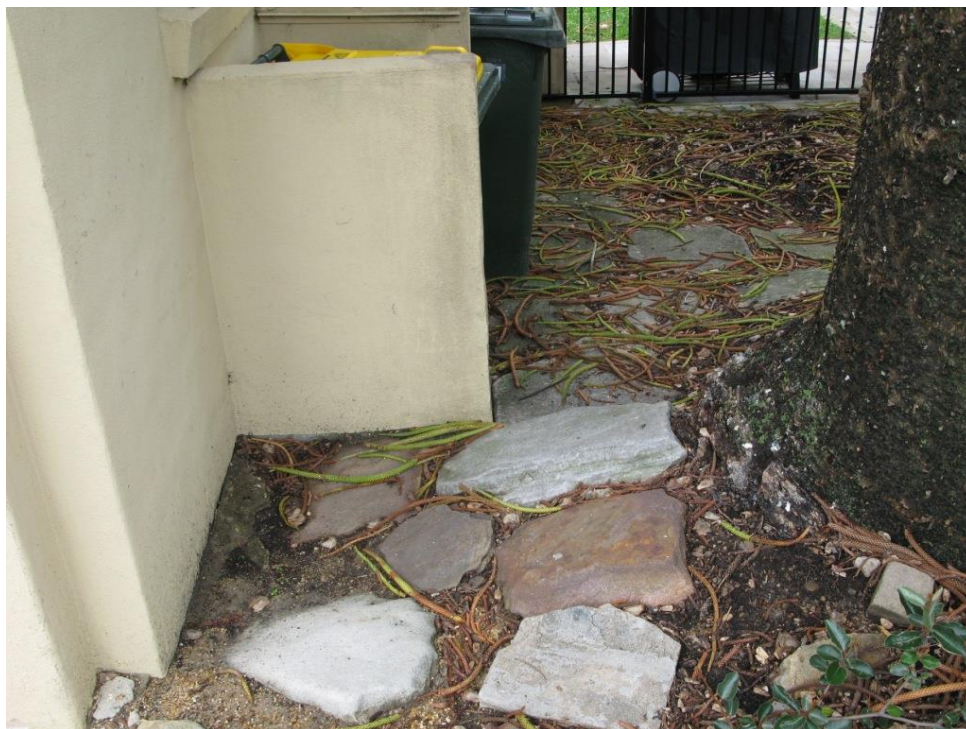
**Figure 4: Illustrates tree trunk location & existing competing structures.**

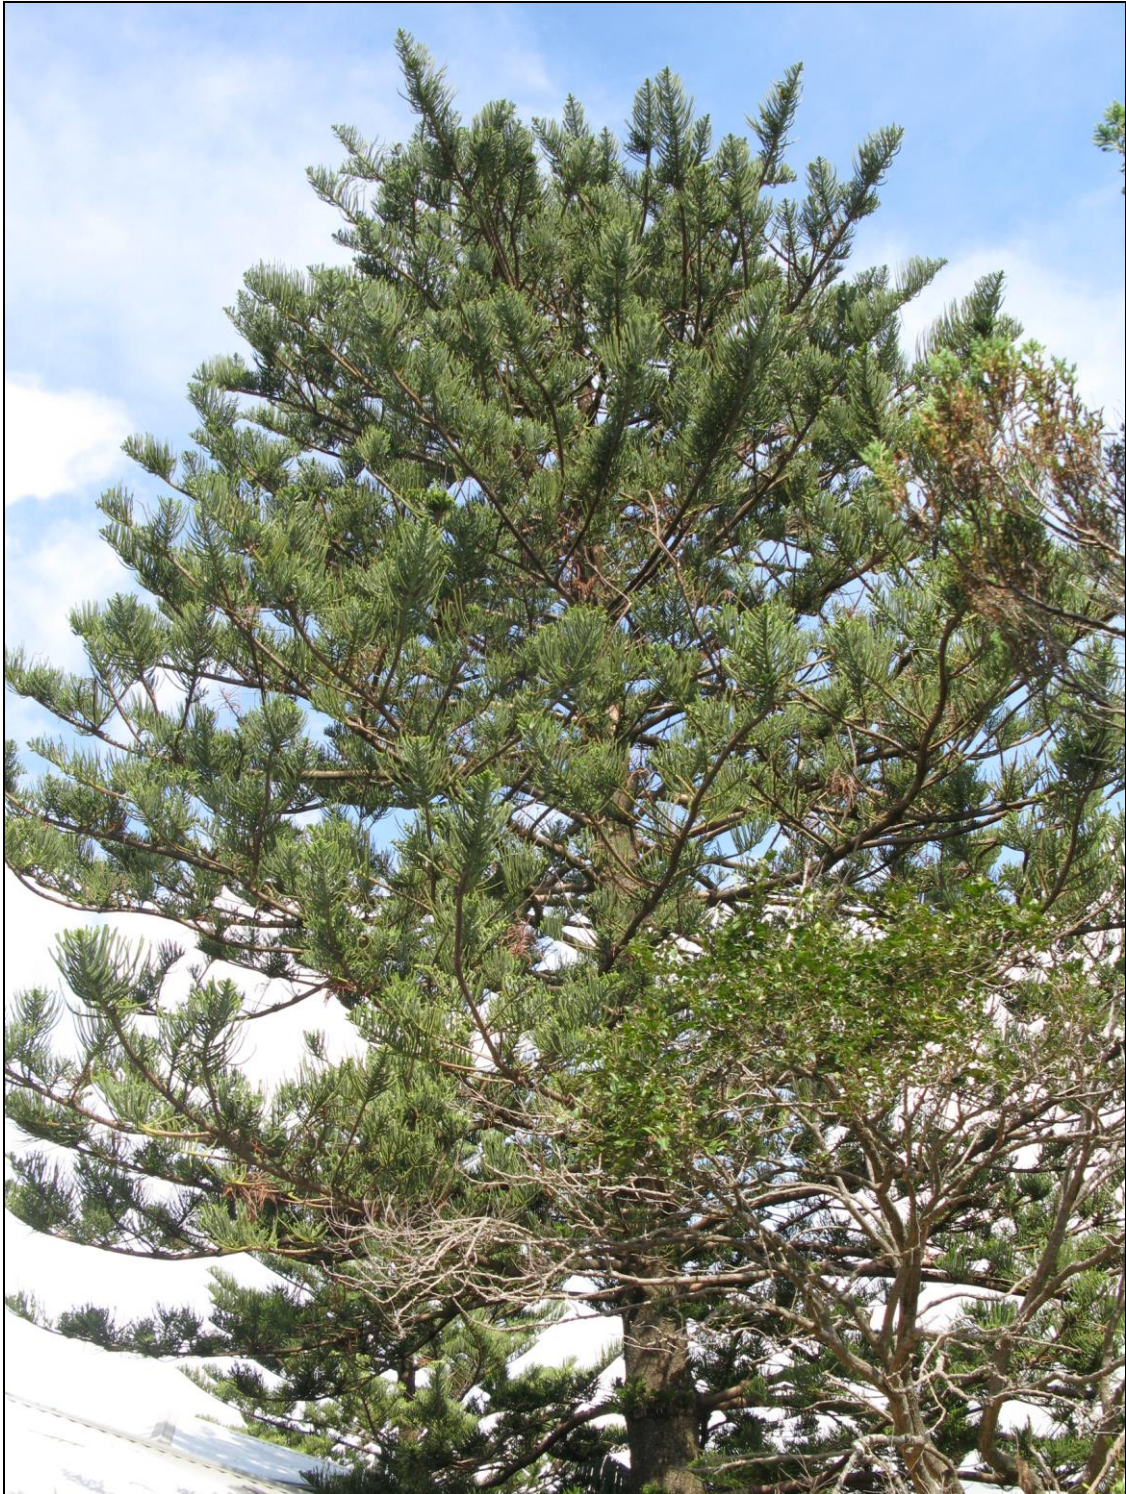
**Figure 5: Illustrates discussed tree canopy.**

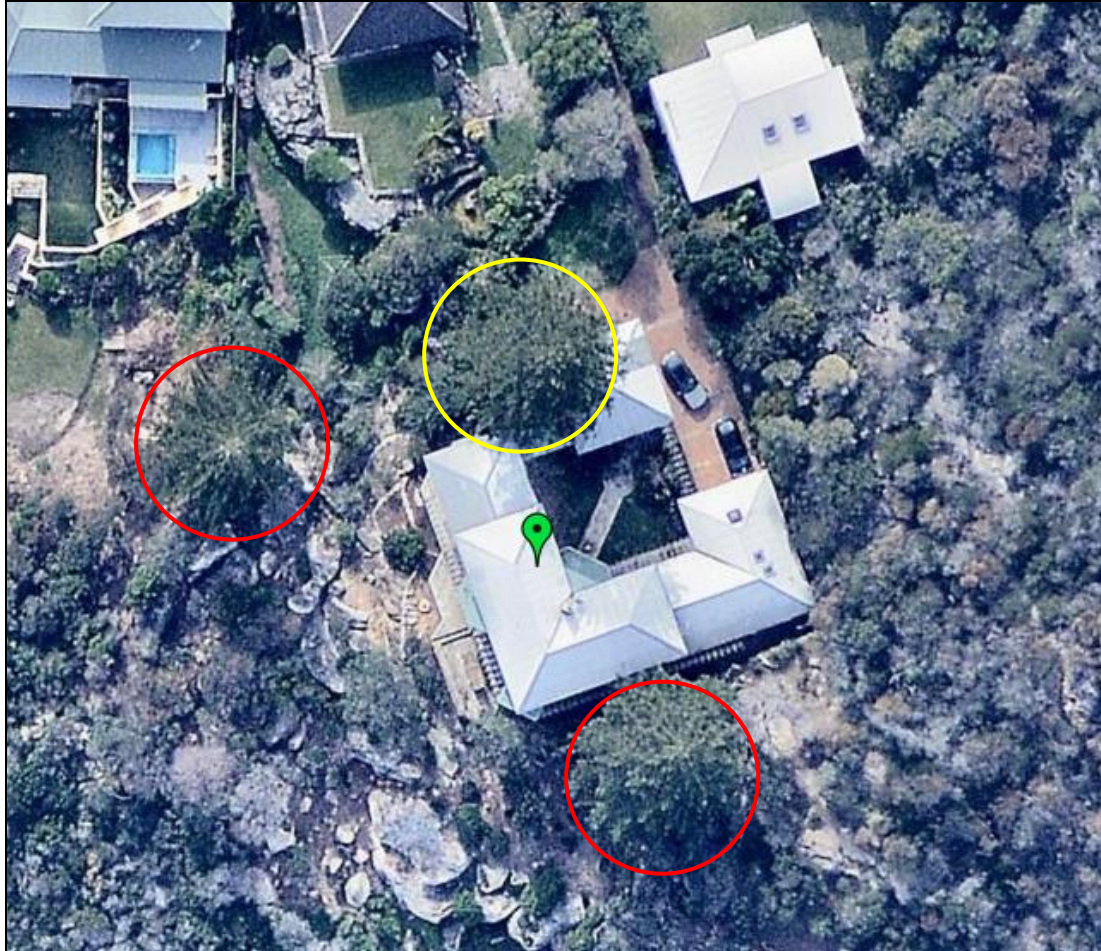
*The two (2) A.h. trees within the subject site (41 Marine Parade) are presumed to have long term Useful Life Expectancies. A third same specie tree is planted within the 37/39 Marine Parade properties. It is also presumed to have a long term Useful Life Expectancy. This tree is noted to be very close to the common boundary shared with the 41 Marine Parade property but is well away from any impact that could reasonably be predicted to compromise its Useful Life Expectancy.*

*The proposed (by lodged DA submission) new residence requires an 18.15m<sup>2</sup> breach of the total 222.00m<sup>2</sup> Tree Protection Zone surface area. This equates to a less than 10% (i.e. 8.2%) total Tree Protection Zone surface area (222.00m<sup>2</sup>) breach by definitions within the Australian Standard (AS4970-2009 Protection of trees on development sites). As such the breach is considered to be minor & therefore*

*acceptable with implementation of a “Site Specific Tree Management Plan”.*

**Figure 7: Illustrates subject tree (yellow circle) plus same specie trees within or near the subject site (red circles). Photo courtesy of NearMap 4 July 2016.**

- Install temporary metal mesh fencing as close to 8.40m TPZ radial distance as site restrictions/proposed works allow.
- Prior to the proposed demolition of existing structures install a “Tree Trunk Guard” (see Appendix C) to a height not less than first whorls of branches (approximately 3.00m). Photographic evidence is essential.
- No demolition or builder’s material of any description (including loose soil) is to be stored within the 8.40m TPZ radial distance.
- Any excavation required within TPZ radial distance, i.e. the identified 8.2% breach of total TPZ surface area **MUST BE UNDERTAKEN MANUALLY**. Photographic evidence is essential.
