## **PRELIMINARY ASSESSMENT: Acid Sulfate**

Alterations, Additions and New Pool at **8 Lido Avenue, North Narrabeen**

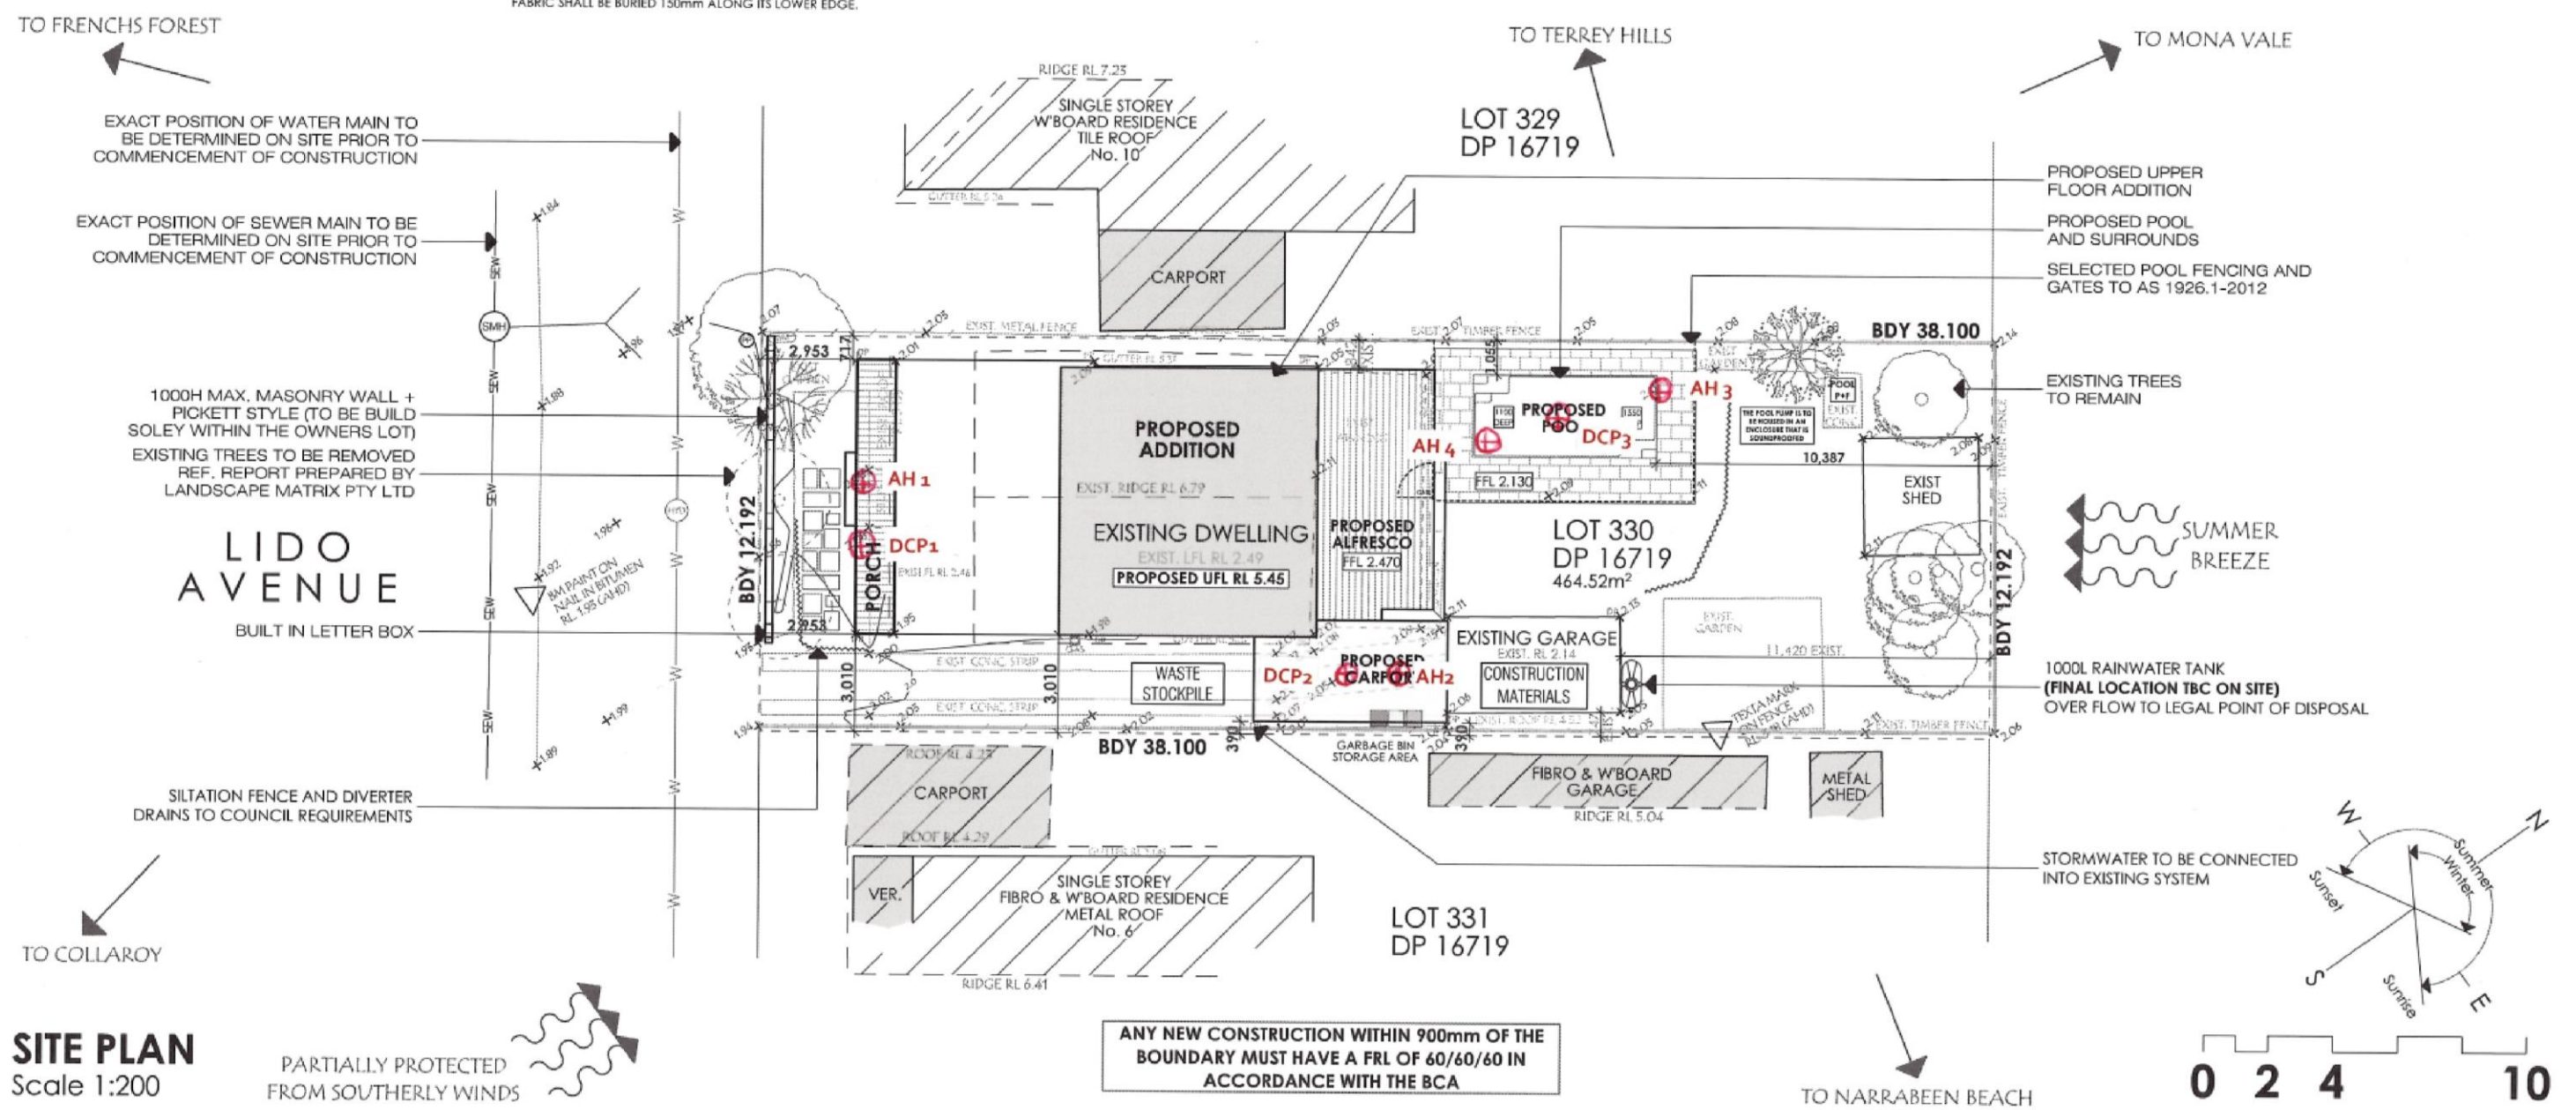
## SITE PLAN – showing test locations

Four hand auger holes were put down in the location shown on the site plan attached. Field pH and peroxide testing was carried out on samples taken from the auger holes at regular intervals. The logs of the auger holes and the test results are as follows.
