# Arboricultural Impact Assessment

1 Highview Avenue, Queenscliff  
NSW, 2100  
B/-/DP330244  
DA2024/0629 – PAN-436241  
20/06/2024

**Temporal Tree Management Pty Ltd.**

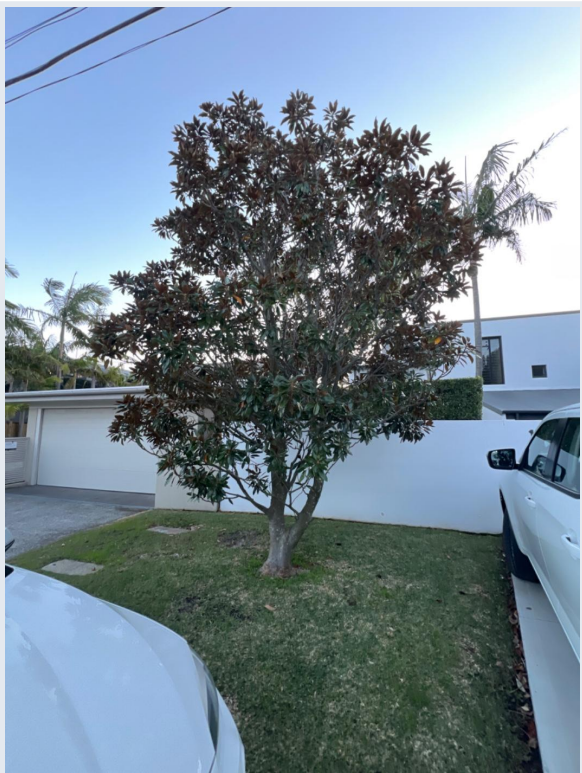
| Tree Comments: | Maturing street tree positioned outside southern boundary of the subject site observed to be in good condition. |
