**From:** John Lawson  
**Sent:** 15/08/2023 12:34:45 PM  
**To:** Council Northernbeaches Mailbox  
**Subject:** DA2023/1023 - 32 Loblay Crescent Bilgola Plateau - Submission Opposing the Development Application

## SUBMISSION IN REGARD TO DA/2023/1023 - 32 LOBLAY CRESCENT BILGOLA PLATEAU

*Description: Alterations and additions to a dwelling house including retaining walls*

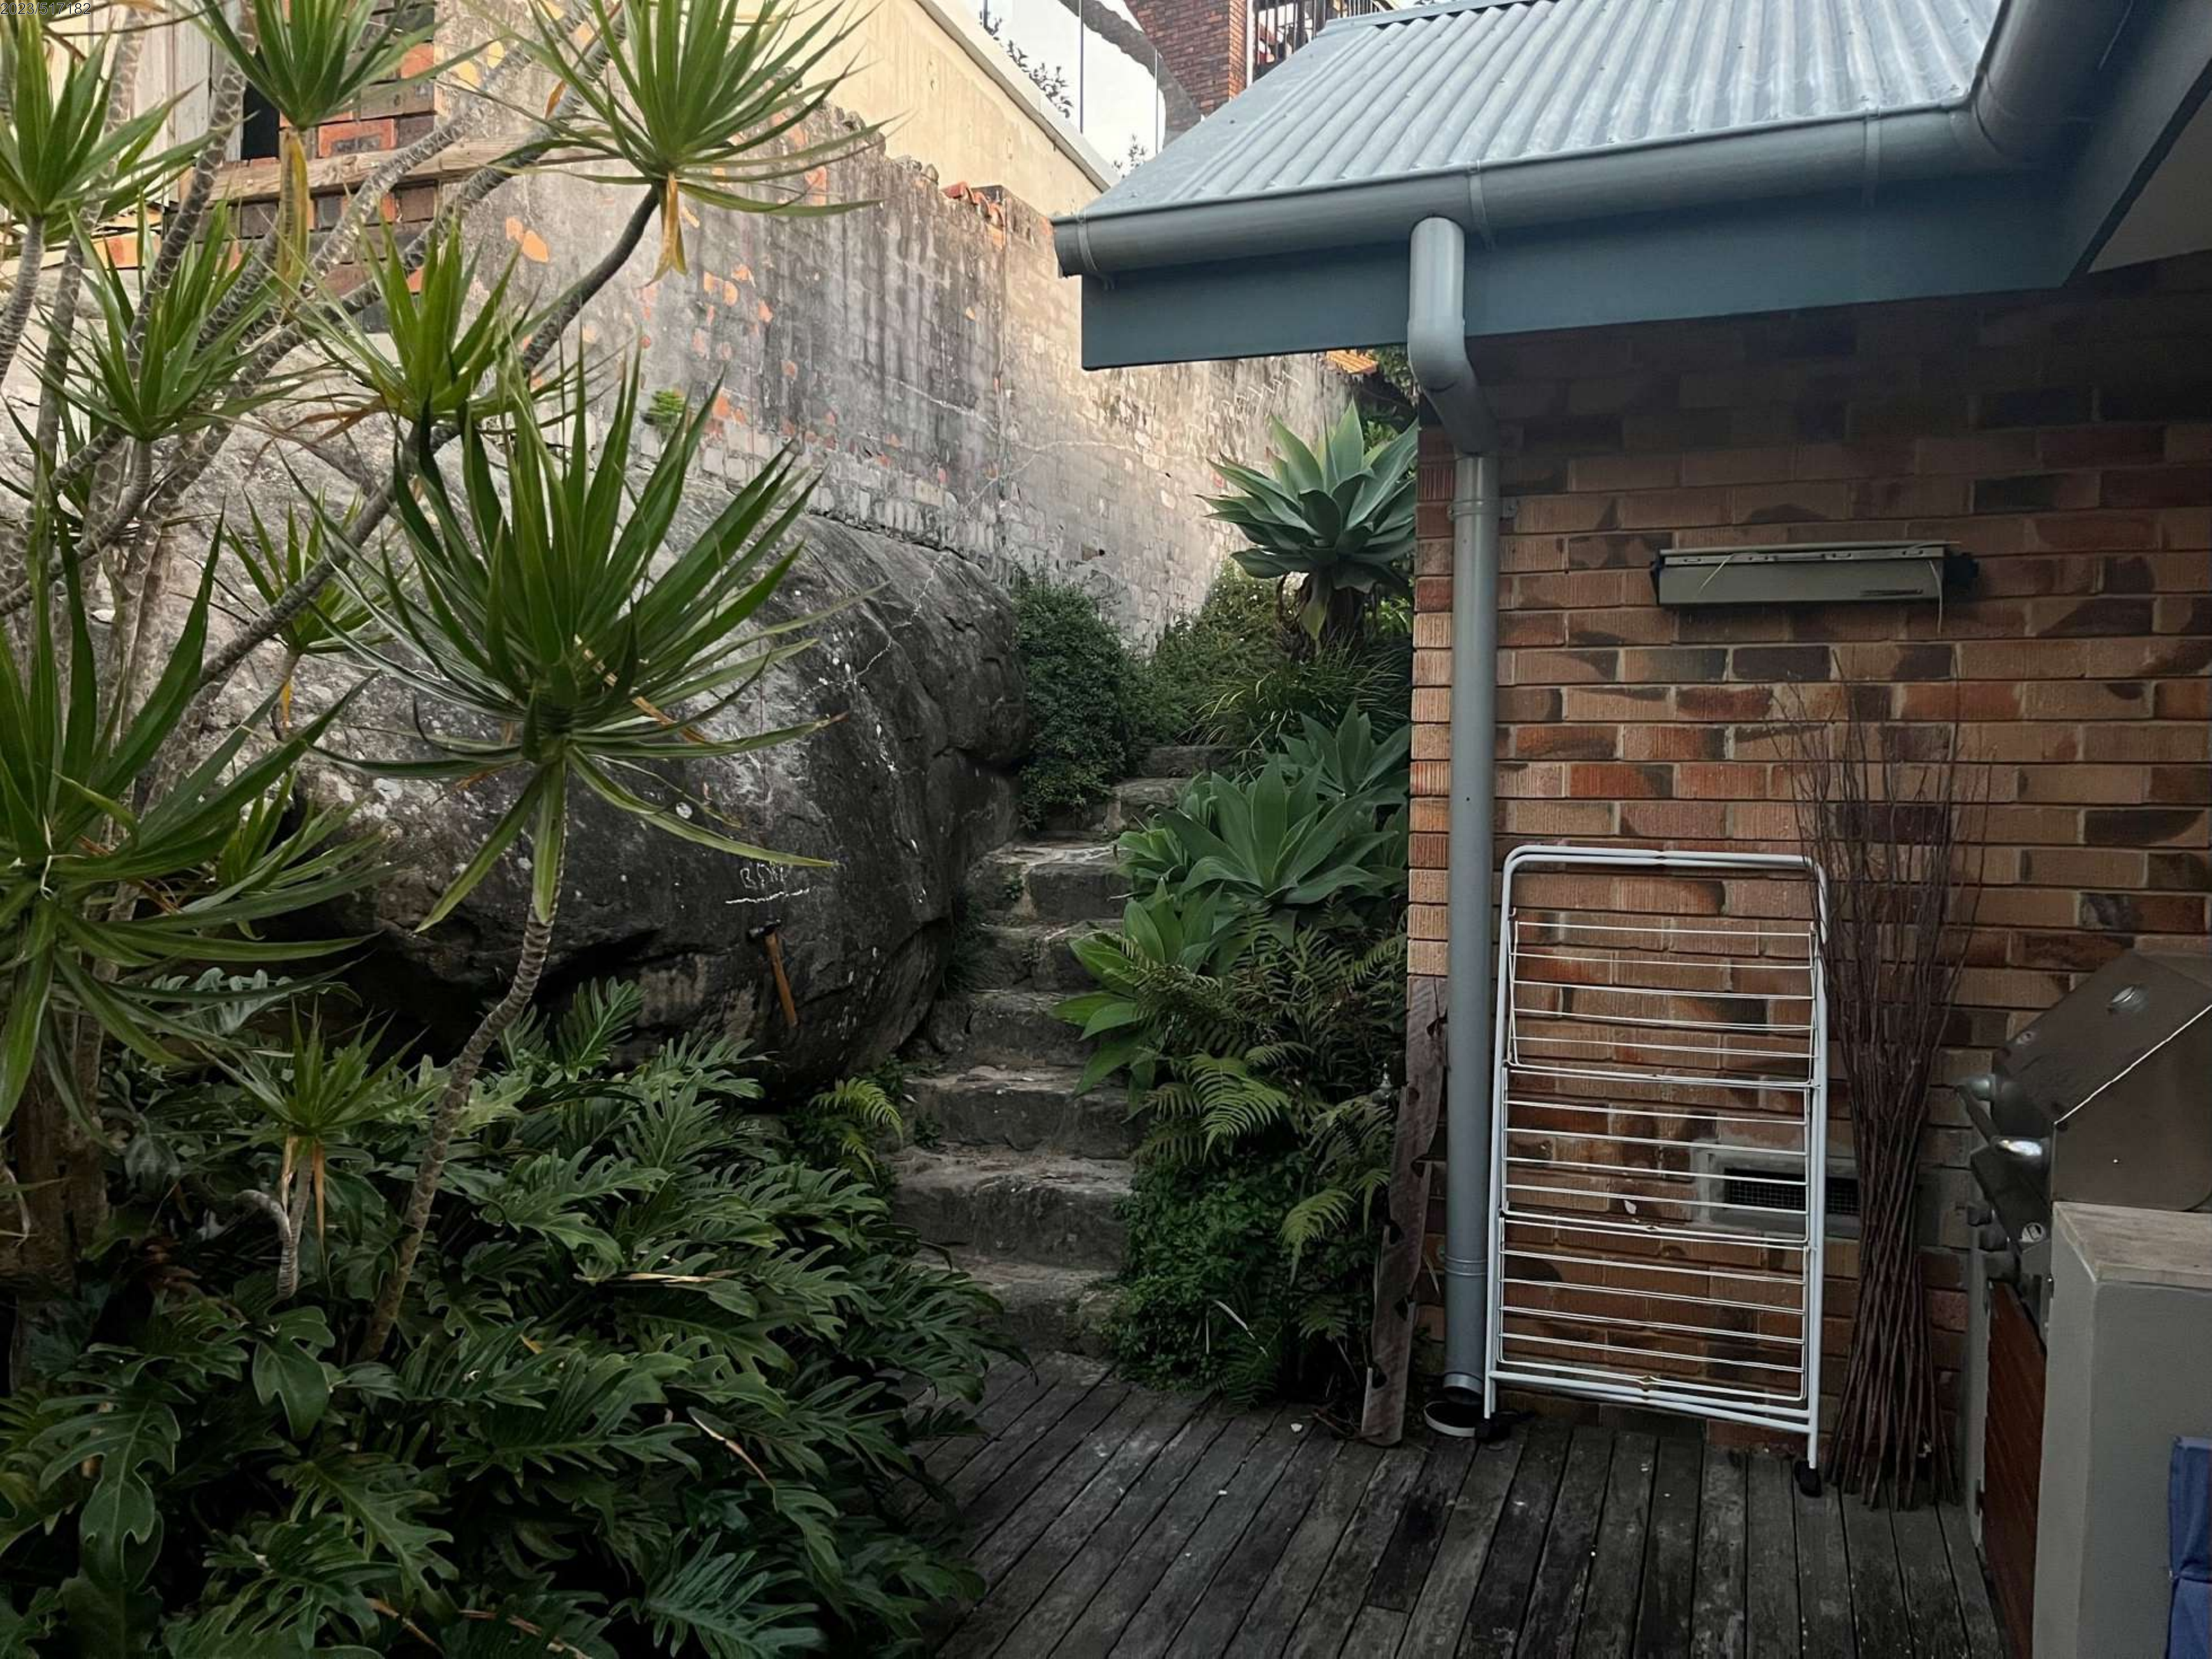
- Photo 1 – Front Lilli Pilli trees v boundary stringline – proximity to trees for footing
- Photo 2 – Rear Sweet Viburnum trees vs. boundary stringline – effect of footings.
- Photo 3 – Tree #1 Bloodwood at wall location at rear
- Photo 4 – Tree #1 flock of birds in trees
- Photo 5 – Front existing dry rock wall / Lilli Pilly trees / boundary at stake / height of existing walls
- Photo 6 – Gas Meter at front & existing dry rock wall
- Photo 7 – Our existing sandstone wall / proposed fence on top
- Photo 8 – Boundary mark on our sandstone wall for proposed fence line
- Photo 9 – Existing rockface / fence / existing deck boundary intersections
- Photo 10 – Existing sandstone steps to rear yard – proposed fence on steps at boundary.
- Photo 11 – Rear proposed wall / Exposing Viburnum trees boundary approx. 100mm away.
- Photo 12 – Existing Rear Garden

I disagree with this statement – earthworks to create concrete footings for proposed sandstone walls ON THE BOUNDARY will certainly affect all the Lilli Pilli trees that are on our property at the front and

the 7 x Sweet Viburnum trees at the REAR. The Arborist report, p6 – Table 2 – acknowledges that the SRZ and the TRZ areas are affected and encroached upon at these locations in a MAJOR way. Please see Photo 1 for front Lilli Pilli's and Photo 2 for the rear Sweet Viburnum.

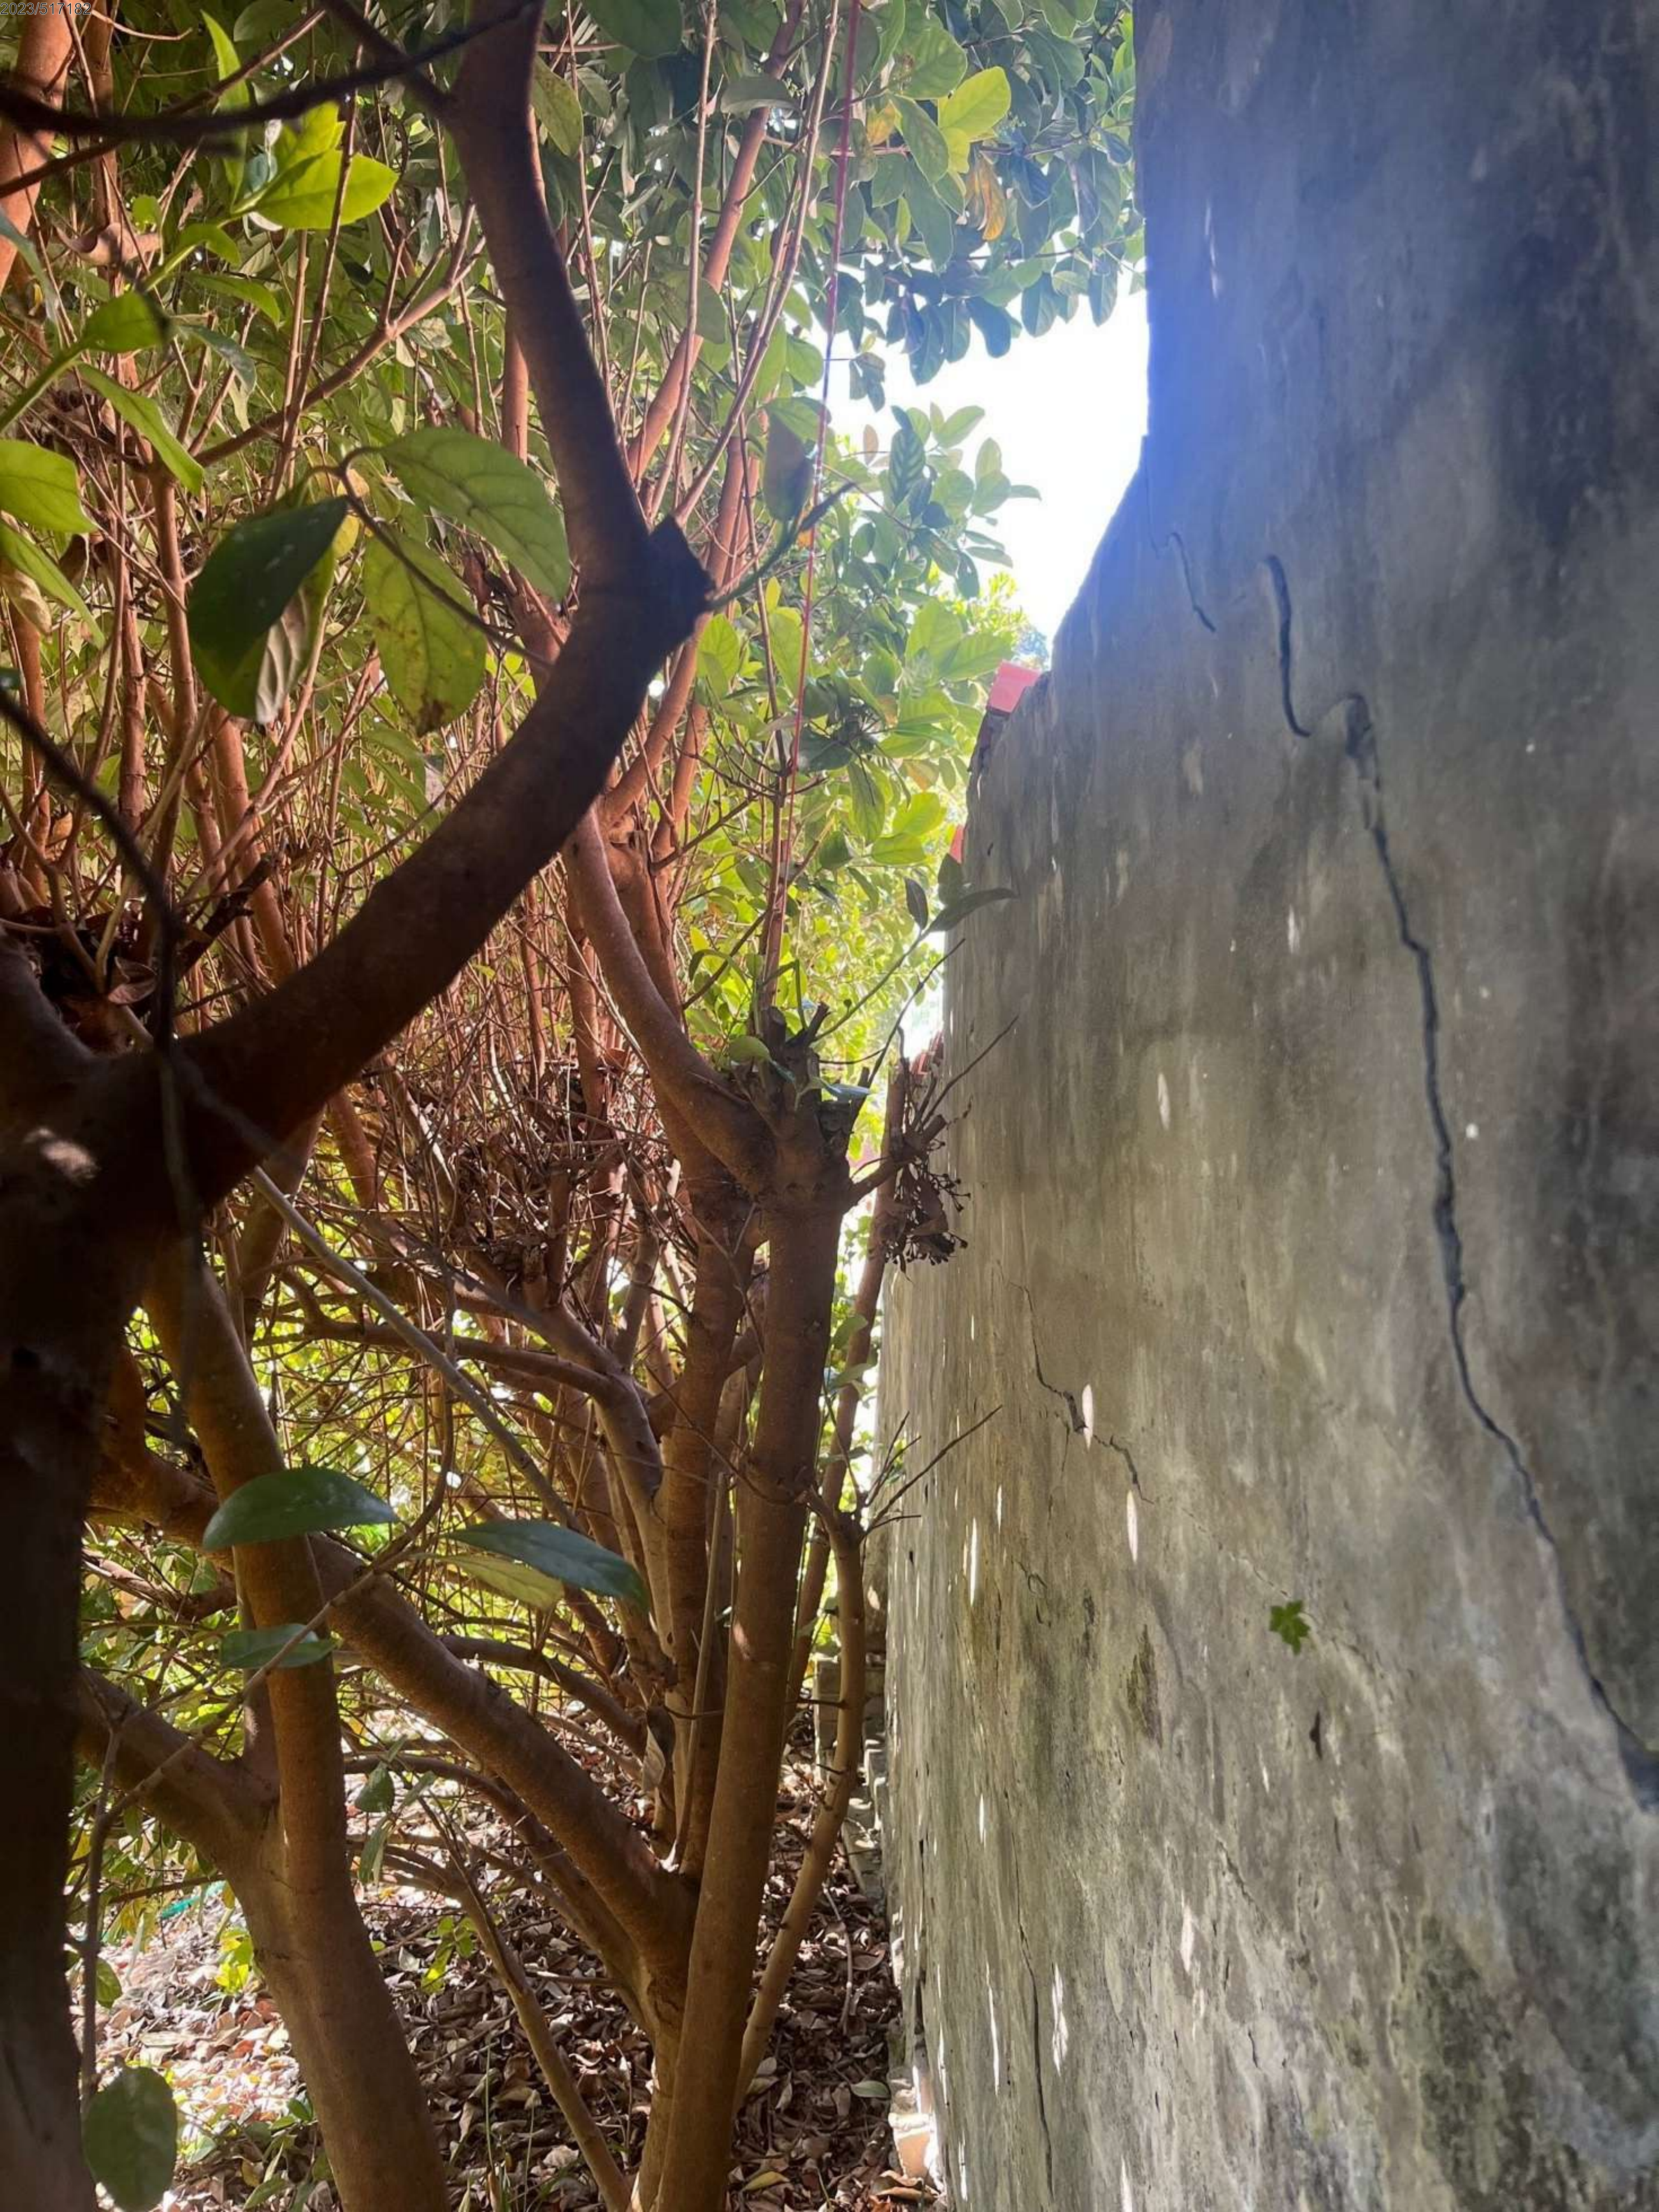
- The 7 x Sweet Viburnum trees at the rear of our property and as noted on the Arborists report will be severely impacted IF the Application is approved. These trees are approx. 20 years old and are regularly trimmed. We disagree completely with the Arborist report that an excavation within 100mm of the main stem of the tree will allow for “a tolerance of root disturbance”. These trees will have their SRZ and their TRZ seriously affected due to any proposed earthworks/ concrete footing.

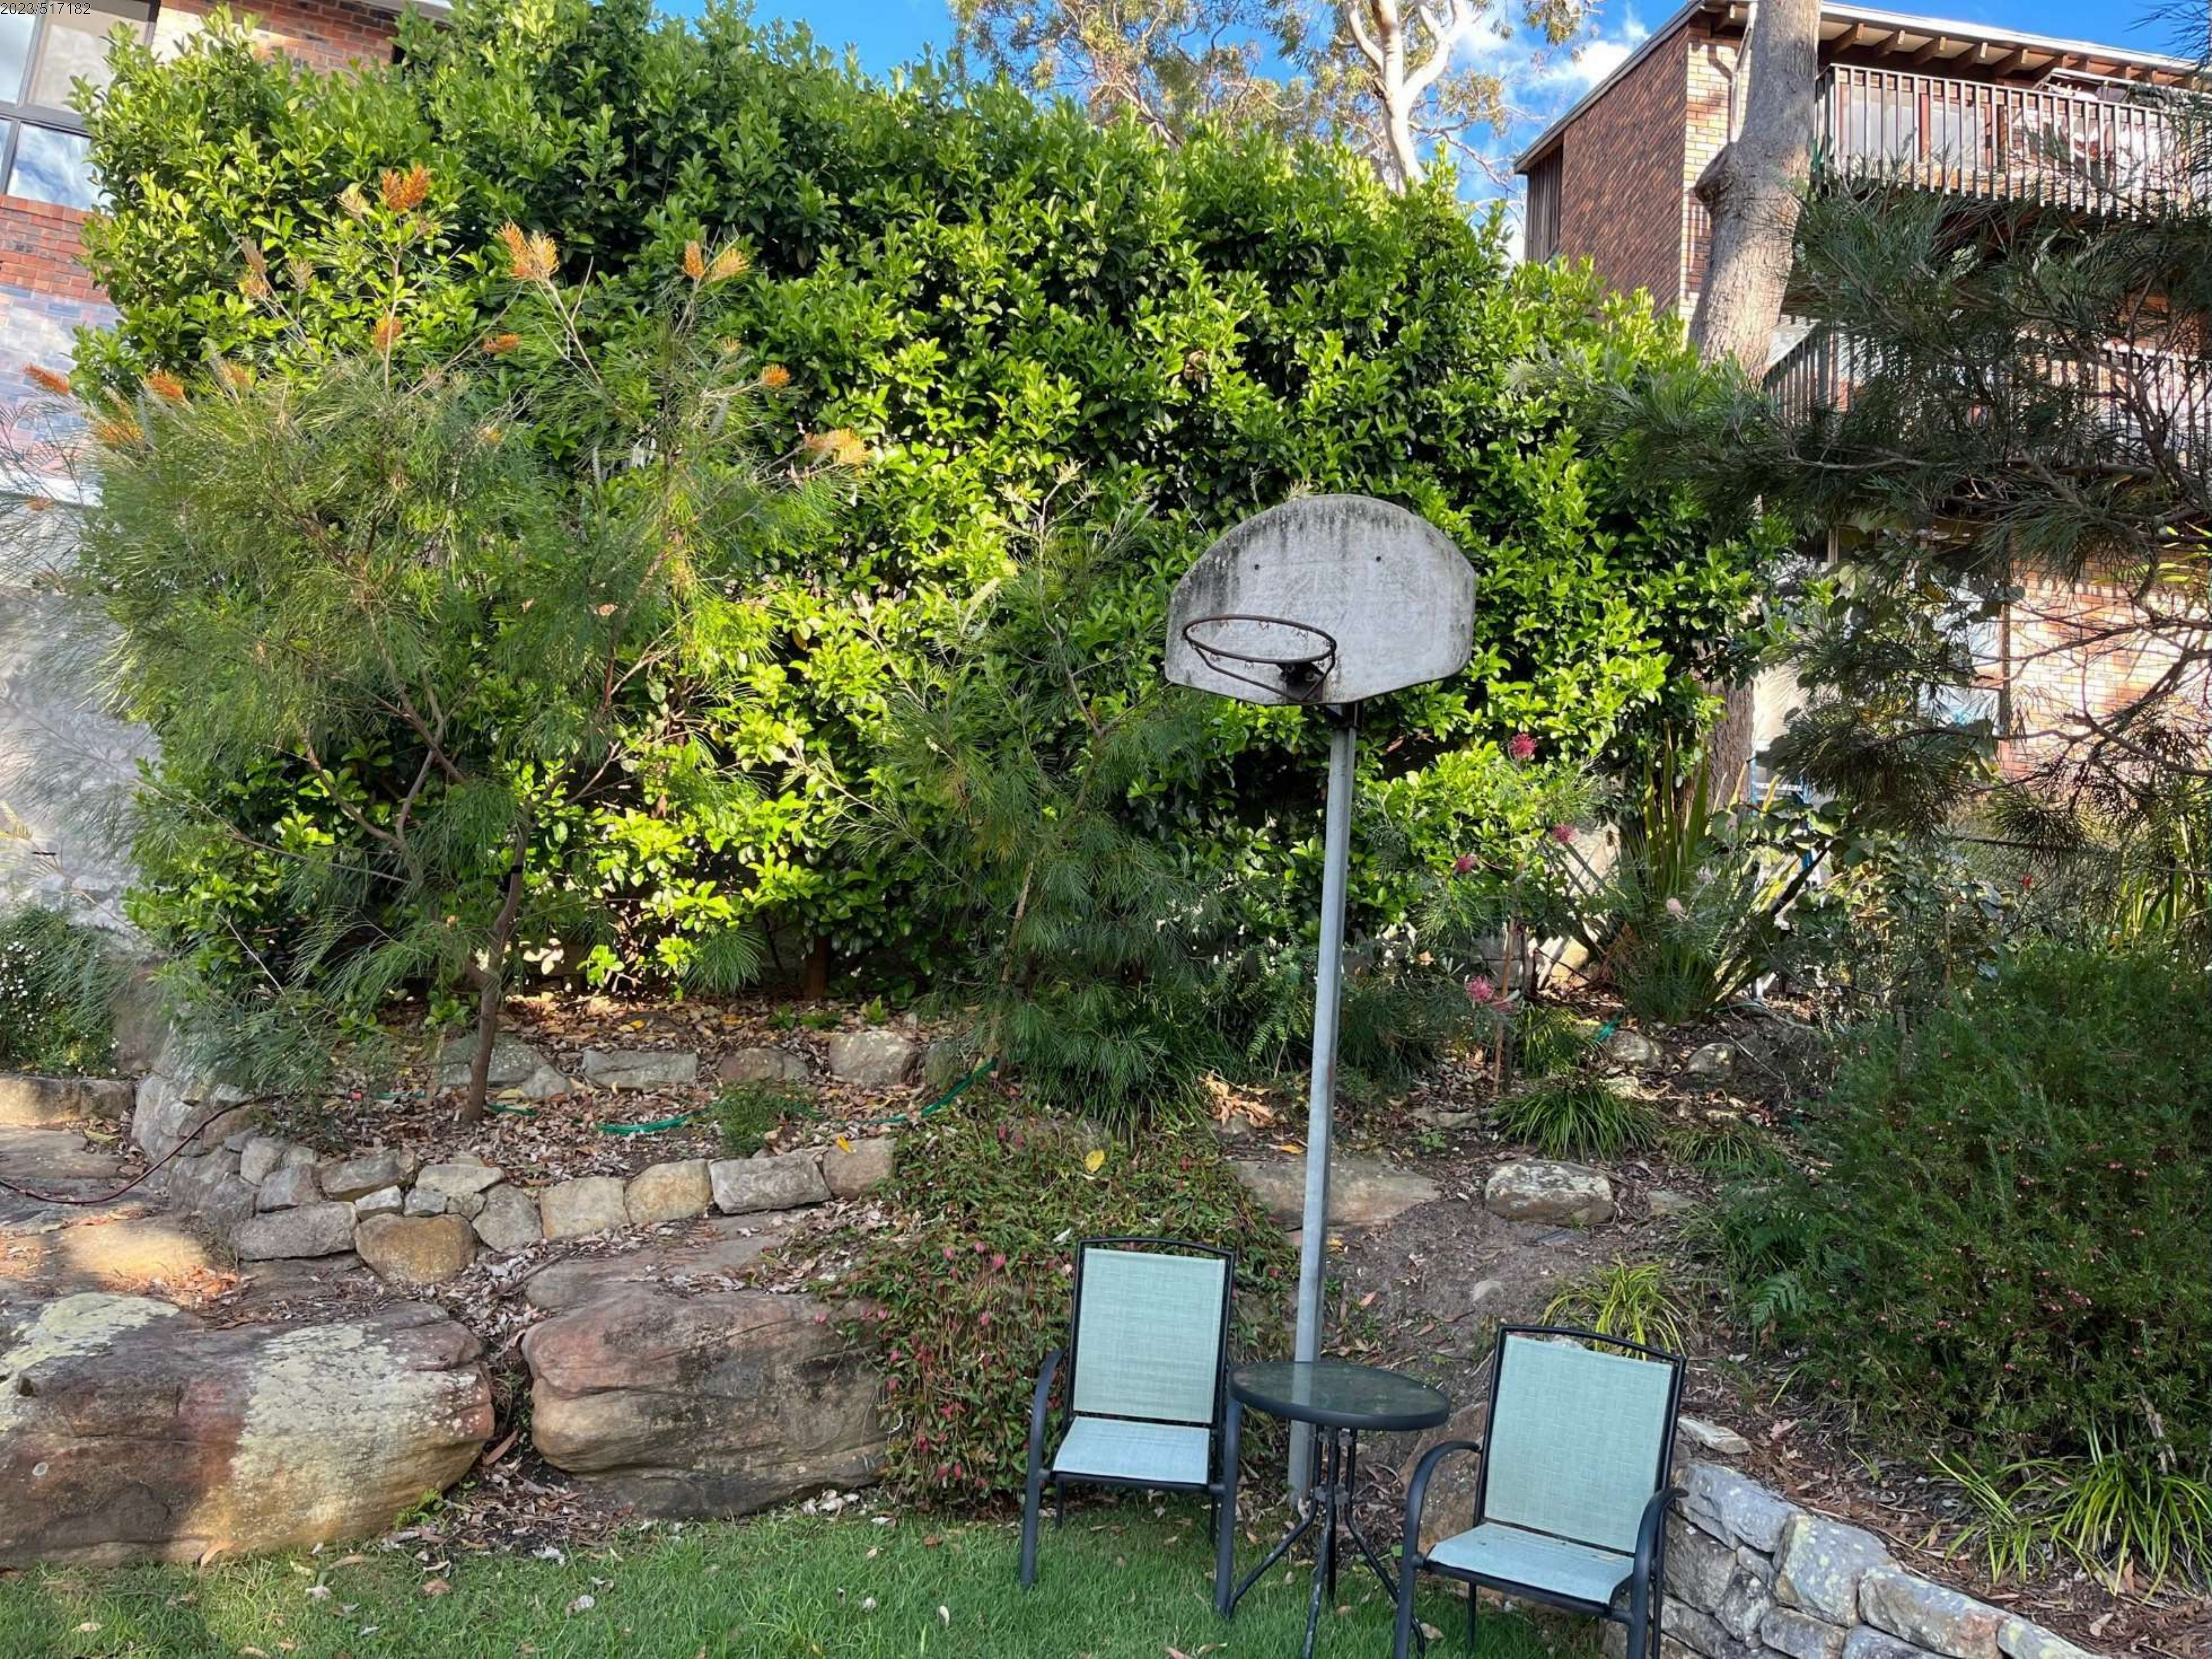
The tree is not using the wall as a" brace", the wall is using the tree as a brace – see Photo # 3.

- The Tree #1 – Red Bloodwood at the rear of the property as previously stated is probably at least 40 years old, same height as when we moved in 25 years ago. This tree is basically located 7/8 on our property on the boundary. I would state that this is a very mature tree. As stated already the tree is not using the wall as a brace but rather the wall is braced / supported off the tree.

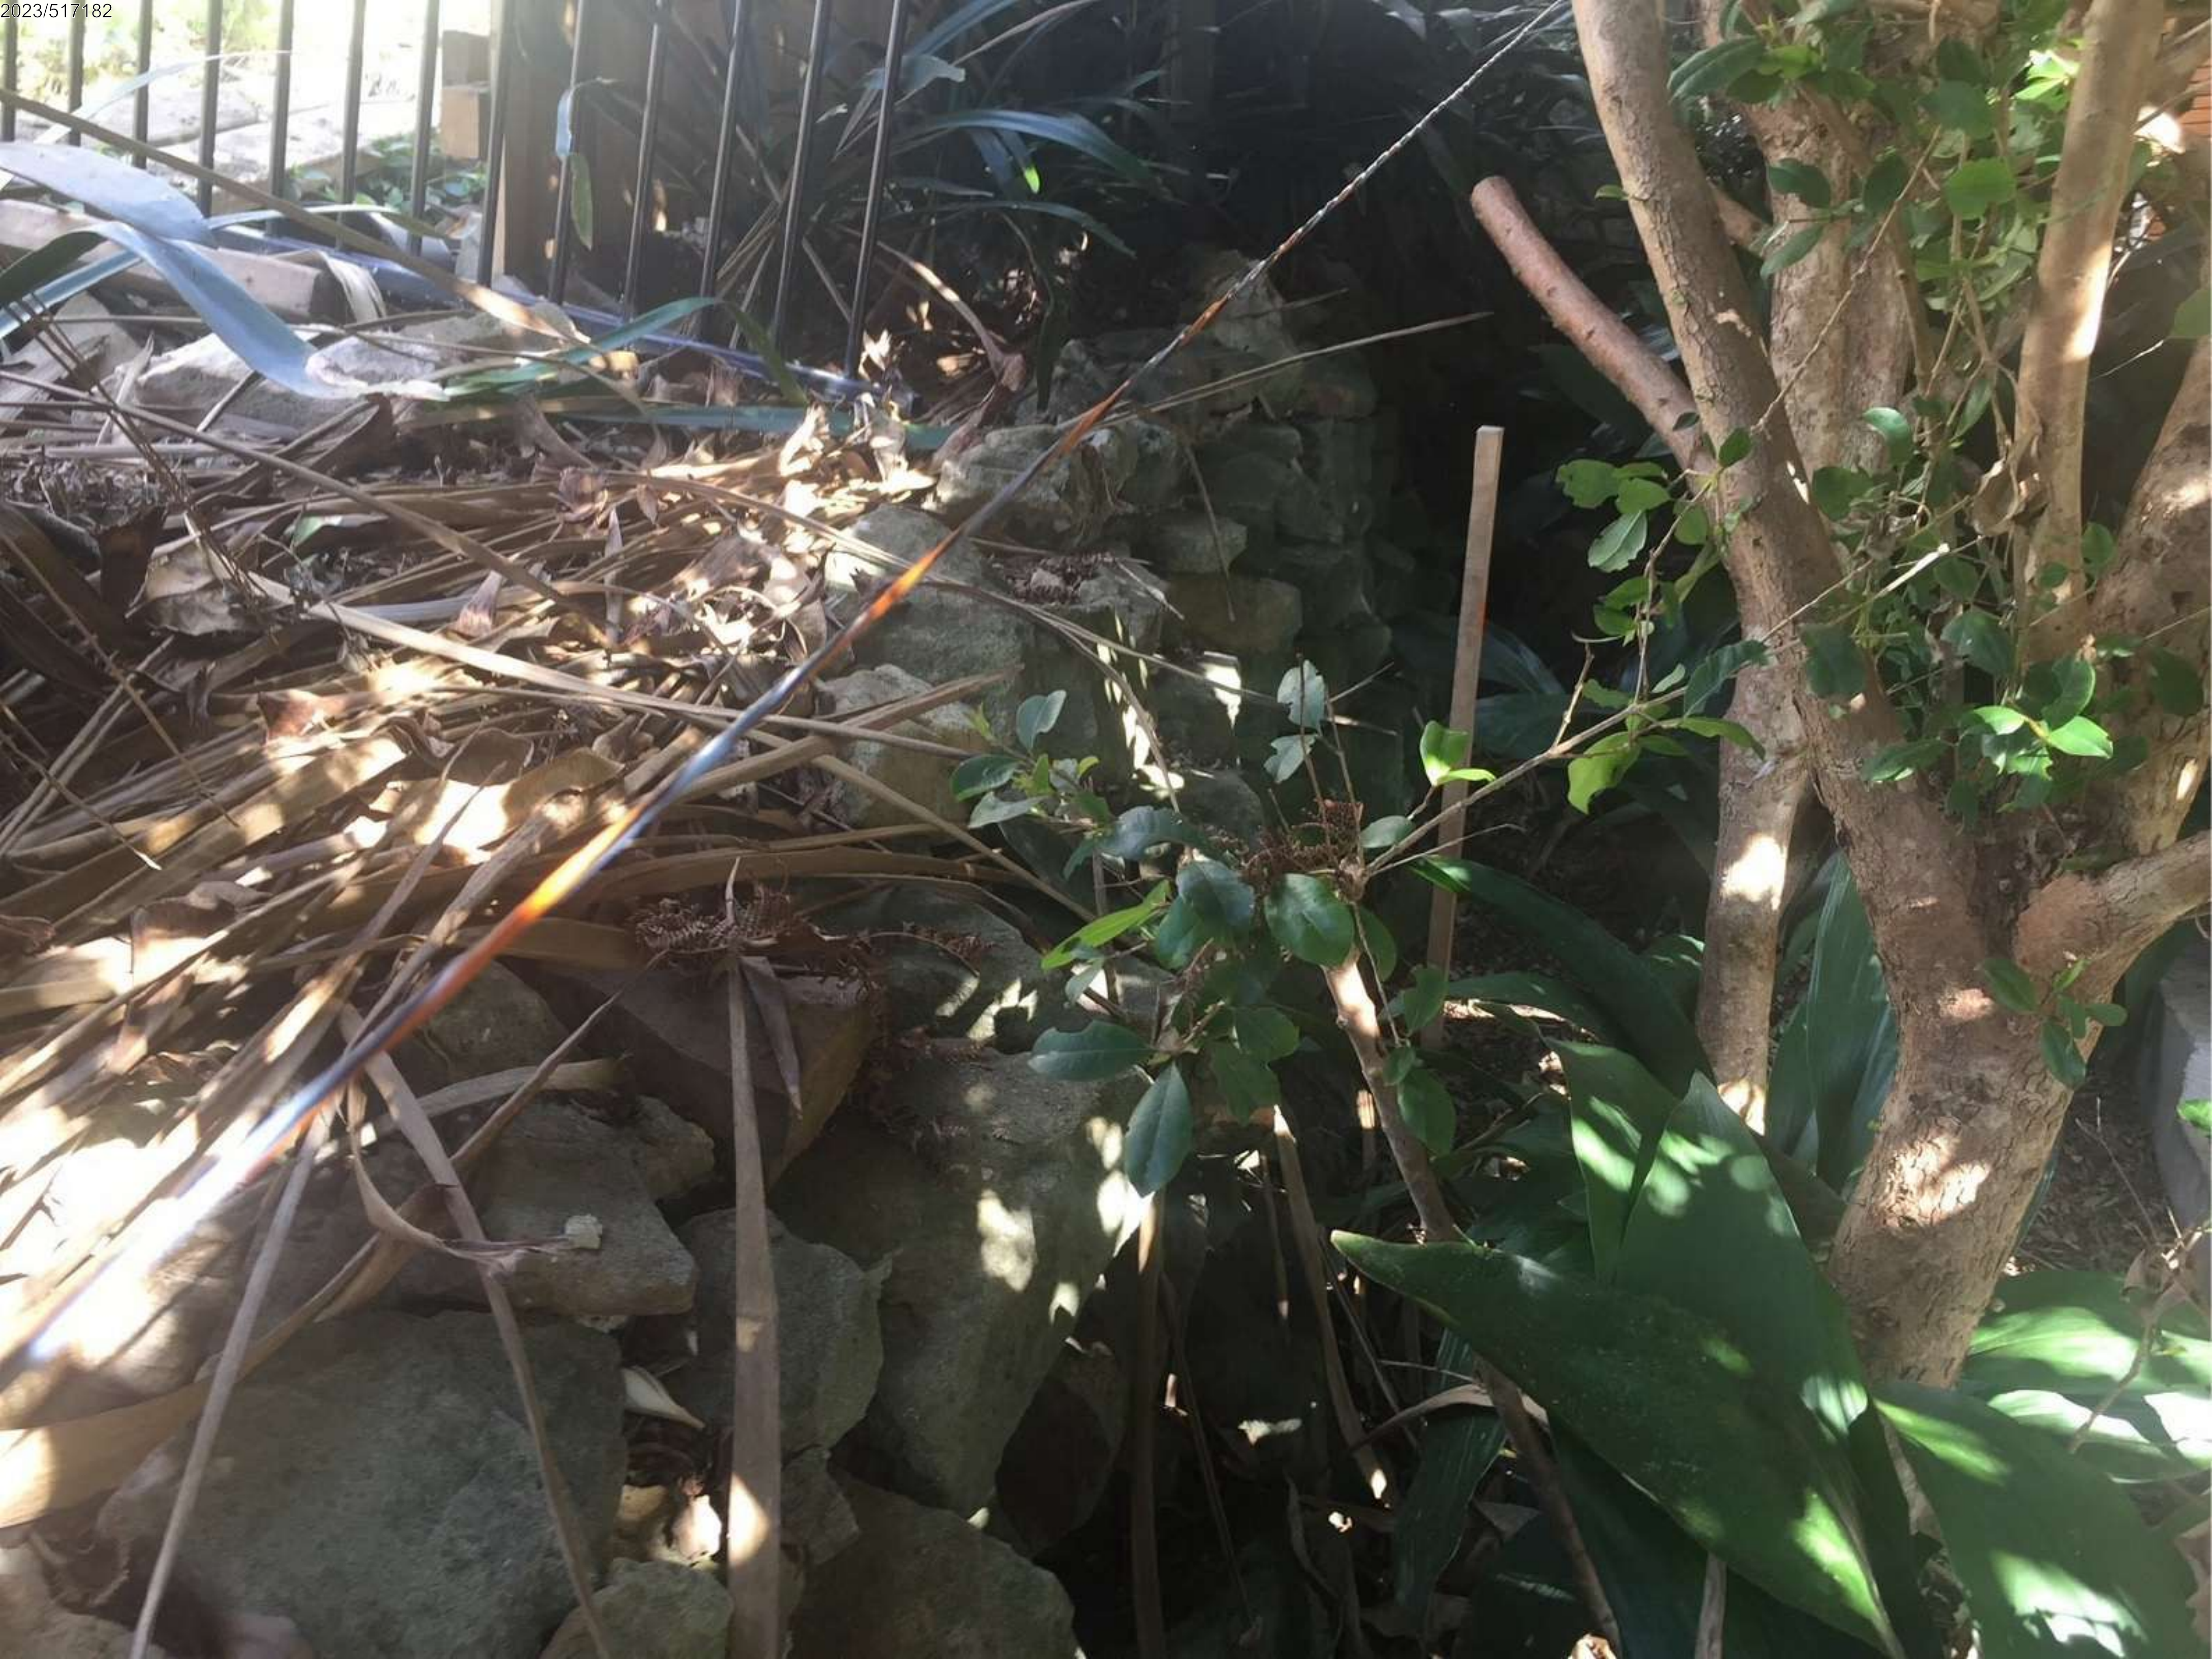
This tree is at least 40-50 years old; we have been in this house for 26 years and the tree was the same height when we bought the house. Please see Photo 4 of flocks of birds within the rear Tree #1.

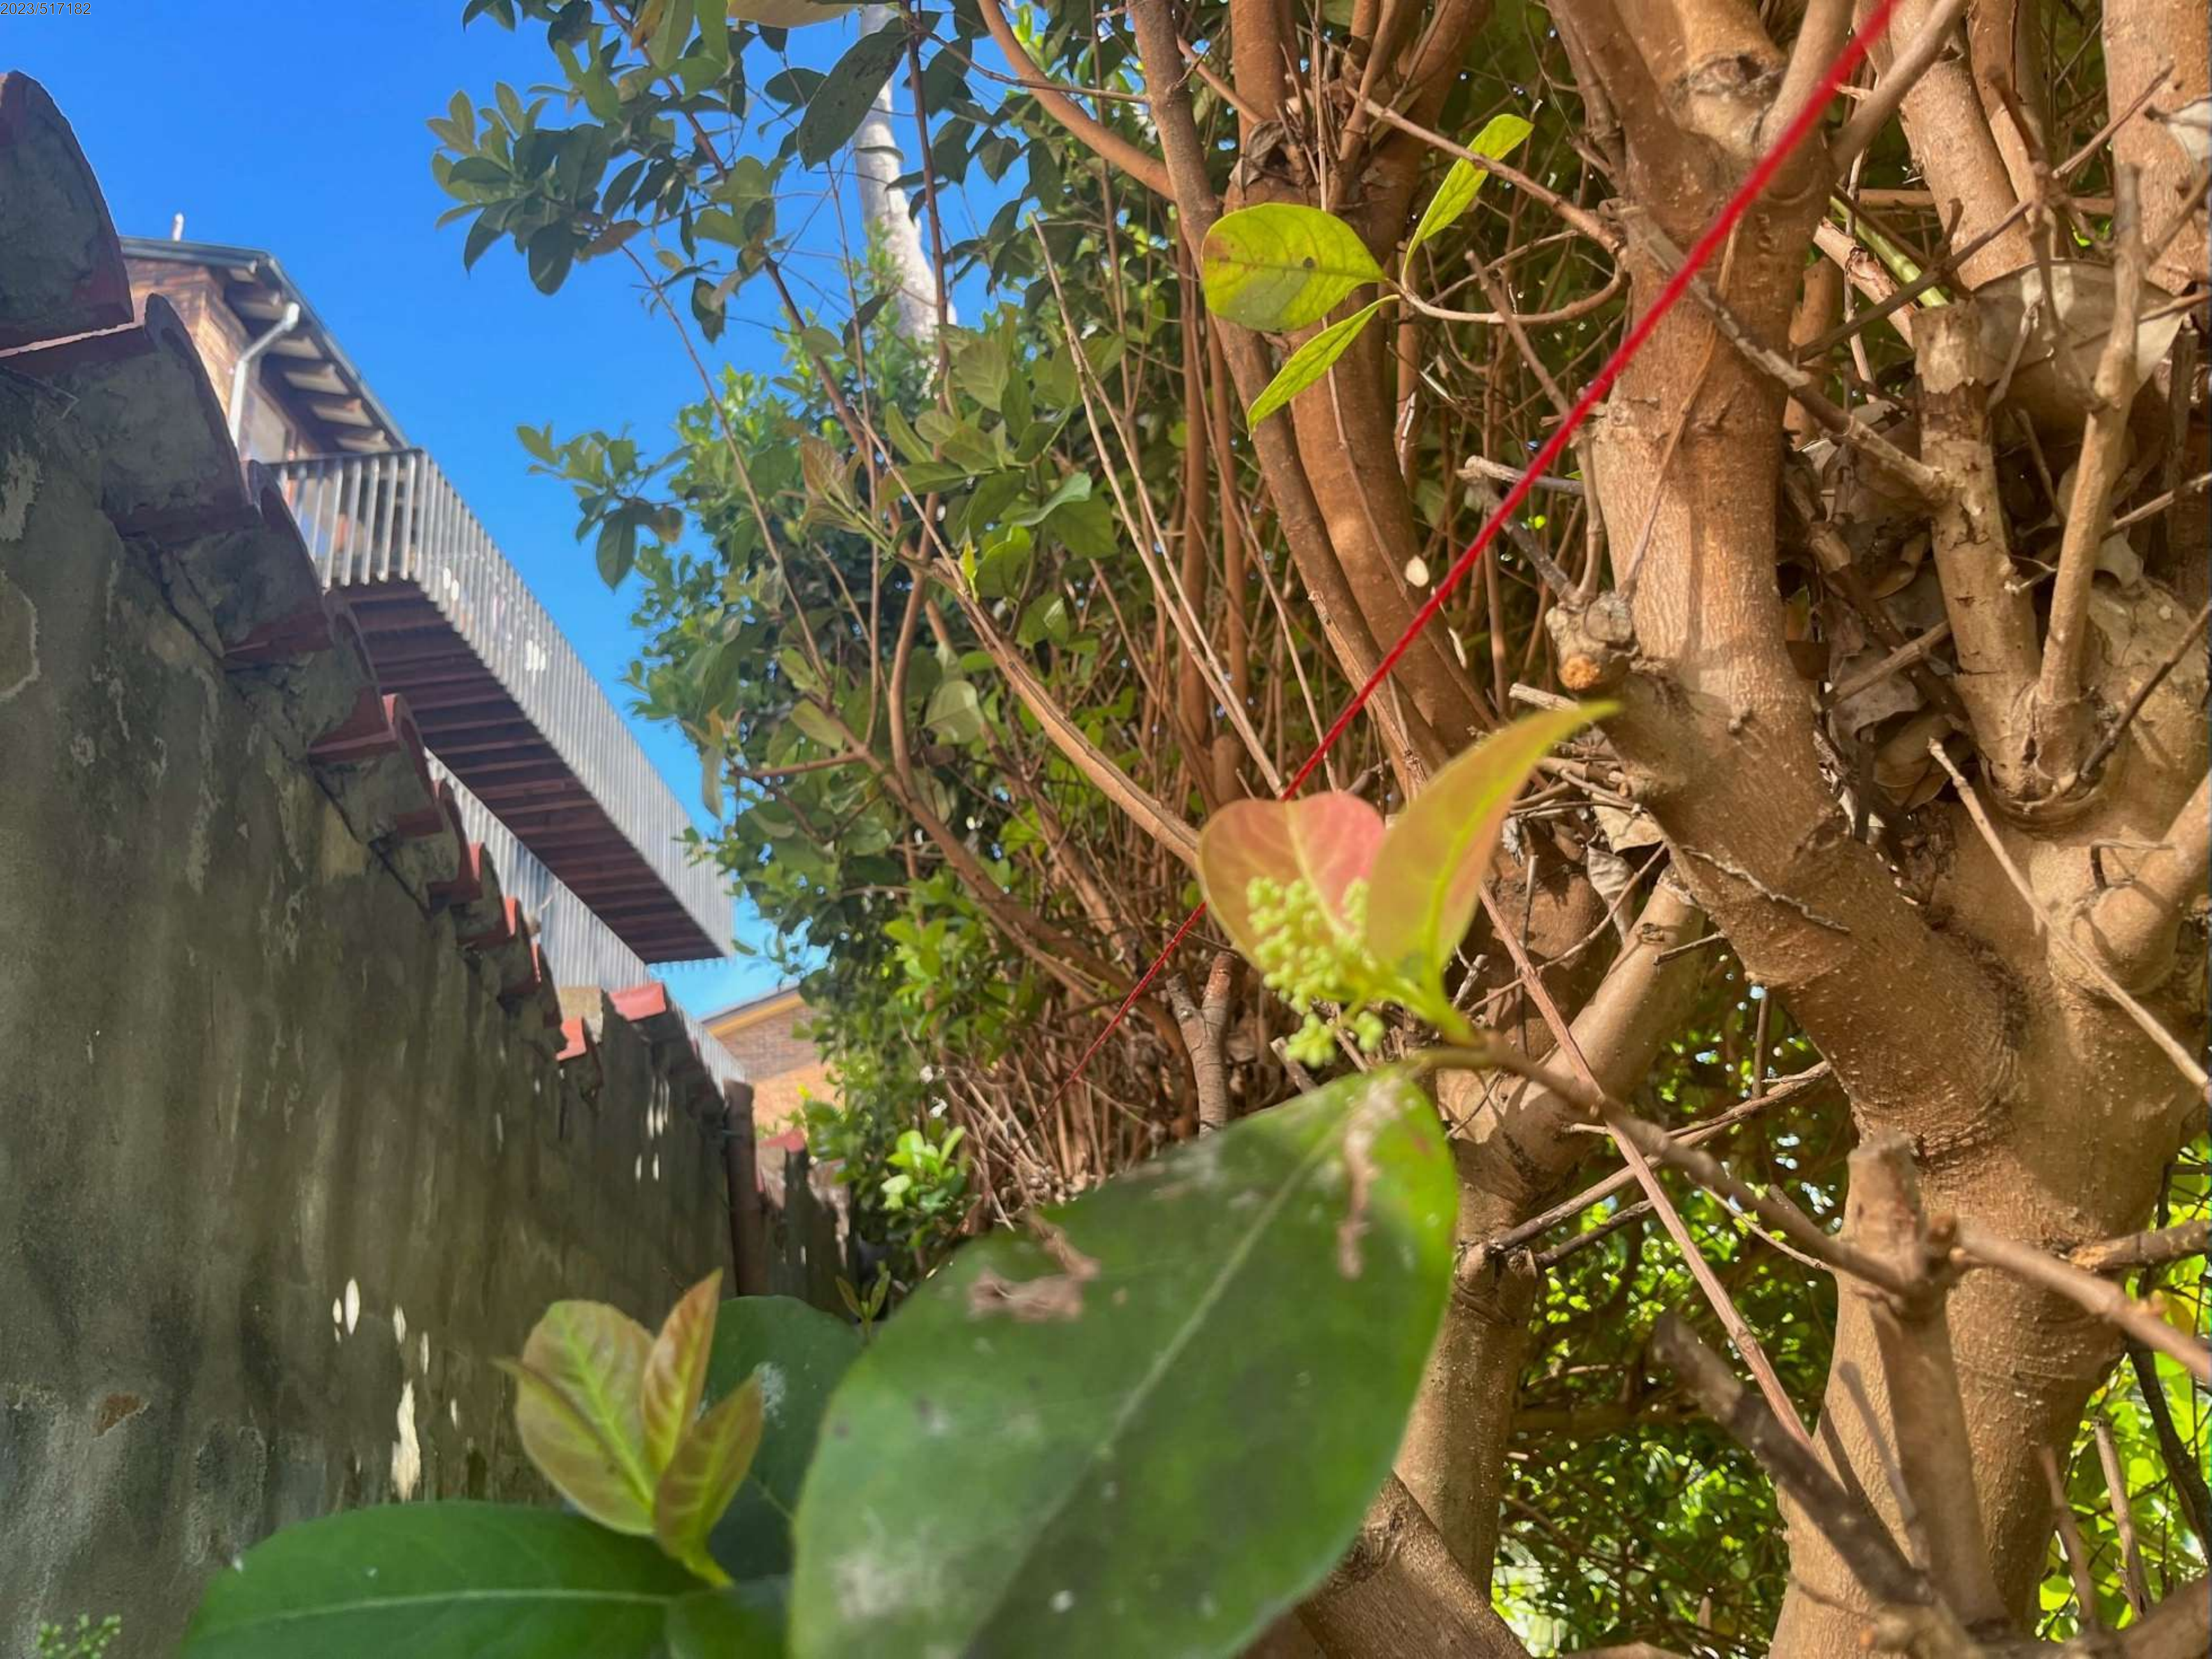
- We also advise that this existing retaining wall has been in this location from when and prior to our purchase 25 years ago. Obviously, it appears to be in conformity to a degree with the 1m offset rule from boundary when constructed. Please see Photo 5 re: Lilli Pilli trees front v stake at the boundary.
