**From:** John Lawson  
**Sent:** 15/08/2023 12:34:45 PM  
**To:** Council Northernbeaches Mailbox  
**Subject:** DA2023/1023 - 32 Loblay Crescent Bilgola Plateau - Submission Opposing the Development Application

## SUBMISSION IN REGARD TO DA/2023/1023 - 32 LOBLAY CRESCENT BILGOLA PLATEAU

*Description: Alterations and additions to a dwelling house including retaining walls*

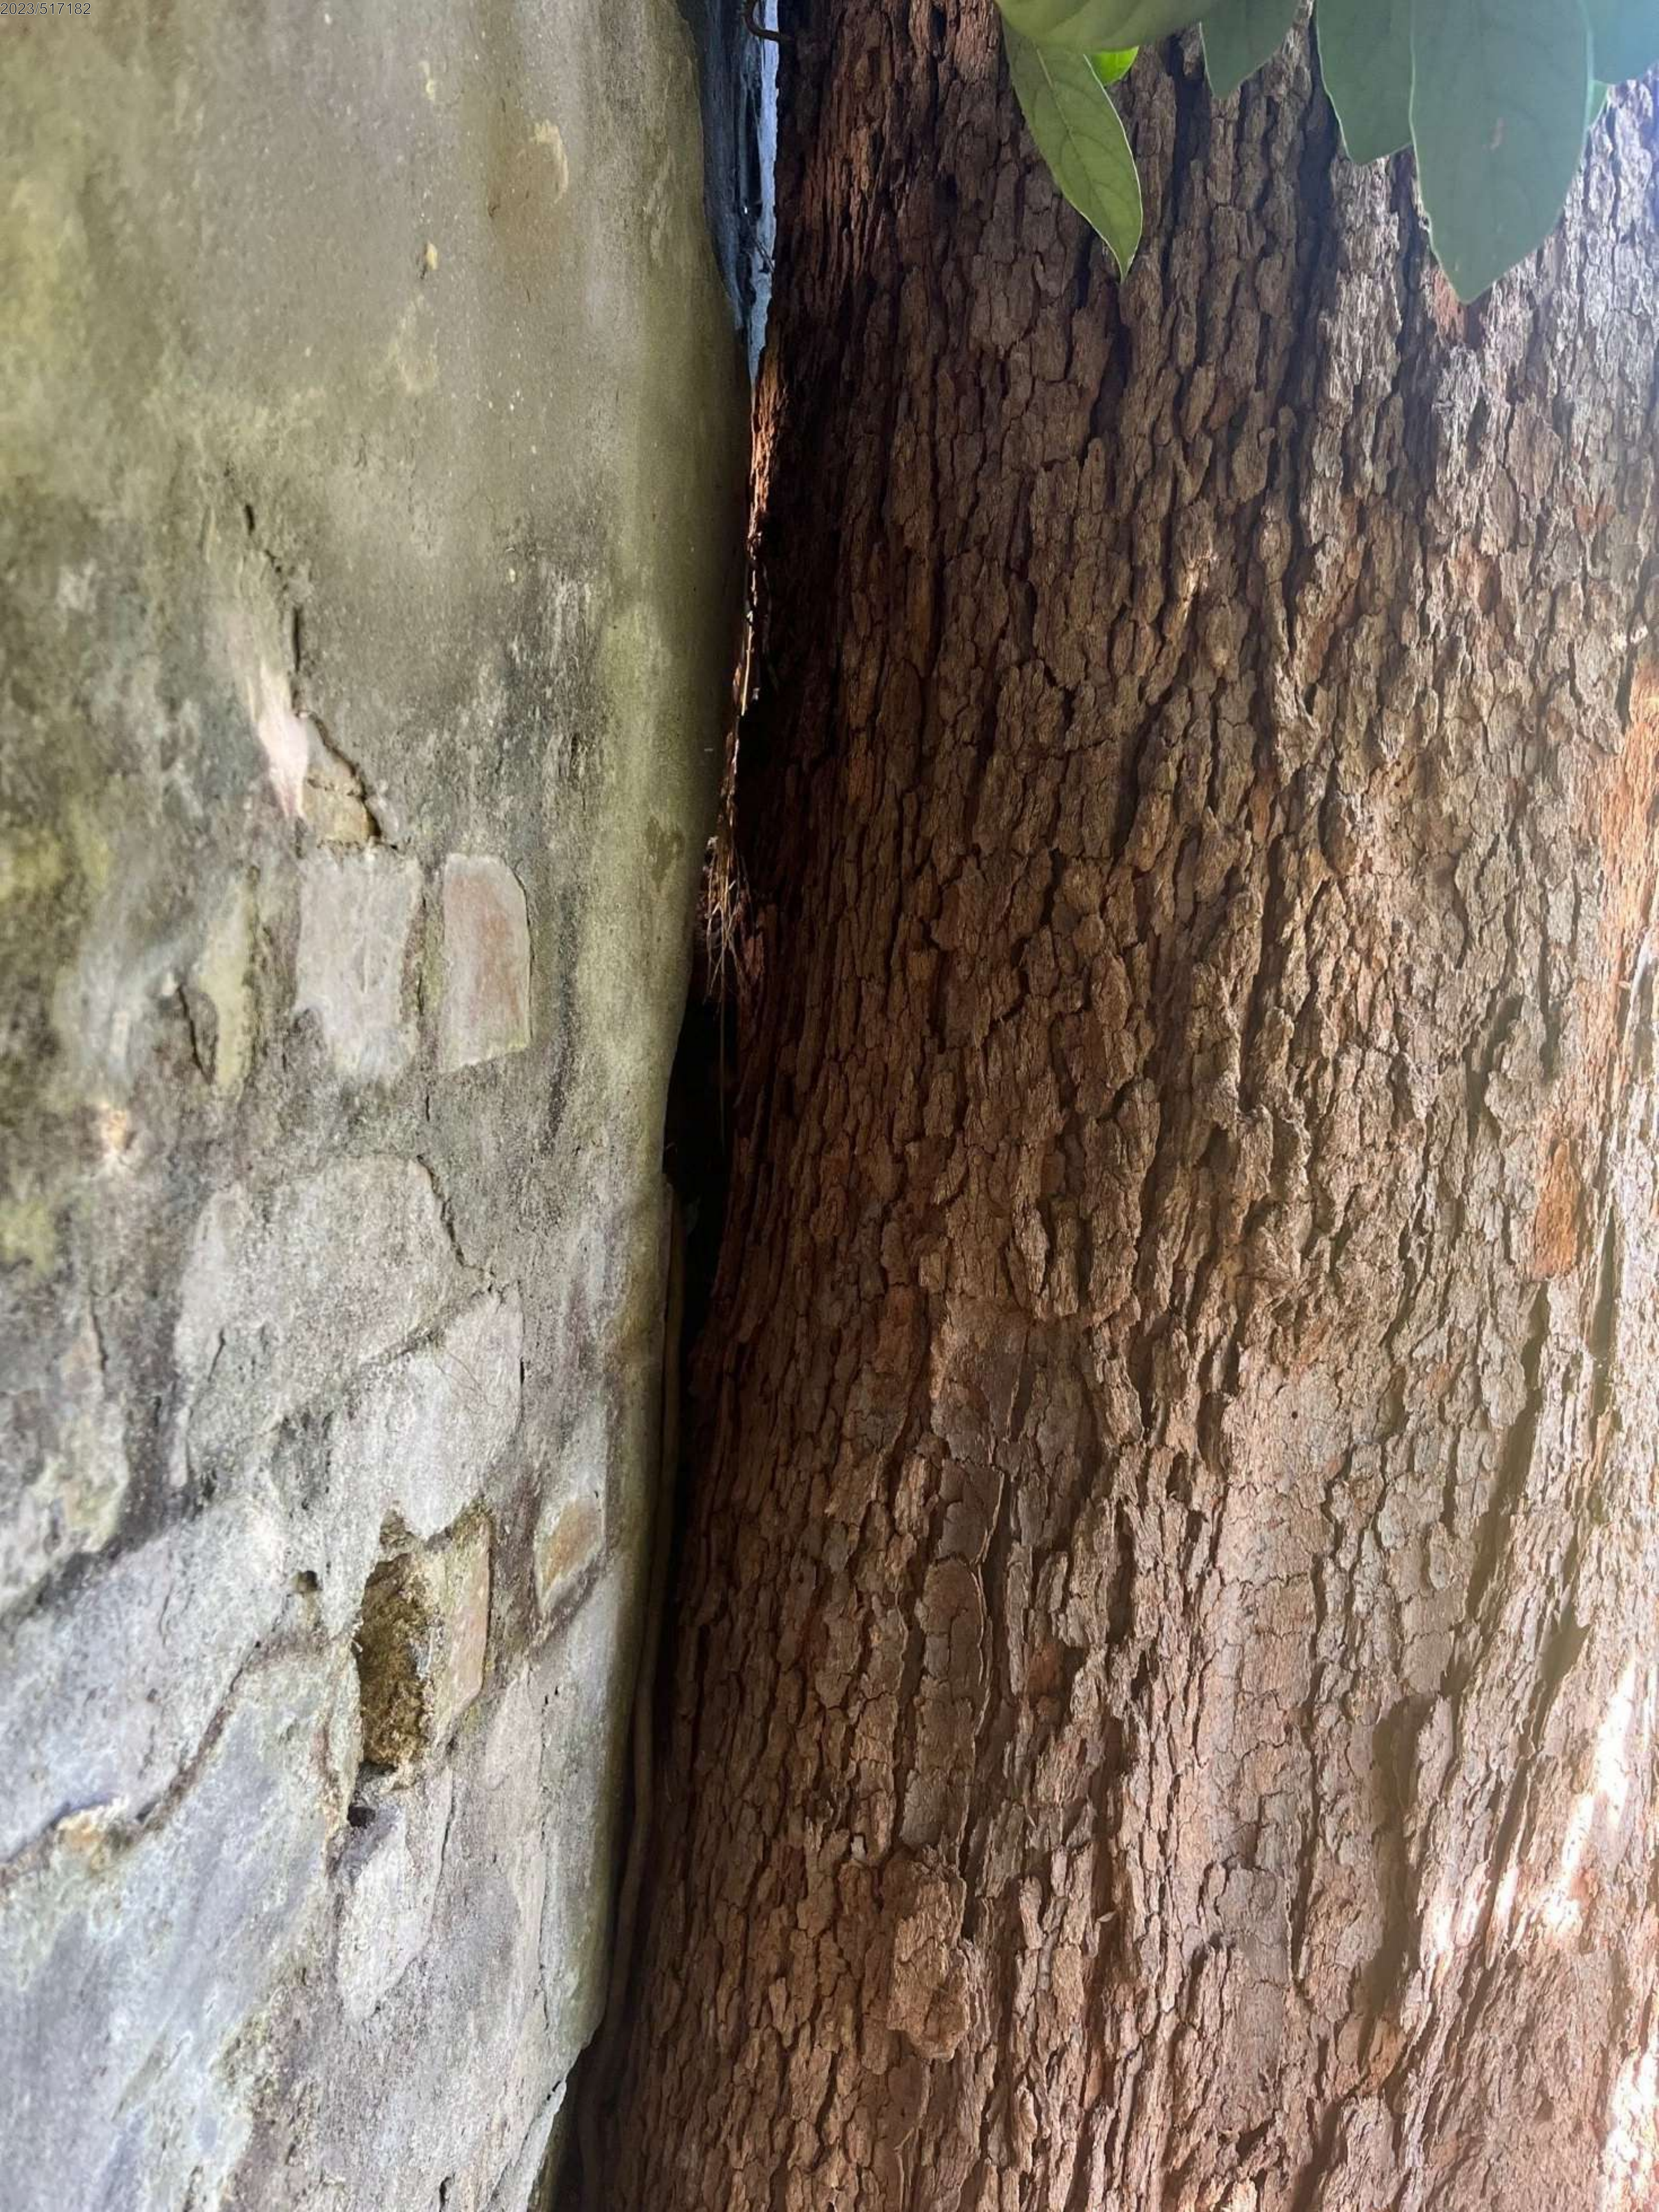
- I would also advise that our gas meter is very close to the boundary location, and we are concerned with the effect of gas services in our existing planter box location. Any

alterations to this service, if required, would need to be at the applicants' costs. Please see Photo 6.

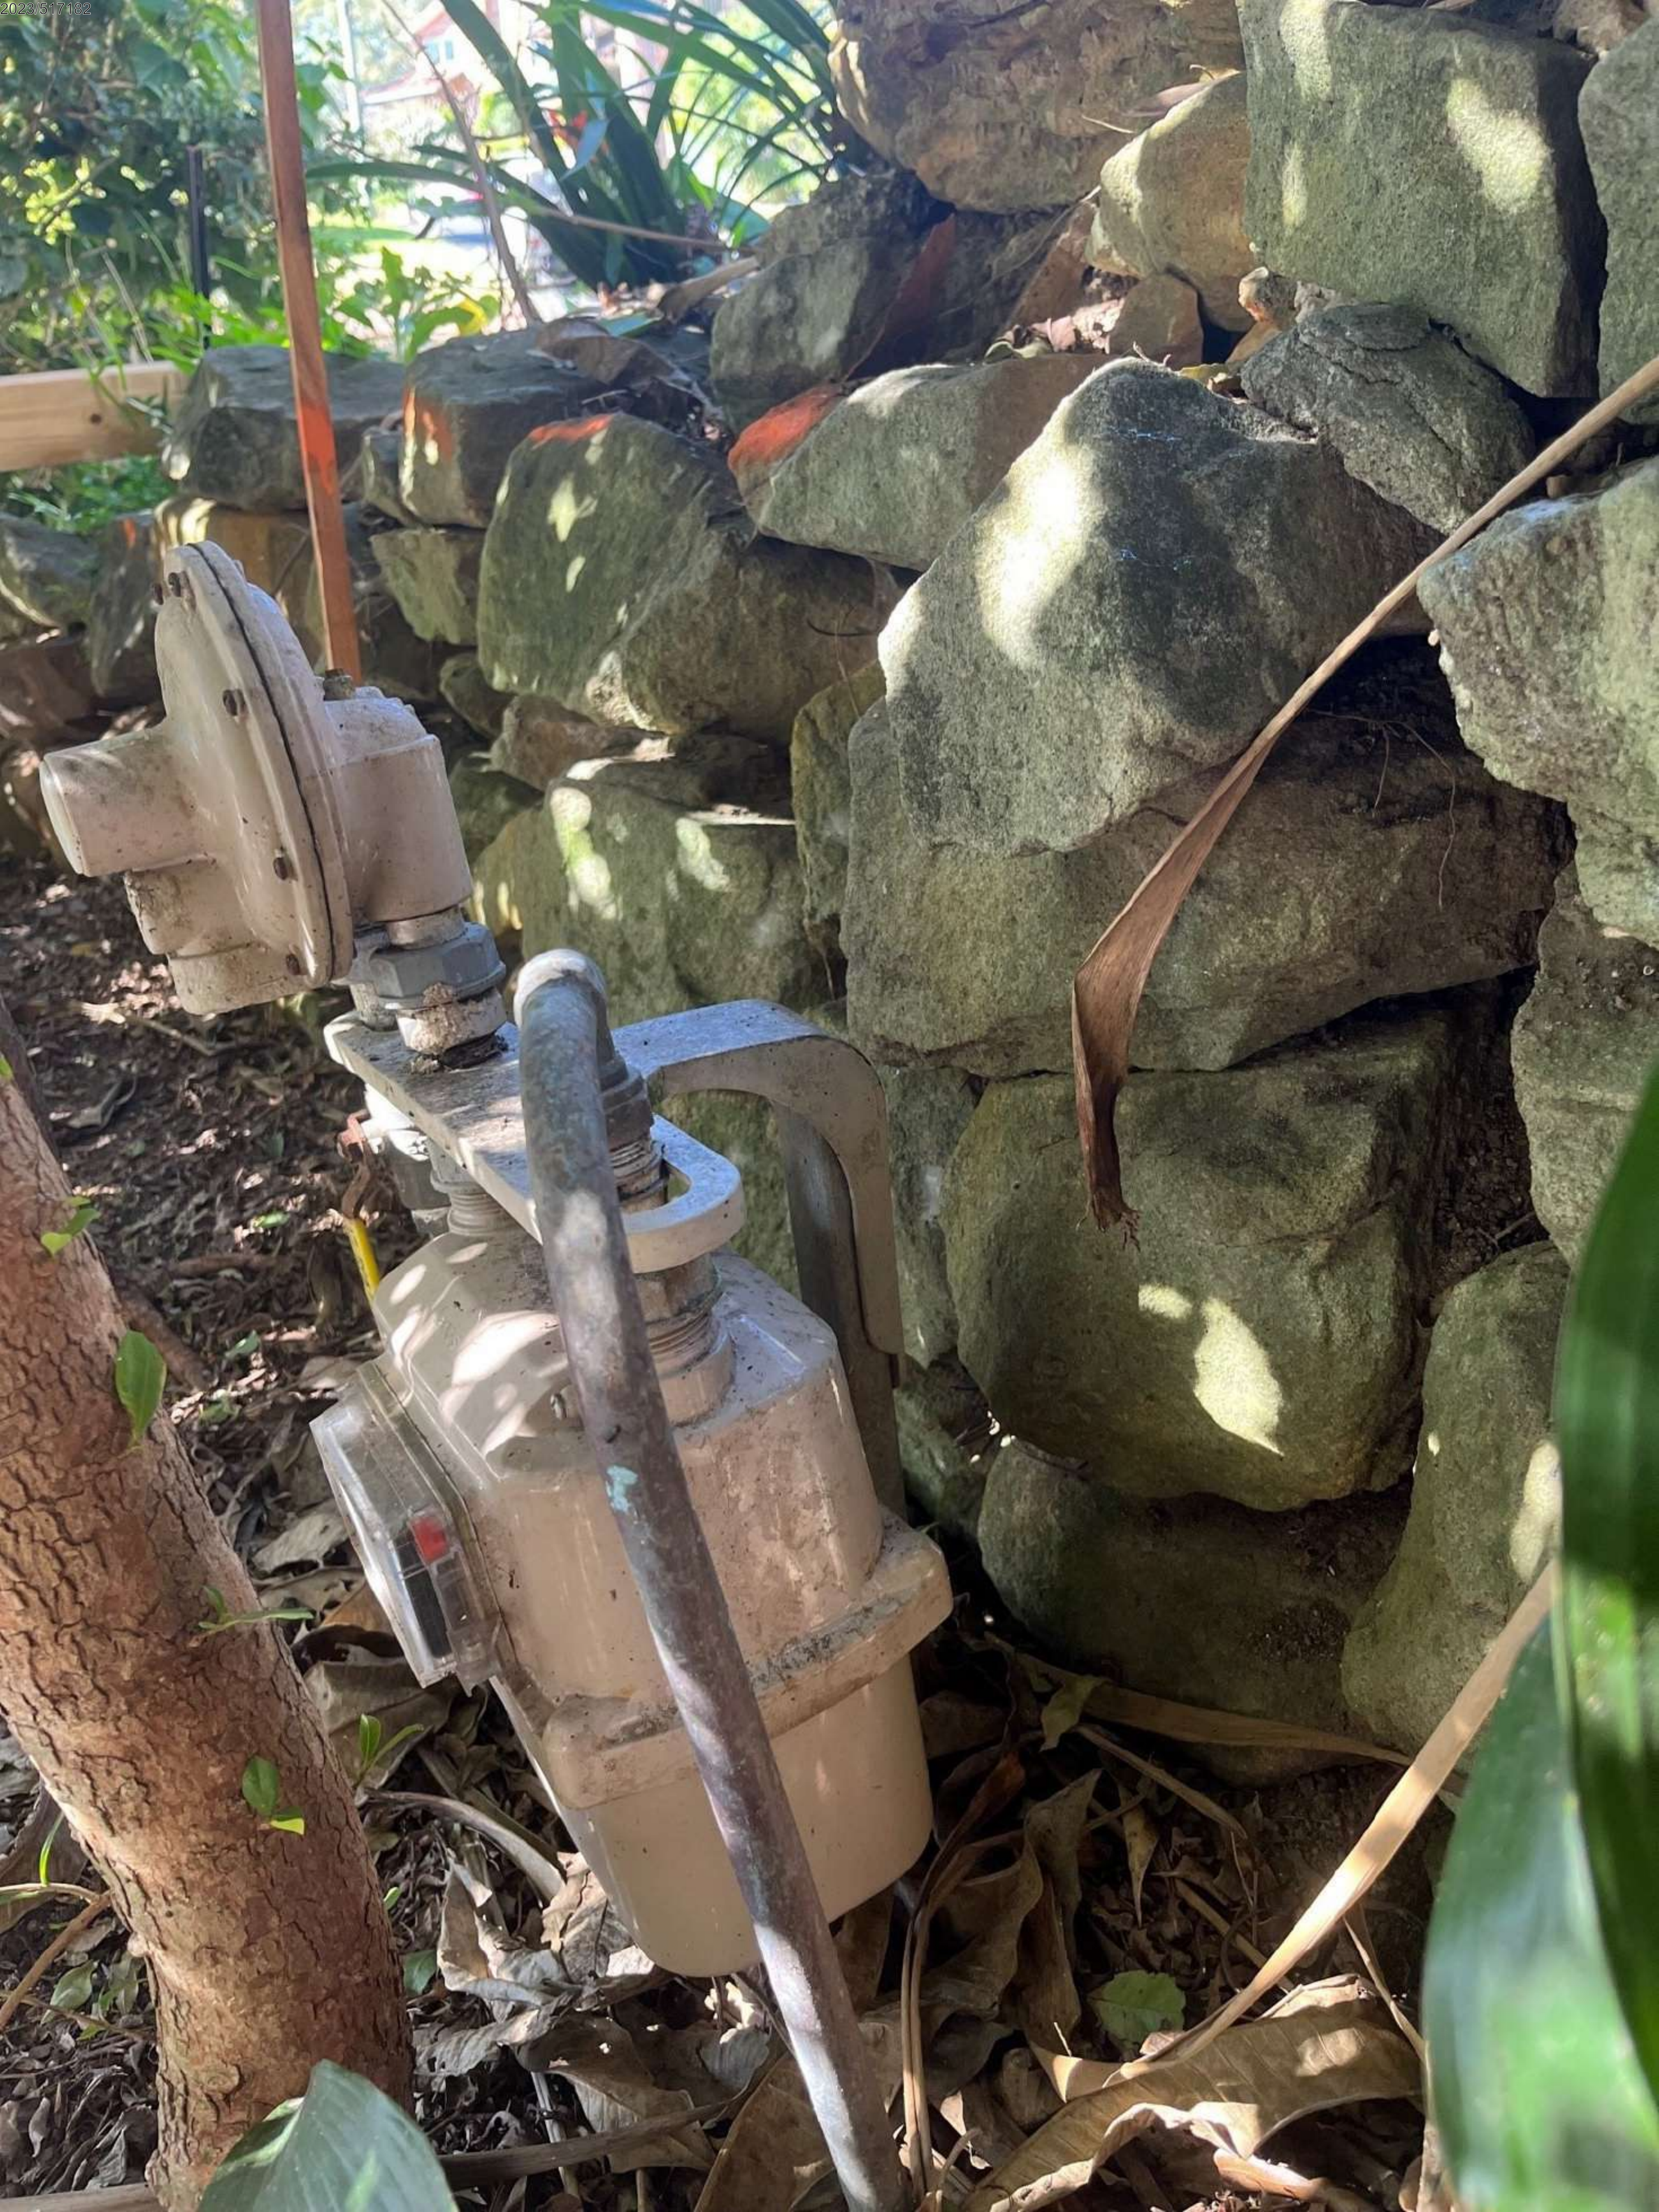
- Heading further southwest along the boundary it will intersect with our existing sandstone landscape steps that allow access into our rear yard area. This will mean that approximately ½ of the width of our steps will be lost rendering the steps ineffective and unable to access our rear yard area. These steps were built in this format due to the presence of a large tree near the S/W rear corner of our house which unfortunately fell over during a large storm and had to be removed. Please see Photo #10 for details.

- We would request please as a condition of the DA; if you approve same, for the rectification/ replacement of our existing sandstone steps so that we can maintain access into our rear yard area. This should be at the Applicants expense, but we would prefer to obtain Tradesmen ourselves to perform the works.

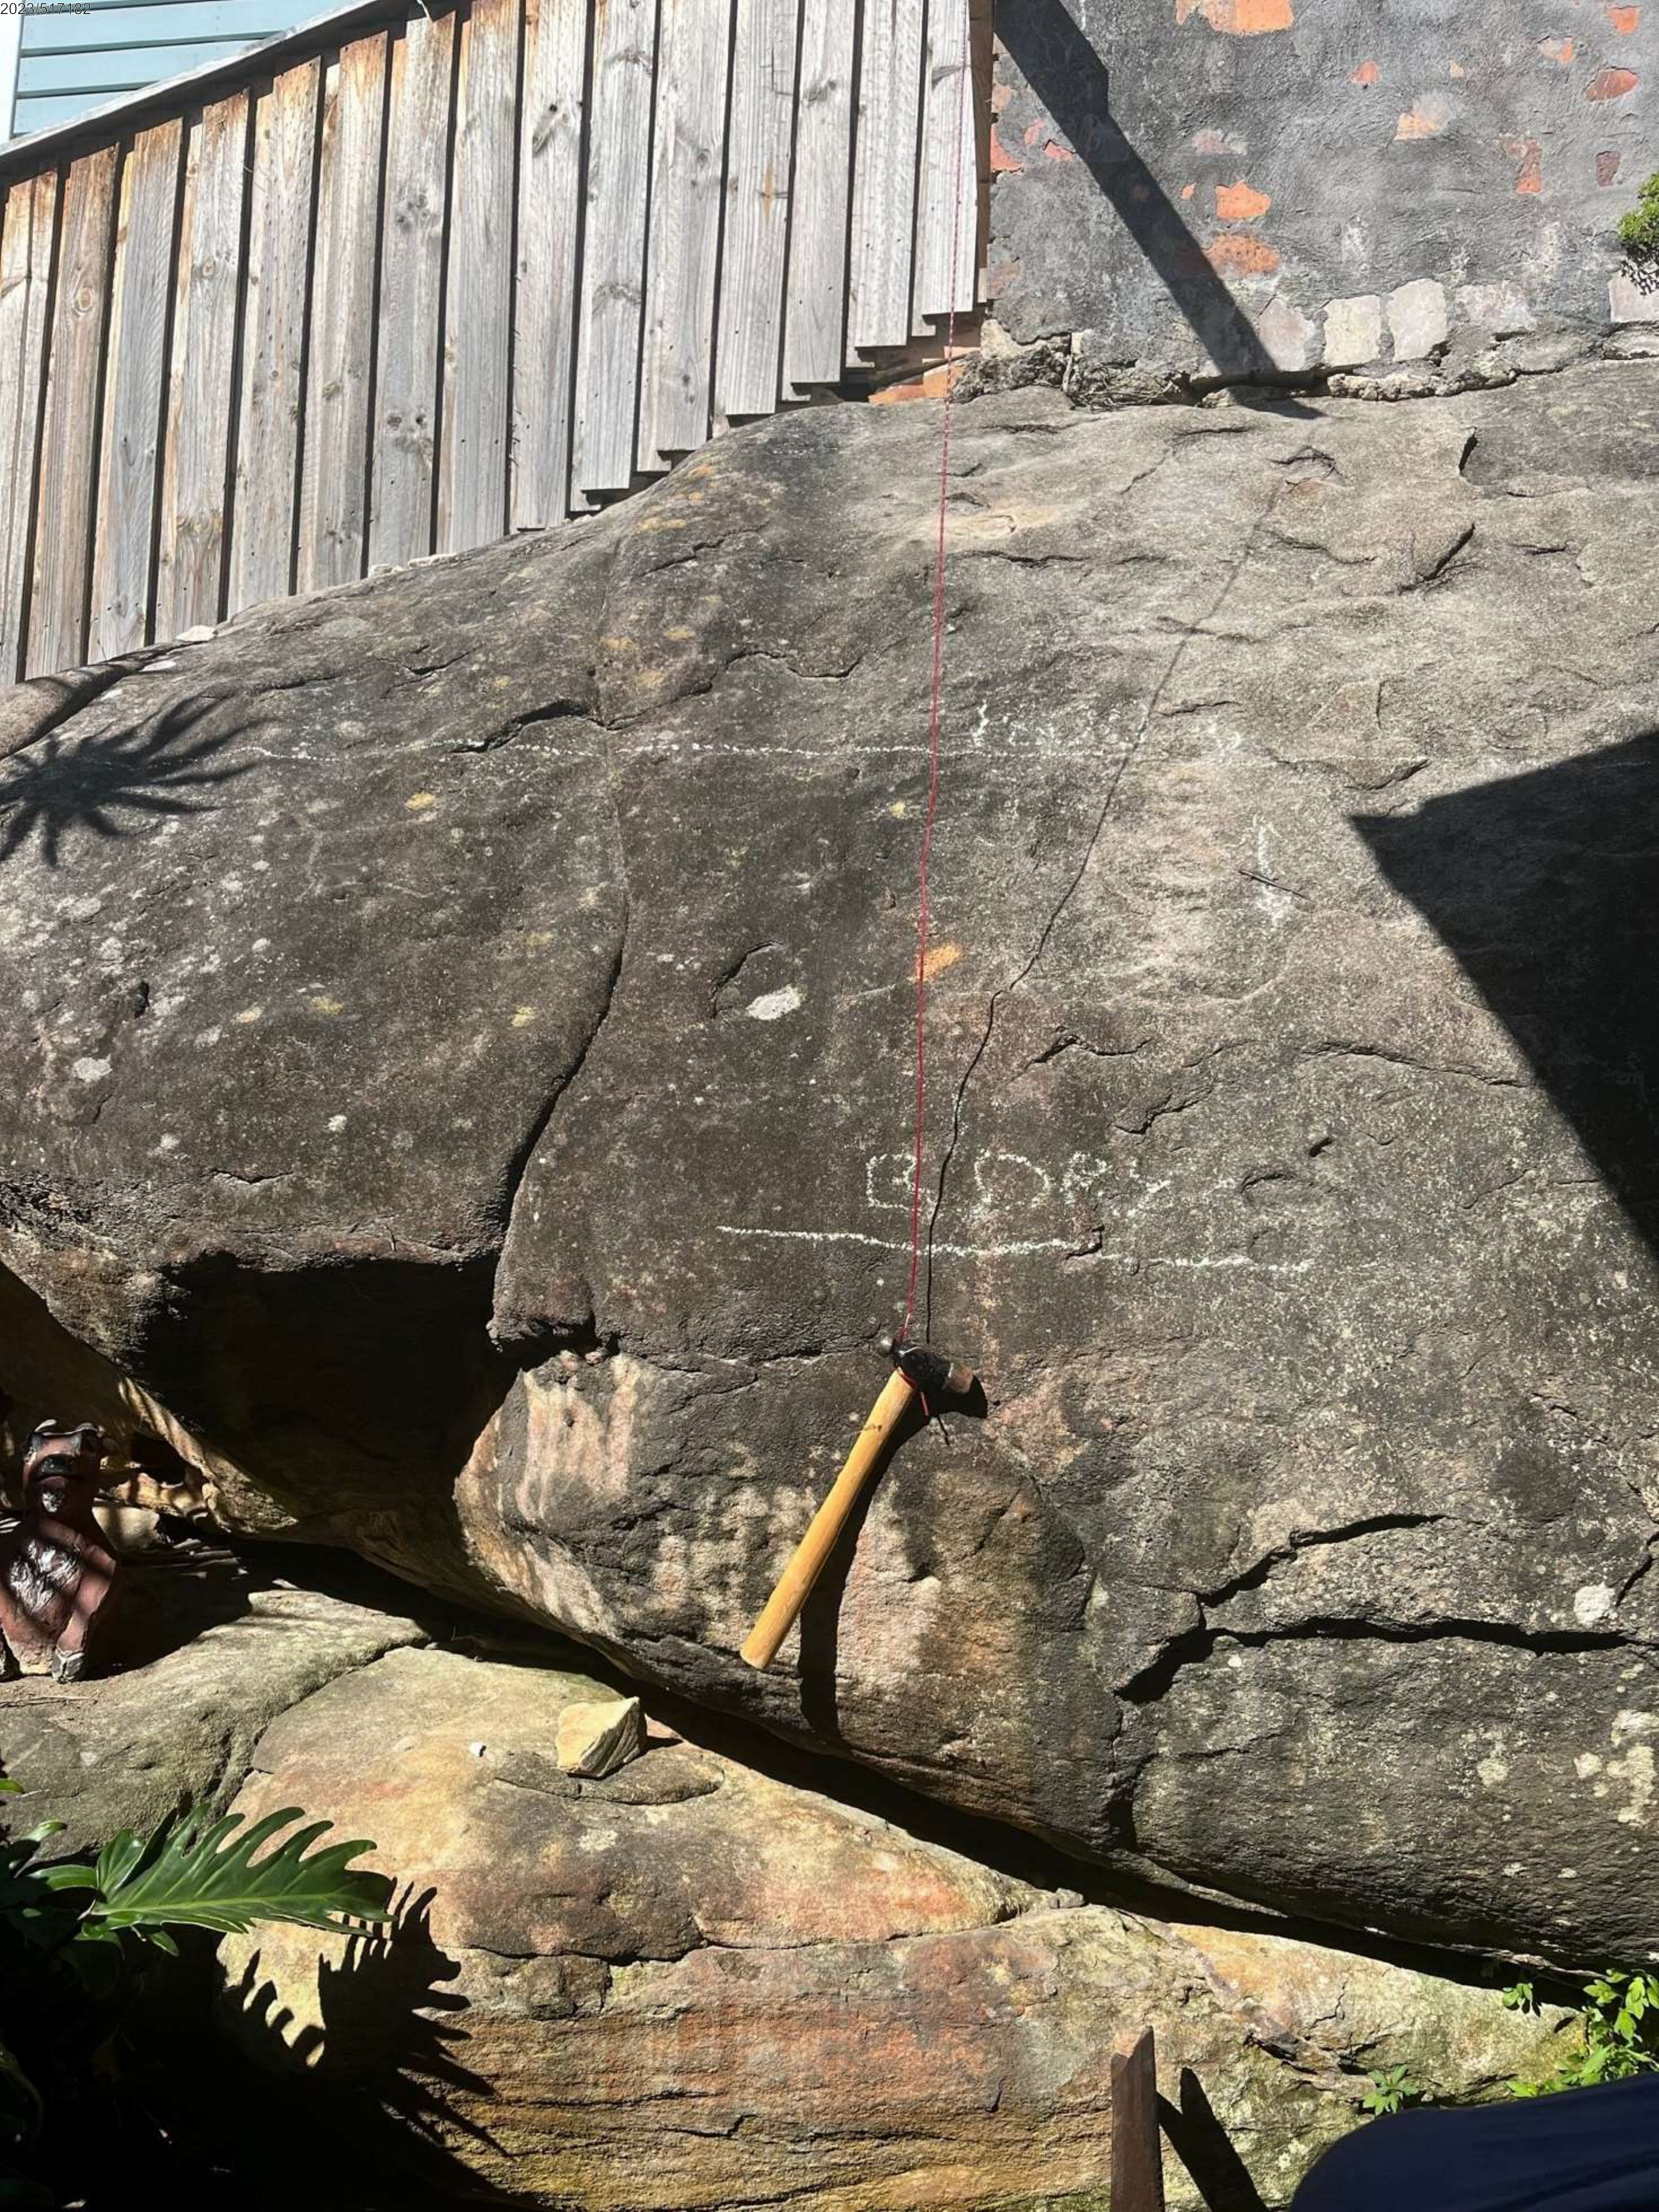
- I note that I would like to see the proposed “Engineering Details” of the construction of the retaining wall so that I might evaluate them.
- Any sediment control fence will obviously be on our property. How will this be restored; I note that considerable garden planting/ native shrubs that we have in place – care is needed so that they are not damaged and who will pay for that / perform that work on an ongoing basis as I’m sure that they will be affected. See Photo 12

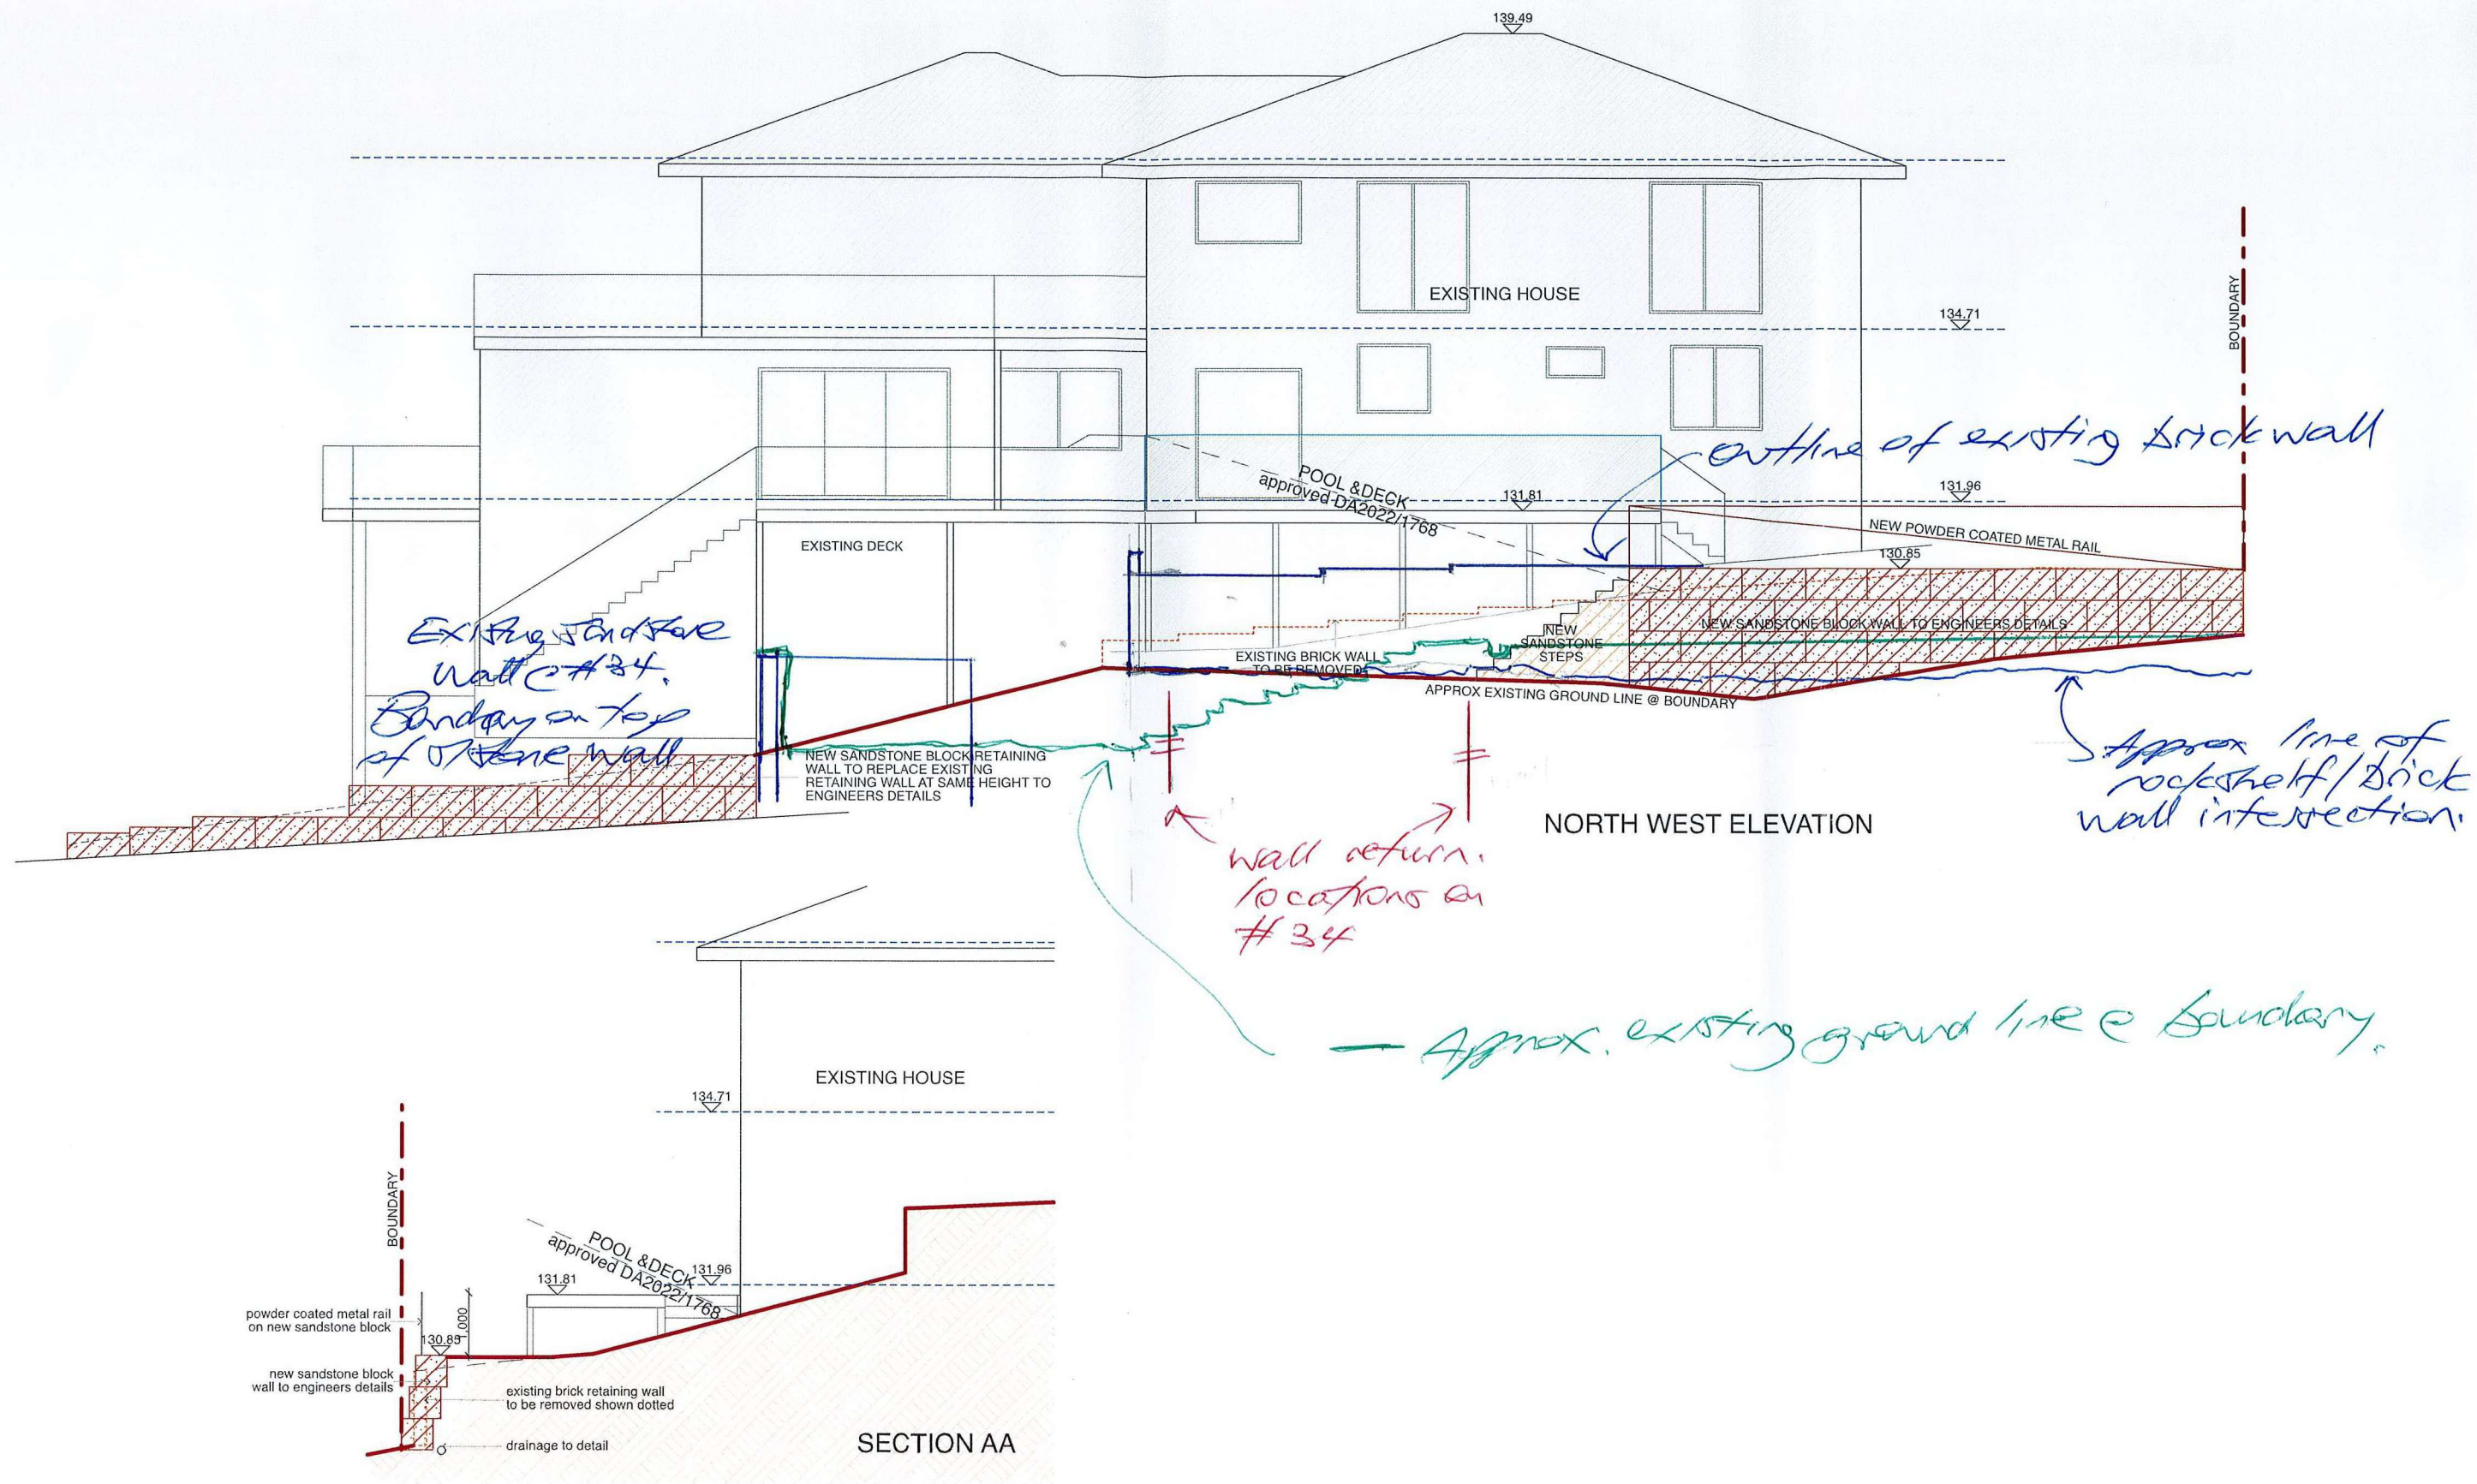
The drawing shows the approx. existing ground line at the boundary – it is incorrect. The height differences shown on the Elevation are much less than in reality and have relevance in terms of the fence height datum and in relation to our existing Sandstone retaining wall that is to have a 1.8m fence built on top of it at the boundary as per the application.

I have attached a revised Drawing DA-03 where I show the approx. actual boundary ground level. This Drawing shows measurements taken at the site based on the locations where the applicant has placed a string line along the boundary.

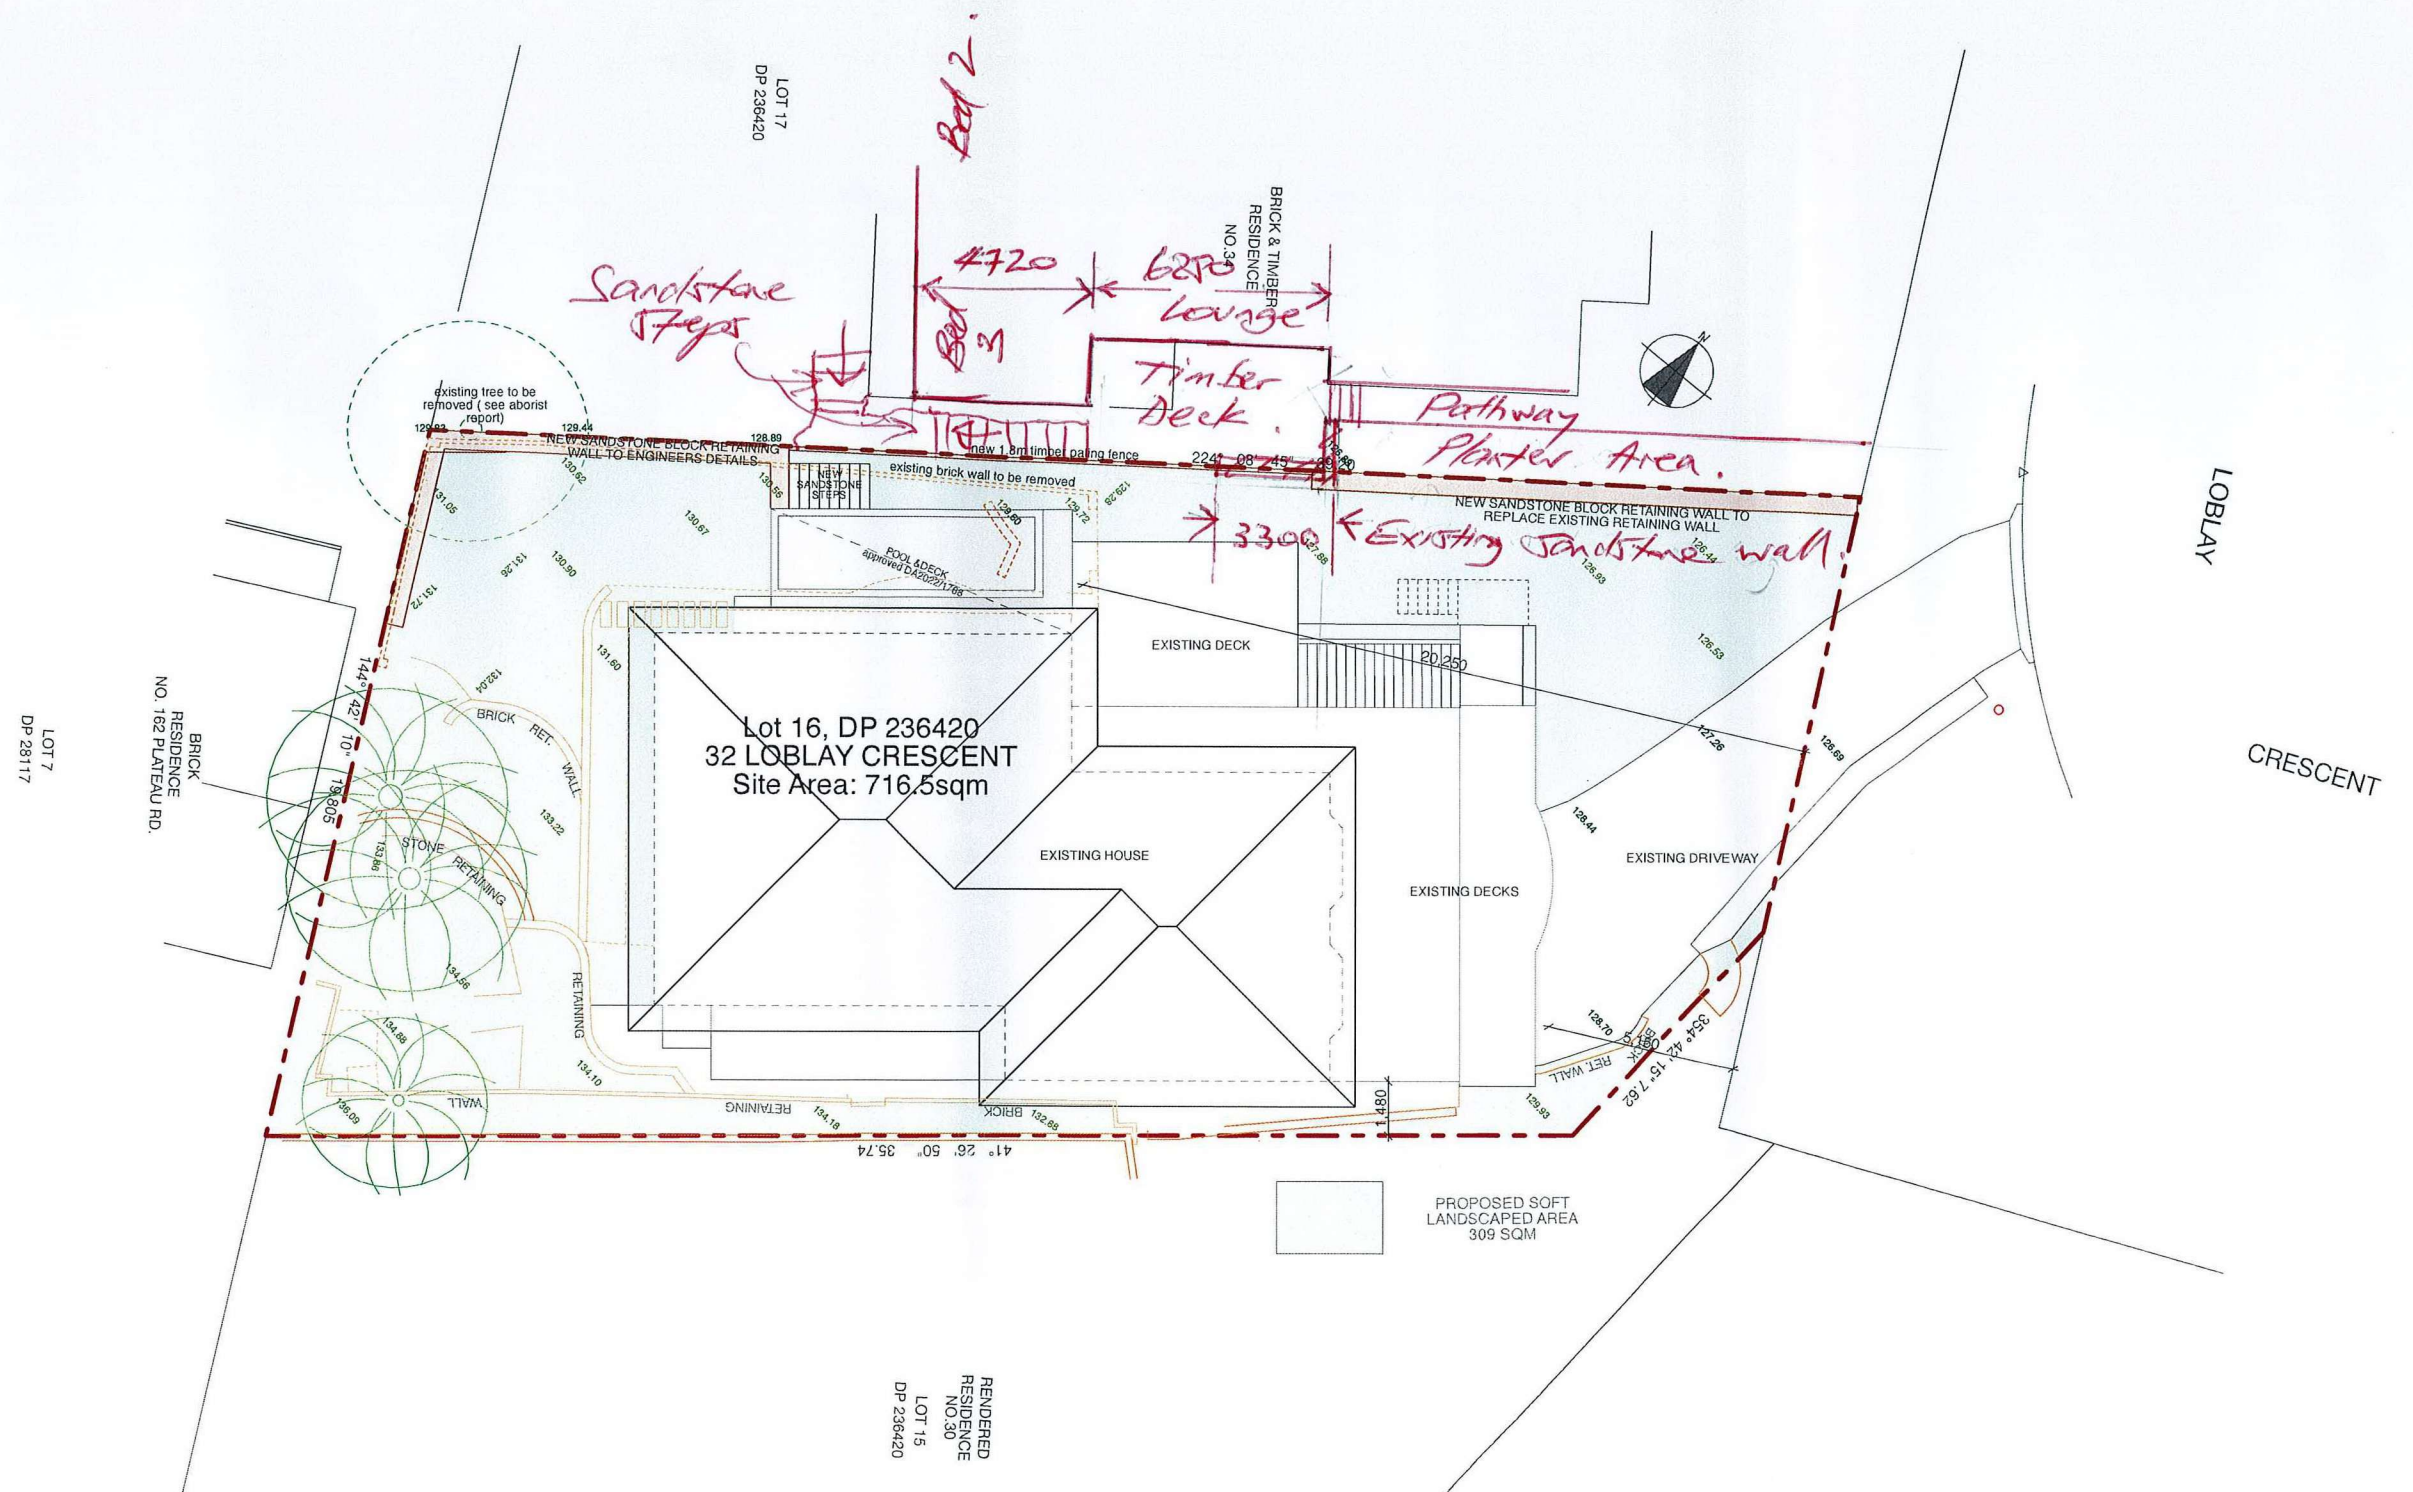
Correct House dimensions #34 & installations.

1. **Survey Details are incorrect – re the position of our house on the Plans provided.**

It is noted on the Assessment Report that Mr. Collier states – “The site inspection confirmed that the survey diagram was in error in representing this corner of the neighbouring dwelling (#34- ours).

I have attached a revised Plan DA-01 showing the correct alignment.

I would suggest that if the Application is approved that a surveyor be engaged by the Applicant to provide boundary marker points at relevant locations involved – i.e., at the start/ finish of the front retaining wall/ at the start finish of the fence and at the start finish of the rear retaining walls.
