7 Laura Street, Seaforth

Geotechnical Comments for Section 96.

GEOTECHNICAL INVESTIGATION:

Alterations & Additions at 7 Laura Street, Seaforth

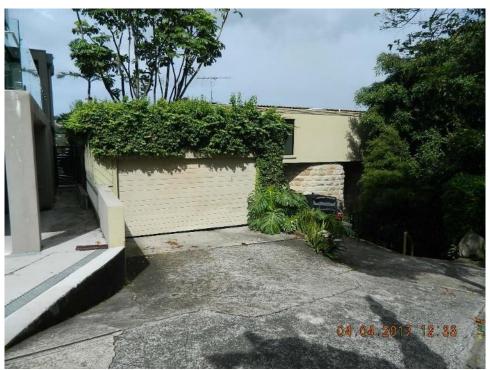
Photo 1

- 2.3 At the road frontage a concrete driveway runs to a garage and parking area on the uphill side of the house (Photo 1). A cut has been made into the slope to create a level platform for the garage. It is supported by a rendered brick retaining wall that appears stable (Photo 2). The downhill supporting brick wall of the garage is tilting and bulging due to the presence of a tree growing immediately beside it. The garage is being demolished and the tree removed as part of the proposed works (Photos 3 & 4). The part three storey brick and dimensioned sandstone block house steps down the slope. The external supporting walls of the house display no significant signs of movement that could be related to slope stability. Competent, medium strength sandstone is

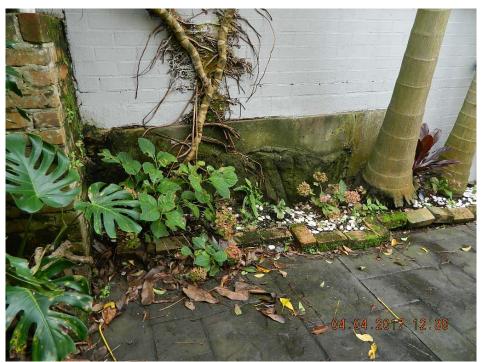
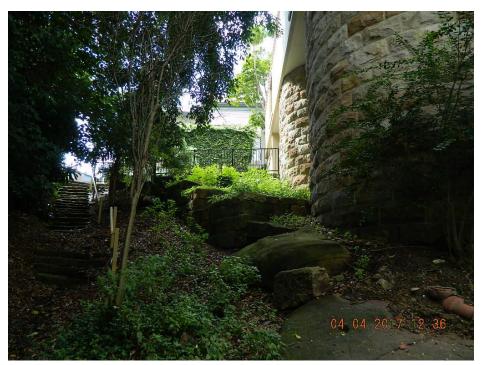
exposed at the surface on the E and W sides of the house (Photos 5 & 6). The lower level of the

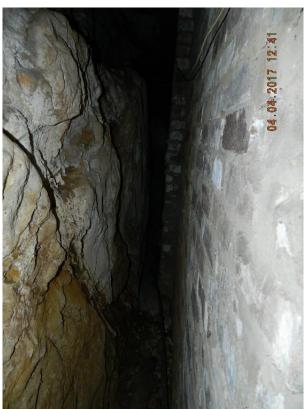
Photo 7

access door of the house. The cut face reaches a maximum depth of ~2.4m. The majority of the

cut face was accessible and from what could be seen it is through competent, medium strength

sandstone (Photo 7). A sandstone block retaining wall supports filling on the W and downhill sides

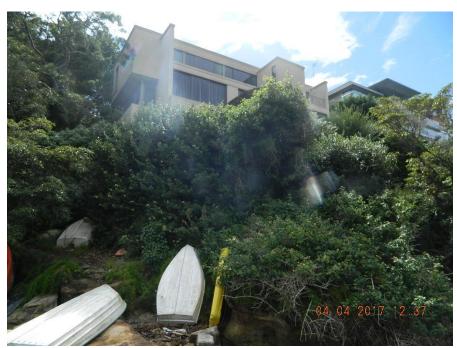
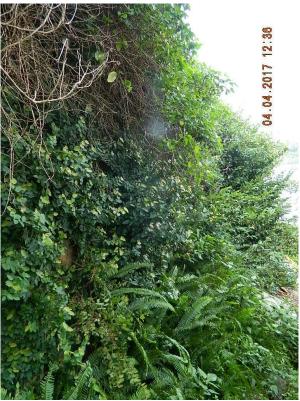
of the house (Photos 8 & 9). The wall is obscured by thick creeper and vegetation and its condition

could not be commented on. It is estimated that the wall is at least 25 years old and no visible

signs of movement were observed immediately above the wall. The lower boundary of the

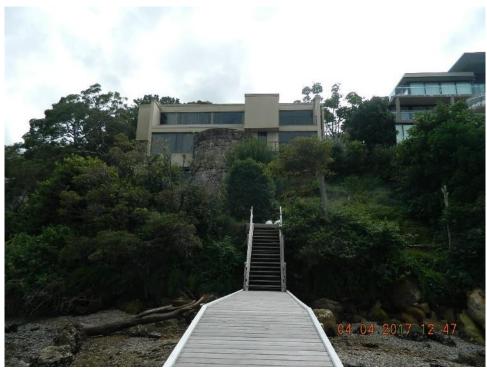
Photo 10

property falls steeply to the waterfront (Photo 10). There is a combination of large sandstone joint

blocks and rough stack rock retaining walls in this area. This area is also thickly vegetated however

from what could be seen, no signs of movement were observed. A timber jetty extends below the
