25 August 2020

Mr & Mrs Thomson  
9 Beatrice Street,  
CLONTARF NSW 2092

Dear Mr & Mrs Thomson,  
Arborist Report – Tree Management Plan  
Carport - DA Mod2020/0335

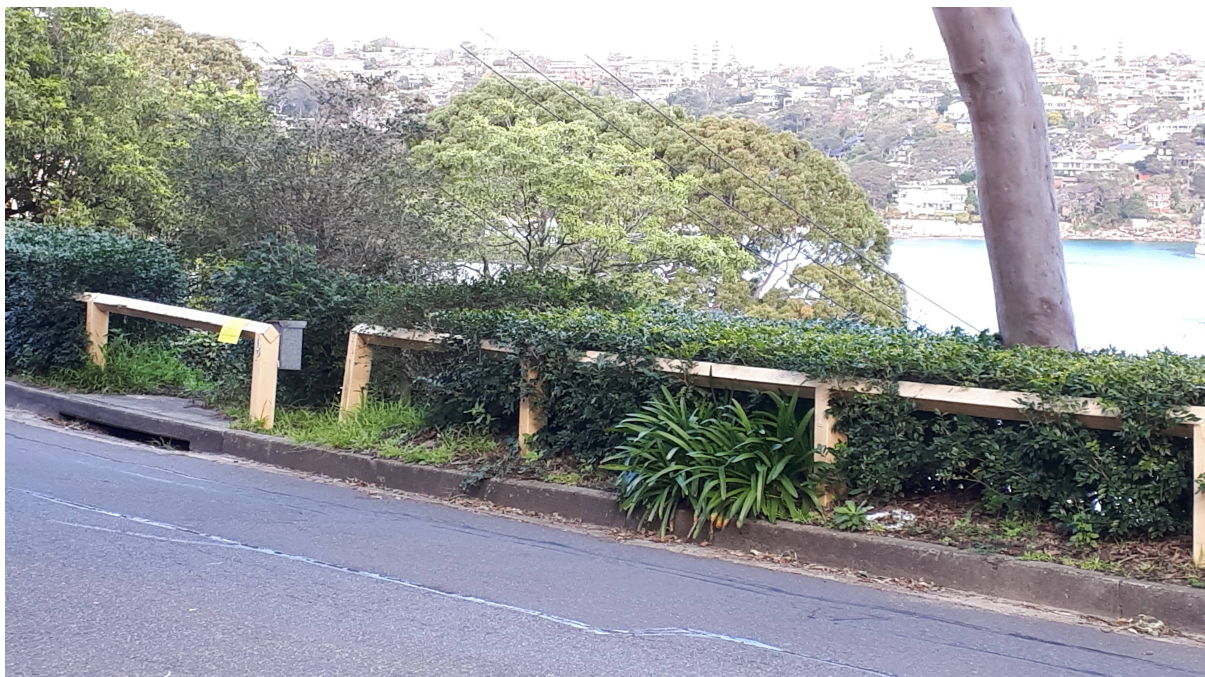
The trees were within the very steep front verge and appeared in good health, condition and were "significant" environmentally. It was not determined the likely orientation of the first order roots at the time of inspection. The driveway/tree offset is particularly close to the upper tree (T1) and distanced further from the lower tree (T2).

Five (5) piers anchor and support the driveway width at street level. Pier diameter for these piers is 300mm. Two piers are within the Structural Root Zone (SRZ) of the tree; two of the remaining piers three piers are positioned within the Tree Protection Zone (TPZ). The fifth pier is outside both TPZ/SRZ zones (AS4970-2009).

1. Trunk damage through construction impact
2. Pier conflict with encountered root/s – likely to be structural roots
3. Encountered roots behind the raised kerb
4. Construction movement inclusive of inground services
5. Rain shadowing beneath structure and a drying of soil

*Photo 1: T1 and white marking left of trunk indicating P1's placement and LHS of photograph the storm water inlet.*

1. The trunks of both trees shall be protected against impact damage. The trunks shall be wrapped in a shade or geotextile like fabric with timber slats placed over the fabric and around the trunks with a gap no larger than 50mm between slats. The timber slats shall be no less than 1.8 metres in height. A purpose manufactured strapping (metal or fabric) will fix the timber slats in place. Nothing is to be nailed or affixed to the trunks. The fabric choice needs to be quick drying. (See appendix 2).
2. For reference purposes, the pier closest to the T1 is P1 and the pier closest to the drain is P5 with consecutive numbering accordingly.

Piers 1, 2 & 3 shall be hand dug down to a depth of 1.5 metres or less should rock be encountered (at the discretion of the structural engineer). In the event a live tree root with a diameter of 30mm or greater be encountered, the pier placement will shift sideways to avoid the tree root/s. It is recommended encountered tree roots smaller than 30mm not be cut but rather the piers moved.

- A minimum gap of 100mm shall be provisioned between edge of root and edge of pier.
  - Any tree root 30mm or greater in diameter exposed shall be kept moist at all times whilst exposed.

- Any tree root 30mm or greater shall not be damaged by way of digging implements.
3. Potentially raise the layback and cross over to accommodate any encountered roots. Council arborist to be engaged in conjunction with engineers should this not be possible for an alternate solution.

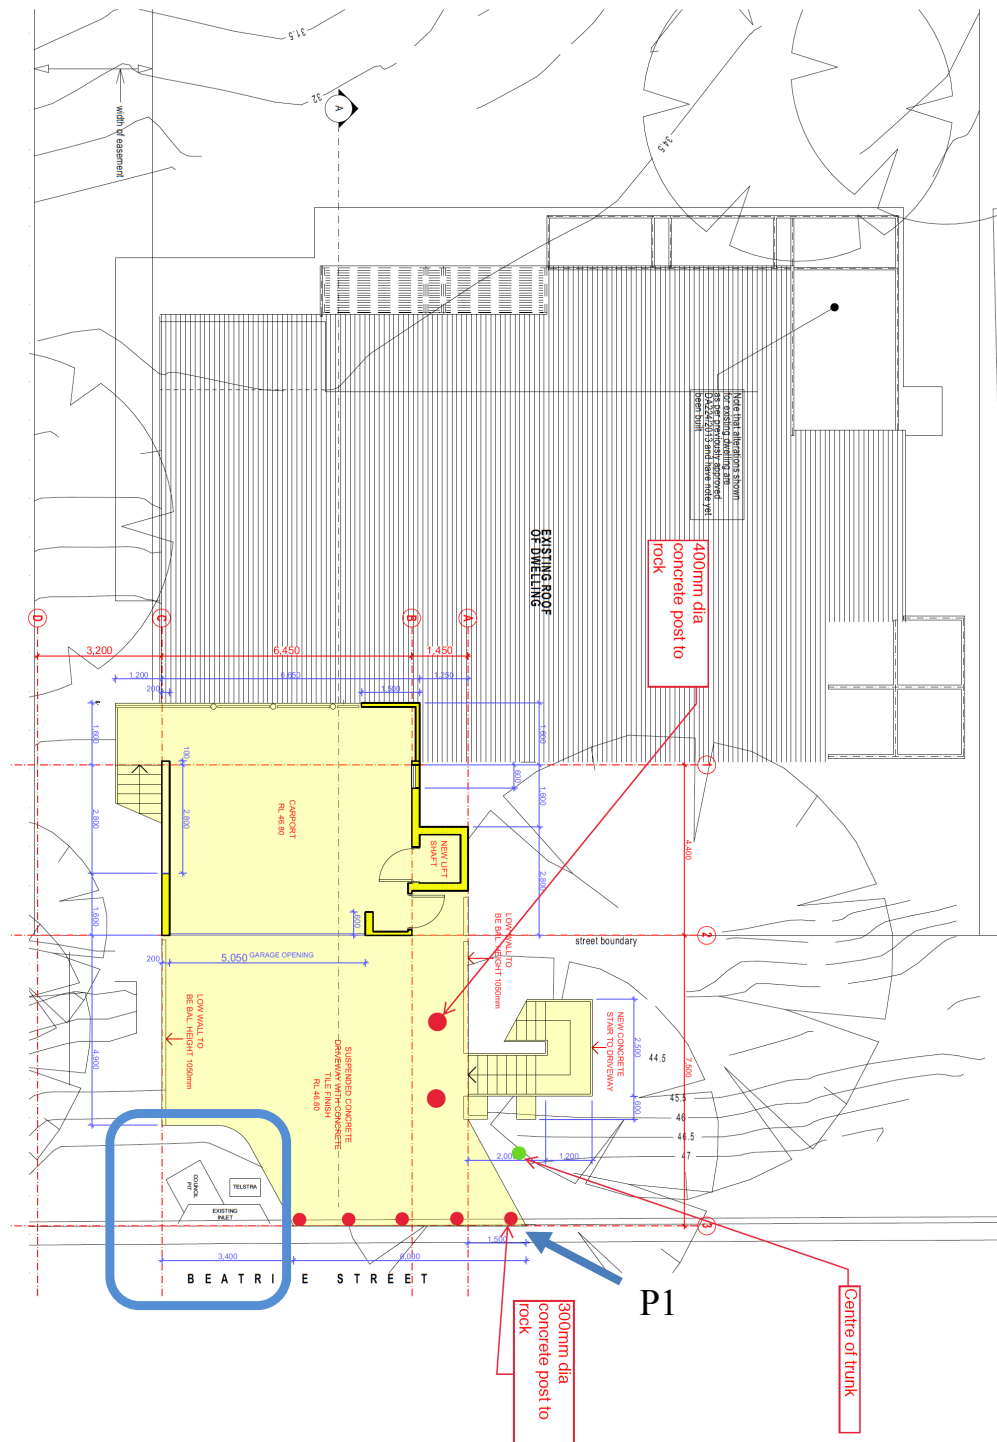
Appendix 1: Proposed pier placement

Proposed is the construction of a carport requiring a suspended concrete crossover enabling offstreet parking. The building's footprint is minimal. The large storm water ingress drain roadside, adds a significant constraint forcing the design modification. These changes include a reduction driveway width by 0.5m approximately as compared to the original plans but pushes and angles the driveway northwards closer to both trees but particularly tree (T1). The stairs connecting carport to lower level are above grade and supported by two piers (see Appendix 1 – Engineering drawing).

Engineering drawings shows 7 piers which anchor and support the structure being:-

- 5 x 300mm piers parallel to the kerb and for the purpose of this report Pier 1 (P1) is closest to the trunk and Pier 5 (P5) is closest to the drain.
- 2 x 400mm piers to support the structure proximal to the stairs and positioned on the sloping verge.

Figure 1: The proposal. Note drain (blue). Drawing supplied by owner.

Tree impact will only be realised upon pier excavation. Pier location flexibility is essential in the event tree roots are encountered but particularly for the two piers closest to the tree kerb side (T1). Simply, the piers need to be positioned between the roots. Any encountered roots must be preserved, protected and remain undamaged to prevent incipient root pathogen entry and subsequent progressive root decay compromising tree stability particularly given the tree's bias lean towards the roadway.

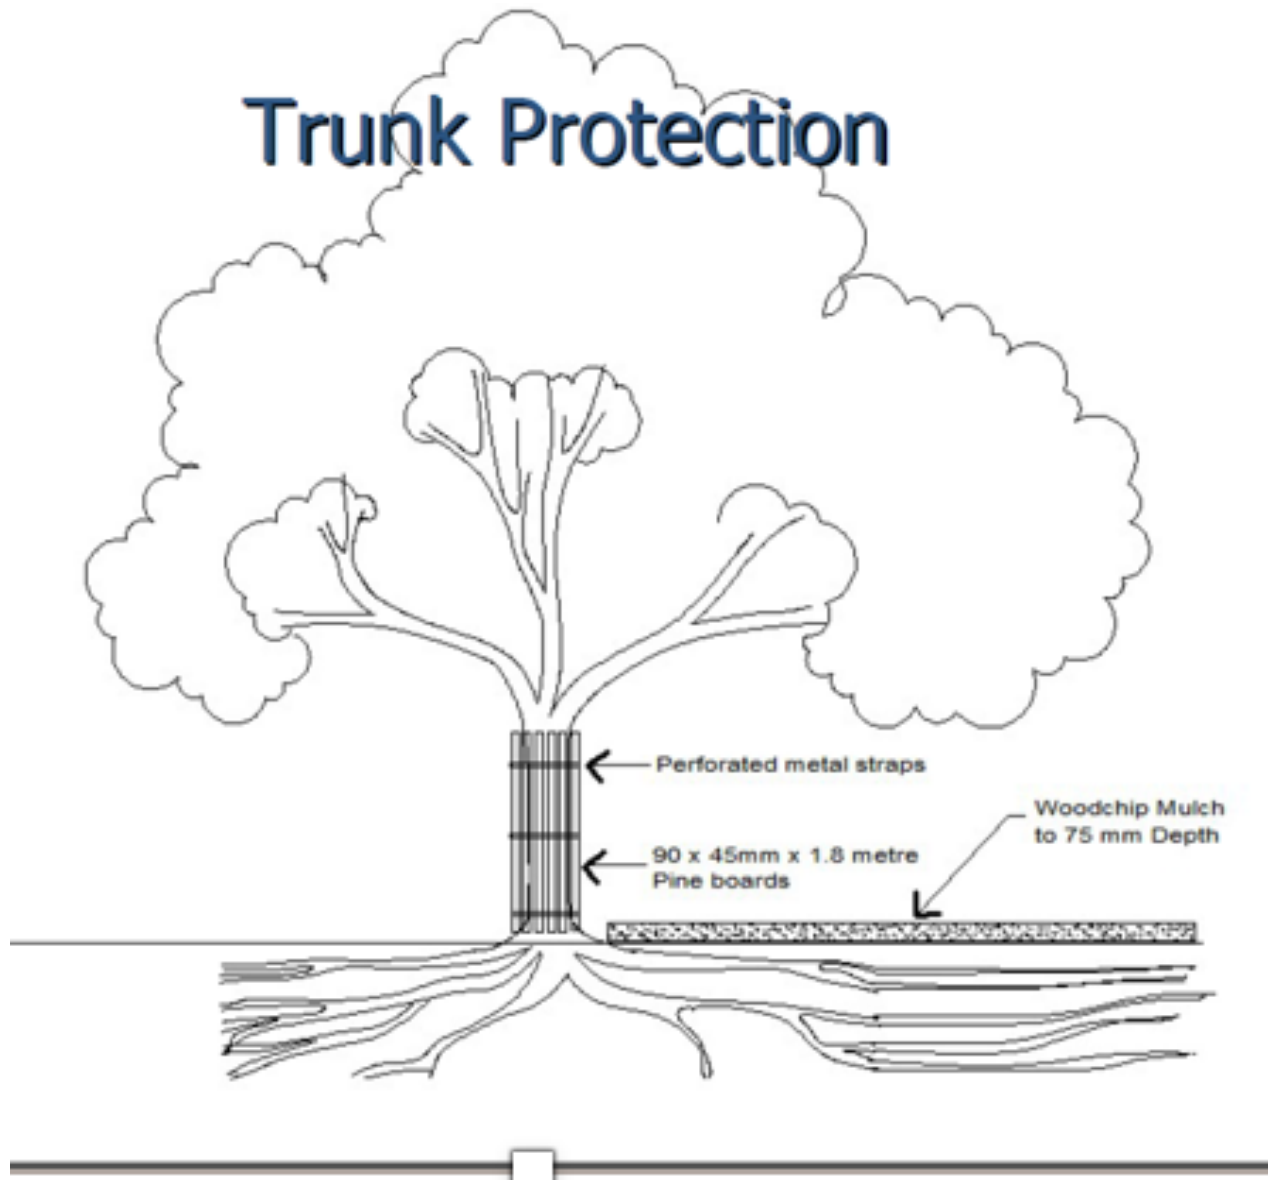
## Appendix 2: Trunk protection

Image 1: Trunk Protection only required

The following is a diagrammatic representation of trunk protection methodology and required for the prevention of impact damage. Ground protection is not required in this instance.
