## **ARBORICULTURAL IMPACT ASSESSMENT**

Date: 10<sup>th</sup> April 2023

Site: 107 Iris Street, Beacon Hill 2100 (Lot 18 DP 19022)

Author: Antony Osborn

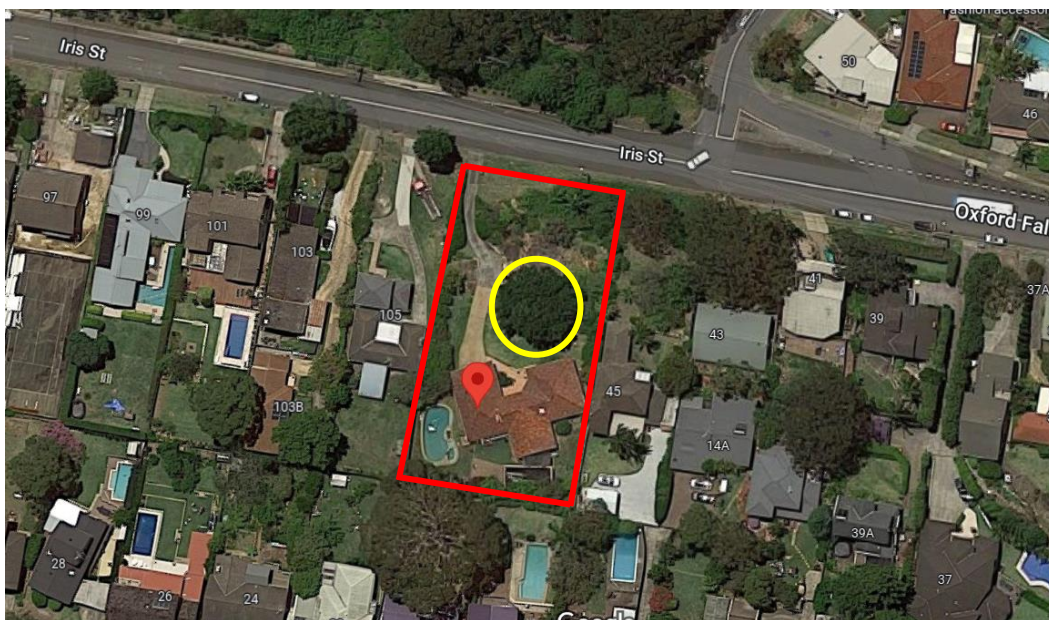
- 4.5 There was one (1) tree covered by Council's Tree preservation order that was assessed during the site inspection. The tree is located in the middle of the property (see Appendix 4 for photograph).
- 4.6 The tree is a mature *Quercus robur* (English Oak). The tree was exhibiting good health and good vigour at the time of inspection (see Appendix 4, figures 1 and 2).
- 4.7 The subject species is not listed under the Threatened Species Conservation Act (1995).
- 4.8 The site is not located in a heritage conservation area. There are no heritage items on these trees.

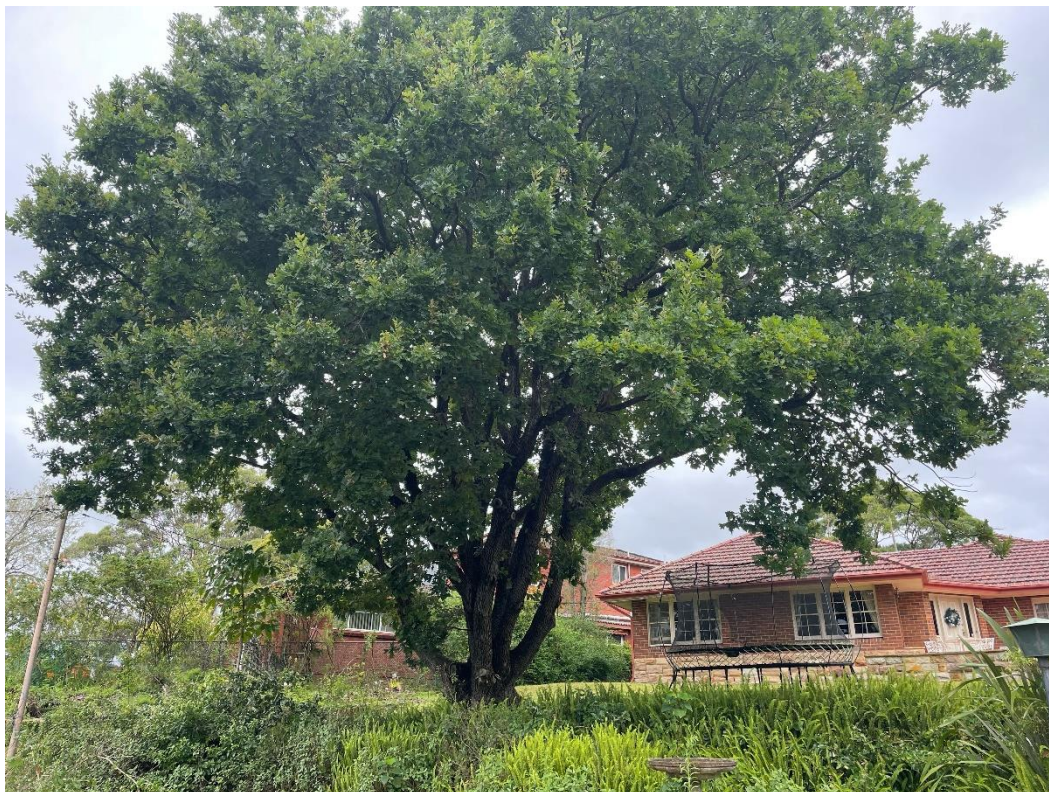
- 5.1 The tree was identified as a mature *Quercus robur* (English Oak). At the time inspection the tree was displaying signs good health and vigour. The tree had good form and no obvious signs of defects. The tree was classified as high landscape significance and retention value (see Appendix 4, Figure 1 photograph).

**Figure 1:** The tree *Quercus robur* (English Oak) displaying signs of good health & vigour, good form and high landscape significance.

- 6.1 It is recommended that the tree *Quercus robur* (English Oak) is to be retained. Therefore further investigation and tree protection will be necessary.

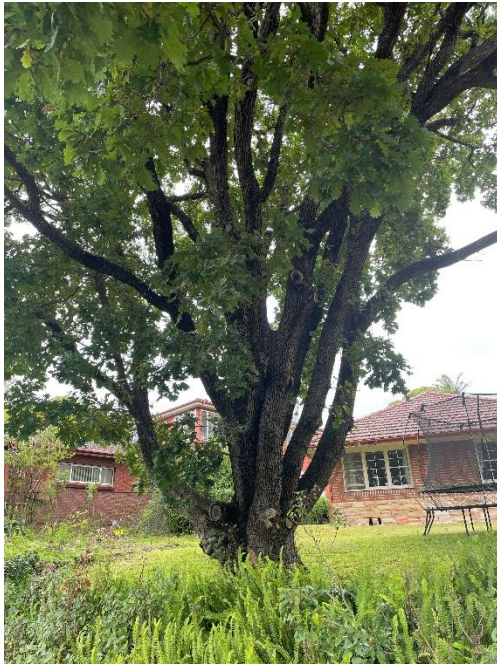
**Figure 2** The tree showing good branch structure.

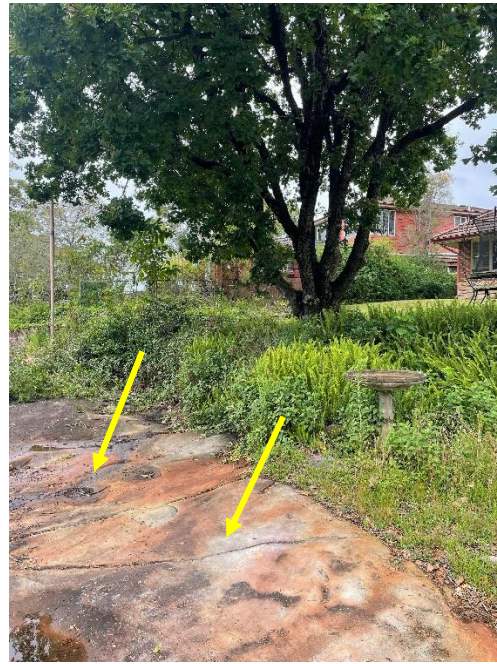
- 1.5 There is a large natural rock formation which is located in the building footprint of Lot 1 and 2. This area has not been included in the encroachment value as there will be no root growth present.

- 5.2 The tree will be affected by the proposed subdivision and development. There is a major encroachment from entire development on the tree (see Appendix 2 for encroachment value). There is exposed natural sandstone rock in the encroachment area. This area has not been included to the encroachment value as there will be no root growth in this area (see Appendix 4, Figure 3 for photograph).

**Figure 3** Showing the location of the natural sandstone rock which would not accommodate root growth.
