## Tree Removal and Tree Pruning Application

### **Arboricultural Statement of Findings**

**Date prepared:** 6 June 2018

**Site Address:** 13 Waiwera Avenue, North Manly, NSW

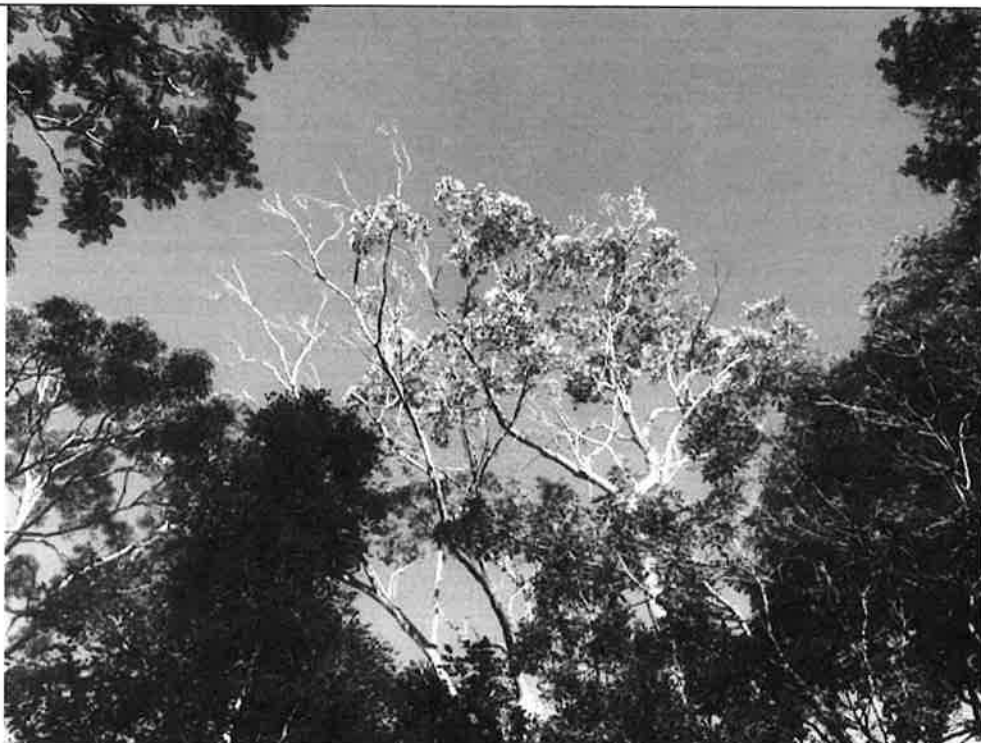
Image 1: Looking South west at the crown of the tree.

The subject tree is a mature *Eucalyptus piperita* or Sydney Peppermint Gum and located in the rear garden of the site, adjacent to the South West corner. The subject tree has an approximate height of 12 meters, a canopy spread diameter of approximately 5 meters and trunk of approximately 500mm at ground level. The tree has a relatively small canopy area for the species (image 1).

At the time of inspection, the tree was displaying signs of reduced health. The foliage density was low for the species and was approximately 70-80% of the normal foliage density (image 1). Significant deadwood is present in the canopy, approximately 20% of the overall canopy area consists of deadwood.

This indicates that the health of the tree is declining. Based on the health of the tree at the time of inspection, it may not completely die back for another five to fifteen years and therefore could be retained if preferred. However, as the tree is displaying signs of reduced stability, I recommend that consideration is given to the removal and replacement of the tree with the same species. If the tree is to be retained, I recommend that detailed investigations are undertaken, including root investigations and tree risk assessment, to determine the risk level associated with the tree and provide risk mitigation options of the future management of the tree.

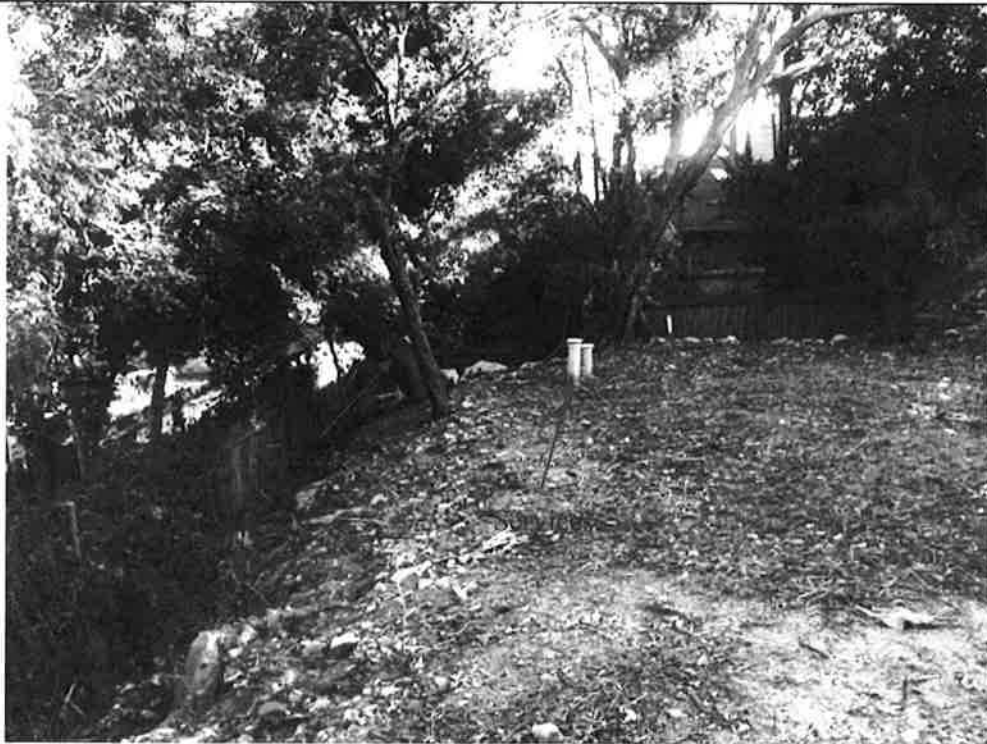
Image 2: Looking West.

The trunk of tree leans significantly to the South, at approximately a forty-five-degree angle (image 2 and 3). The trunk leans towards 10 Western Avenue, and the whole of the canopy is located above this property. At the time of inspection, there was no indication of recent movement at the base of the trunk or root system, indicating that the tree is not an imminent risk of failing due to stability.

At approximately 1.5-2 metres to the North of the trunk, there are outlets of below ground service (image 2 and 3), indicating that the tree has restricted root growth in this direction and also that of potential root disturbance. I was informed by the site owner the services are were installed at least

ten years prior to the inspection. Generally, tree roots on the opposite side of a trunk lean are of increased importance to tree stability, as trees will produce additional root growth that will extend further when under tensile loading force. This indicates that the tree has an increased likelihood of failure at its root system.

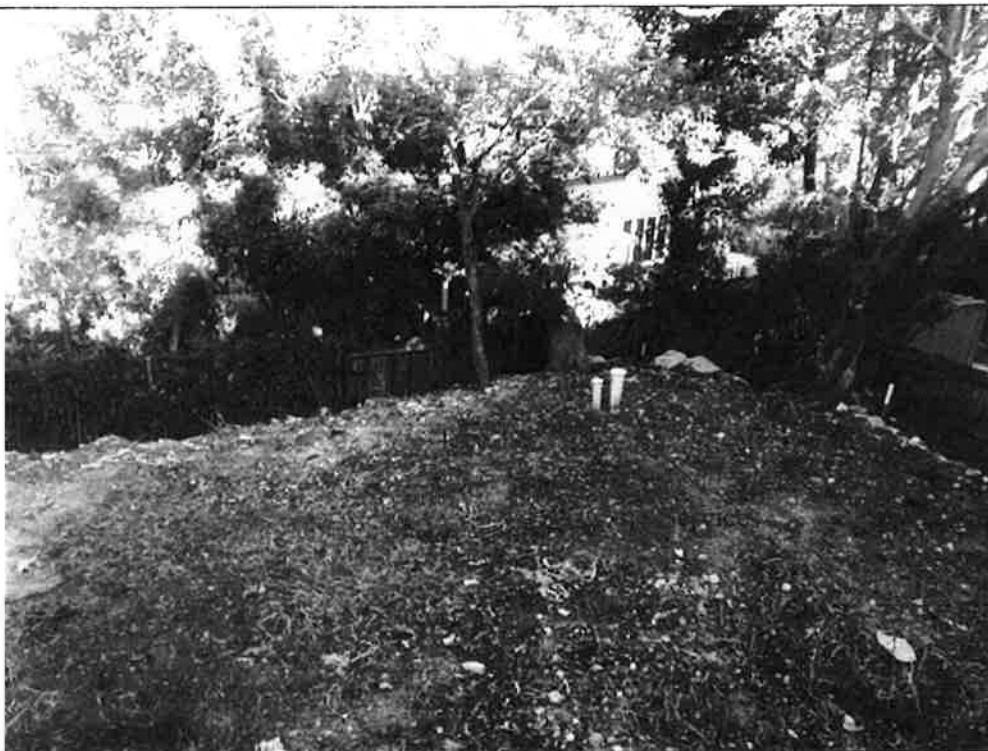
Image 3: Looking South.
