Arboricultural Impact Assessment Report For Development Application Submission.

December 2023 Prepared for; Cameron Mcgeachie.

Site Address, 179 Plateau Road Bilgola Plateau NSW 2107.

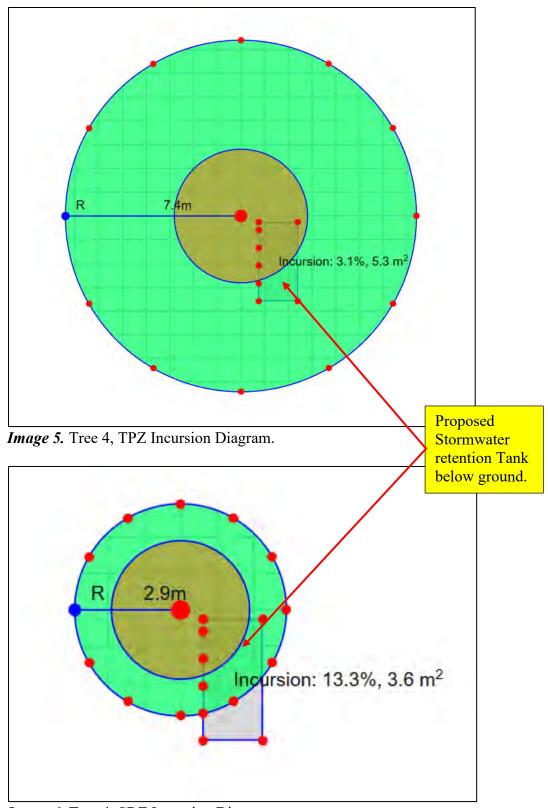
Image 6. Tree 4, SRZ Incursion Diagram.

Tree 4 Is located adjacent to the proposed below ground Rainwater retention tank. For the instillation of the tank, major root severance <20cmfrom the base of the tree on the East (E) side will be required, as a consequence of the root severance to tree will have a unacceptable likelihood of failure. The tree has a minor TPZ incursion of approximately 3.1% or 5.3m² and an SRZ incursion of approximately 13.3 % or 3.6m². The SRZ incursion is **Not Acceptable** under the guidelines set out in AS 4970–2009 *Protection of trees on development sites*.

The Author recommends that **Tree 4** is **Not Viable** for retention due to **major SRZ Incursion** that will impact the health, vitality, and stability of the tree. The impact is considered major. This tree should be replaced in the landscape plan for the proposed construction.

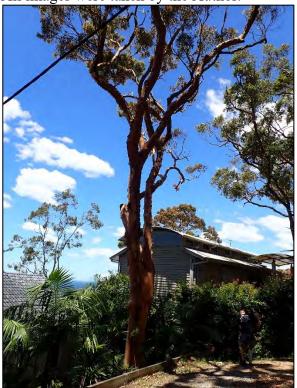
Image 7. Tree 4. Location & overall view.

The tree is mature displaying Fair Health and Vitality, Fair Form, and Structure. The tree has a single trunk of approximately 3m, then divides into two (2) stems. Previous pruning has been observed. Dieback in the crown to the South (S) and the West (W) is evident. Some small epicormic shoots have been observed. The canopy density is approximately 50% typical of the species.

It must be considered that the tree is displaying Fair Health and shows a significant decline in health and vitality since the last report that was commissioned in February 2017 which included this tree. It is likely that the tree is in an early stage of decline. It is not likely that the tree will ever become a significant specimen of this species.

The Tree Is Not Viable for Retention.

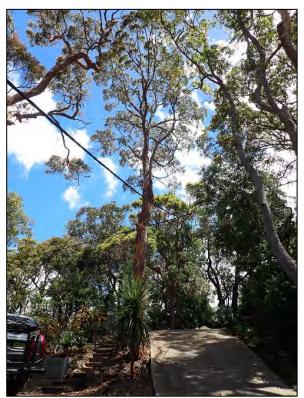
Image 11, Tree 3. Overall view.

The tree is mature and displaying Fair Health and Vitality, and Good Form and Structure. The tree has a single straight trunk. The canopy spread is predominately to the West (W) most likely as a result of the conflicting crown of T4. The canopy density is approximately 70% typical of the species. Deadwood within the crown <15cm.

Tree 3 Has No New TPZ or SRZ incursion. The tree is Easily Viable for retention, install Tree Trunk Protection (TTP).

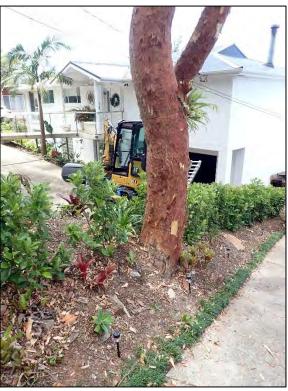
Image 16, Trees 5. Location.

The tree is mature displaying Good Health, Vitality, Form, and Structure. The tree has a single trunk and a narrow crown projecting predominately North (N) to South (S) and is phototropic to the East (E), Deadwood <10cm has been observed. The canopy density is approximately 60% typical of the species.

Tree 5 is located in the adjacent property to the North (N). It has NO SRZ incursion and No TPZ incursion. The existing concrete driveway will be used as a load-bearing surface for the duration of the construction.

The tree is Easily Viable for retention, install Tree Protection Fencing (TPF).

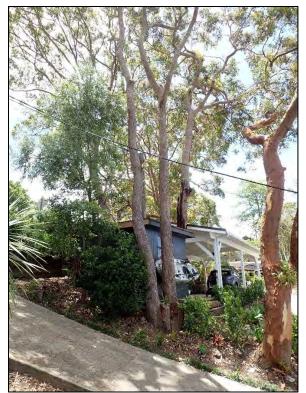
Image 18, Tree 6. Location.

The tree is mature displaying Good Health, Vitality, Form, and Structure. The tree has Two (2) stems approximately 1m AGL, and Two (2) stems that have been previously removed. The tree has a small canopy for both of the stems, and a crown density of approximately 90% of typical for the species. Deadwood <12cm to the West (W) has been observed. The crown of the Two (2) stems is phototropic to the East (E) as a result of the conflicting crown of the trees located on the road reserve to the West (W).

Tree 6 is located on the adjacent property to the North (N). It has NO SRZ incursion and No TPZ incursion. The existing concrete driveway will be used as a load-bearing surface for the duration of the construction.

The tree is **Easily Viable** for retention, install Tree Protection Fencing (TPF).

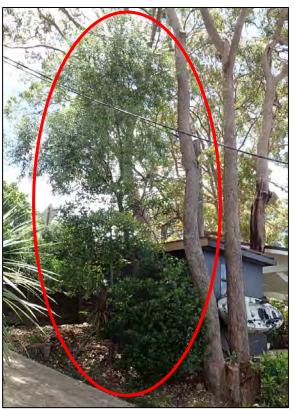
Image 21, Tree 7. Location.

The tree is Semi-Mature and considered an invasive weed species in NSW.

Tree 7 is **Exempt by Species** in *NBC*, therefore is not considered for retention. The tree is not locally endemic and is regarded as an invasive environmental weed species in NSW.

Tree 7 is classified as an invasive environmental weed in NSW. It is recommended that the client discuss the removal and replacement of the tree with the property owner 177 Plateau Road for permission to replace the tree.
