**ARBORICULTURAL ASSESSMENT REPORT  
FOR  
JEFFREY & MICHELLE SAPER  
907 BARRENJOEY RD  
PALM BEACH  
DA NO210/16**

**PHIL PACKHAM HORTICULTURE  
ARBORICULTURAL & HORTICULTURAL CONSULTING  
124 WOODCOURT RD, BEROWRA HEIGHTS, NSW, 2082  
ABN 12.671.920.303**

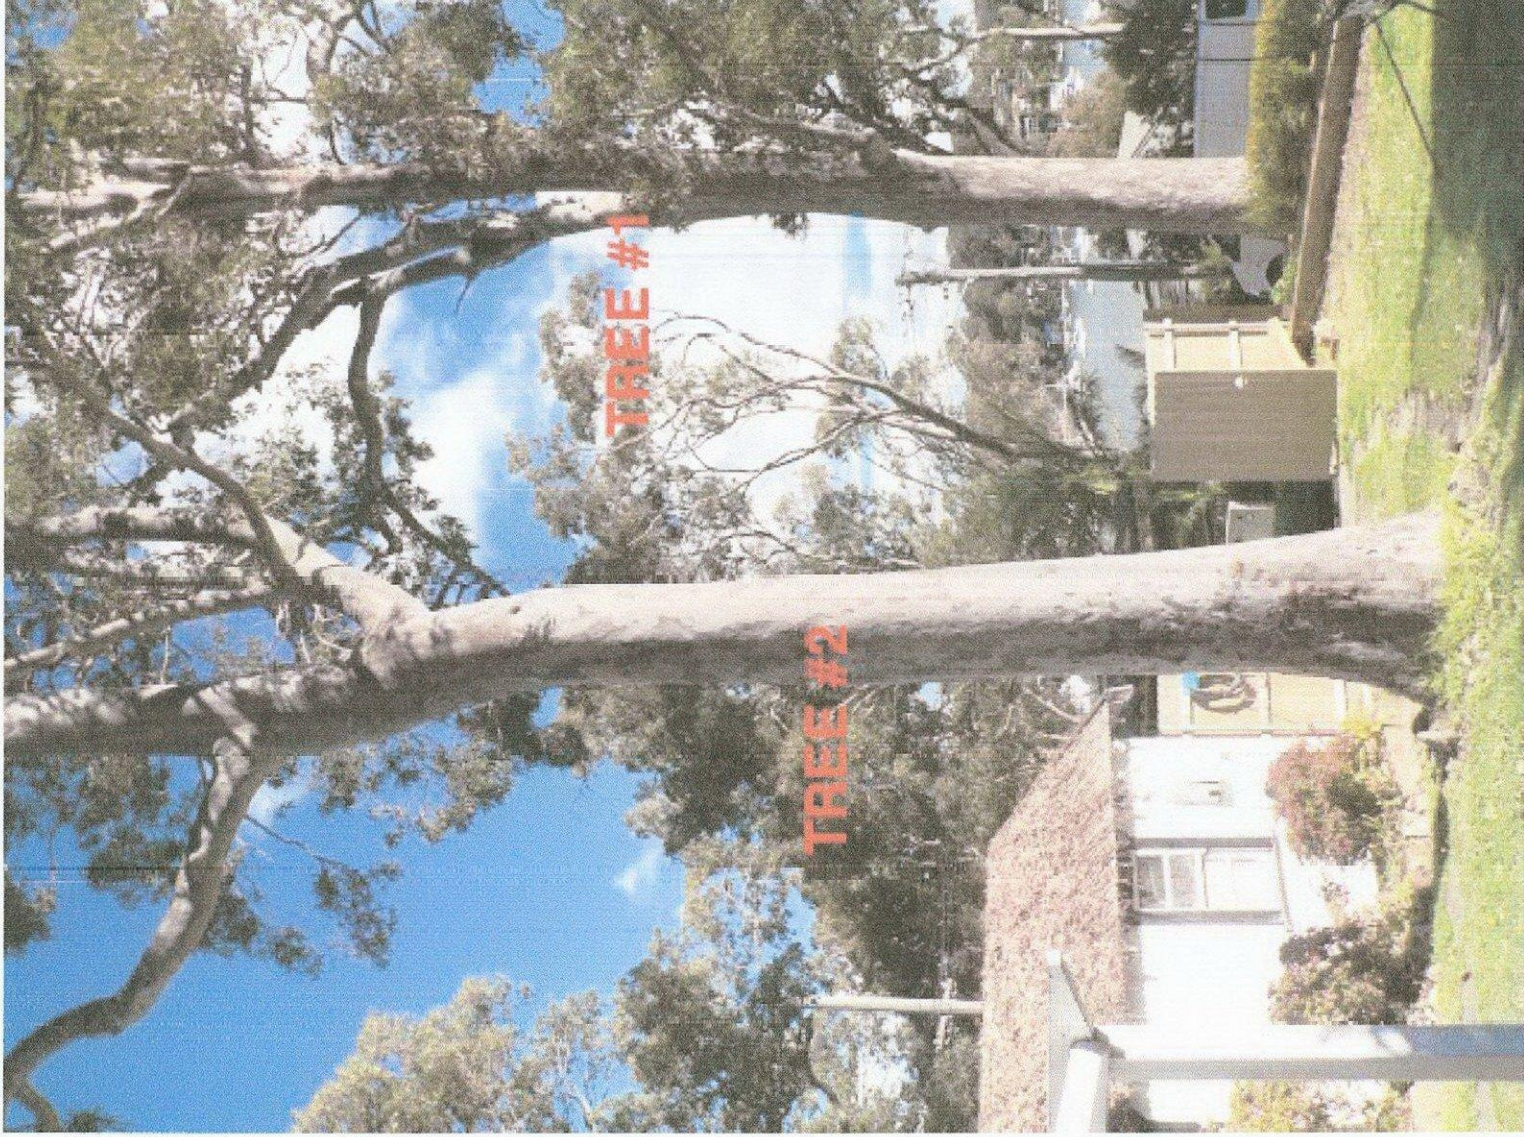
PIC 1

Significance in the local streetscape is moderate, being visible from many directions but being part of a surrounding continuous canopy [tree on right in pic 1].

The soil level across the root zone appears to have been raised in leveling for the lawn area [pic 1].

Significance in the local streetscape is moderate, being visible from many directions but being part of a surrounding continuous canopy [tree on left in pic. 1].

It has a clear trunk to 6 metres AGL, where a major scaffold extends to the west [upper centre, pic 1].

At 7 metres AGL another large scaffold extends to the southwest, over the garage [upper left, pic 1].

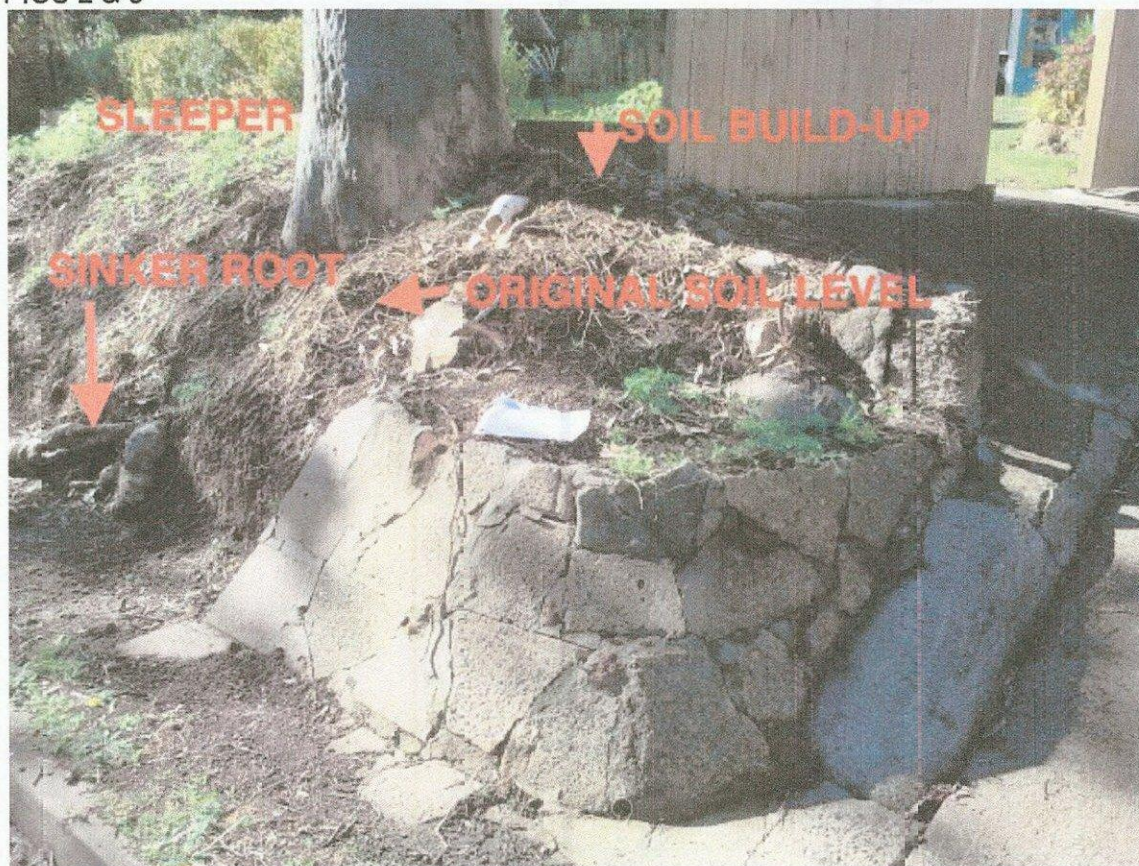
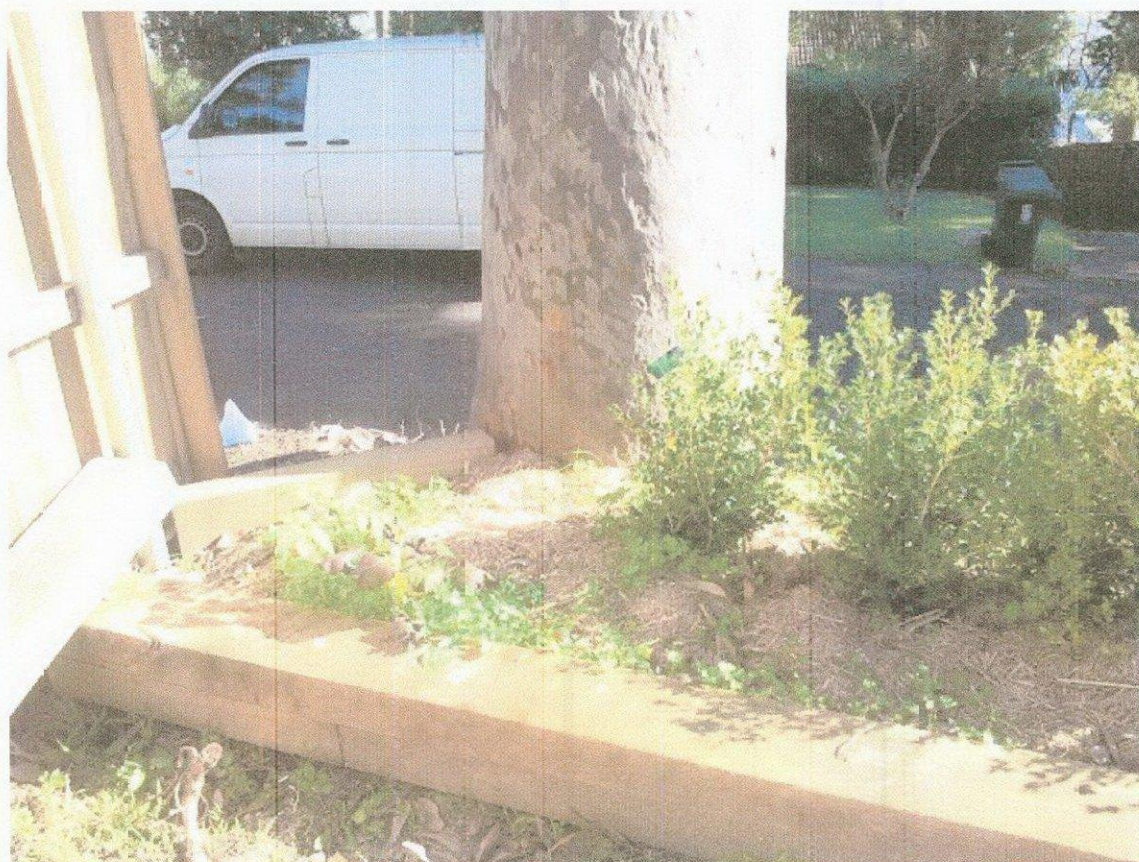
PICS 2 & 3

The tree is located at the top of a bank approx. 1m high, created by the formation of Thyra Rd. The bank has been concreted for many years but recently exposed. [pic 2]

It appears that soil has been built up around the base of the trunk flare in the past and more recently a bed has been made with sleepers, also changing the trunk's natural intersection with the ground [pics 2 & 3].

The root system is visible where the wall on Thyra Rd has been removed [pics 2 & 7] It appears that the tree has developed 'sinker' roots which extend behind the wall and along to the north, due to restriction in this direction.

The sleeper beds adjacent to the tree should be reduced to no closer than 2 metres from the trunk flare, the soil level be reduced in this area and the beds be reconstructed.

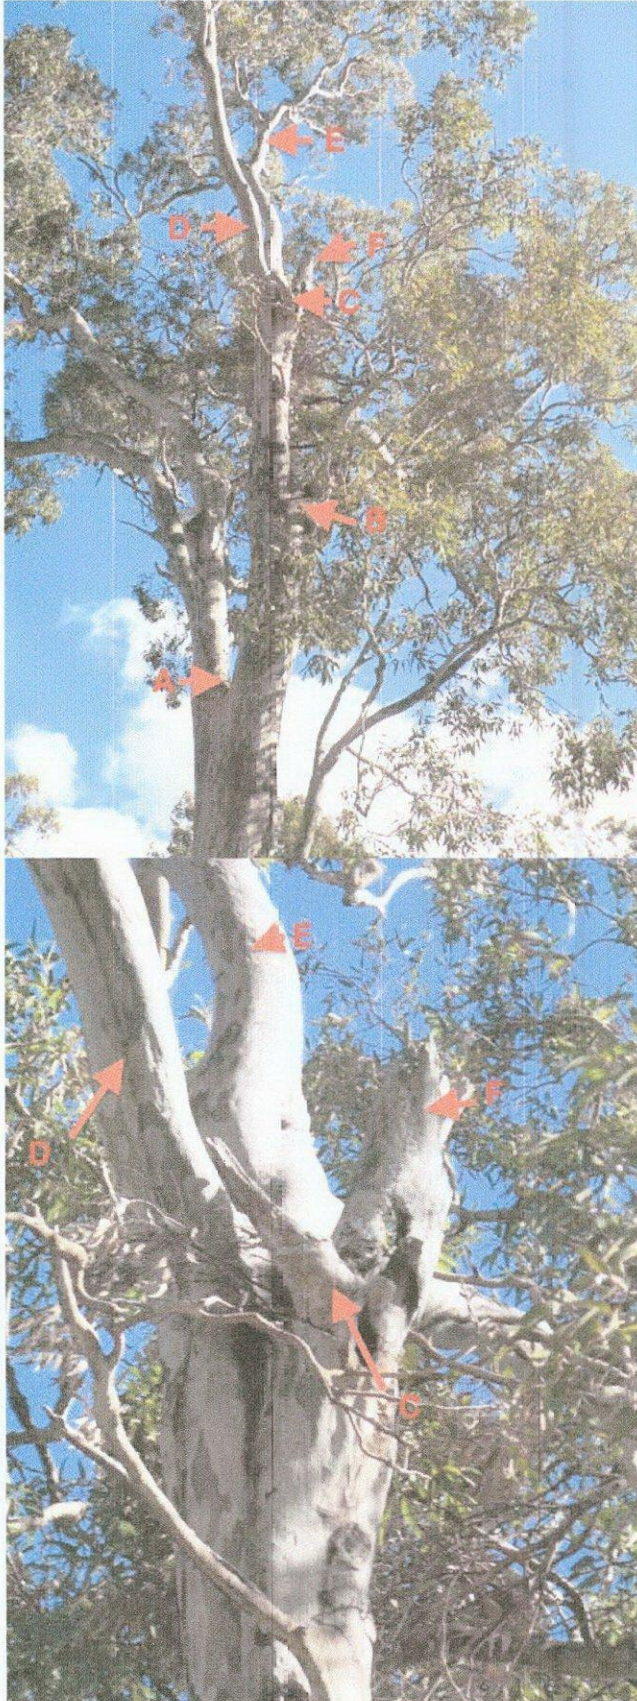
PICS 4 & 4A

The trunk rises straight to the first branch to the west at approx. 4 metres AGL. It divides into codominant trunks at 6 metres AGL [A – pic 4].

The northern trunk is approx. 45cm diameter and forms a main scaffold at 2.5 metres from its origin [B – pic 4].

The trunk then divides into 3 minor scaffolds – it appears that a hollow is developing at this point [C – pic 4].

1. to the east has gum formation visible for approx. 3m from the junction [D – pic 4, 4A]
2. is a vertical scaffold which appears sound [E – pic 4, 4A]
3. the scaffold extending west has lost a section approx. 15cm in diameter [F – pic 4, 4A]

No significant epicormic growth development was observed [pics 4 & 6A].

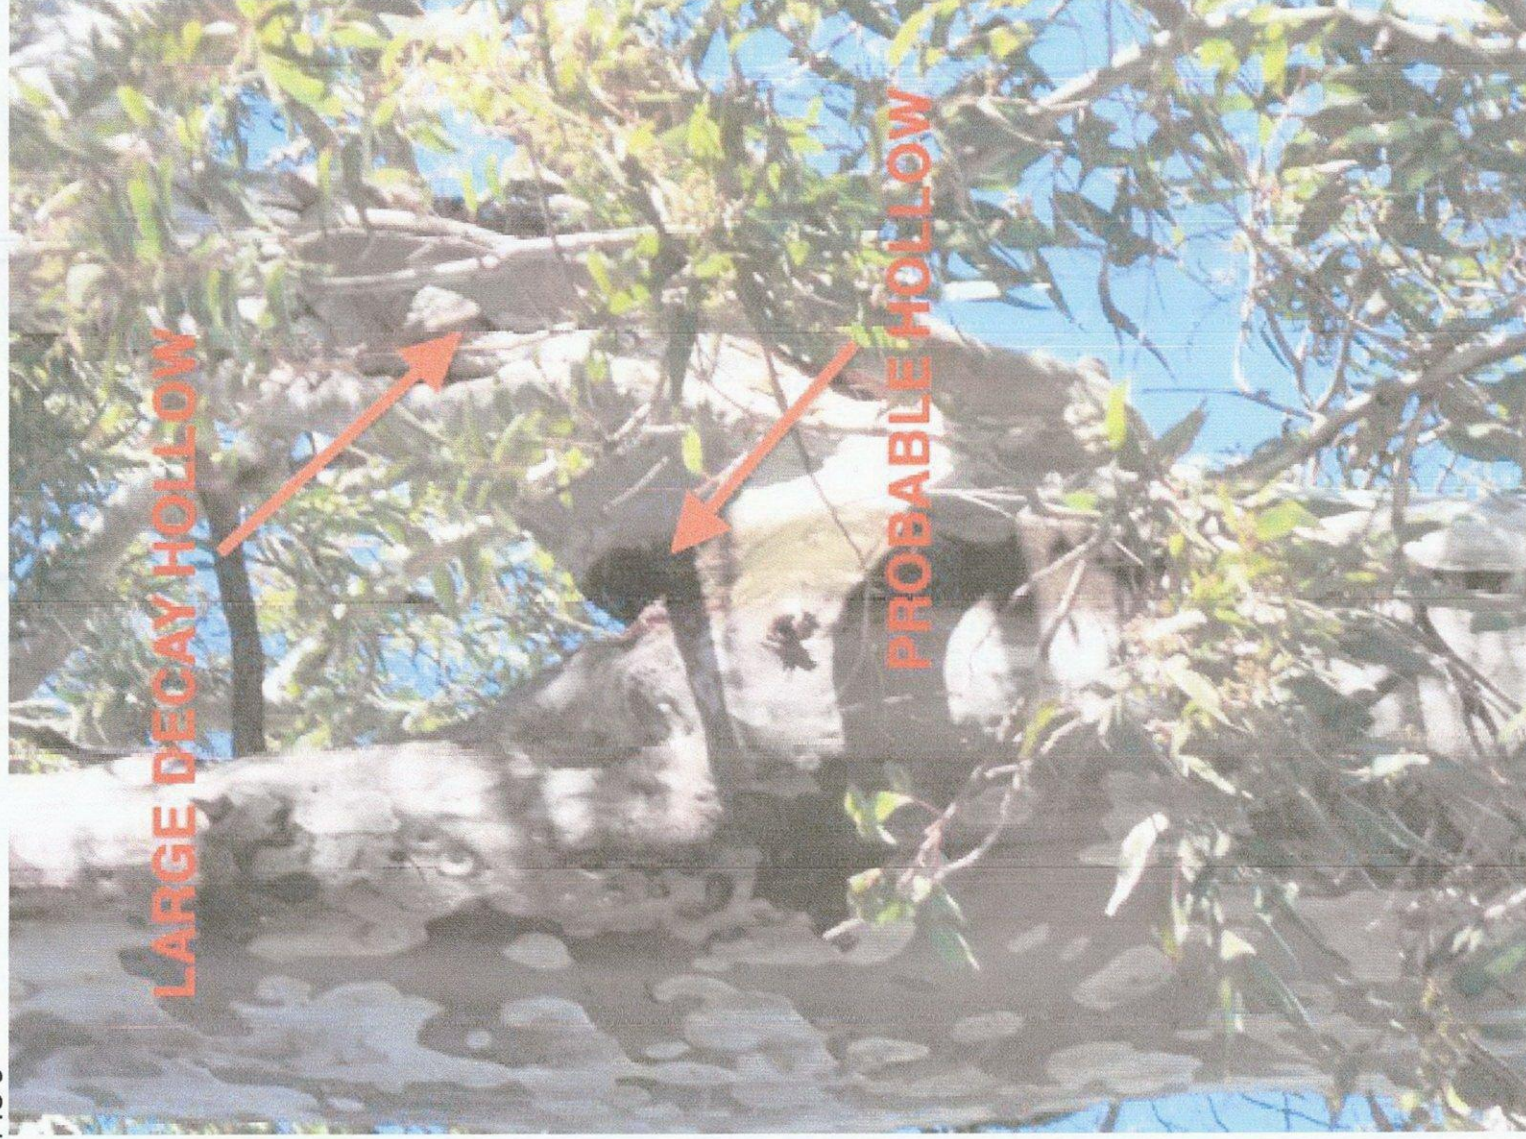
PIC 5

This scaffold is approx. 25cm in diameter and extends approx. 5 metres to the west - it has a large wound and hollow at its base [pic 5]. [See RECOMMENDATIONS]

It is strongly advised that assessment, and probably removal, of the scaffold to the west, which has a large wound at its base [pic 5], be carried out as soon as possible.

An expert climber/arborist will be required to assess the hollow and likely strength at that point – however, it extends over a high target risk area [residents, vehicles] and removal is advisable on a precautionary basis.

The hollow at its base is likely to be compartmentalized and should be left as is.

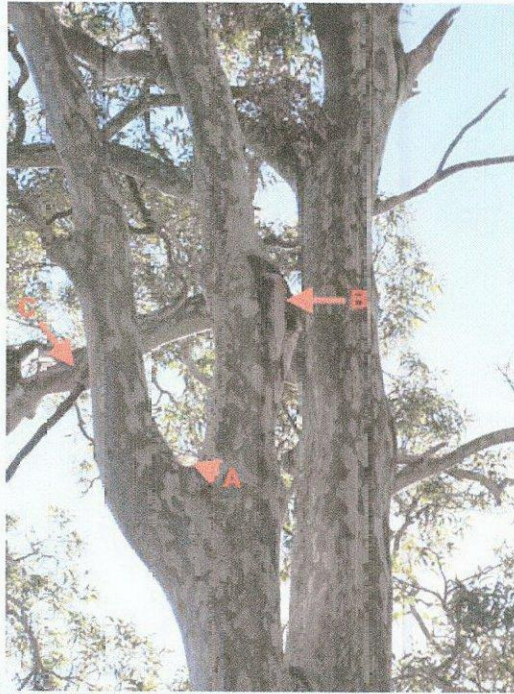
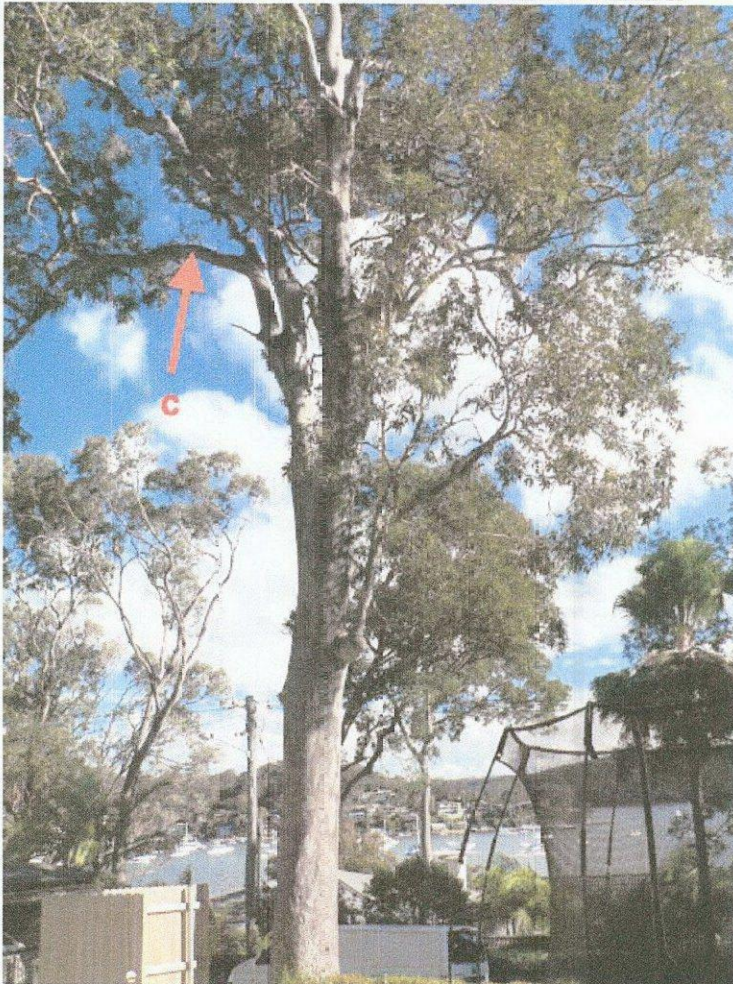
PICS 6, & 6A

The southern trunk divides into two scaffolds approx. 1m along [A – pic 6].

The more vertical scaffold has a hollow 1.5m along [B – pic 6].

The scaffold to the south extends over the drive [C – pic 6, 6A] and has approx. 10-15% deadwood.

The branch extending over the driveway [C, pic 6 & 6A] is also recommended for removal, due to the high target area risk [child activity, driveway], as a precaution.

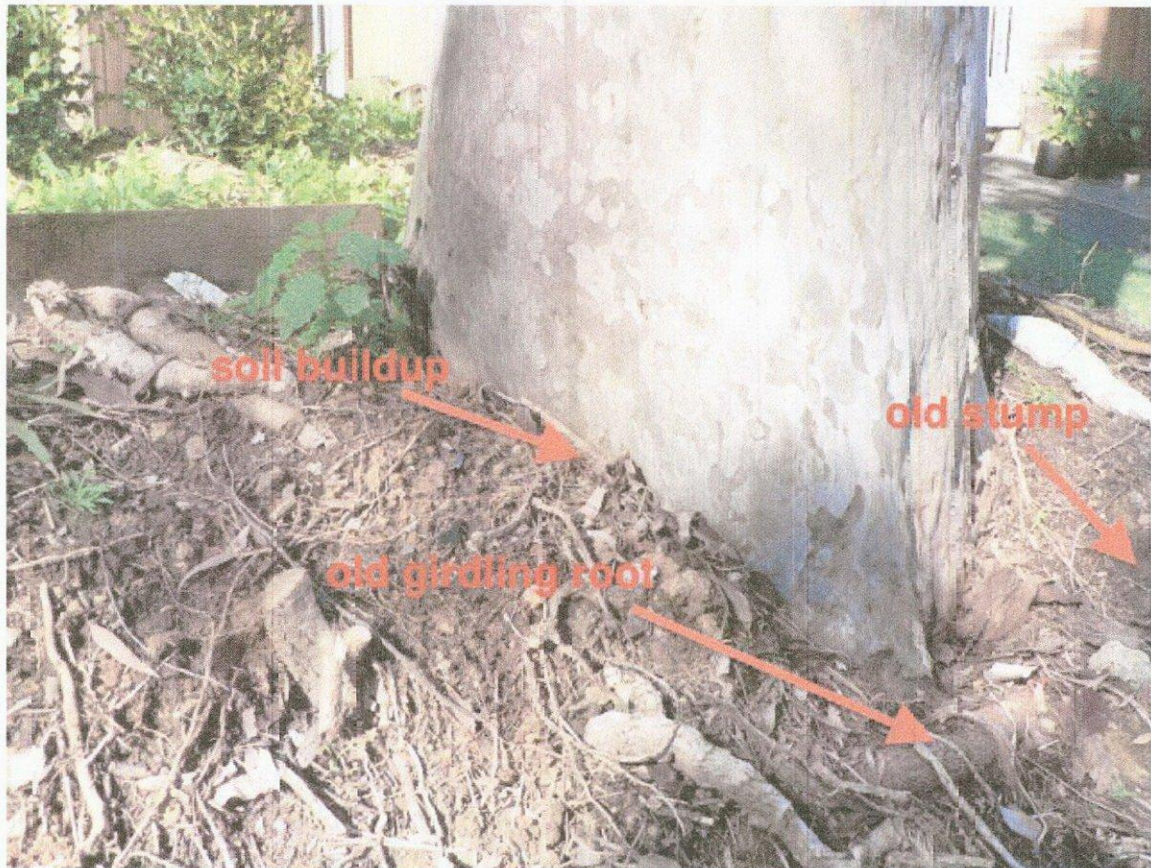
PIC 7

The trunk flare has clearly been buried to a depth of 20-30cm, most likely during 2. above, as indicated by the obscuring of the expected visible emergent part of the flare with soil [pic 7].

A 75mm diameter root, a remnant of a recently removed tree, lies hard against the exposed base of the trunk flare [pic 7] and is likely to cause girdling of the tree in time.

The soil level towards Thyra Rd should be reduced [by hand to avoid trunk/root damage] until the natural trunk flare is visible, to reduce the chance of pathogens entering through damage to the bark of the lower trunk.

The girdling root and old stump [pic 7] should be removed, carefully by hand, to avoid future issues.

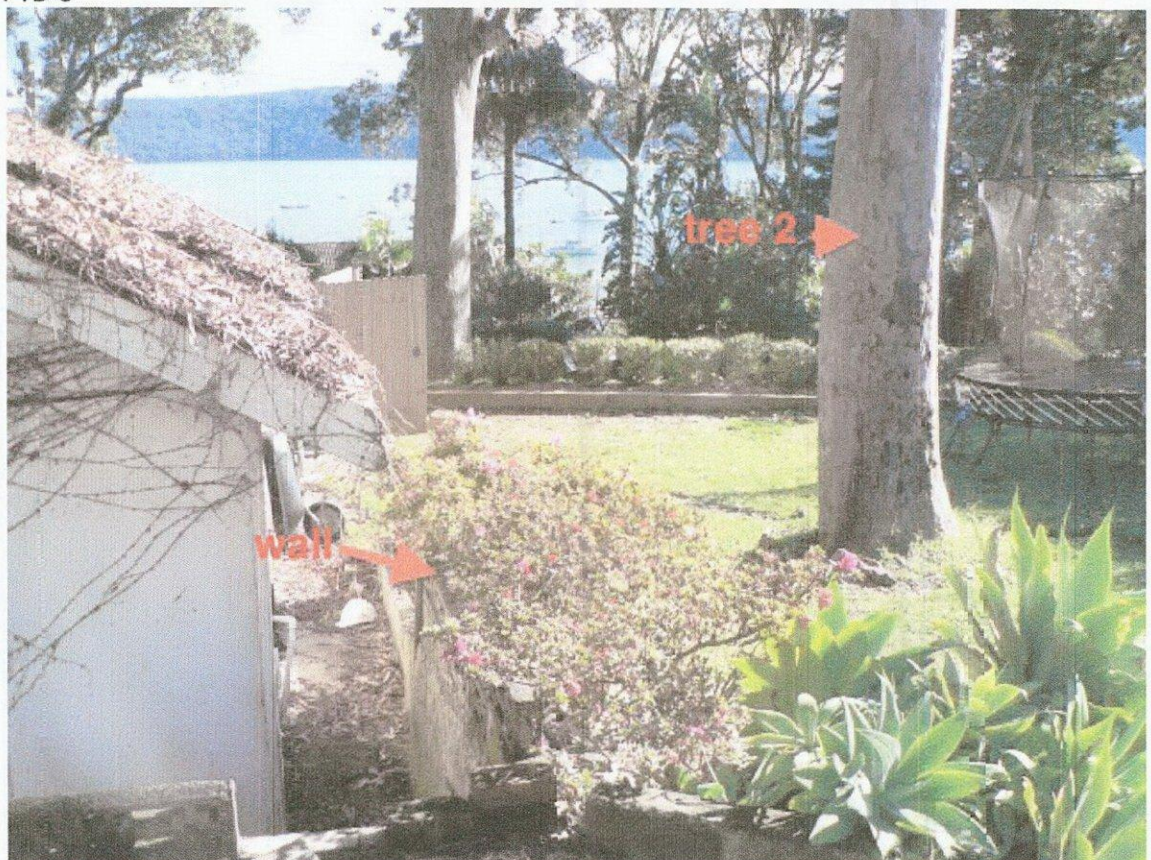
PIC 8

If reconstruction of the wall [pic 8] is required then precautions as for Tree #1 possible wall reconstruction would also apply.

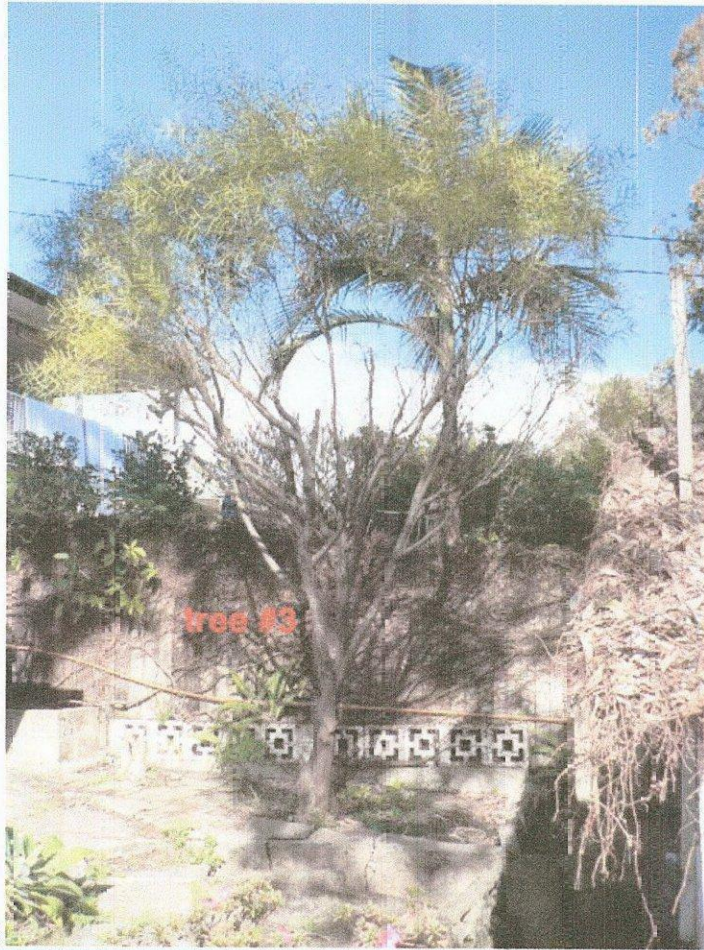
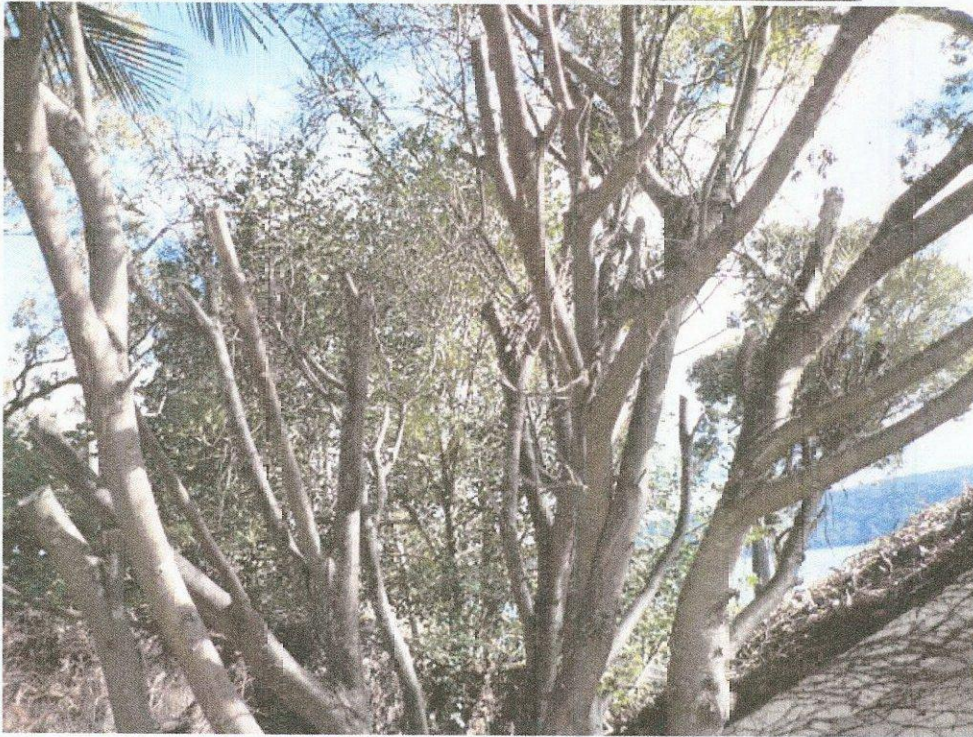
PICS 9 & 10

A small Acacia specimen is located between the house and the garage in an area of sandstone flagging [pic 9].

The tree has been pruned extensively [pic 10], possibly to remove deadwood caused by borer infestation [pic 11 & 12].

If the owners wish to do so, I would fully support removal of this tree and recommend its replacement with a long-lived, bird-attracting species eg Callistemon citrinus Endeavour, or C. viminalis Hannah Ray.

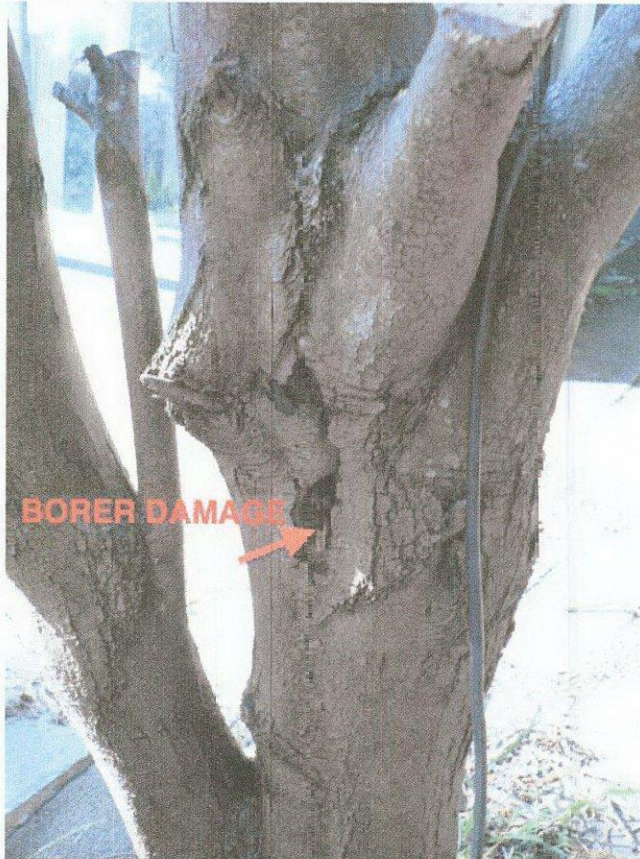
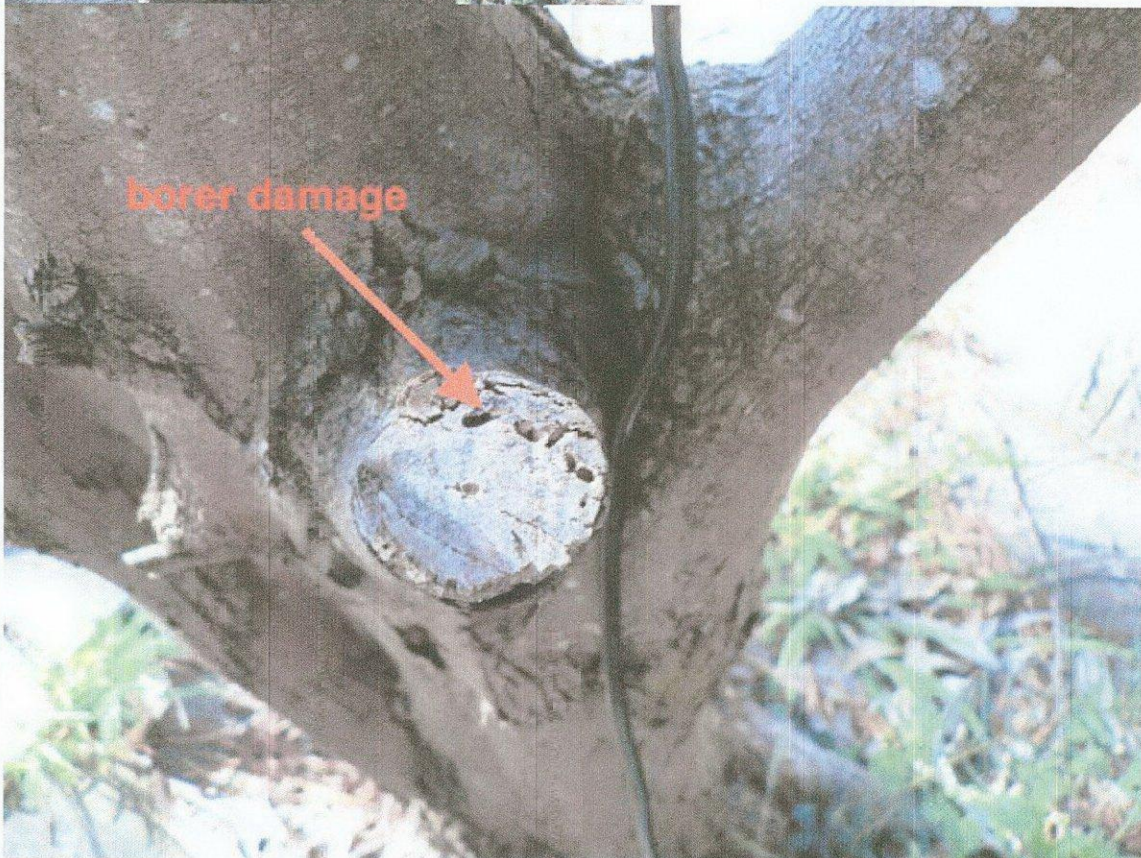
PICS 11 & 12

Borer galleries approx 3-4mm in diameter are seen in the cut ends.

This is a shortlived species, usually due to borer infestation as seen here, which cuts through the cambium layer and causes progressive branch loss.

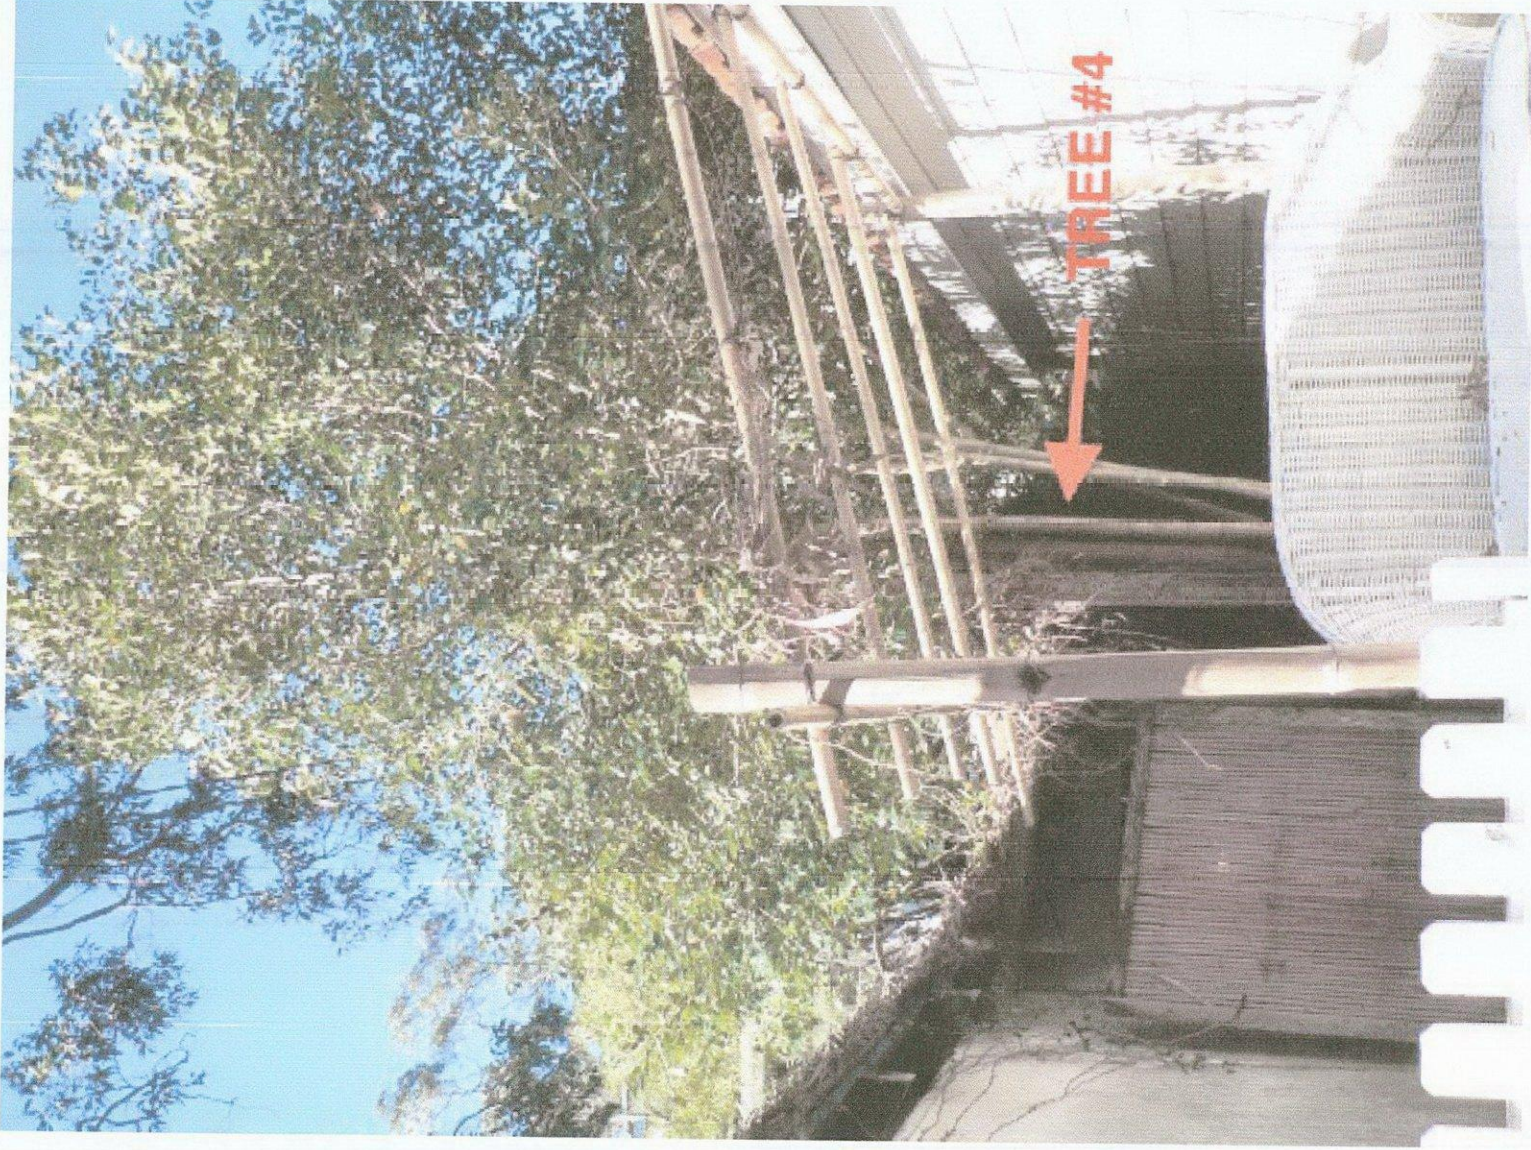
PIC 13

This tree is located in the property to the south [pic 13].

Health appears good [access for assessment is difficult [pic 13].

The root system appears likely to run along the boundary and probably under the garage. If reconstruction of the wall along that boundary is undertaken, care must be taken not to damage the roots in this area.

If a strip footing is required, then pier and beam construction must be used over the roots, with a minimum clearance of 100mm allowed for future growth.
