From: [REDACTED]
Sent: 25/11/2023 6:03:39 PM
To: Council Northernbeaches Mailbox
Cc: [REDACTED]
Subject: Submission for application Mod2023/0554
Attachments: Objection to Boat Ramp to 316 Hudson Pde Clareville10046_Kim edit and removed 2 appendix.pdf;

Please find attached our submission for Mod2023/0554 for the modification of development consent DA2020/1762 granted for demolition works and construction of boatshed, ramp, slipway, jetty and steps.

In relation to the Modification of Development Consent DA2020/1762, granted for demolition works and construction of boatshed, ramp, slipway, jetty and steps (application number Mod2023/0554).

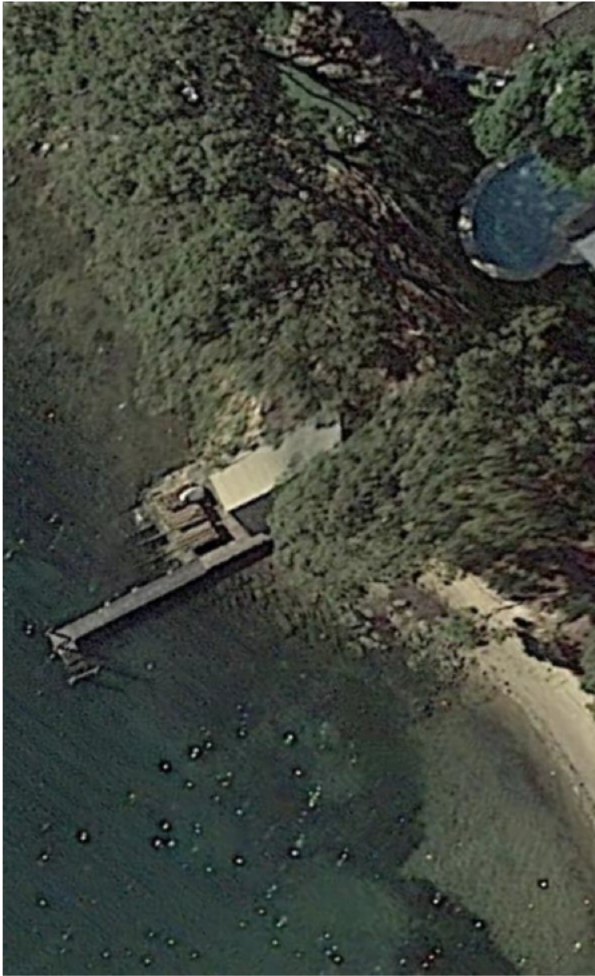
Image A: Google Earth screen shot approx. 2016

Image A shows the original boat house with jetty and jetty pylons.

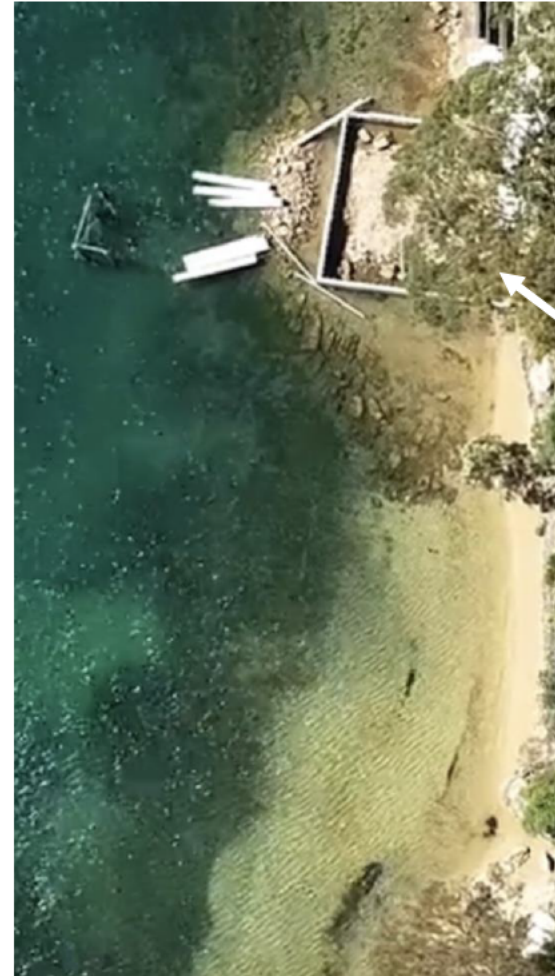
Image B: Aerial photo 2nd November 2018

The more recent Image B shows the footprint of the new boat house.

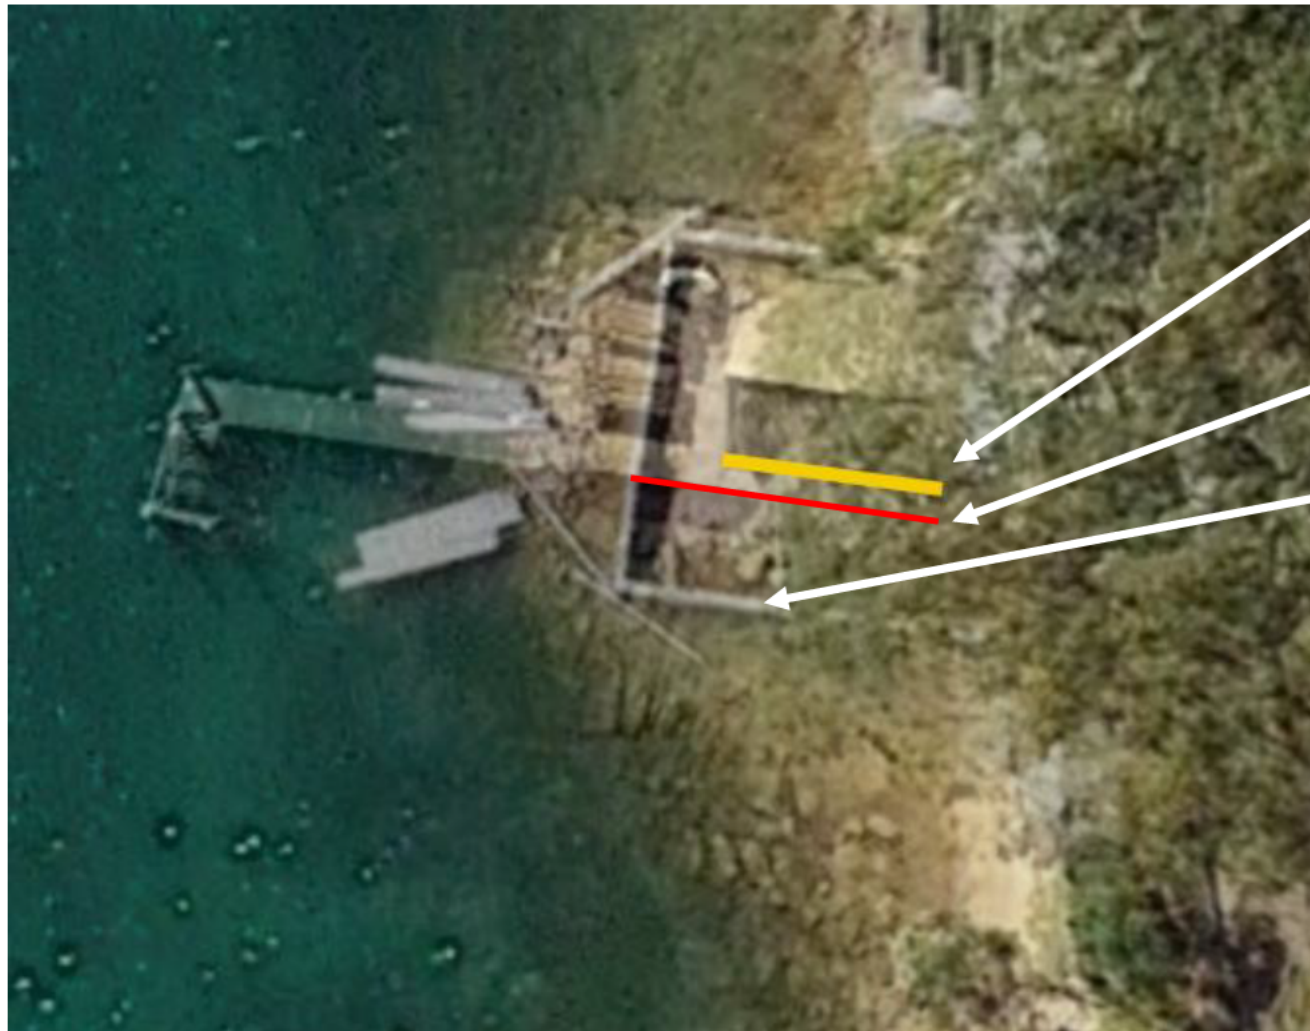
Image C: Overlay of Image A and Image

Approx. location of original sandstone wall of previous boat house.

Approx. Location of the original sandstone wall

Location of new southern Dintel wall, considerably further south than the original sandstone wall footprint

These images show the southern Dintel wall of the new boat house is significantly further south than the sandstone wall of the original boat house.

Image C is an overlay of Image A & B, in which you can see the new southern Dintel wall is now in line with the southern two jetty pylons, whereas the southern wall of the previous structure was set back and to the north from these pylons

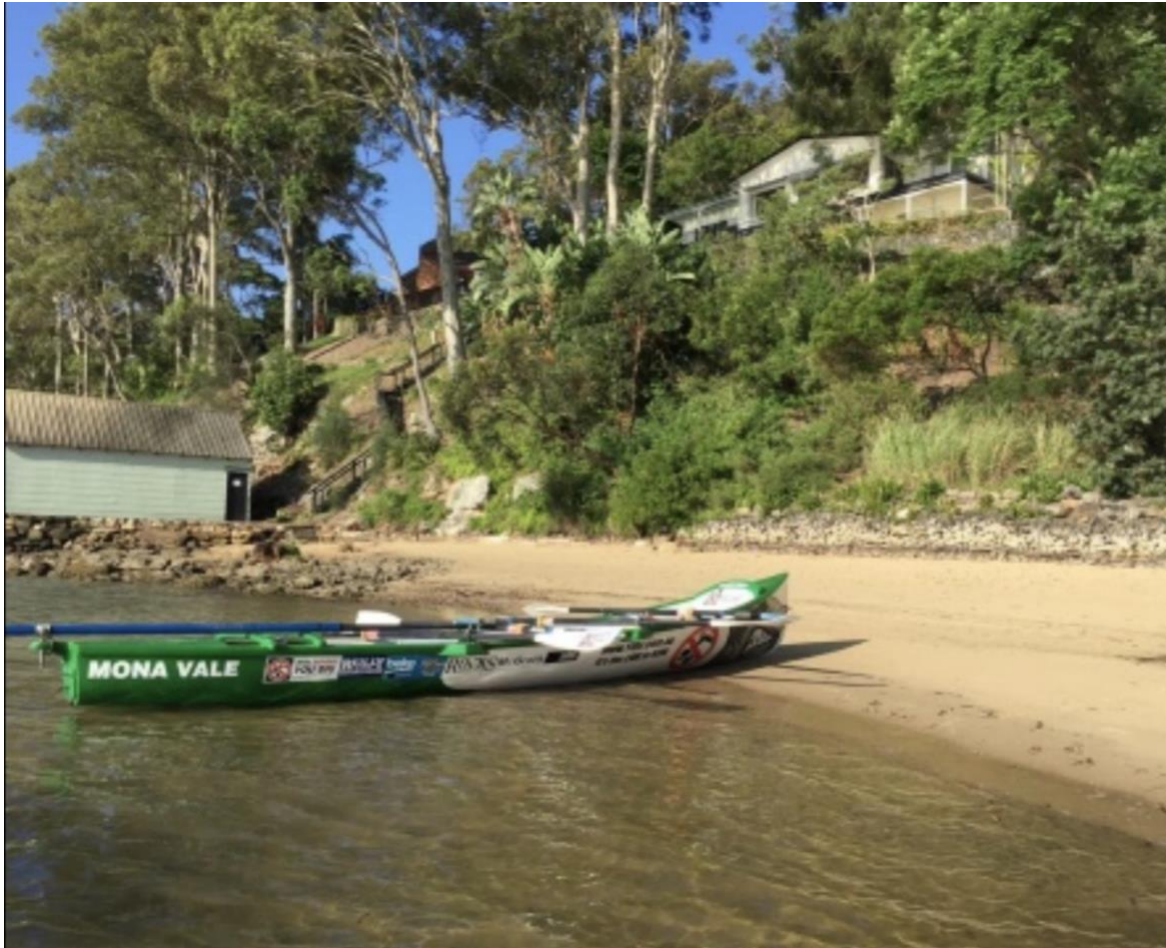
Beach Image 1: Photo taken 9th February 2016

Shows the original boat shed & beach with plenty of sand. Note the sand running high up the highwater mark and into the rocks. Great condition.

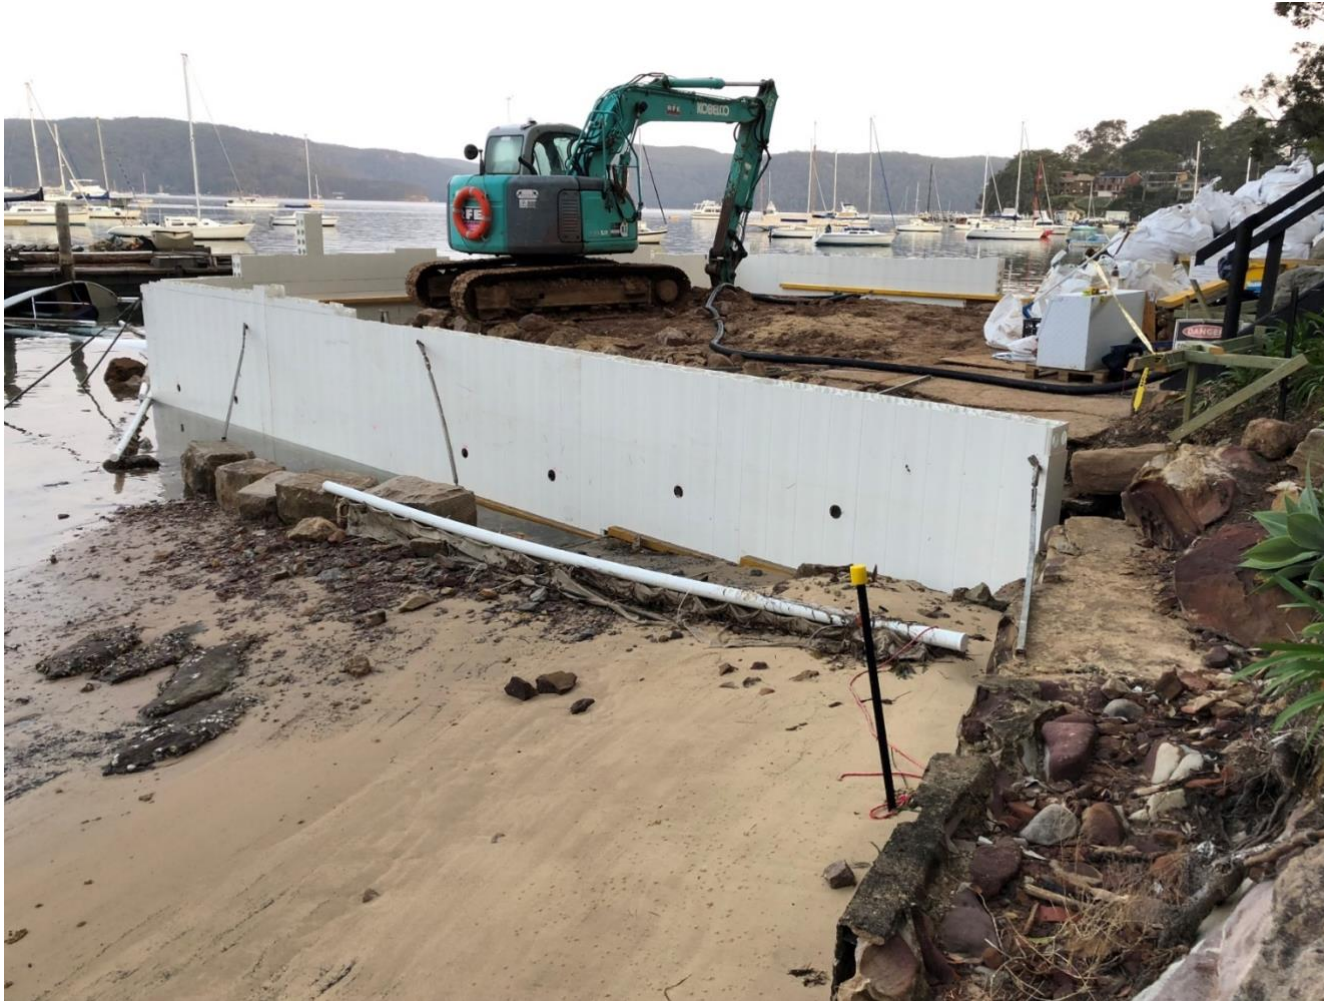
Erosion of beach Image 3: Photo taken 11th September 2018

Again showing plenty of sand and very few rocks to be seen.

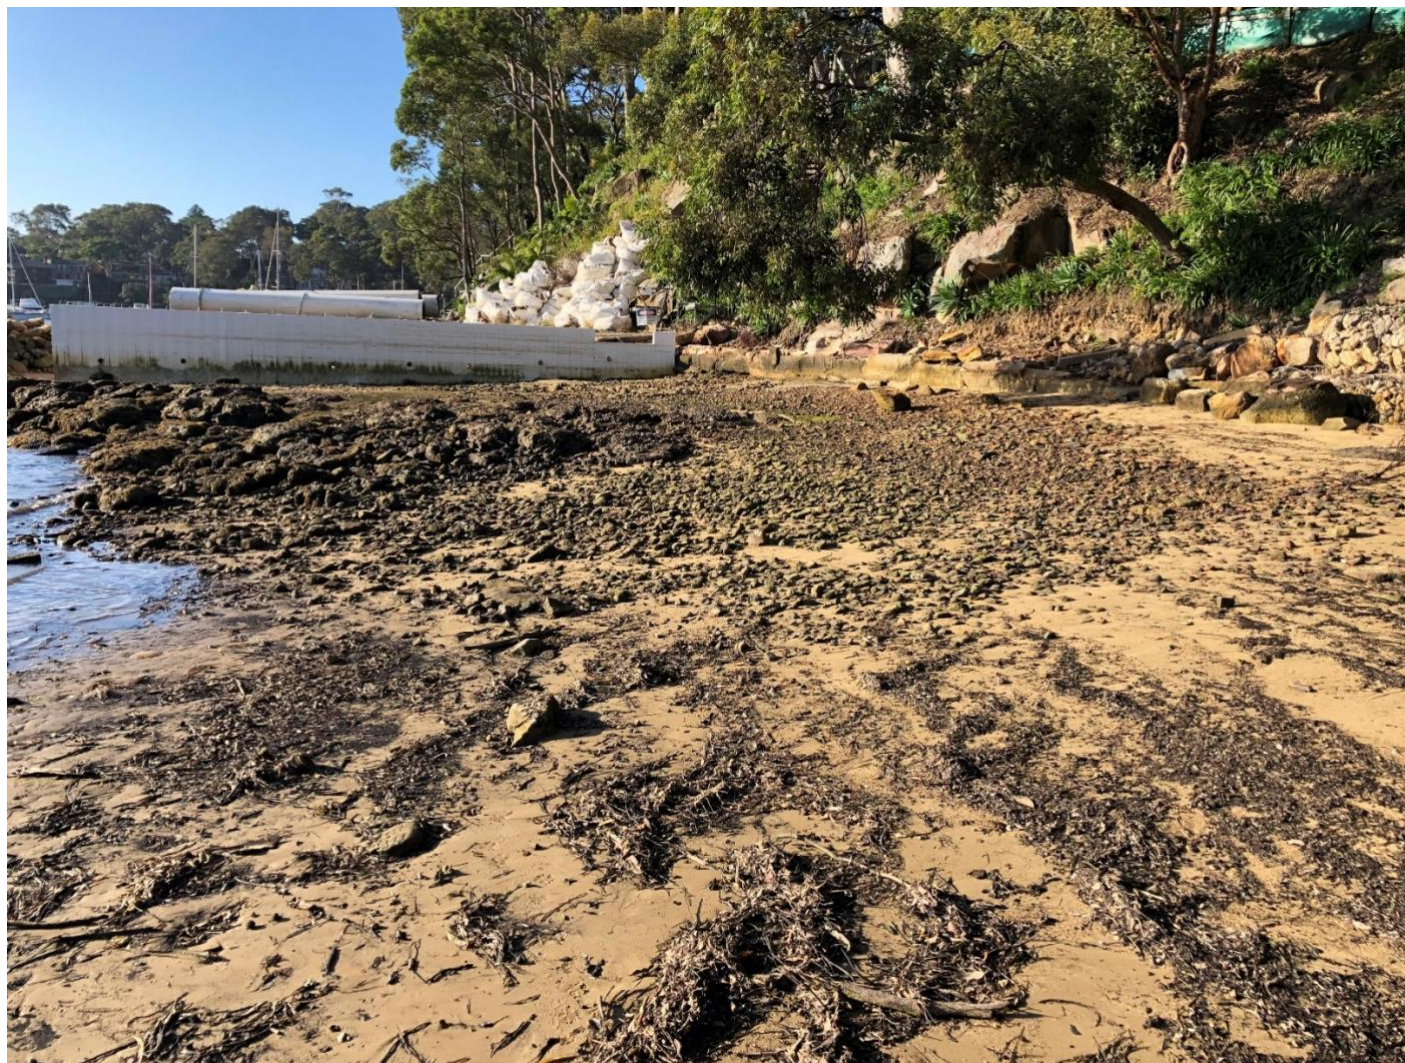
Erosion of beach image 7: Photo taken 19th April 2019

By April 2019 you can see that there is now more rocks than sand.
