# ARBORICULTURAL IMPACT ASSESSMENT REPORT

relating to the proposed inclinor at

**106 PRINCE ALFRED PARADE  
NEWPORT NSW 2106**

22 November 2023  
Revision A

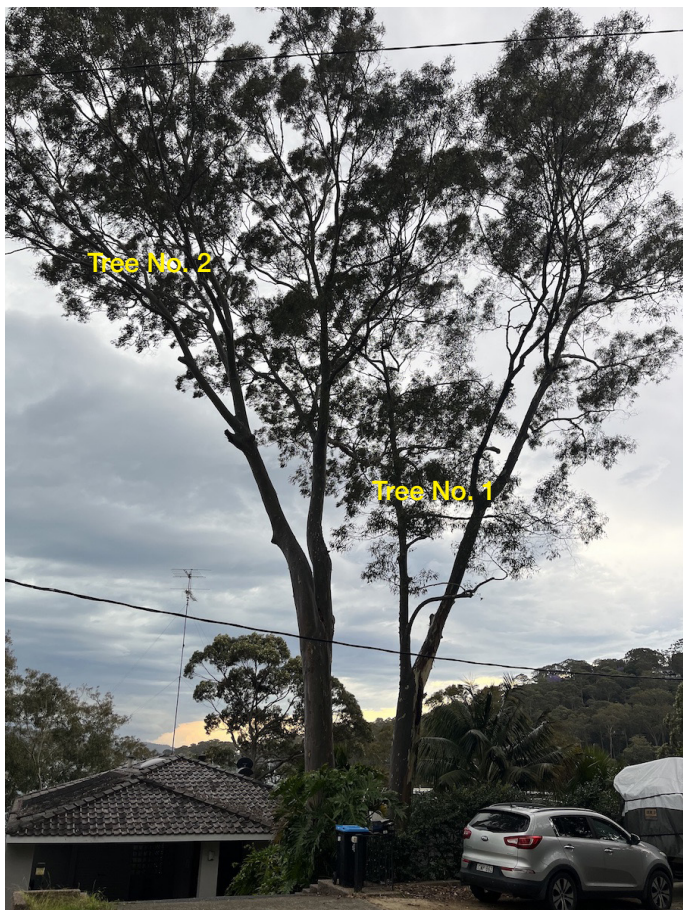
Figure 4 (above): Photograph viewing north to Tree No. 1 & No. 2 (Spotted Gum) from Prince Alfred Parade. (Photo: J Willis)

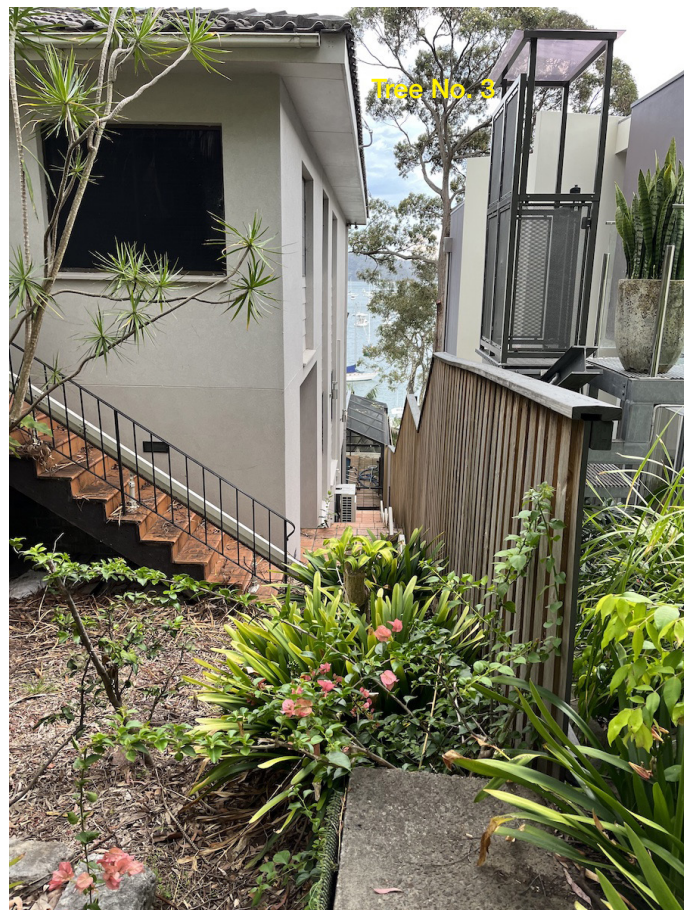
Figure 5 (above): Photograph viewing north along the eastern boundary from the front of the site. The neighbouring Tree No. 3 (Grey Ironbark) is visible in the background. (Photo: J Willis)

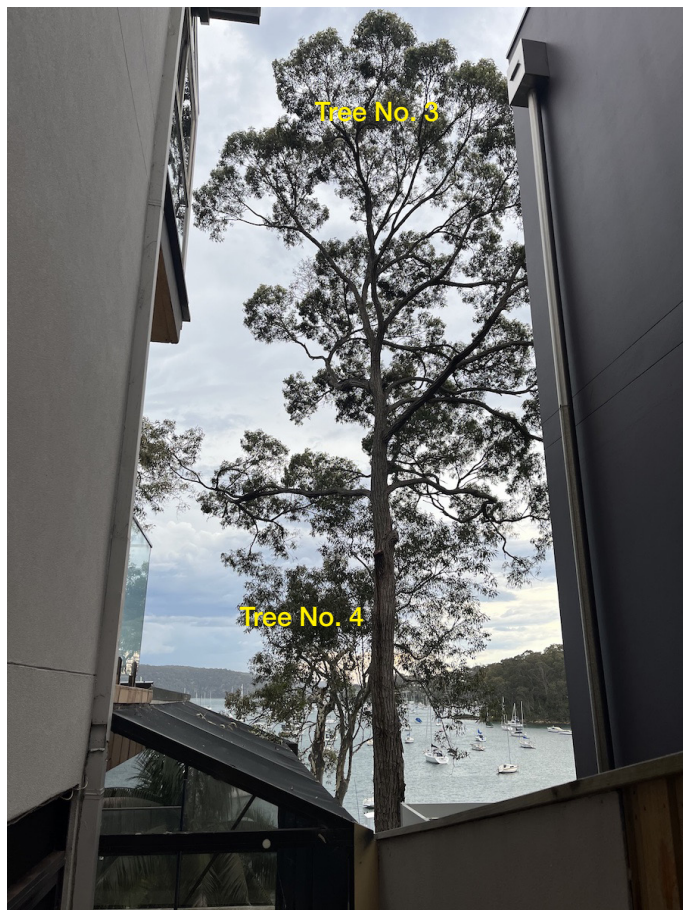
Figure 6 (left): Photograph viewing east to Tree No. 3 (Grey Ironbark) and No. 4 (Spotted Gum) located on the neighbouring site at No. 108 Prince Alfred Parade. (Photo: J Willis)

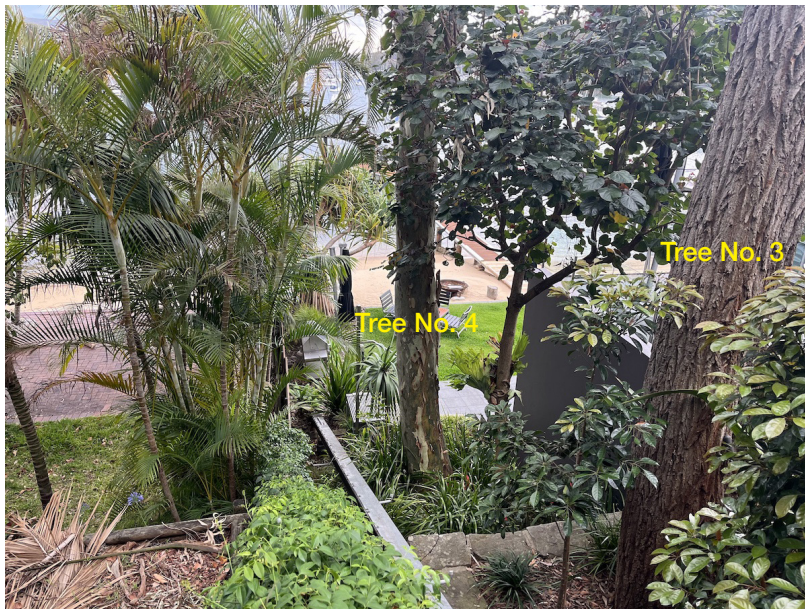
Figure 7 (left): Photograph viewing north along the eastern side boundary with the neighbouring trees visible. (Photo: J Willis)

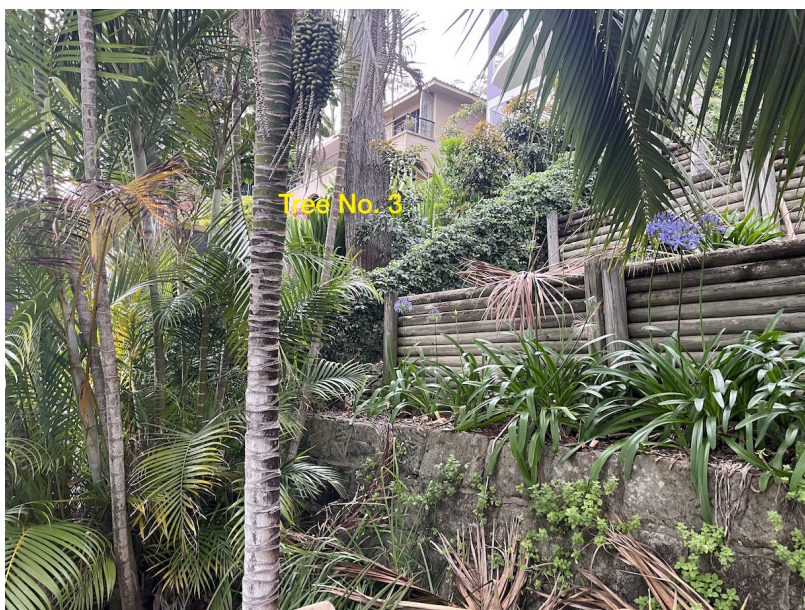
Figure 8 (left): Photograph viewing southwest to the existing retaining walls in the rear yard. Tree No. 3 is visible in the background. (Photo: J Willis)

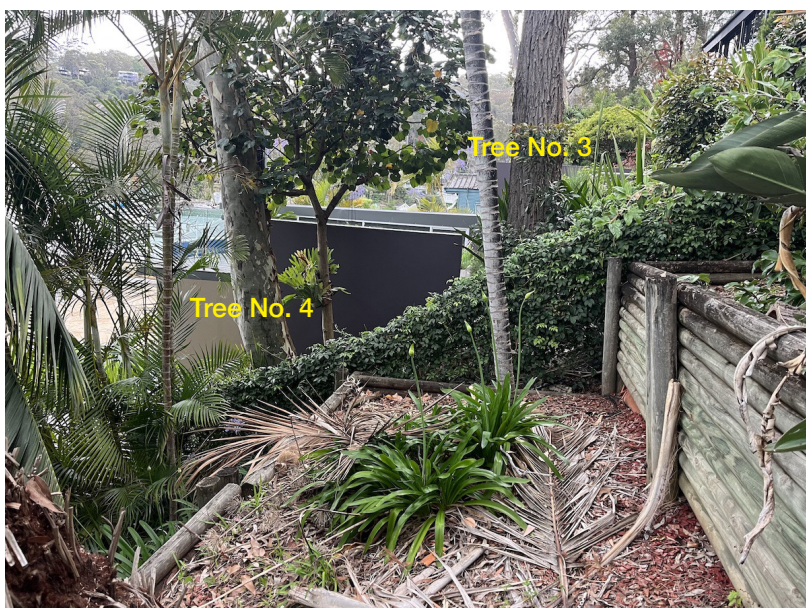
Figure 9 (left): Photograph viewing east to Tree No. 3 (Grey Ironbark) and No. 4 (Spotted Gum) located on the neighbouring land. (Photo: J Willis)

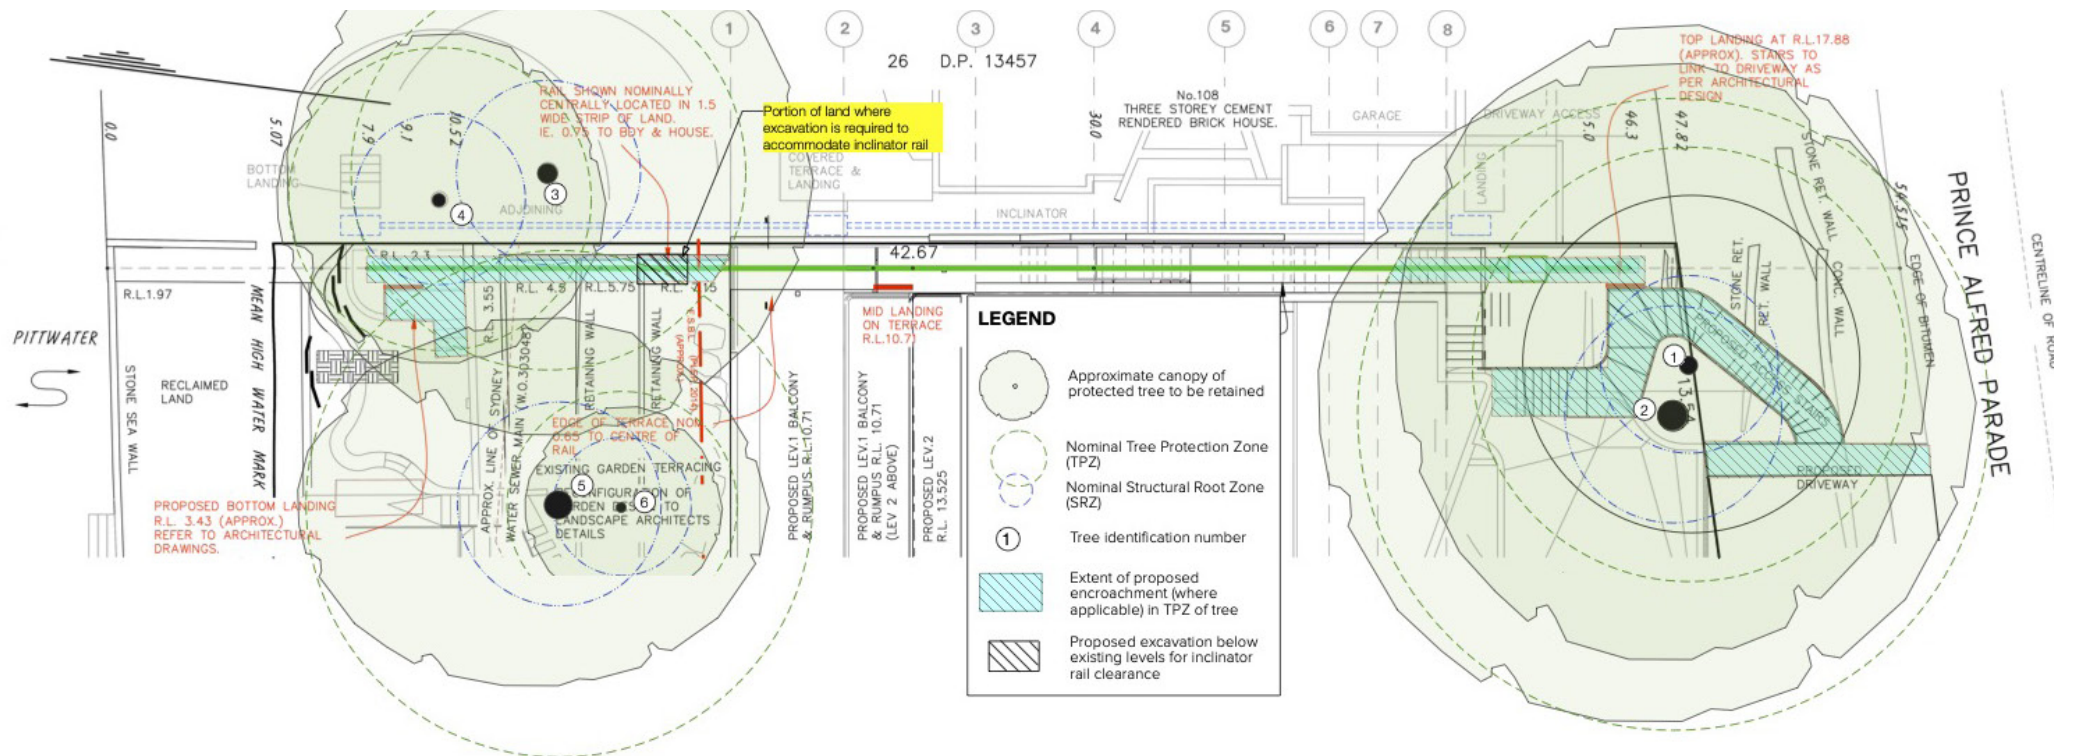
- a) The inclinator rail extends over the TPZ of Tree No. 1, 2, 3, 4 and 5. The lower section of inclinator rail extends over the SRZ of one of the neighbouring Tree No. 4.

- b) The upper landing is located in the TPZ of Tree No. 1 and 2, and the bottom landing is located in the TPZ of neighbouring trees, No. 3 and 4. The landings shall be a light weight structure supported on post footings.

Figure 10: Proposed Inclinator Design including an overlay of the TPZ and SRZ of the trees. The extent of encroachment is indicated as blue hatching. Note, not to scale.

Overall, the inclinator works are considered acceptable providing the final position of all footings and piers are determined on site following preliminary hand digging. Should a woody root equal to or greater than 40mm diameter be uncovered, the footing should be relocated. All footings should be positioned outside the SRZ of the above mentioned trees. Providing no large woody roots are severed as part of the excavation works, the proposed inclinator and associated works should not result in any adverse impact upon the trees.

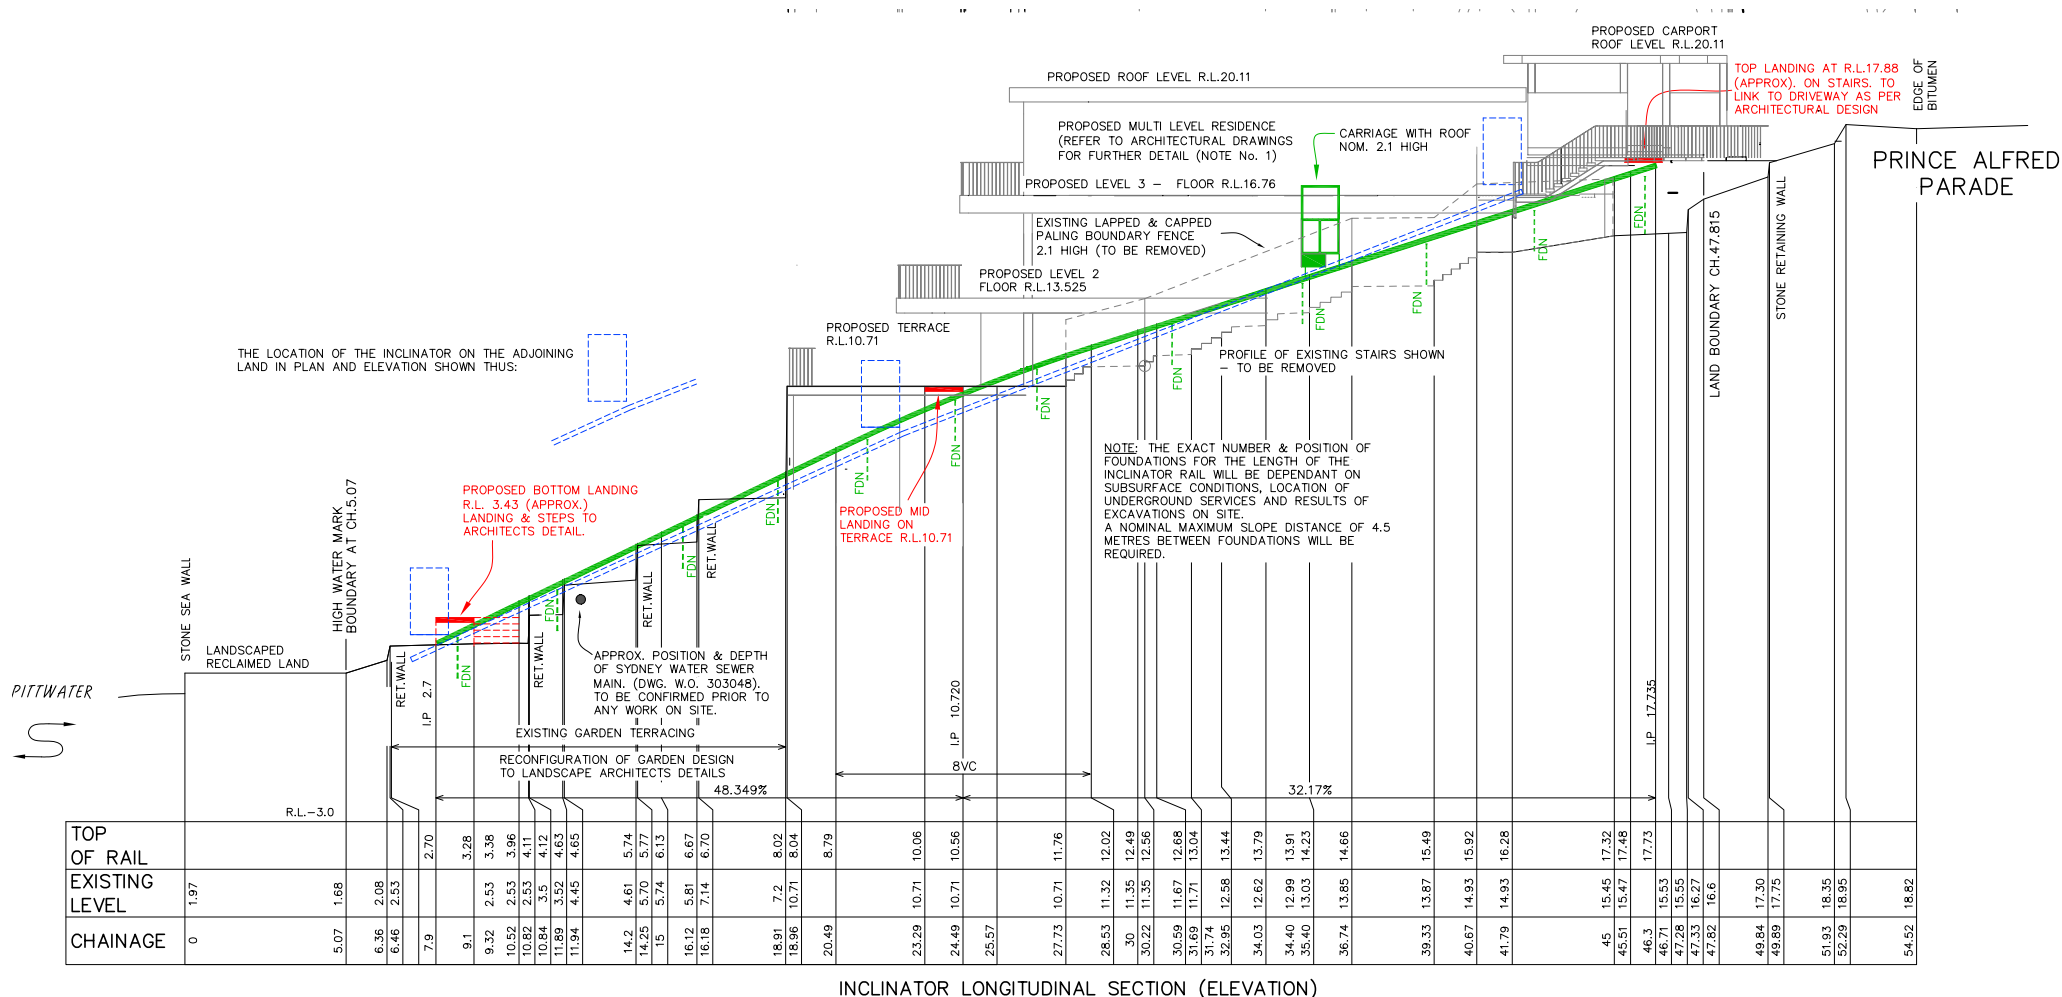
INCLINATOR LONGITUDINAL SECTION (ELEVATION)

- c) Based on the longitudinal section drawing (refer to **Figure 11**) the inclinator rail shall be elevated above existing ground levels with exception to a small portion of the existing terraced garden area (RL 7.15) which is located in the TPZ of neighbouring Tree No. 3 (refer to **Figure 10**). The section drawing indicates minor excavation to achieve clearance between the ground level and the inclinator rail. With consideration to the existing retaining walls and associated level changes located within the TPZ of Tree No. 3, it is the author's opinion it is unlikely the root system of the tree will be impacted upon by the adjustment to the retaining wall level.

Figure 11: Inclinor Longitudinal Section drawing (provided by YSCO Geomatics) indicating the proposed works in relation to the existing ground levels. Note, not to scale.

**(ii) Excavation Works:** Excavation for foundations, piers and all footings must be hand dug with extreme care when located in the TPZ of the assessed trees. Additionally, adjustments to retaining wall and terraced garden level (RL 7.15) in TPZ of Tree No. 3 must be undertaken by non-mechanical methods. Under no circumstances should excavation occur via mechanical methods unless rock is encountered. The final location of all foundations, piers and footings must ensure there is no cutting of any woody roots greater than 40mm diameter. Where woody roots greater than 40mm diameter are encountered and the foundation cannot be relocated, further advice must be sought from a qualified Arborist prior to root severance. Any roots less than 40mm in diameter shall be cut cleanly with sharp pruning implement.

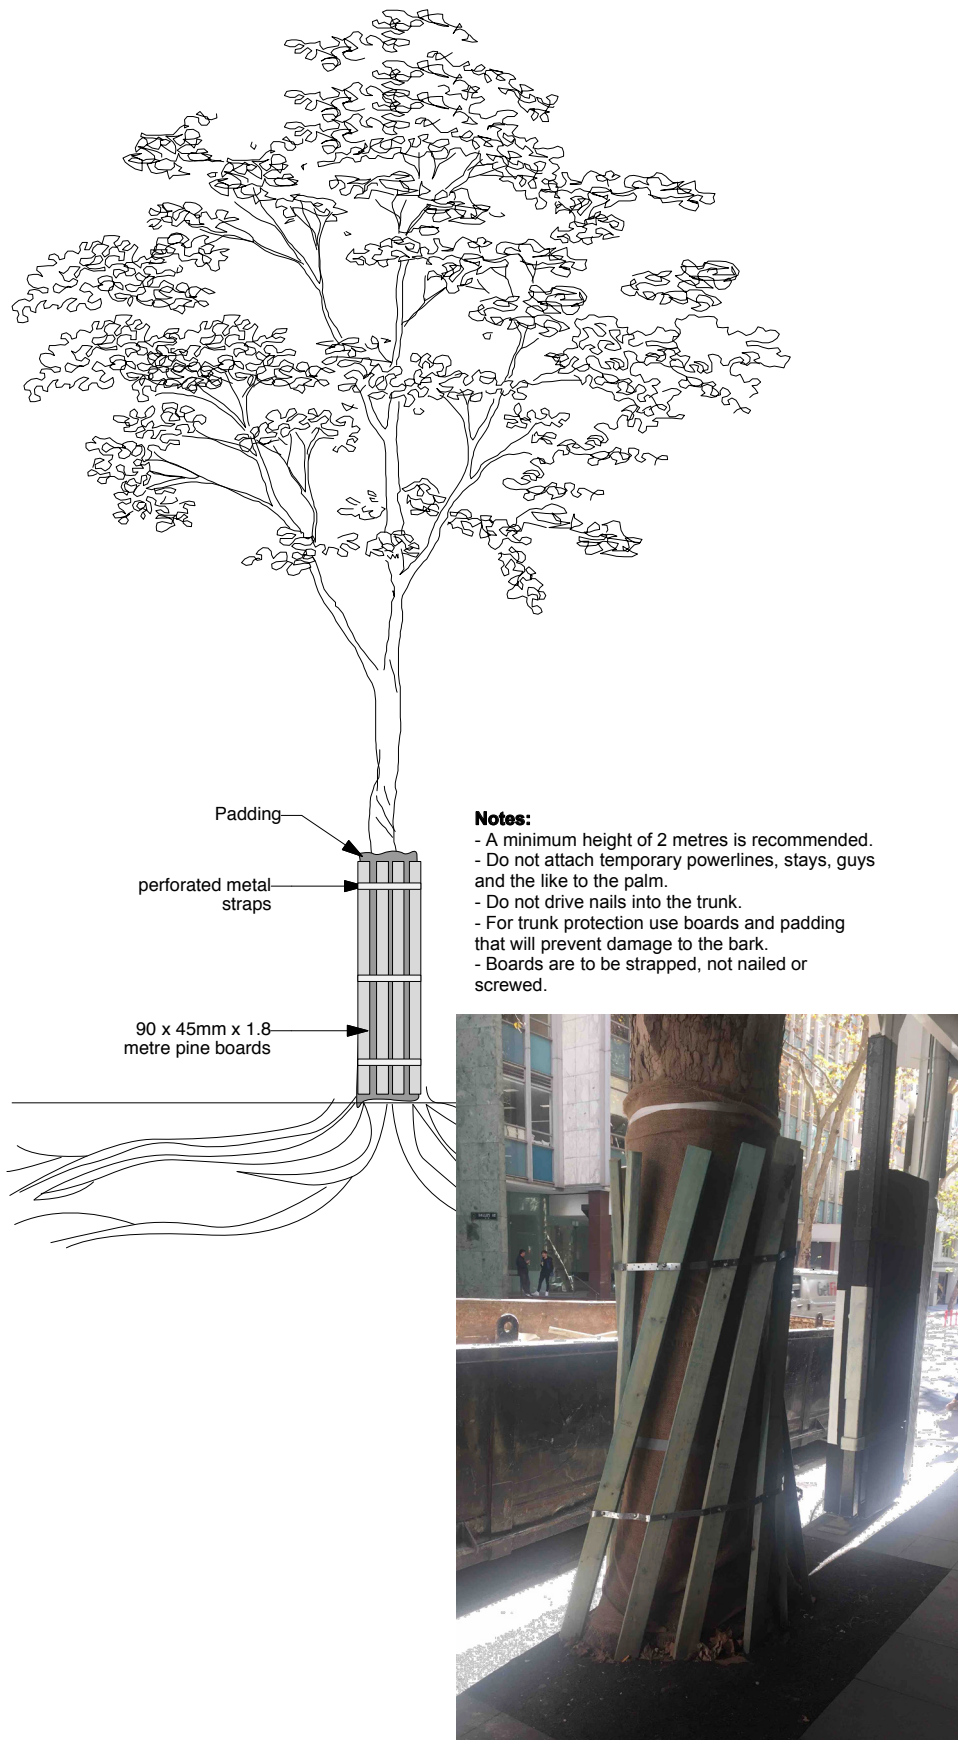
Example of trunk protection installed around a tree

**(i) Trunk Protection (refer to Appendix 3):** Prior to commencement of any works on the site, trunk protection is to be installed around the assessed trees located on the site (including Tree No. 1, 2, 5, 6) and on neighbouring sites (Tree No. 3, 4). As a minimum, the trunk protection shall consist of 1.8 metre lengths of pine board timbers (90 x 45mm) spaced at 100-150mm centres secured together with perforated metal straps. These shall be strapped around the trunk (not fixed in any way) to avoid mechanical injury or damage. Trunk protection should be installed prior to the commencement of any site works and maintained in good condition for the duration of the works. Trunk protection will help to protect the tree from any inadvertent damage that may result from activities during the course of the works.
