## 129 Rickard Road, North Narrabeen

Arbor Impact Assessment  
Version 1.1  
Client: Jacob Chapple

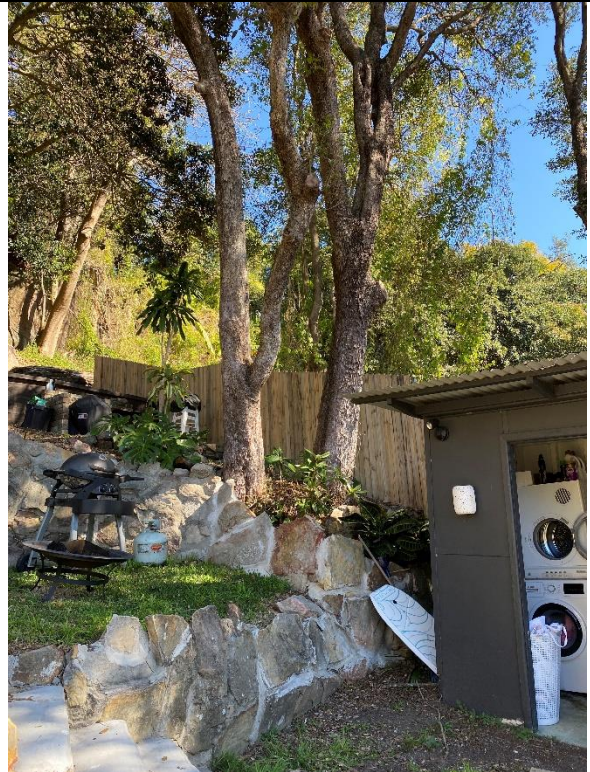
| NO# | Genus | Species | Common Name | Age | Vigor | Growth Habit | Crown Form | Height (m) | Canopy Spread (m) | DBH 1 | DBH 2 | DBH | DRB | SRZ | TPZ | Amenity Value | Eco Value | Sig. Rating | DW % | Defects | General Comments | Encroachment |
|---|---|---|---|---|---|---|---|---|---|---|---|---|---|---|---|---|---|---|---|---|---|---|
| 1 | <i>Glochidion</i> | <i>ferdinandi</i> | Cheese Tree | M | F-AV | L | AS | 12 | 4 | 410 | | 410 | 490 | 2453 | 4920 | | | M | | Phototropic lean away from T2, suppressed to W from Ficus. Growing on edge of steep tiered garden. Epicormic shoots on main trunk and FOB. | | Within Development Footprint |
| 2 | <i>Glochidion</i> | <i>ferdinandi</i> | Cheese Tree | M | AV | CD, U | AS | 12 | 5 | 500 | | 500 | 590 | 2652 | 6000 | | | M | | Rubbing branches @ 7m. Recent heavy crownlifting. | Most dominant canopy of the 4 trees. | Within Development Footprint |

- Tree No.'s 1 & 2 are unsuitable for retention if the proposed development is to proceed in its current form due to being located within the footprint of the proposed tank pool and associated retaining wall. These trees should be removed prior to site establishment.

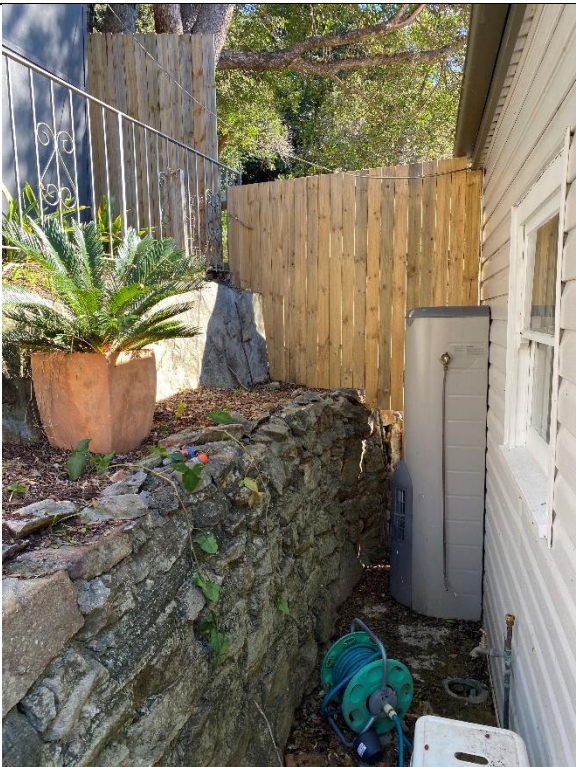
Retaining walls to keep existing levels

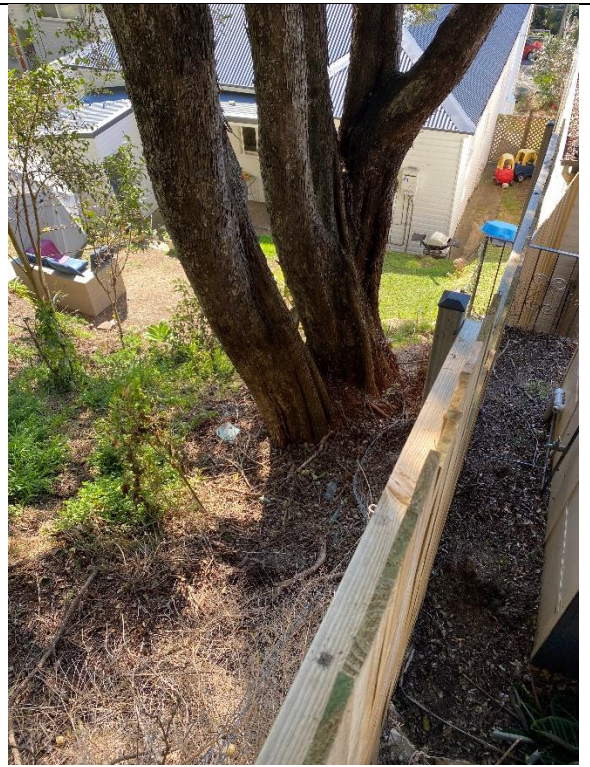
Tree No.'s 3 & 4

| NO# | Genus | Species | Common Name | Age | Vigor | Growth Habit | Crown Form | Height (m) | Canopy Spread (m) | DBH 1 | DBH 2 | DBH | DRB | SRZ | TPZ | Amenity Value | Eco Value | Sig. Rating | DW % | Defects | General Comments | Encroachment |
|---|---|---|---|---|---|---|---|---|---|---|---|---|---|---|---|---|---|---|---|---|---|---|
| 3 | <i>Glochidion</i> | <i>ferdinandi</i> | Cheese Tree | M | AV | CD, L | AS | 13 | 4.5 | 420 | | 420 | 480 | 2431 | 5040 | | | M | | Entwined canopy with T4, and suppressed by T2. Included juncton @ 5m. Rubbing leaders @ 6m. | Tree located in neighbouring property. DBH and DRB estimated due to access. | Located 3m from proposed new stairs to the south and 3.3m from proposed new stairs to south-west posing a combined 9% cut/fill encroachment within the TPZ |
| 4 | <i>Glochidion</i> | <i>ferdinandi</i> | Cheese Tree | M | AV | CD, U | AS | 13 | 6 | 480 | 460 | 665 | 650 | 2762 | 7980 | | | M | | Codominant @ 1m with associated included bark and litter buildup. | Tree located in neighbouring property. DBH and DRB estimated due to access. | Located 2.8m from proposed new stairs to the south and 3.5m from proposed new stairs to south-west posing a combined 16% cut/fill encroachment within the TPZ |

- Tree 3 is a Cheese Tree (*Glochidion ferdinandii*) located in a neighbouring property to the north-west of the site and is 3m from a proposed stairwell and retaining wall, providing a 9% encroachment within the Tree Protection Zone. This tree is considered as having a Medium STARS© Significance rating and must be retained and protected as it is not located on the client's property.

- Tree 4 is a Cheese Tree (*Glochidion ferdinandii*) located in a neighbouring property to the north-west of the site and is 2.8m from a proposed stairwell and retaining wall, providing a

16% encroachment within the Tree Protection Zone. This tree is considered as having a Medium STARS© Significance rating and must be retained and protected as it is not located on the client's property.

While the construction of the stairs and wall is a low impact to the tree's root system, this would be deemed as sustainable by the tree if tree sensitive construction techniques are utilised when working within the TPZ as prescribed by the Australian Standard AS4970-2009 - Protection of trees on development sites. Specifically, excavation for the stairs and retained area at the line of cut should be completed under the supervision of a Project Arborist with a minimum AOF5 level qualification. If roots greater than 40mm diameter are identified, they should be clean cut with a pruning saw or chainsaw under the direction of the Project Arborist.

While the construction of the stairs and wall is a moderate impact to the tree's root system, this would be deemed as sustainable by the tree if tree sensitive construction techniques are utilised when working within the TPZ as prescribed by the Australian Standard AS4970-2009 - Protection of trees on development sites. Specifically, excavation for the stairs and retained area at the line of cut should be completed under the supervision of a Project Arborist with a minimum AOF5 level qualification. If roots greater than 40mm diameter are identified, they should be clean cut with a pruning saw or chainsaw under the direction of the Project Arborist.

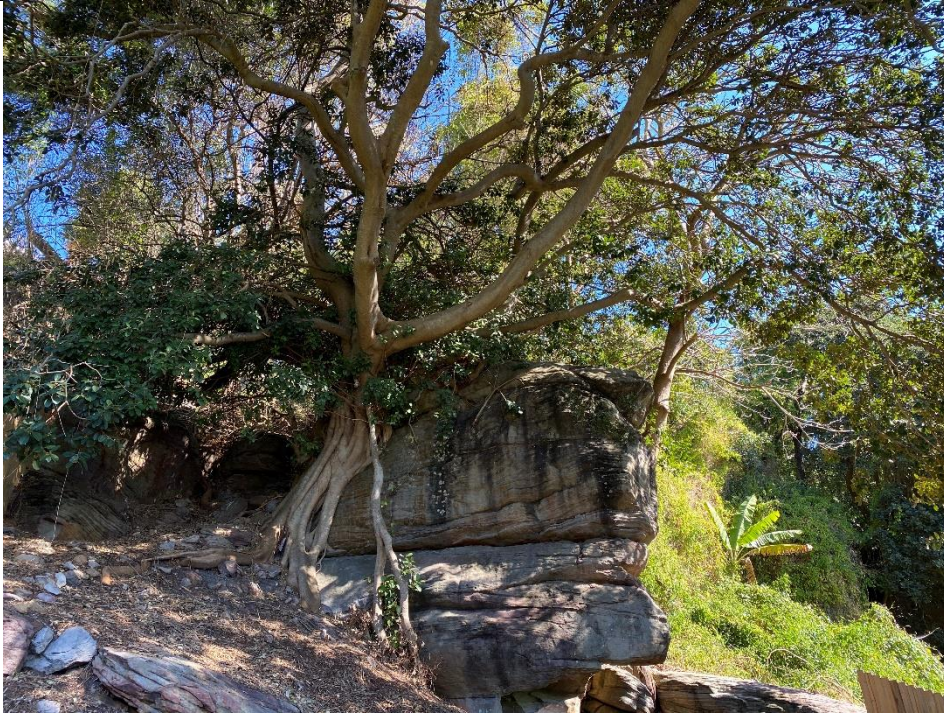
- A Port Jackson Fig (*Ficus rubiginosa*) was noted to be located in the land behind the rear boundary of the property, however no fencing was in place to delineate the property boundary. No works are indicated on the plan (Alterations & Additions inc. Secondary Dwelling completed by Network Design; July 2021) to the area that would be calculated as the Tree Protection Zone for this tree. However, care should be taken when transporting equipment, machinery and goods in and around this tree if such should occur.
- Existing fencing on the boundary that is adjacent to the trees in the neighbouring property is an appropriate height that it can be utilised as tree protection fencing. This section of fencing should be sign posted with a 'no access' instruction and contact details for the Project Manager and Project Arborist.

Port Jackson Fig behind rear boundary
